# **Rail Accident Report**

Passenger train derailment near East Langton, Leicestershire 20 February 2010

Report 01/2012 January 2012 This investigation was carried out in accordance with:

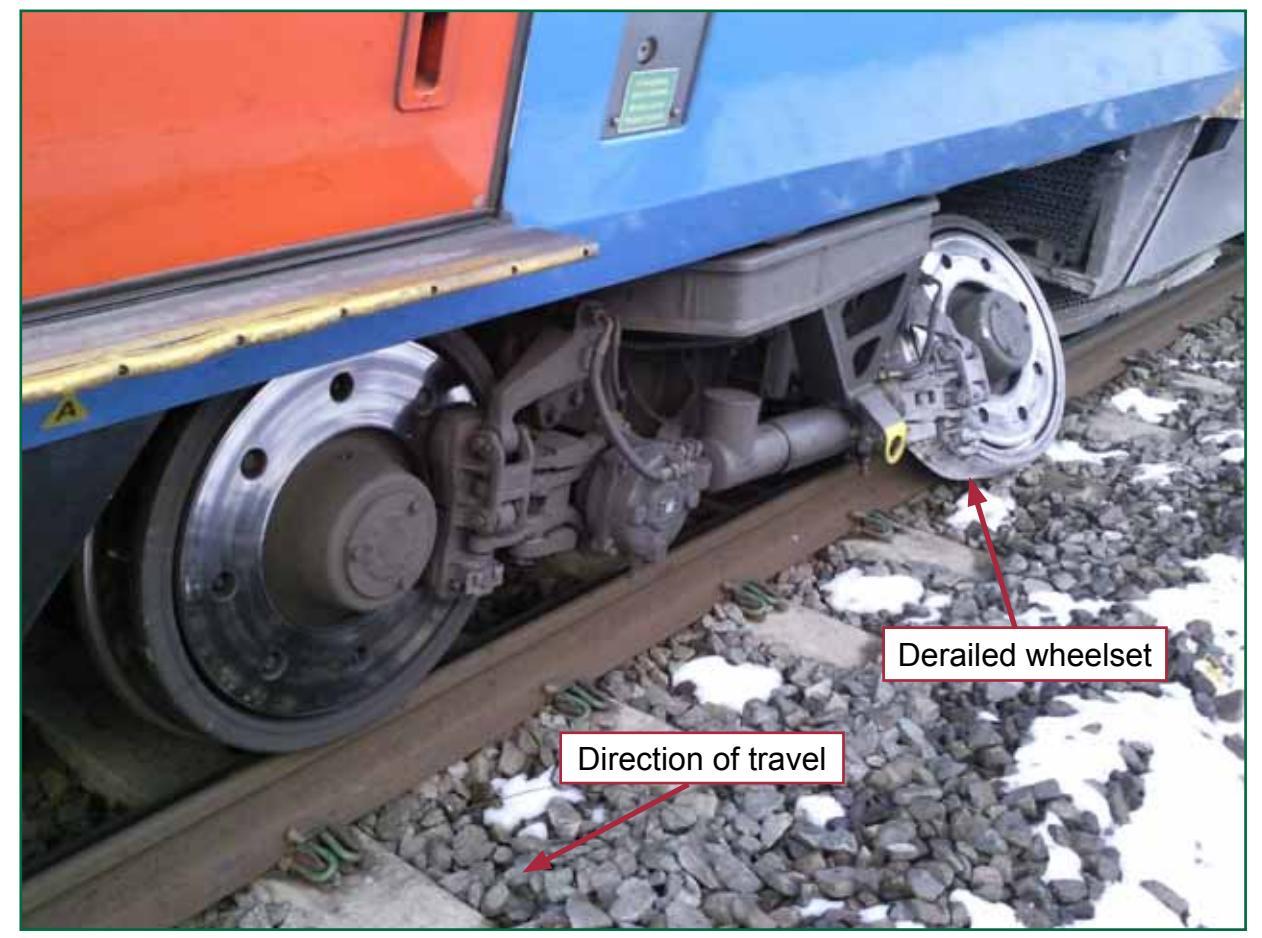
Figure 2: Derailed trailing wheelset of leading bogie (fourth vehicle)

- 8 The train, a seven-car Class 222 Meridian, ran derailed for approximately 2 miles (3.2 km) before stopping. The derailed axle was the trailing axle of the leading *bogie* of the fourth vehicle. All the vehicles remained upright and clear of the adjacent *up* line throughout the derailment. Figure 2 shows the derailed left-hand side wheel.
- 9 There were 5 crew members and approximately 190 passengers on board the train. There were no reported injuries.

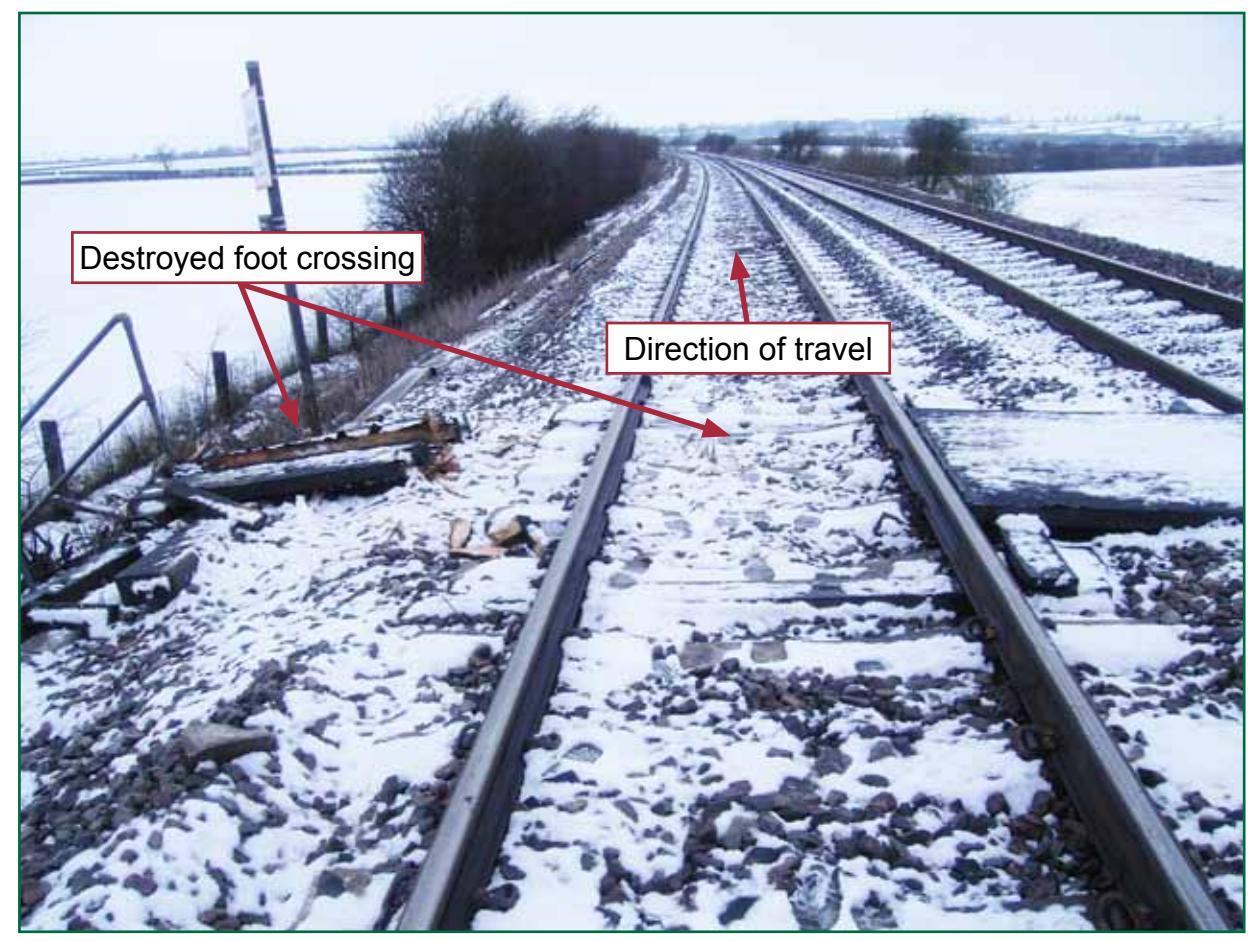
Figure 4: The derailment site and the destroyed Thorpe Langton foot crossing

- 21 The railway at this location is double track with a permitted speed of 100 mph (161 km/h). The first part of this section of railway lies on an embankment (figure 4) which merges progressively into a cutting at the end of this section. The gradient of the line after Market Harborough station falls gently at between 1 in 165 and 1 in 500 to around the 86 mile post and then rises at 1 in 167 towards overbridge 25. The track construction in this area is continuous welded rail (CWR), laid on concrete sleepers. The condition of the track did not contribute to the accident.

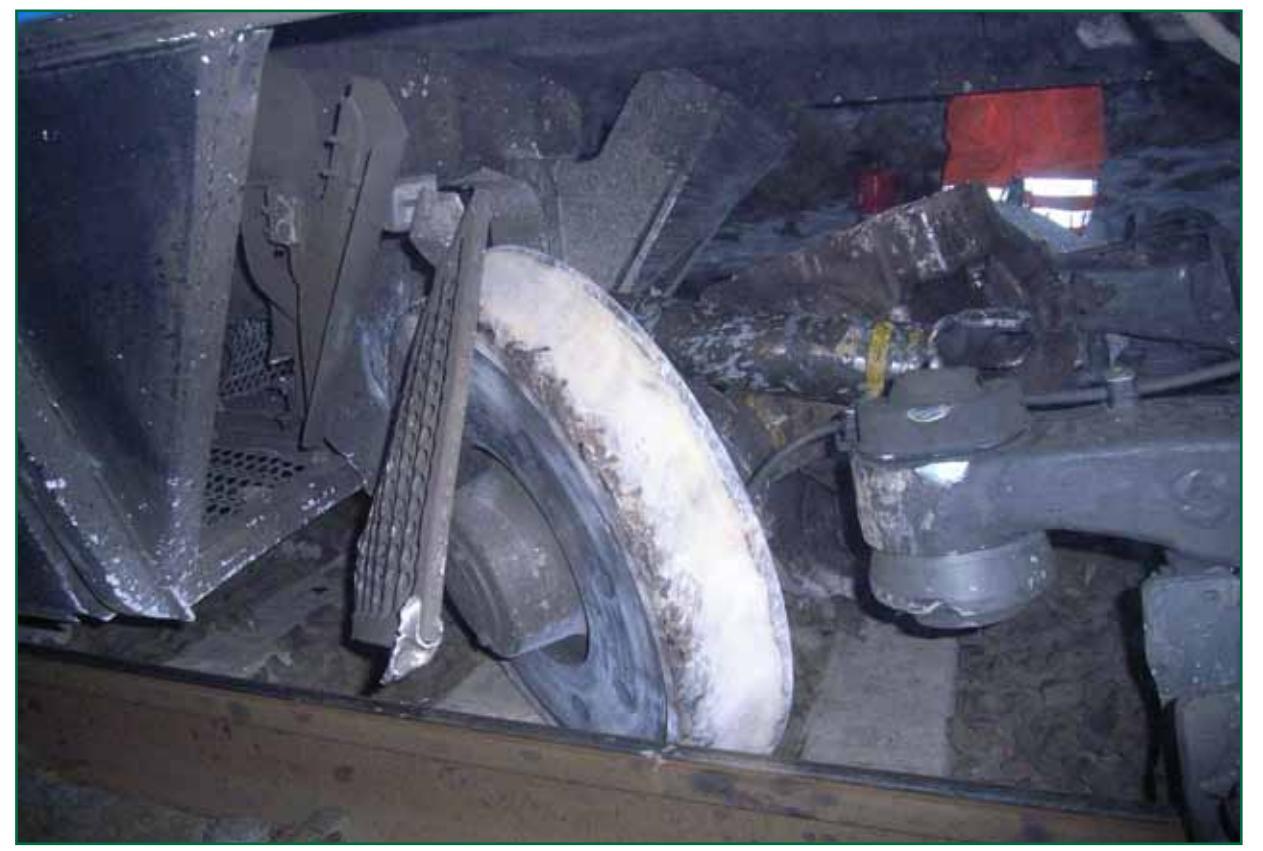
Figure 7a: Fractured axle as found on site (right-hand wheel side)

- 54 Witness evidence indicates that the driver carried out an inspection of the fourth coach (vehicle 60625), from the cess. He saw that the axle was fractured and the final drive gearbox was lying upside down in the four-foot (figure 7a). The portion of the axle around the fracture, just outboard of the left side of the final drive gearbox (figure 7b) was still glowing orange. He noted that the automatic fire extinguisher system on the vehicle underframe had operated and that the diesel tank had been punctured and was leaking. The driver deployed a hand-held fire extinguisher he had brought with him, onto the hot end of the fractured axle and shut down the engine on the vehicle. He then returned to the cab, made an announcement to reassure passengers, and informed the signaller and East Midlands Trains' control of the situation.

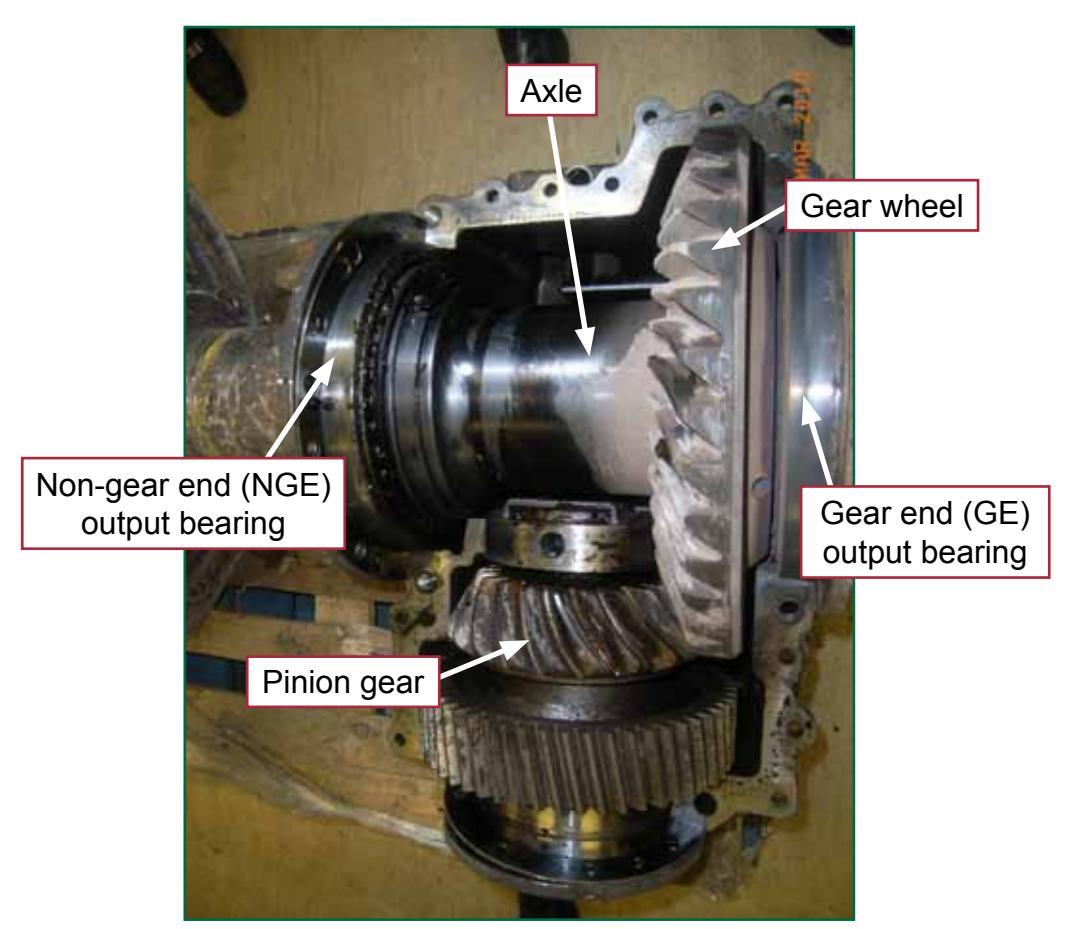
Figure 8a: Failed final drive gearbox (lower half)

64 Relevant parts of the final drive gearbox and axle are shown in figure 8a (photograph) and figure 8b (schematic). Throughout the following text and associated appendices, the abbreviations 'GE bearing' and 'NGE bearing' are used to denote the gear end and non-gear end tapered roller output bearings<sup>2</sup> respectively. A cutaway of this type of bearing is shown in figure 8c.

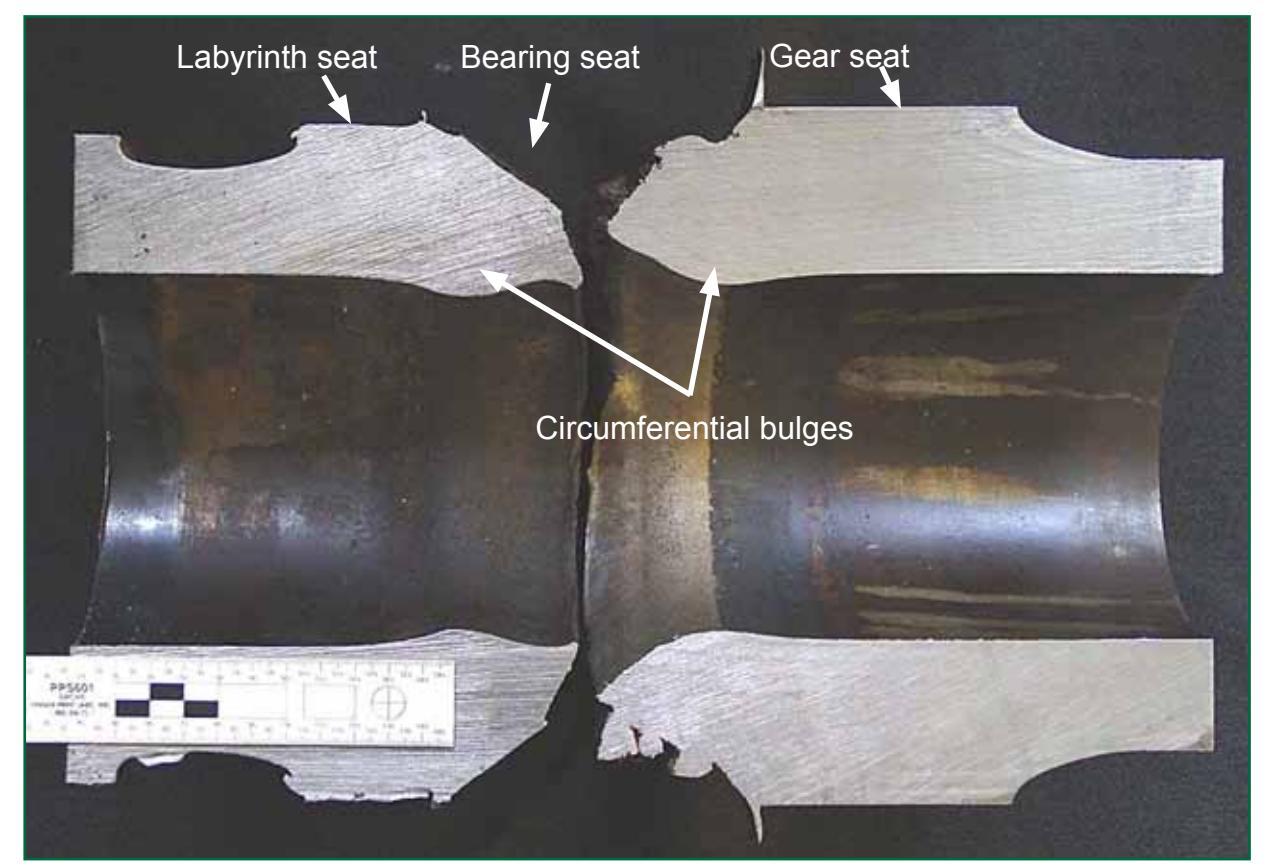
Figure 9a: Section through axle either side of fracture face (courtesy of Serco)

- 71 Metallurgical analysis of the axle material around the fracture faces showed that the highest temperature occurred at the GE bearing axle/inner ring interface, where the temperature had reached around 1100 1200°C, and therefore that this interface was the source of the heat. Figure 9b shows the heat affected zones on polished sections through the axles. Figure 9c shows a section through the GE bearing, labyrinth and bearing housing. The heat affected zone in this section is at the bore of the inner ring.

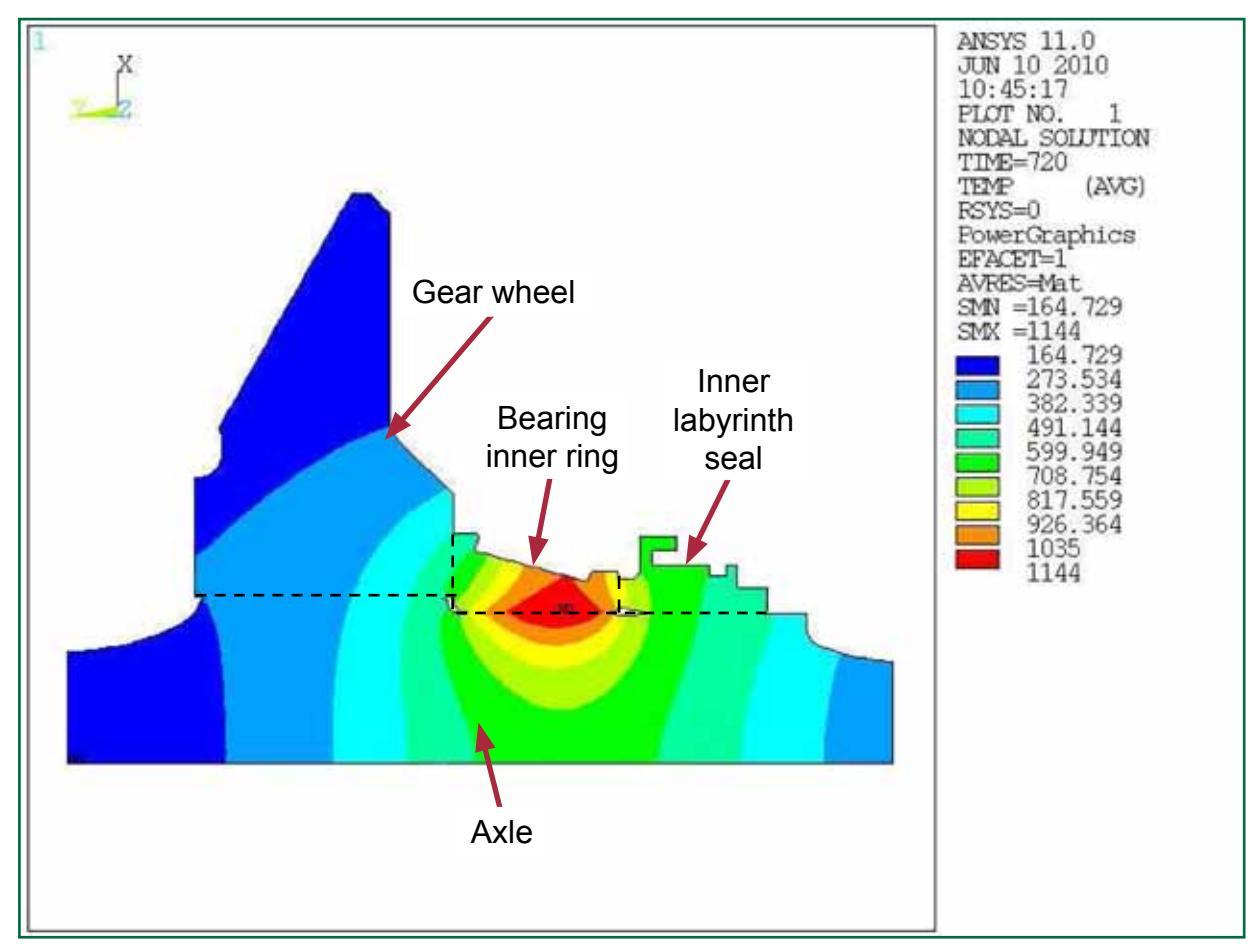
Figure 10: Calculated temperature distribution at axle/inner ring interface after 12 mins with 30 kW heat input (courtesy of Interfleet Technology)

- 30 kW: 12 mins
  - 15 kW: 60 mins
  - 7.5 kW: maximum temperature reached 550°C
- 74 Figure 10 shows the calculated temperature distribution around the axle/inner ring interface after 12 minutes for a heat input of 30 kW. By this time the outer surface of the axle would be expected to have reached around 1100°C, and the inner surface around 650°C. At these temperatures, the strength of the axle material is likely to have been between 5% (outer surface) and 24% (inner surface) of its strength at room temperature<sup>6</sup>. While some of the heat input is lost from the axle/inner ring interface (mainly by conduction into cooler parts of the axle), a stage would have been reached when the temperature throughout the thickness of the axle was high enough for gross plastic strain, ductile thinning of the weakened material (paragraph 69) and fracture to occur.

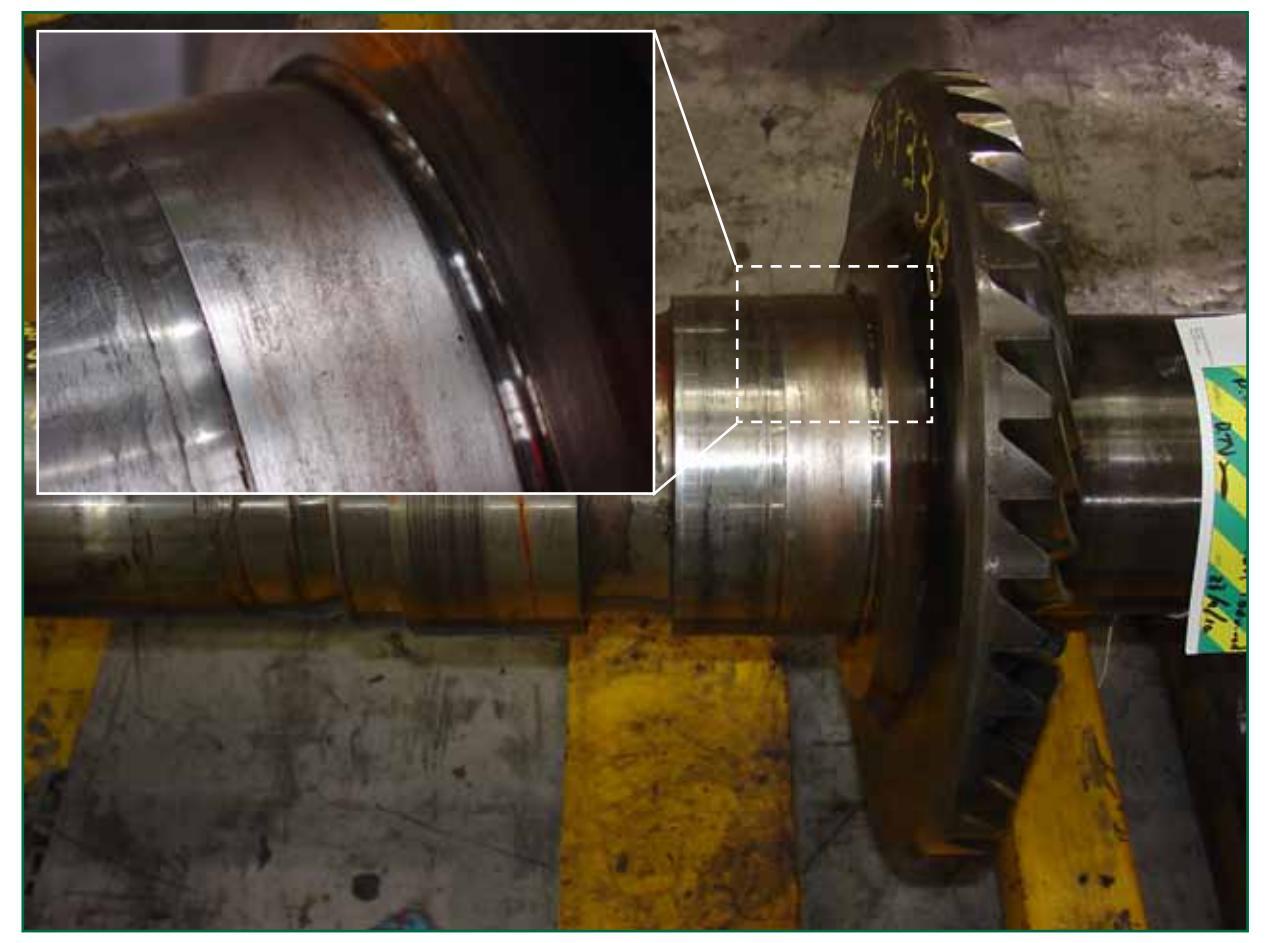
Figure 11: Final drive from wheelset E1604/58 after strip down, showing wear on bearing seat due to inner ring rotation

83 The first two axles in table 1 were found to have significant fretting, confined mainly to the bore of the inner ring, and evidence of the early stages of creep between the inner ring and axle. The other four axles were found to have axle/ inner ring clearances of up to 79 µm at the GE bearings. The inner rings on these axles had been creeping on the axle (figure 11), resulting in wear to both the axle and inner ring bore and clearances at the interfaces. On the bearing inner ring of wheelset E1604/10, there were regular scroll marks on the abutment face made by a piece of hard material caught between this face and the gear wheel. From these marks the maximum rate of creep of the inner ring relative to the axle and gear wheel was estimated to have been 0.22 mm per revolution. These observations were consistent with those described in Nagatomo and Toth<sup>8</sup>. None of these axles with clearances showed signs of overheating but they did have abnormally dark oil. Had they not been removed from service for the reasons given in table 1, it is possible that some of them could have progressed to failure.

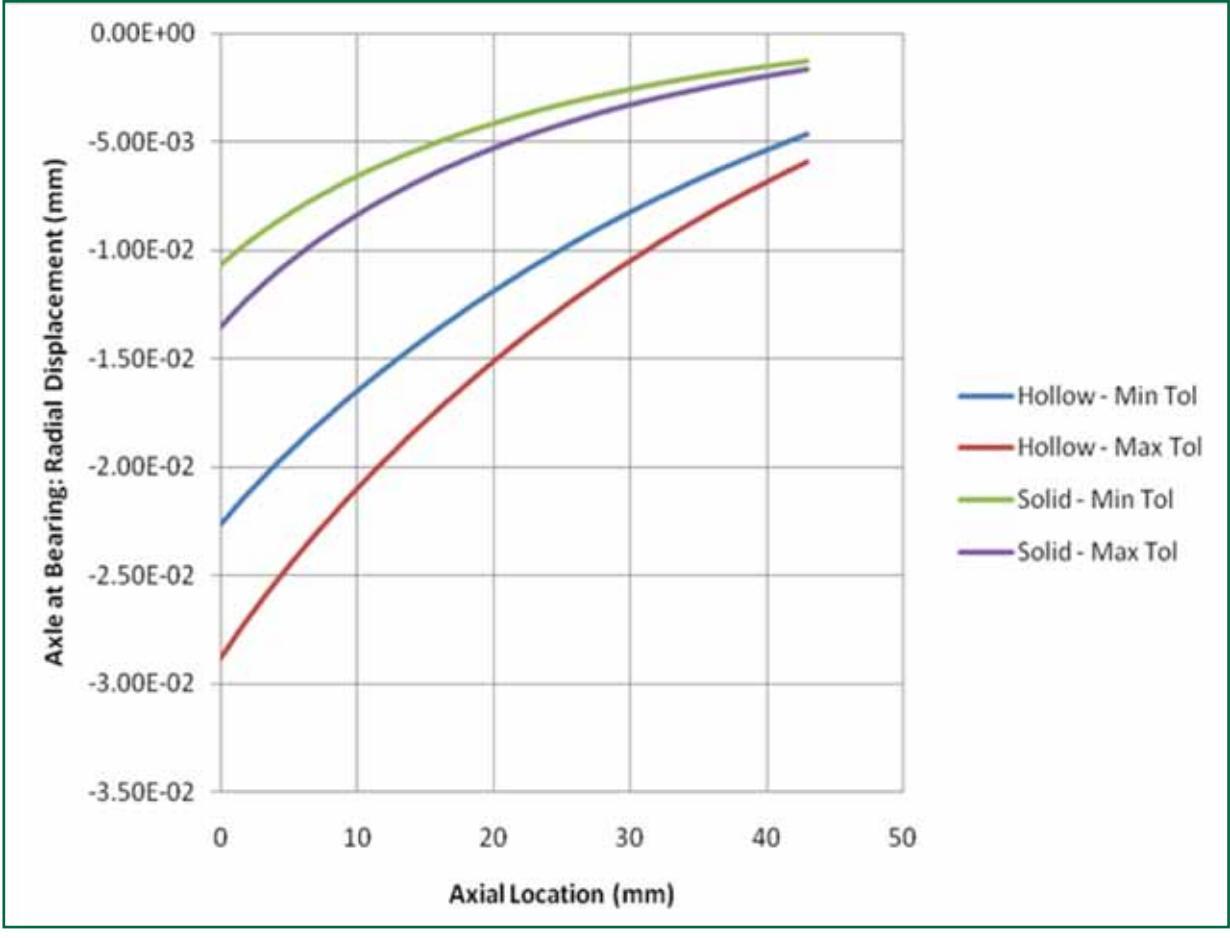
Figure 12: Calculated radial displacement of gear-side output bearing seat for Meridian (hollow) axle and equivalent diameter solid axle (courtesy of Interfleet Technology)

- 105 This shrinkage was confirmed by both calculation and measurement. Mathematical modelling of the Meridian axle, gear wheel and GE bearing indicates that between 24 and 30  $\mu$ m of shrinkage on diameter (12-15  $\mu$ m on radius) could occur at the centre of the bearing seat, depending on the level of interference between the gear and axle (figure 12). Another effect of the gear fit is that it causes the bearing seat to be tapered (figure 12); the inner edge of the seat closest to the gear wheel shrinks more than the outer edge. The corresponding amount of bearing seat shrinkage for a solid axle (figure 12) would be significantly lower at between 5 and 10  $\mu$ m on diameter. Measurements carried out on a sample of four Meridian bearing seats, with and without the adjacent gear wheel fitted, indicated an average amount of shrinkage of 27  $\mu$ m on diameter and a range of 21 - 38  $\mu$ m.

106 The effect of this shrinkage is to reduce the interference fit of the GE bearing on the axle. Within a population of gearboxes, the minimum interference fit could be reduced from the minimum design value of 75 µm to 37 µm (taking the maximum measured shrinkage of 38 µm). It was not possible to determine what the interference fit of the GE bearing inner ring was on the failed axle when it was new because the bore size of the inner ring is not known. However, the evidence indicates that, like some other axles discussed at paragraph 82, it could have lost around half the minimum intended interference due to the adjacent gear fit. This reduction in interference is significant and would have left the bearing inner ring vulnerable to eventually becoming loose, due to other factors which are discussed below.

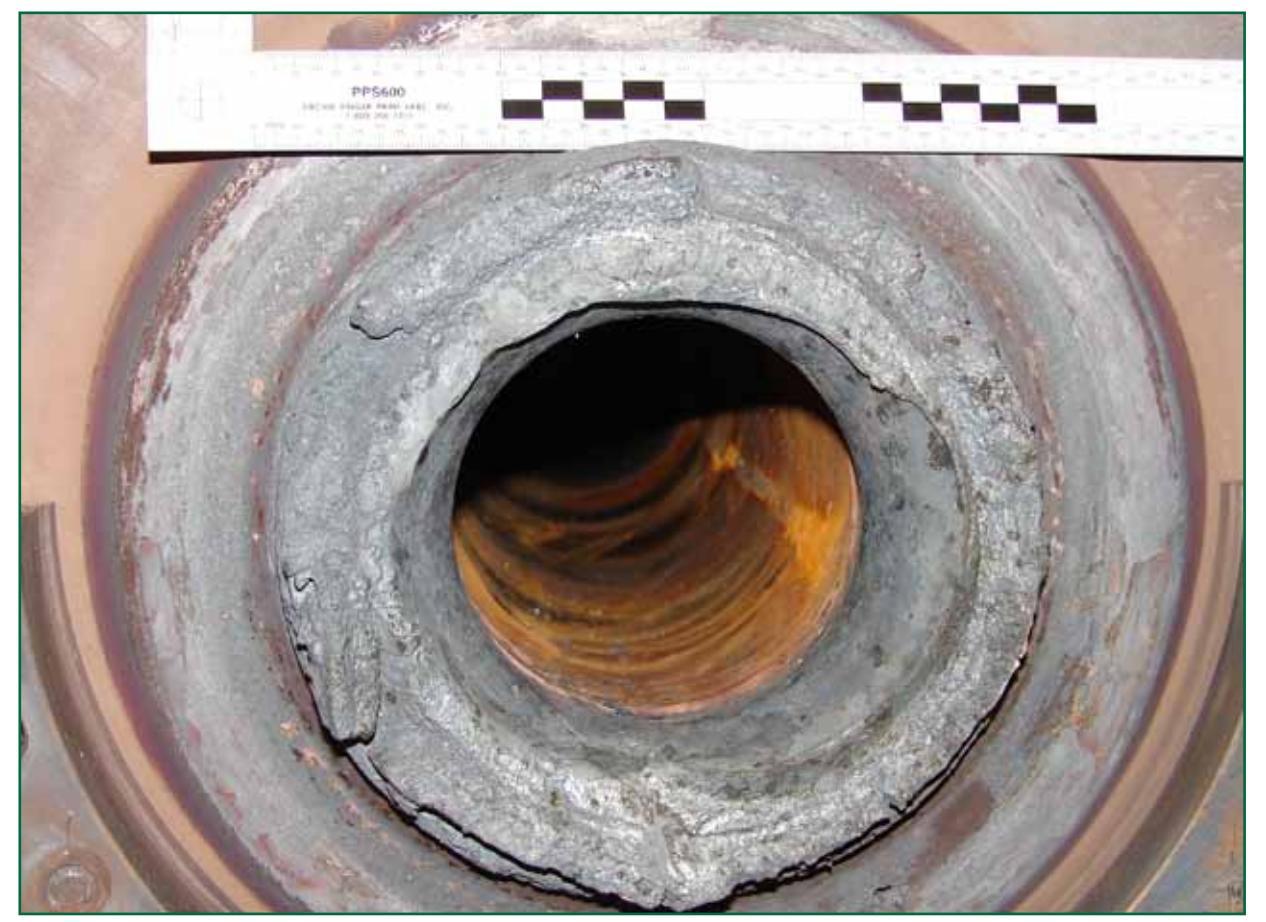
Figure D1: Axle fracture face

- D5 The total length of the axle (axle end faces to fracture extremities) was 26 mm longer than it had been originally. This was caused by ductile elongation of the axle and indicates that the axle had been overheated prior to the fracture. Had a fatigue crack caused the axle to fracture, the total length would have been similar to the original length or been shorter due to battering and wear between the faces.

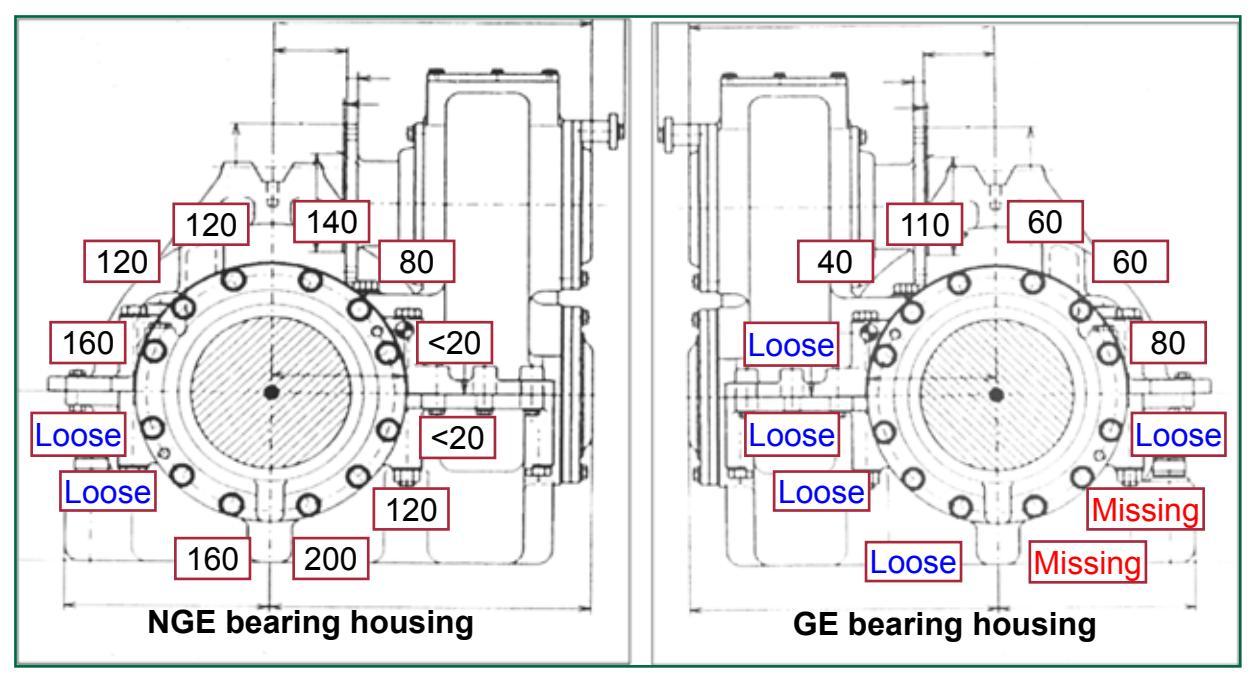
Figure D5: Loose bearing housing bolts (values above in Nm of torque tightness)

- D25 The external surface of the GE bearing housing is estimated to have reached 350°C 400°C during the failure. At such high temperatures, some relaxation of the bolt pre-load from the original torque tightening would be expected due to thermal effects as the housing and bolt materials have different coefficients of thermal expansion. A tendency for the housing bolts to lose preload was also noted in the laboratory tests (see appendix E, paragraph E17). Following the derailment, the severe loadings from the impacts with the foot crossing and AWS magnet are likely to have caused the bolted joints to slip at the joint interface and the bolt pre-load to drop further. Once the bolt preload is lost, the bolts are vulnerable to unwinding under vibration.

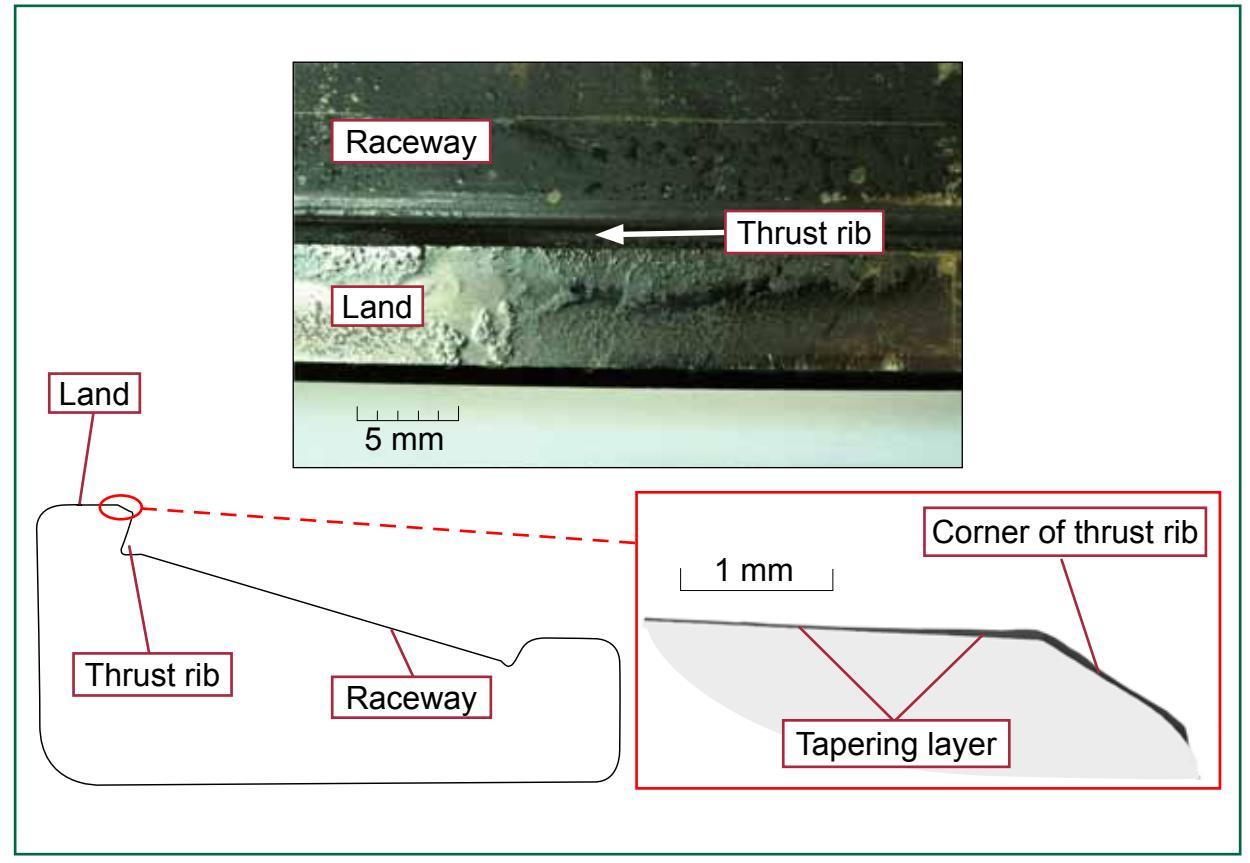
Figure D8: Carbon deposit on thrust rib of NGE bearing (photograph courtesy of ESR)

- D36 There was a blackish carbon deposit on the interior surfaces of the gearbox casing, axle and NGE bearing, indicating that oil had been falling on these surfaces during the failure. In particular the thrust rib of the NGE bearing (figure D7) had a layer of carbon deposit on the inner race and around the corner of the thrust rib. The thickest part of the layer on the thrust rib was around 40 50 µm at the corner (the hottest exposed part of the rib) and tapered down in thickness over the land (figure D8). These deposits indicated that oil had been present while the bearing was running hot. Metal particles found embedded in the layer also indicated that the oil was in liquid rather than vapour form as vapour could not have transported the metal particles onto the surface of the thrust rib.

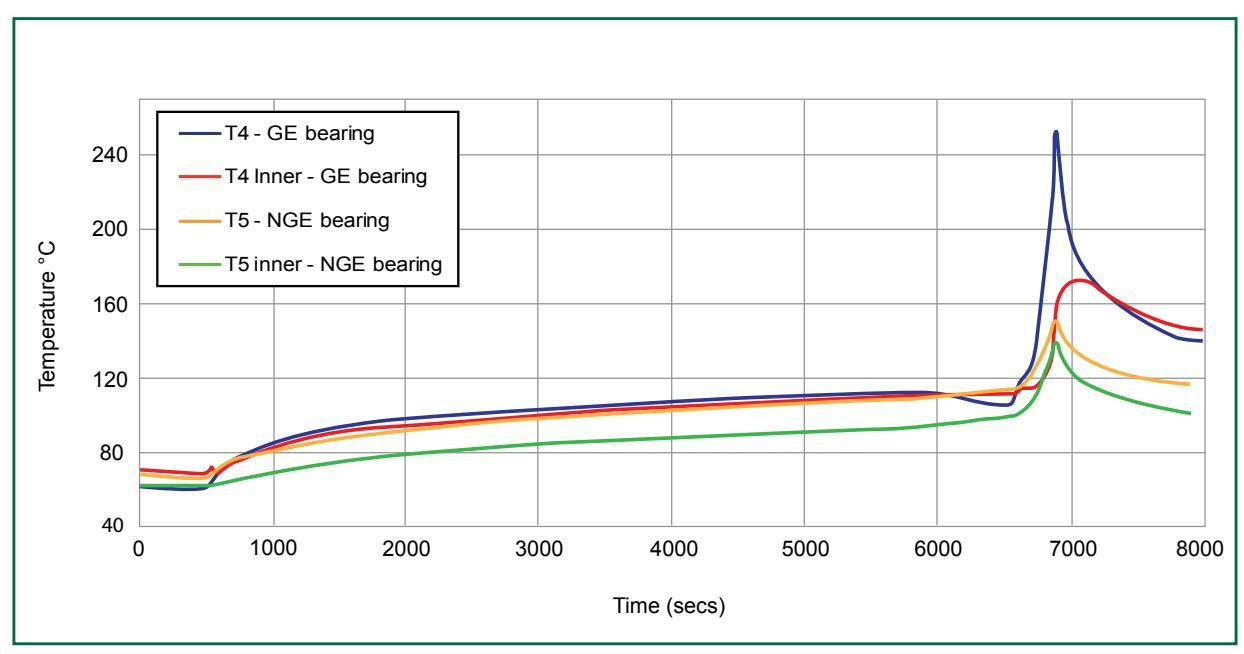
Figure E3: Output bearing temperature rise of gearbox 2 at failure with 1 litre oil

- E14 Increasing the oil fill to 7 litres or reducing the oil to 4 litres and then 3 litres did not have a significant effect on the output bearing temperatures. At 2 litres of oil, there was a drop in temperature to 100°C on the outer ring of the GE bearing. When the cooling fan was switched on, there was a noticeable rise in temperature at both the GE and NGE bearing, to 120°C and 109°C respectively. This tendency for the output bearing temperatures to rise when cooling air was directed at the casing was also noted on gearbox 3 (paragraph E20) and is discussed at paragraphs 88 and 91.
- E15 At 1 litre of oil, the gearbox ran for around 100 minutes without incident but shortly after the cooling fan was switched on, the GE bearing temperature rose sharply to around 250°C (figure E3) and then it failed. The NGE bearing temperature had also risen from around 112°C to around 150°C.

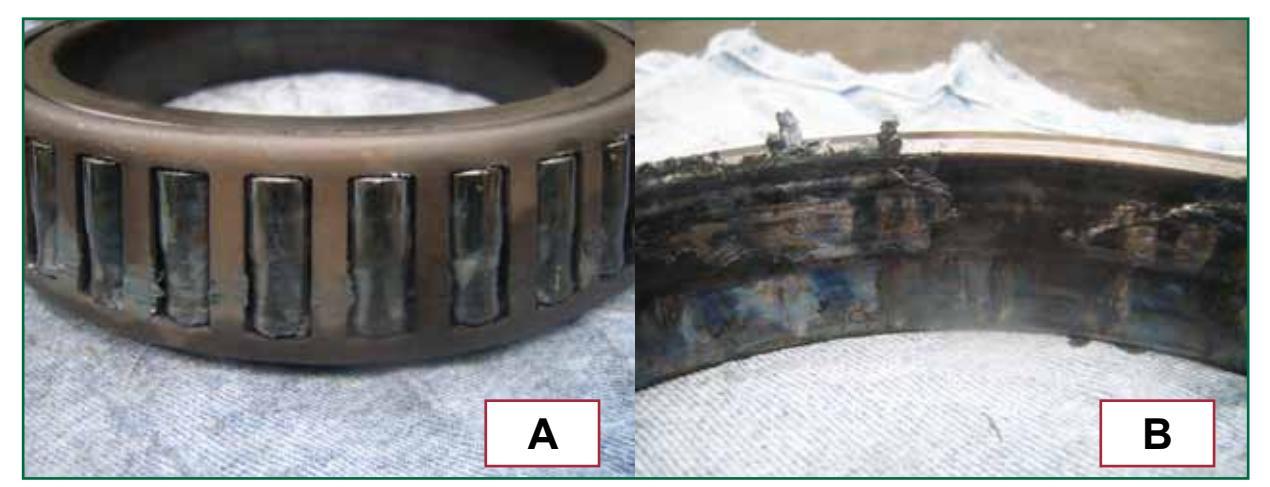
Figure E4: GE bearing from gearbox 2 after failure at 1 litre oil showing rollers and cage (A) and smeared material on outer raceway (B)

- E17 When gearbox 2 was stripped down the gears were found to be in good condition with no scuffing of the bevel gears and some minor indentation damage on the helical gears due to debris from the failing bearing. The seat of the GE bearing on the axle was covered in fretting residue and there was evidence of metal pick-up and welding between the inner ring and the abutment face of the adjacent gear wheel, indicating that the inner ring had been rotating relative to the axle and stopping from time to time. The GE bearing rollers were deformed (figure E4) and there was heavy metal smearing on the outer raceway. The torque tightness of 7 of the 12 bolts securing the gear-side output bearing housing were noted to have reduced (to between 140 and 190 Nm) from the nominal assembly torque tightness of 200 Nm.

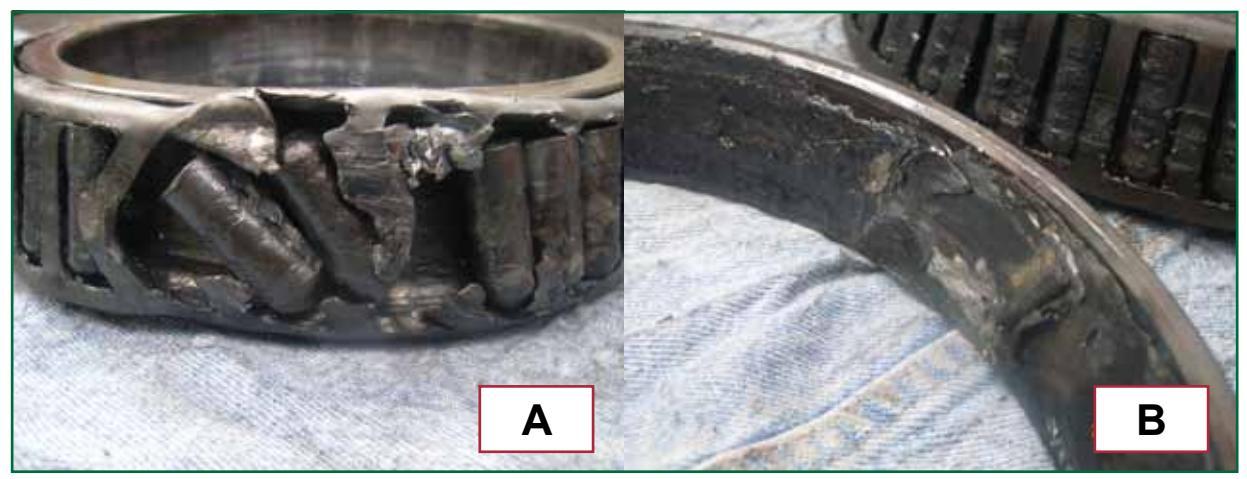
Figure E7: GE bearing from gearbox 3 after failure showing rollers and cage (A) and smeared material on outer raceway (B)

E25 The GE output bearing was severely damaged (figure E7). The cage was broken and the rollers were skewed in the raceway and deformed, particularly at the ends running on the thrust rib, which had become rounded. There was also heavy metal smearing on the outer raceway.
