## **Rail Accident Report**

Derailment at Bletchley Junction, Bletchley 3 February 2012

Report 24/2012 November 2012 This investigation was carried out in accordance with:

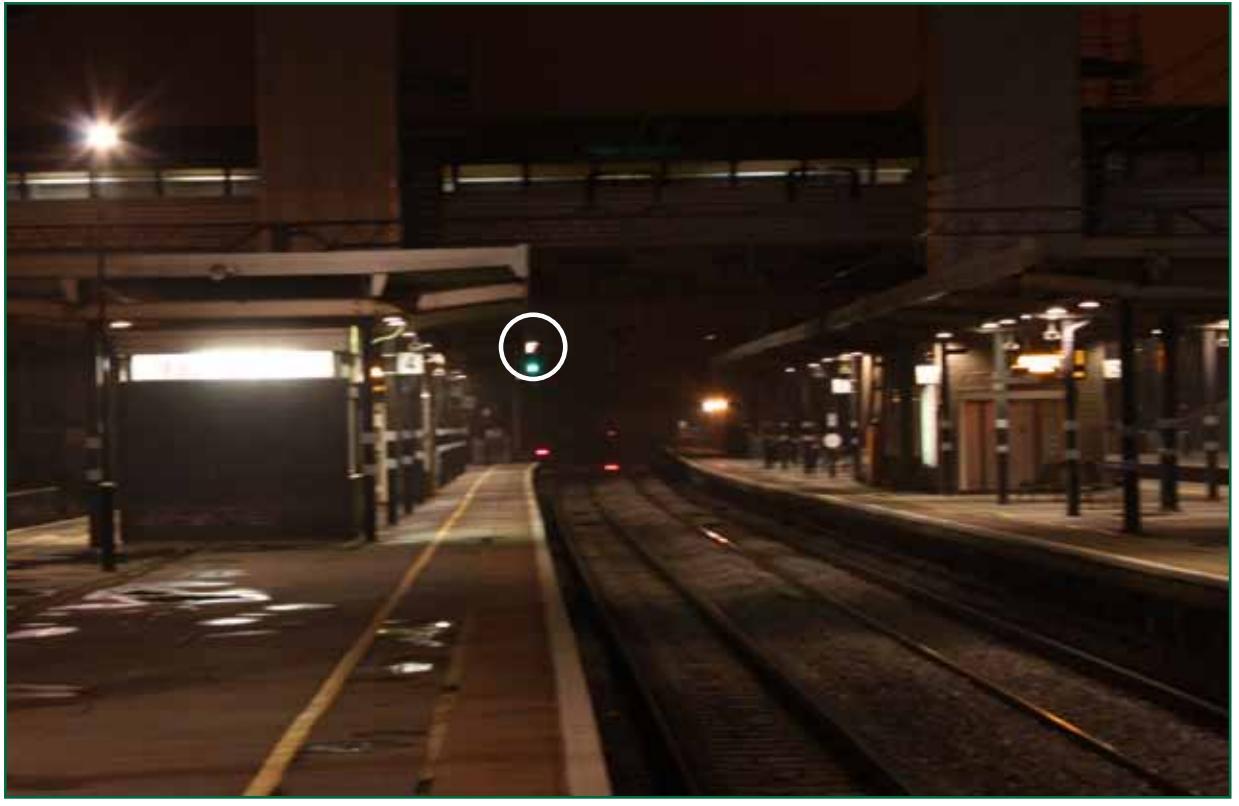
<sup>&</sup>lt;sup>2</sup> This system was fitted to the network in response to the Railway Safety Regulations 1999 SI1999/2244.

88 The RAIB commissioned an examination of the sighting of signal BY19's route indicator and to identify any human factors issues that could cause errors. The approach view of the route indicator was found to be satisfactory, being free of obstructions and with sufficient time for a driver to see and interpret its meaning. No human factors issues were identified increasing the probability of errors being made. Figure 9 shows a night time view of signal BY19, with the 'F' illuminated, from its associated automatic warning system magnets.

Figure 9: Night time view of signal BY19, with the 'F' indication illuminated, from the automatic warning system magnets

2 The intention of this recommendation is that, at potentially high risk diverging junctions, such as those where the approach speed is 60 mph (96 km/h) or greater and requiring a reduction in speed of a third or more, the risk from a train overspeeding on a diverging route following the clearance of the junction signal under approach control conditions is reduced. Different or additional mitigation may be justified depending on the level of risk identified; this may include replacement by position light junction indicators; replacement of junction indicator by one in modern equivalent form; alteration to signalling controls etc.
