# **Rail Accident Report**

Class investigation into landslips affecting Network Rail infrastructure between June 2012 and February 2013

> Report 08/2014 April 2014

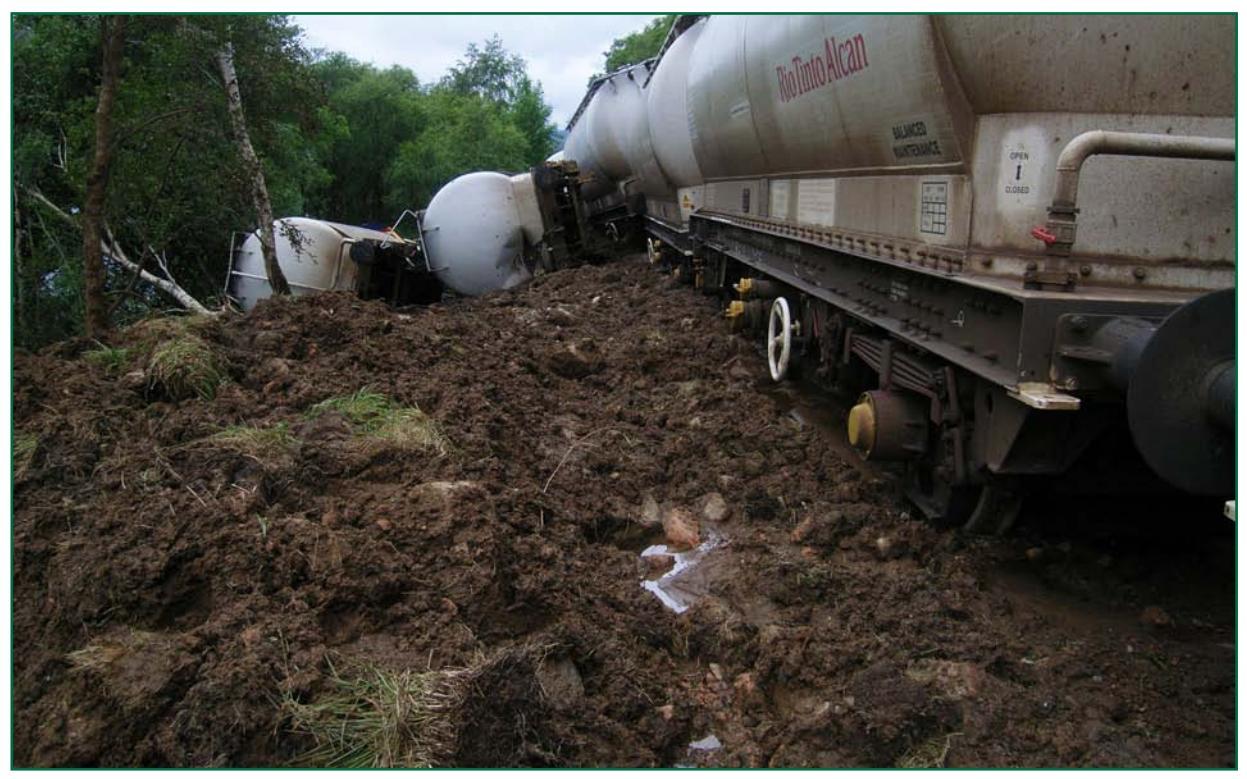
Figure 3: Loch Treig: derailed wagons

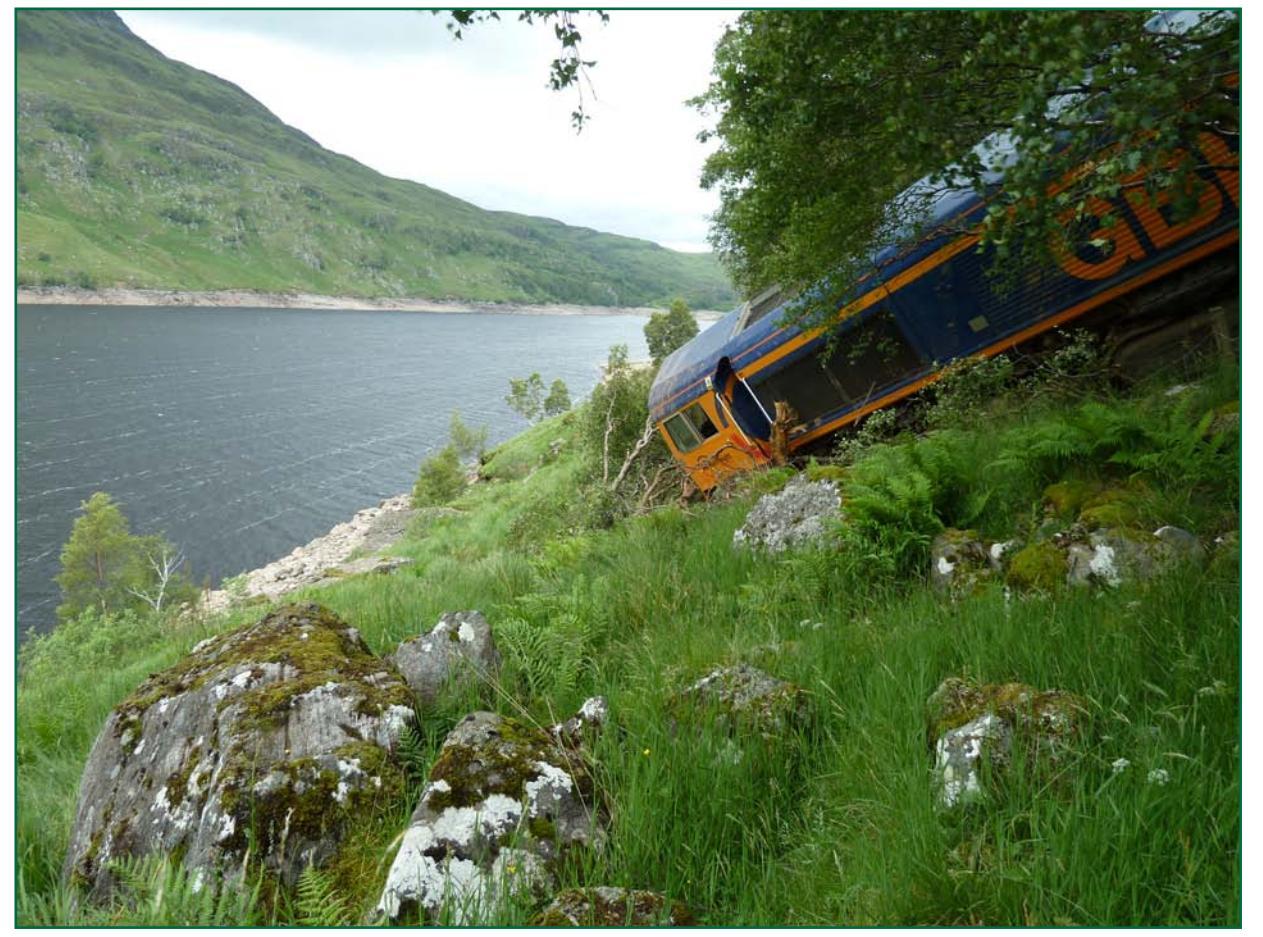
Figure 4: Loch Treig: derailed locomotive (image courtesy of Network Rail)

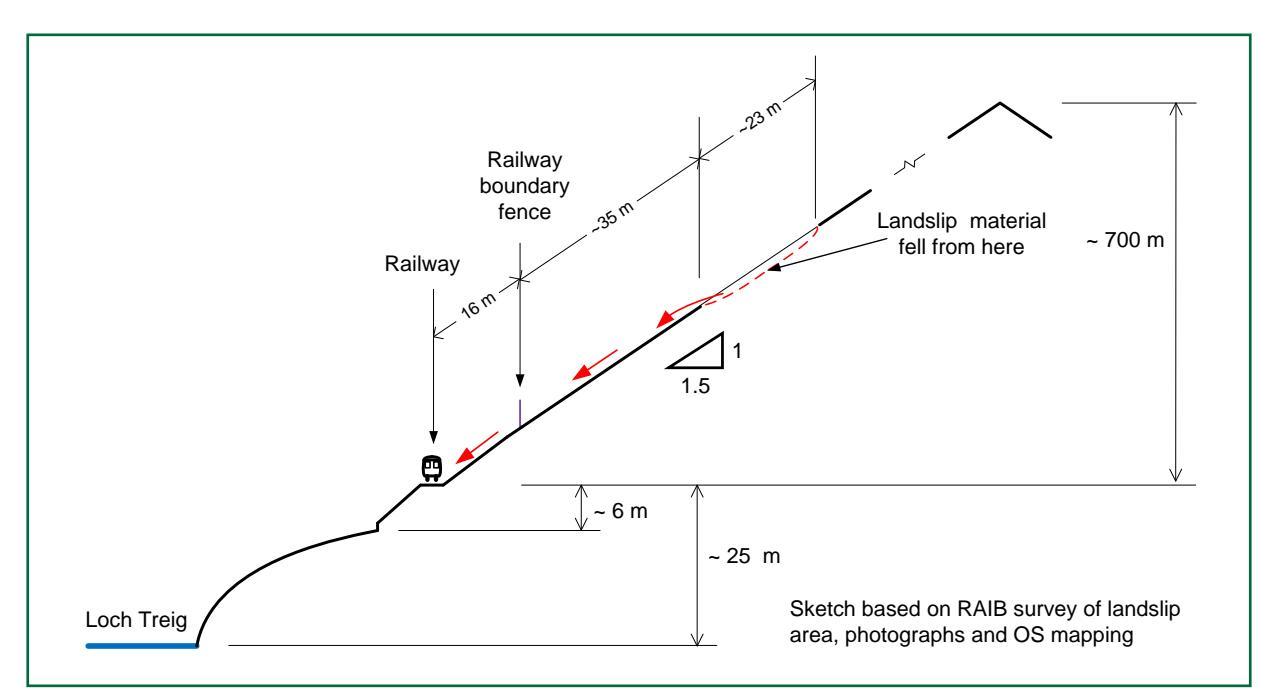
Figure 5: Loch Treig: slope geometry (cross-section)

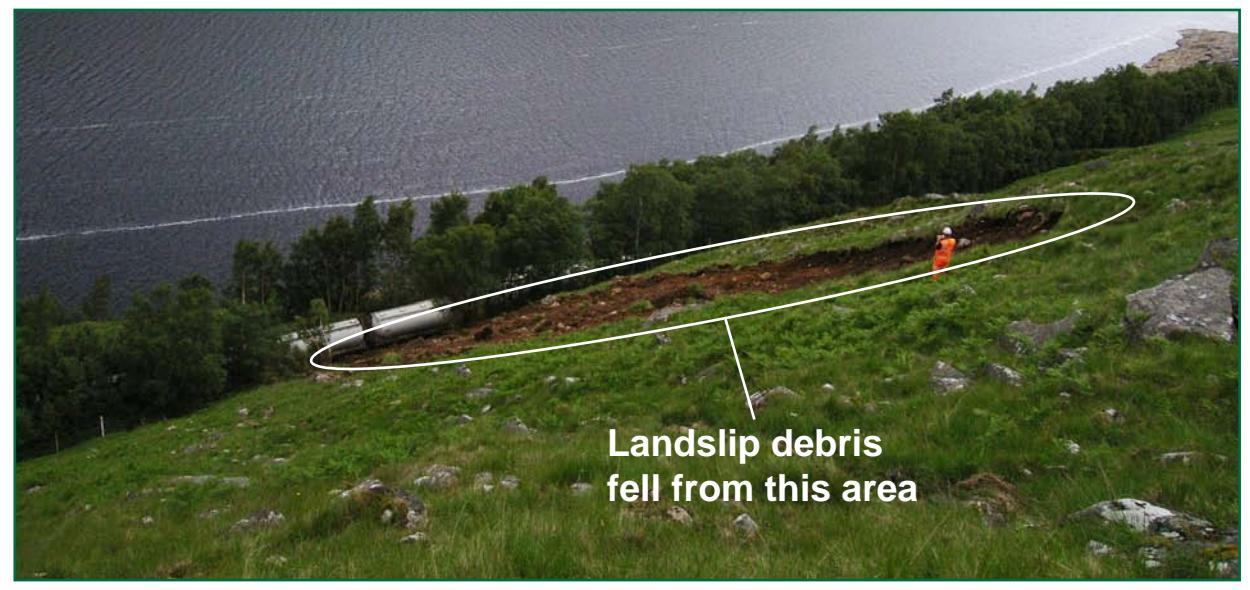
- 12 The debris had come from a landslip which had occurred in the natural slope about 35 metres upslope of the railway boundary (figure 6). RAIB noted that the slip had developed in a shallow valley area which was waterlogged. RAIB (and Network Rail) consider that the slip was triggered by water accumulating in this valley and destabilising the soil.

Figure 6: Loch Treig: landslip

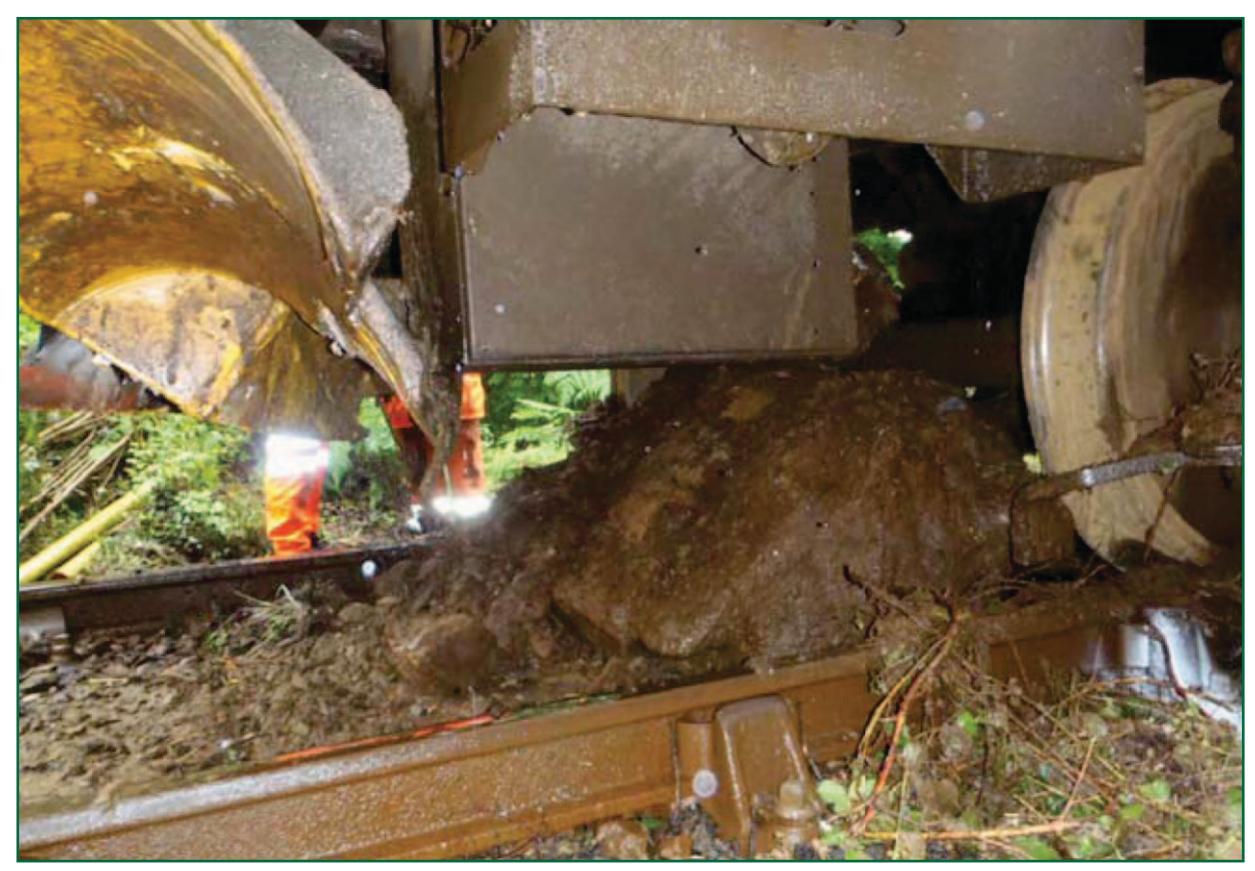
Figure 8: Falls of Cruachan: debris preventing train movement (image courtesy of Network Rail)

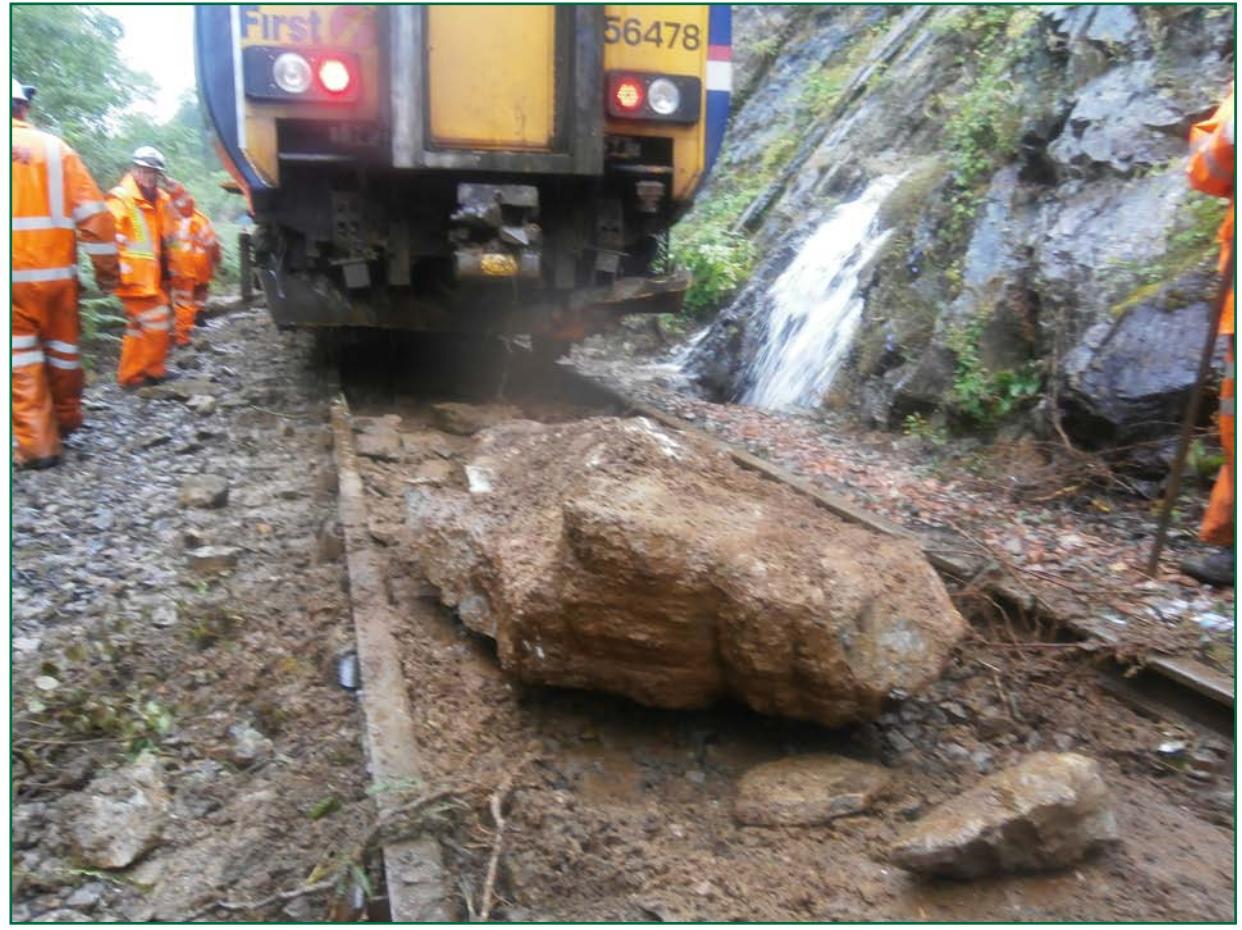
Figure 9: Falls of Cruachan: view after train moved clear of boulder shown on figure 8

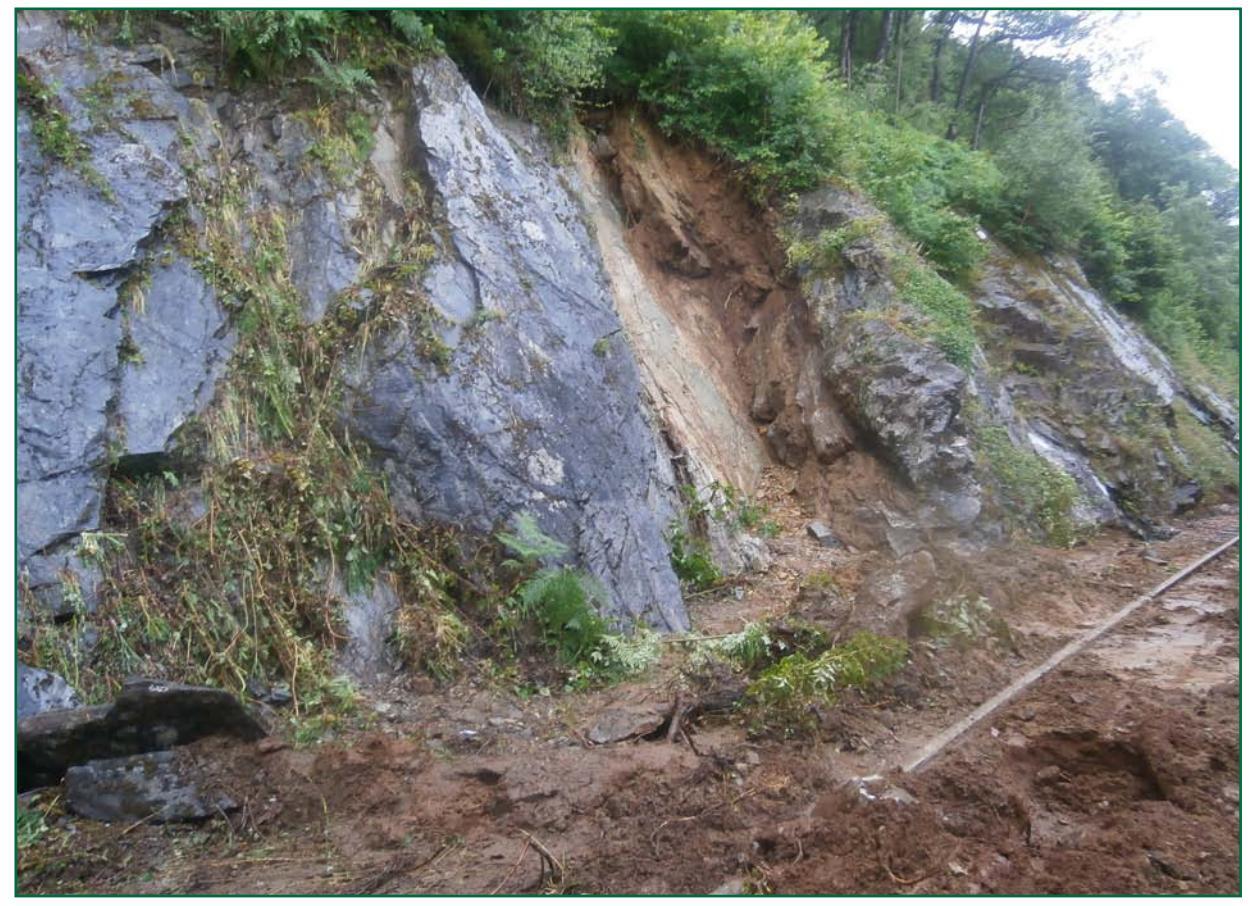
- 27 A post-incident inspection of the site undertaken by Amey staff on behalf of Network Rail<sup>8</sup> showed that the landslip had been triggered by a flow of water which had been diverted from its normal course by a blocked culvert about 60 metres upslope of the north side of railway (figure 11). The flow had therefore entered the cutting at a location where there was no channel to control the flow of water and the uncontrolled flow was sufficient to dislodge soil and boulders from the cutting face (figure 12).

Figure 12: Falls of Cruachan: material washed from cutting face

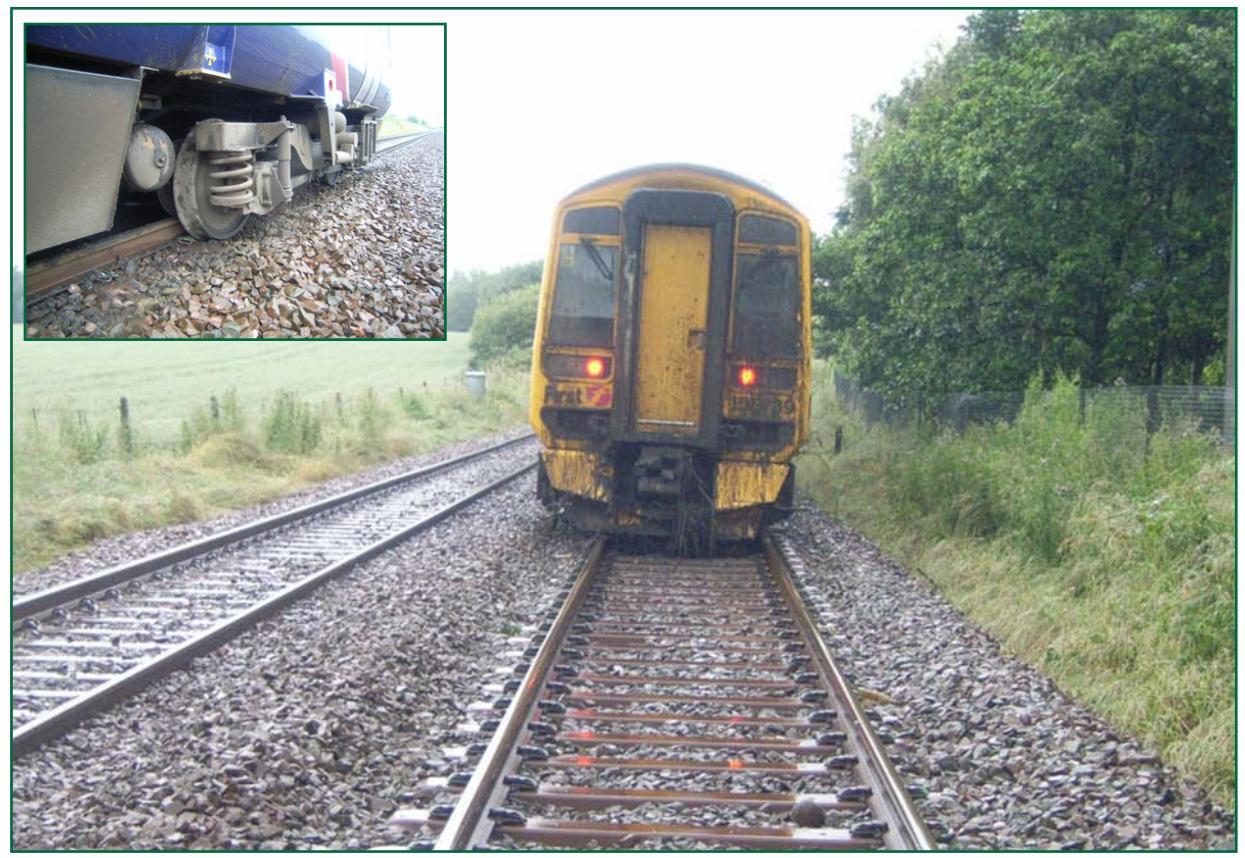
Figure 14: Rosyth: derailed train

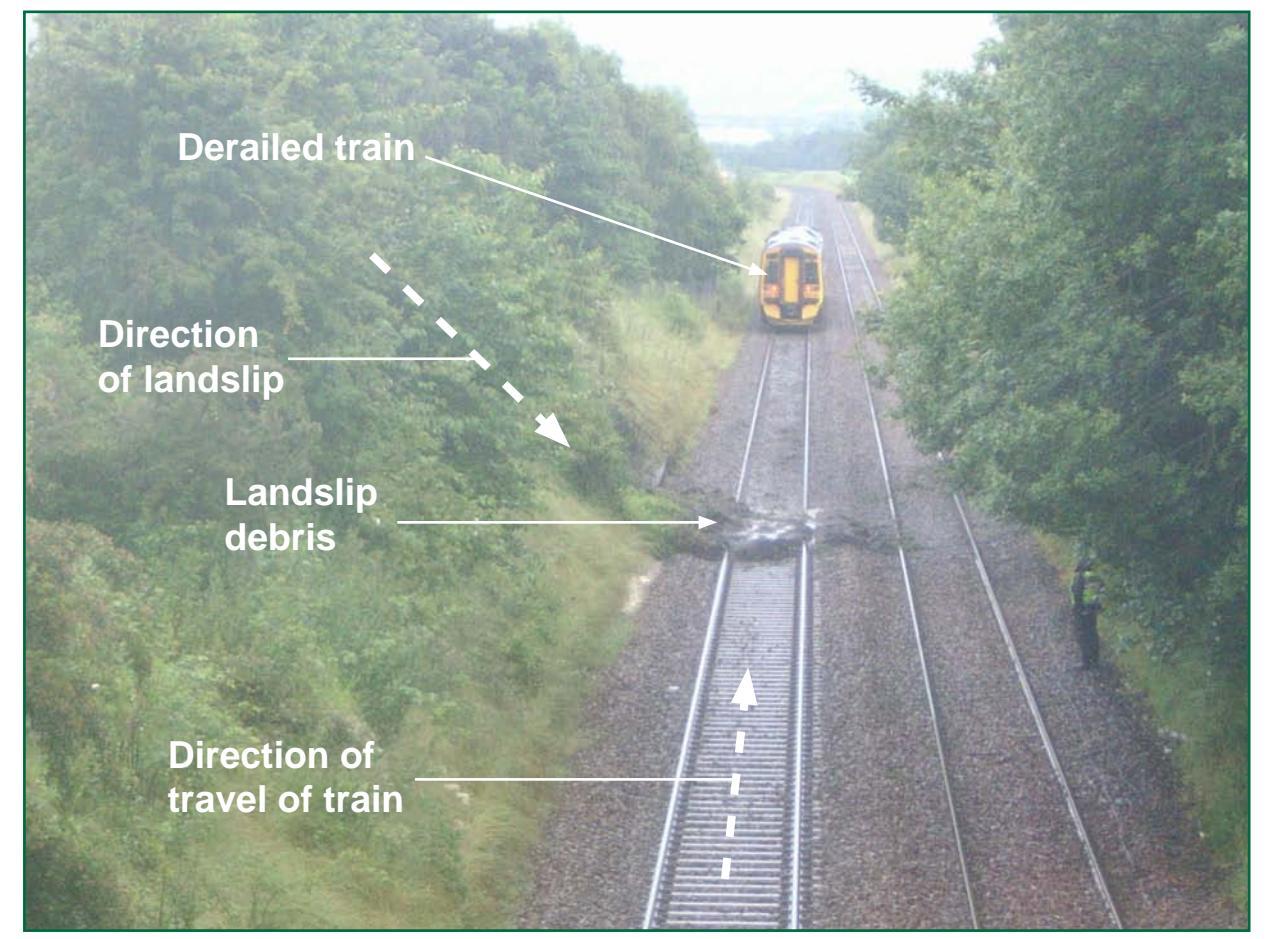
Figure 15: Rosyth: landslip

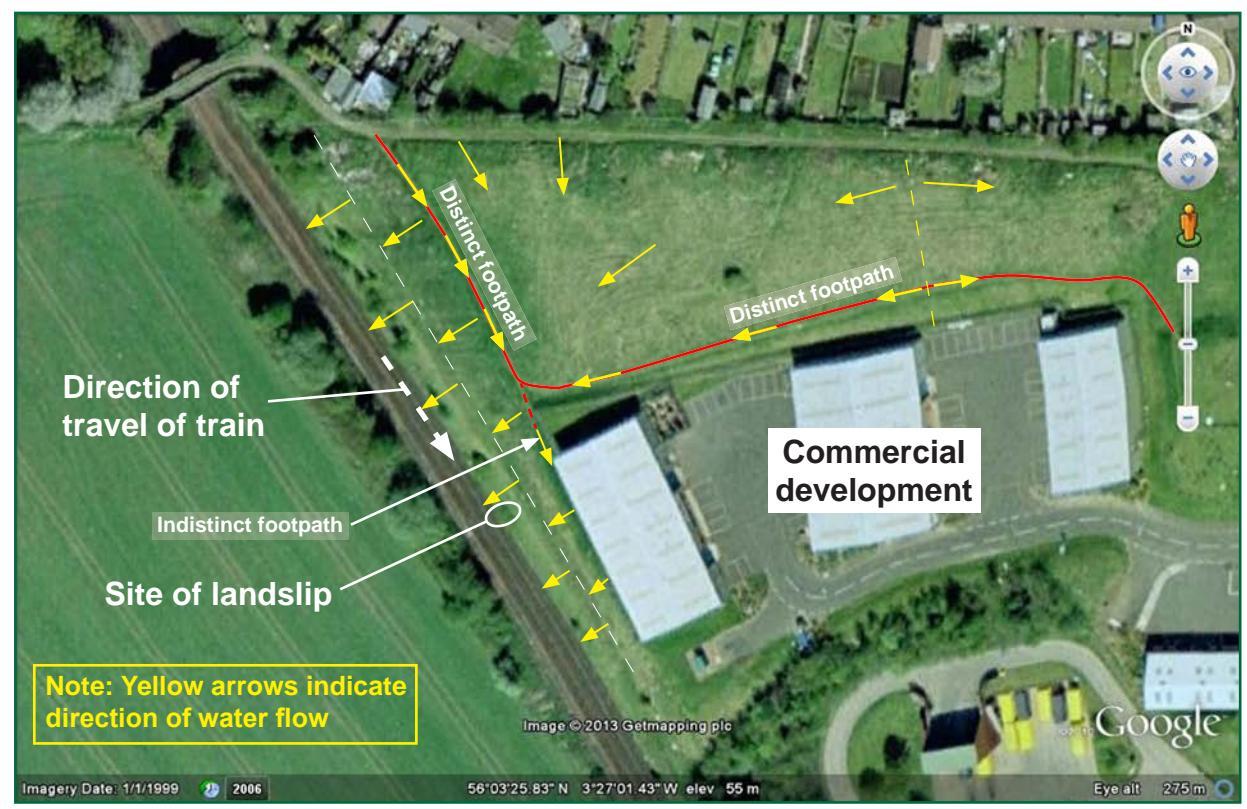
Figure 16: Rosyth: landslip and surrounding land features (pre-incident photograph)

- 40 The waste ground is roughly grassed and slopes at typically 1 in 50 in a direction which encourages surface water to flow almost, but not directly, towards the railway. No distinct drainage system serves the waste ground but informal footpaths provide preferential drainage routes which encourage surface water flows towards the top of the railway cutting close to the location of the landslip (figure 16).

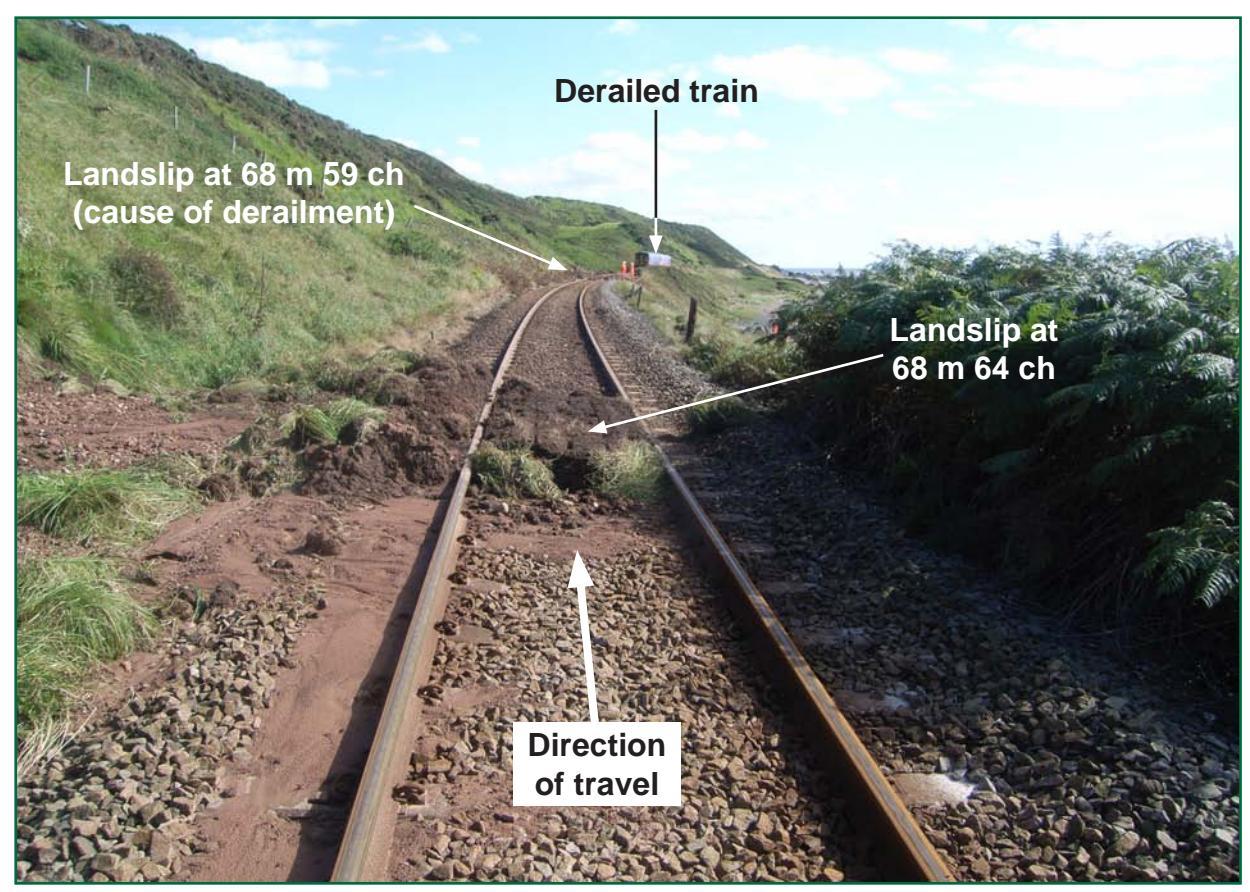
Figure 18: St Bees: landslip at 68 miles 64 chains

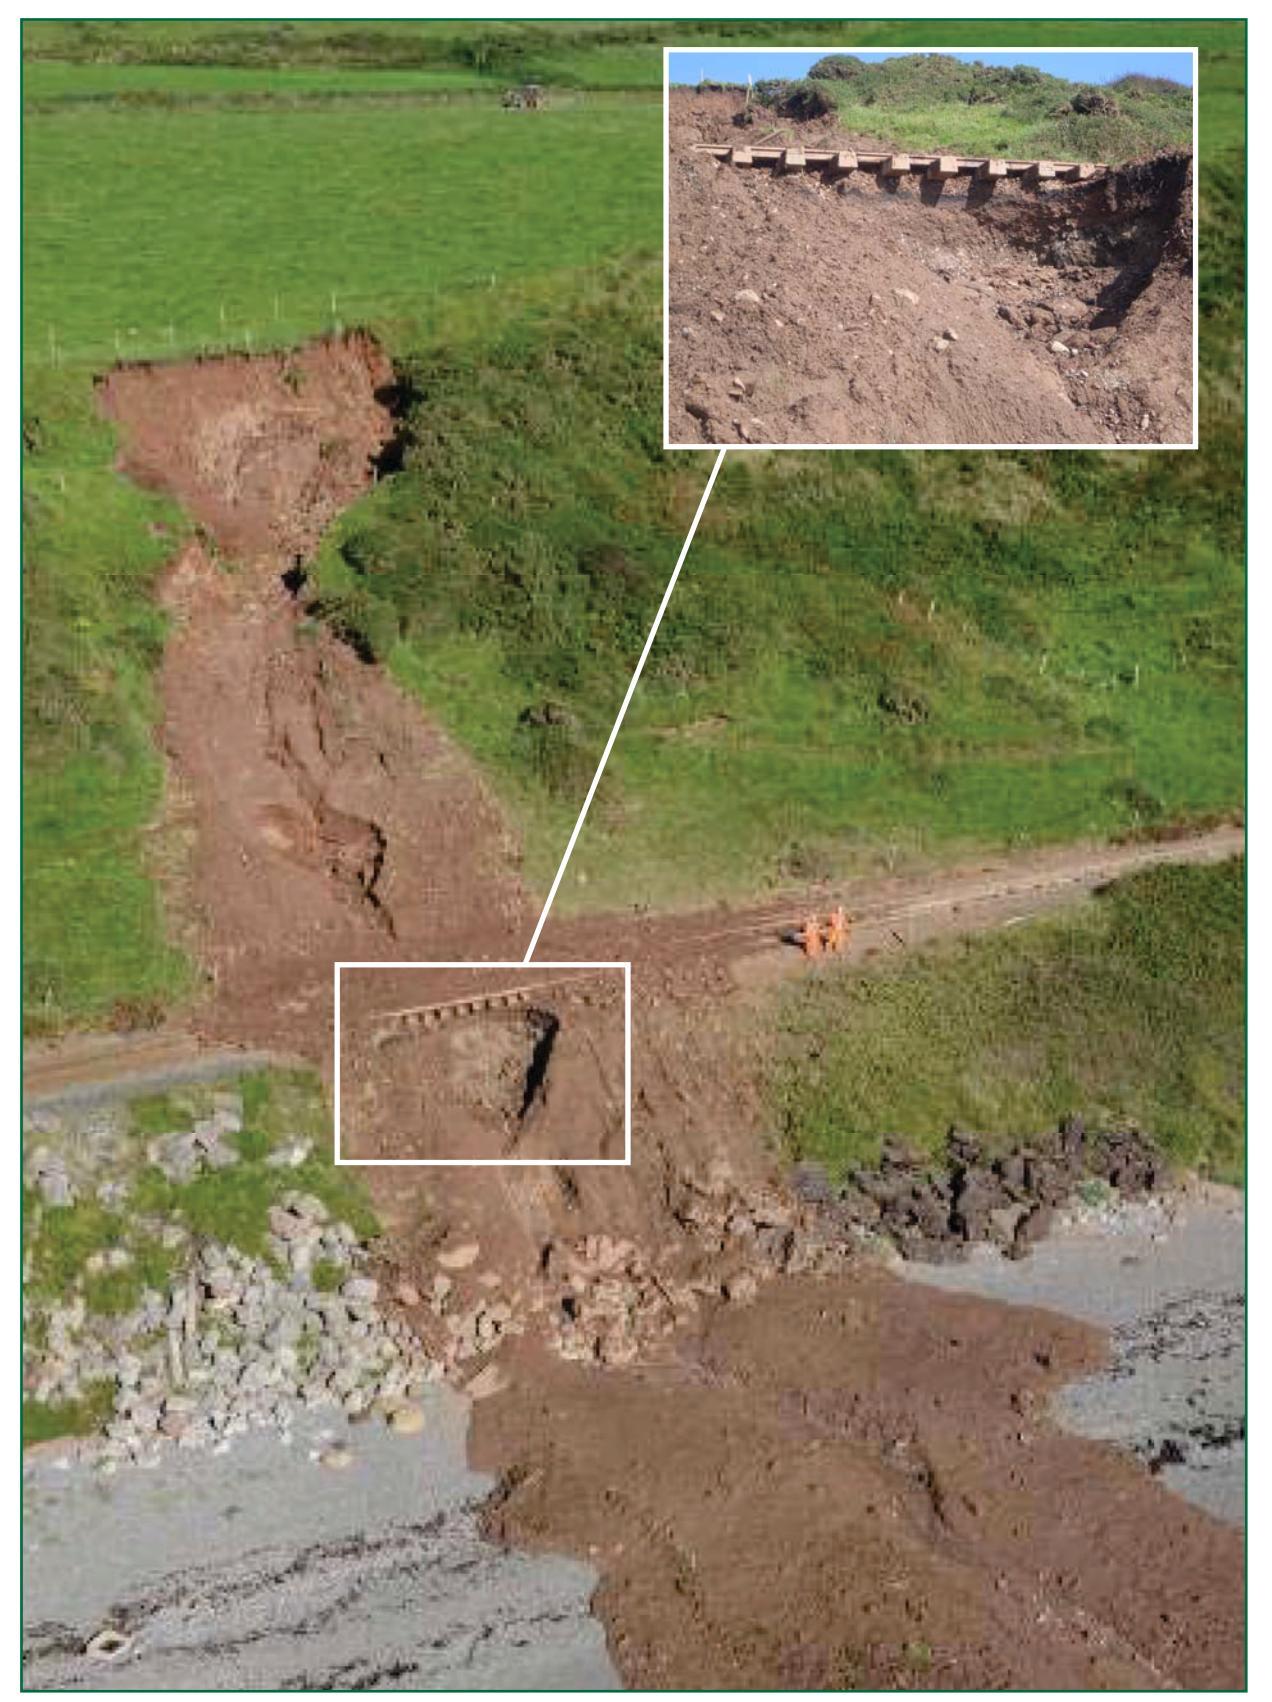
Figure 19: St Bees: landslip at 68 miles 59 chains (main image courtesy of Network Rail)

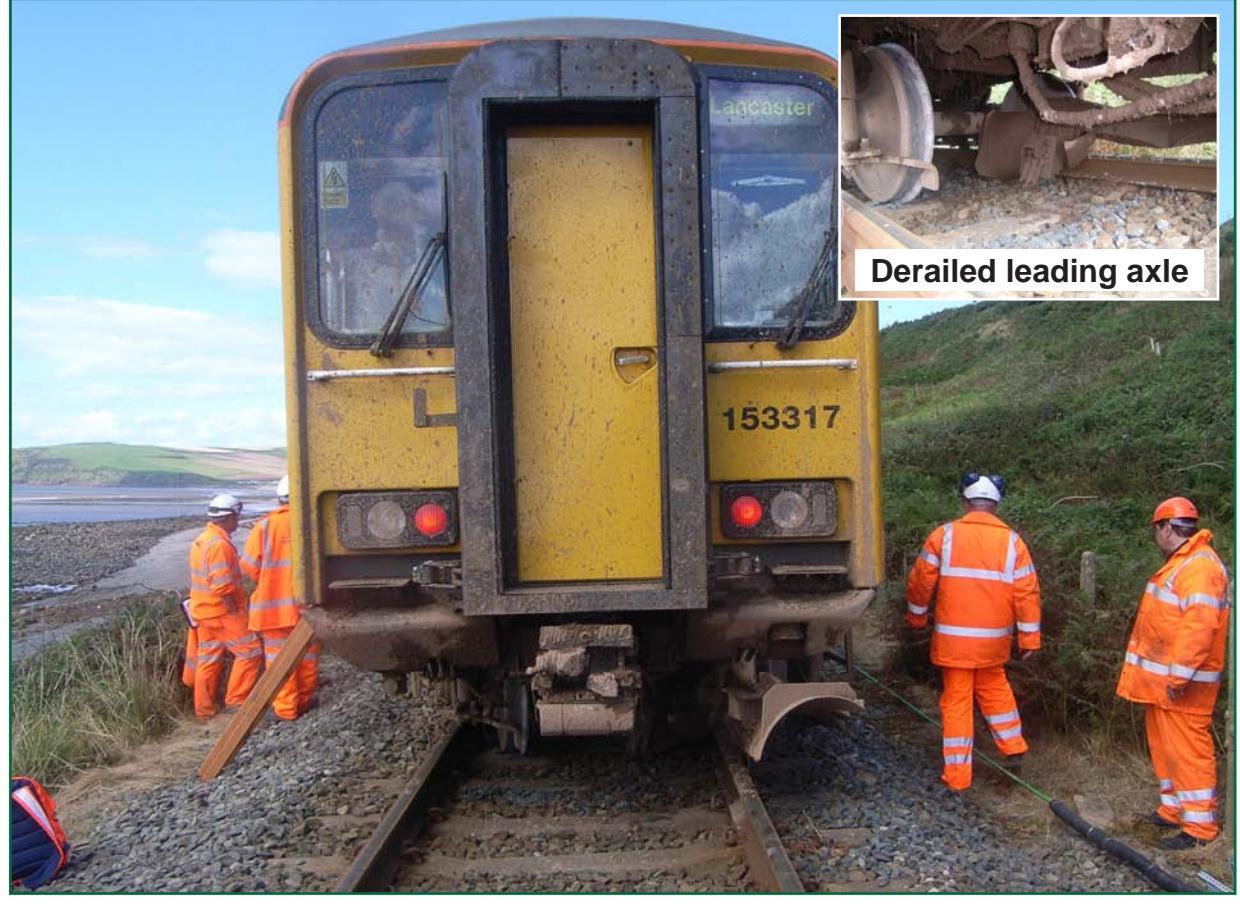
Figure 20: St Bees: derailed train

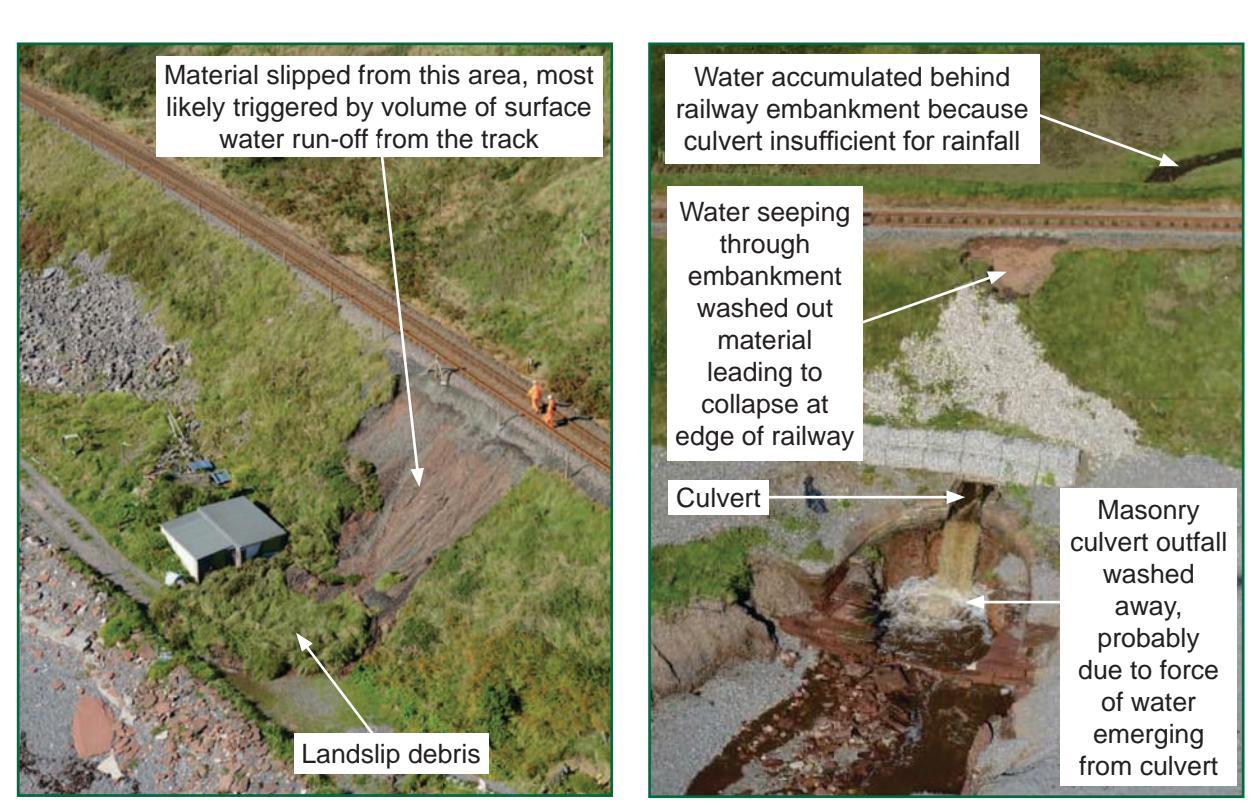
- 58 The heavy rain also triggered a landslip at 67 miles 61 chains and a washout of material from beneath the track at 66 miles 60 chains (figures 22 and 23). Although the southbound train involved in the accident did not reach these locations, these events prevented another train being used to rescue passengers from the train involved in the accident.

- 59 The landslip at 67 miles 61 chains occurred in the natural slope below the railway and undermined the track. It was probably triggered by water running off the slope above the railway. The washout of material from beneath the track at 66 miles 60 chains was caused when a build up of water on one side of an embankment resulted in water forcing its way through poorly compacted embankment material around a culvert. This culvert was intended to prevent water building up behind the embankment but it lacked the capacity to carry the exceptional amounts of water draining from the surrounding land.

Figure 22: St Bees: landslip at 67 miles 61 chains (image courtesy of Network Rail)

Figure 23: St Bees: landslip at 66 miles 60 chains (image courtesy of Network Rail)

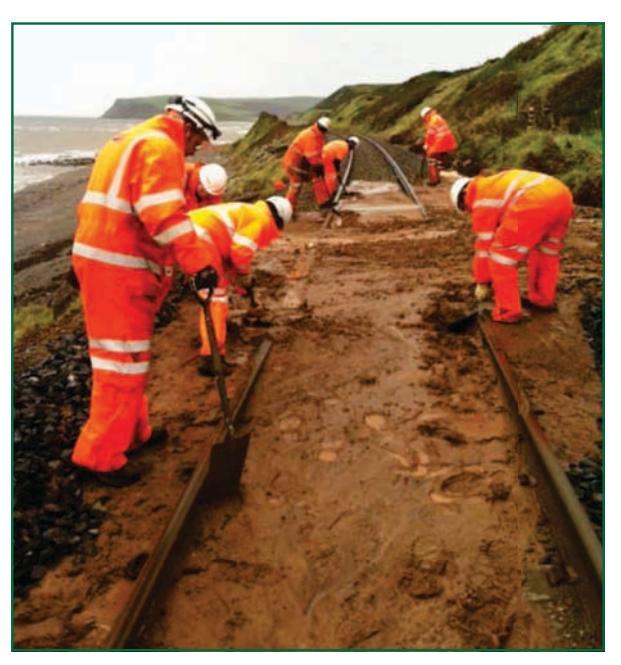
60 Permanent repair works were still awaiting completion at 68 miles 59 chains when a further incident occurred on 17 October 2012. Network Rail reported to RAIB that heavy rain (24 mm in 5 hours) during the afternoon of 17 October caused soil to be washed out from the slope above the railway in the area of the August 2012 landslip. A small amount of this material passed around the ends of a temporary barrier wall and was deposited on the railway (figure 24). The presence of this material was reported by the driver of a passing train and train services were suspended until the debris was removed from the track.

Figure 24: St Bees: October 2012 incident (image courtesy of Network Rail)

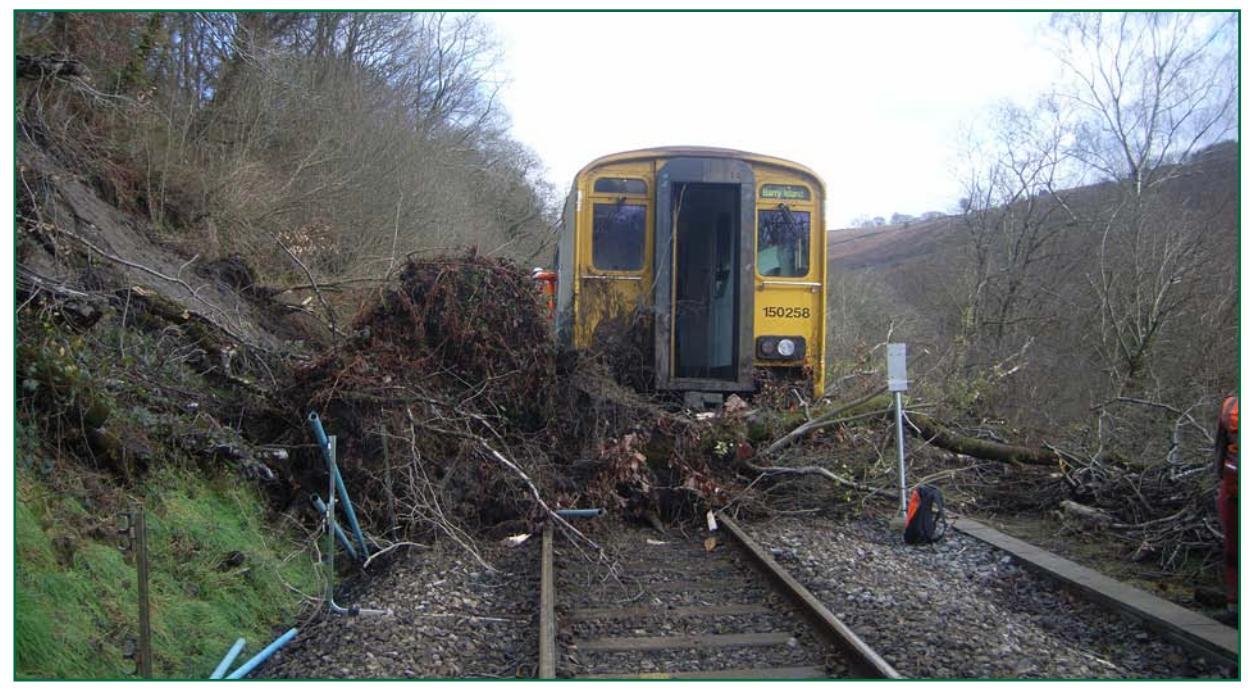
Figure 26: Bargoed: derailed train

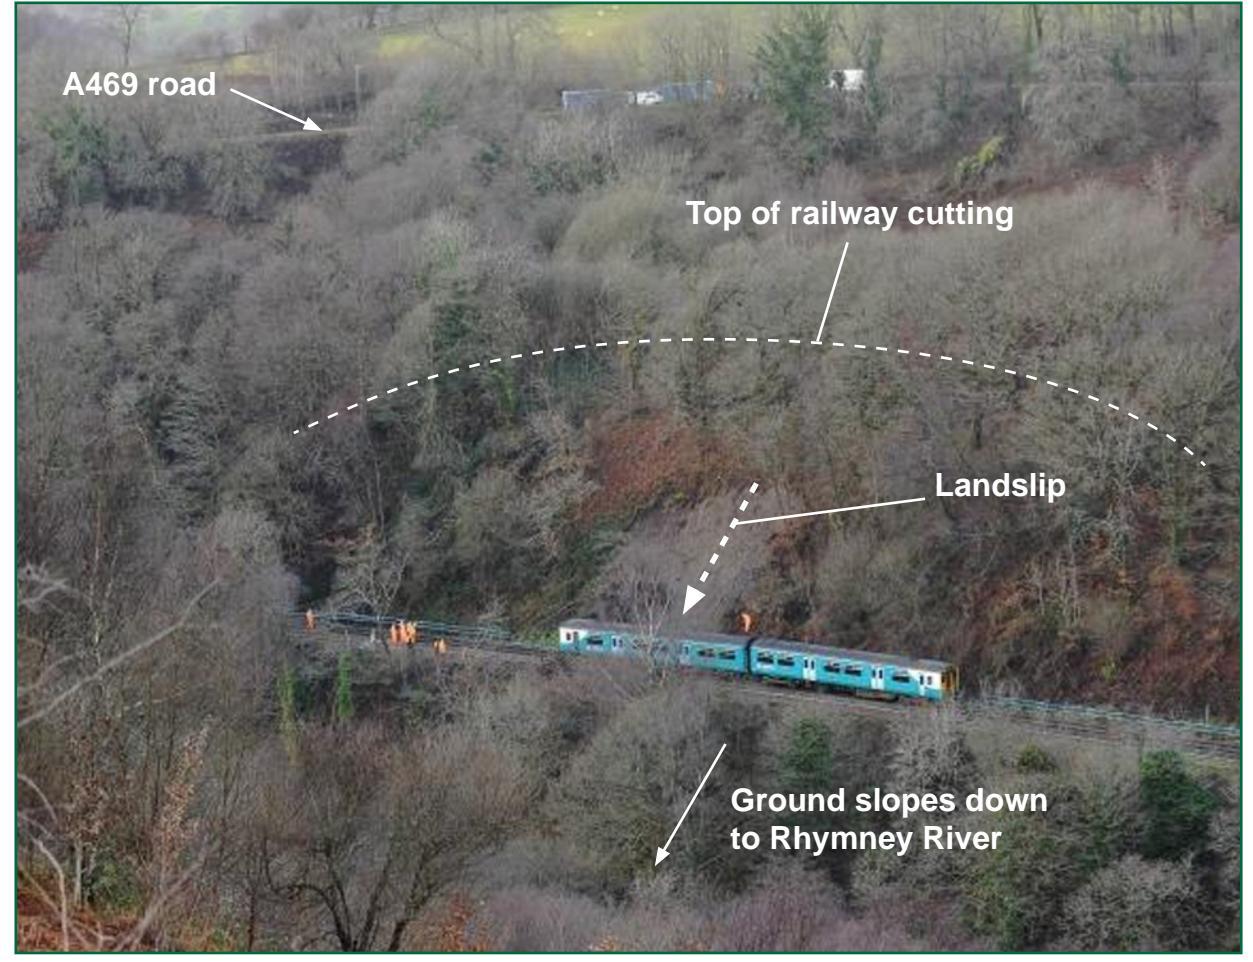
64 The hillside above the railway forms a natural valley directing surface water towards the area of the slip. There was no formal stream channel within the valley but, a few hours after the accident, RAIB observed water being discharged from a pipe into the valley immediately downslope of the road. It is likely that this pipe was acting as a drain intended to prevent water accumulating upslope of the road (figure 28).

Figure 28: Bargoed: site overview (image courtesy of ITV Cymru Wales)

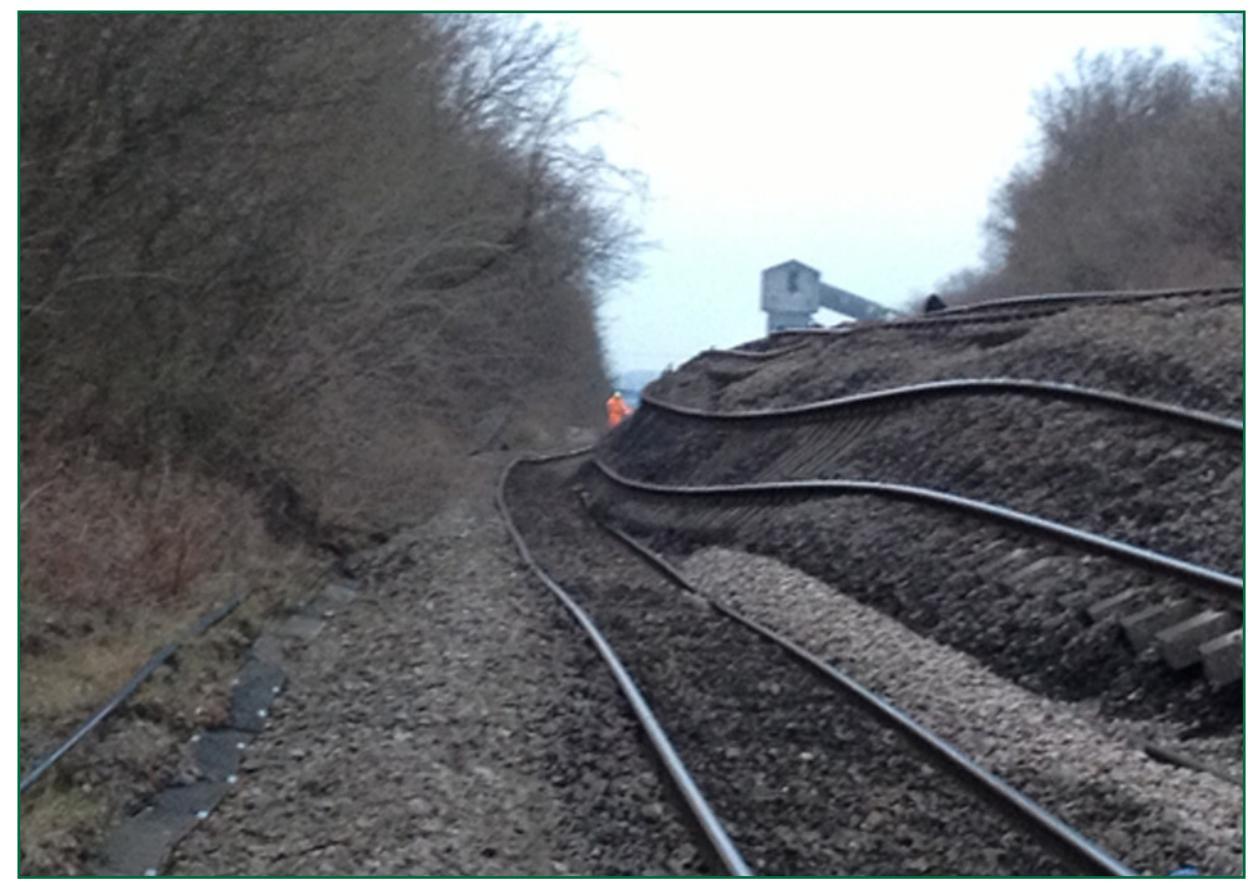
Figure 30: Hatfield Colliery: track deformation (image courtesy of Network Rail)

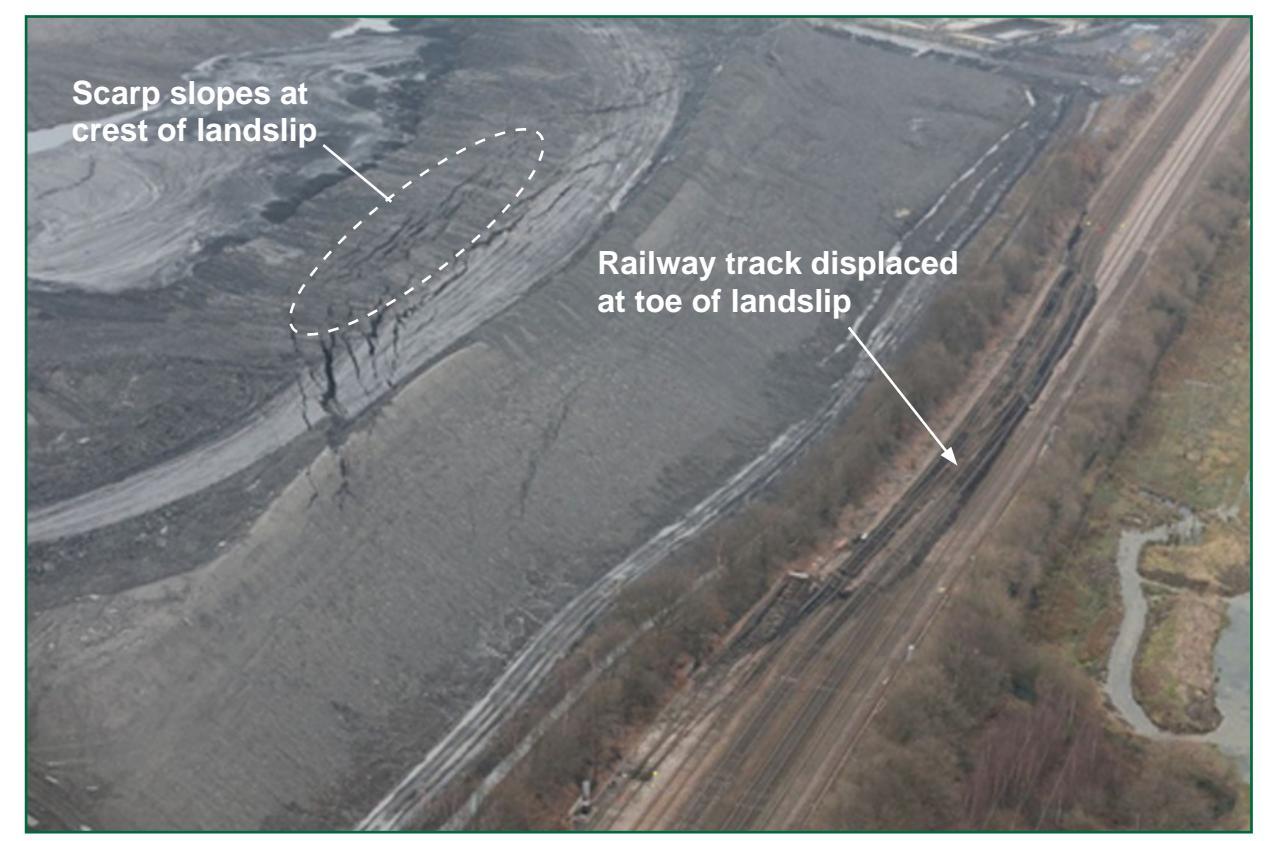
- 78 Aerial photographs taken by Network Rail show that the track deformation was a consequence of a large landslip caused by a spoil tip located outside the railway boundary and within Hatfield Colliery (figures 31 and 32). The precise reason(s) why the landslip occurred remain to be determined and, in addition to the ground loading imposed by the spoil tip, may involve factors such as unexpected weakness in the natural ground. RAIB has not investigated these reason(s) because this was not expected to lead to additional RAIB safety recommendations.

Figure 31: Hatfield Colliery: aerial view (image courtesy of Network Rail)
