# **Rail Accident Report**

Class investigation into landslips affecting Network Rail infrastructure between June 2012 and February 2013

> Report 08/2014 April 2014

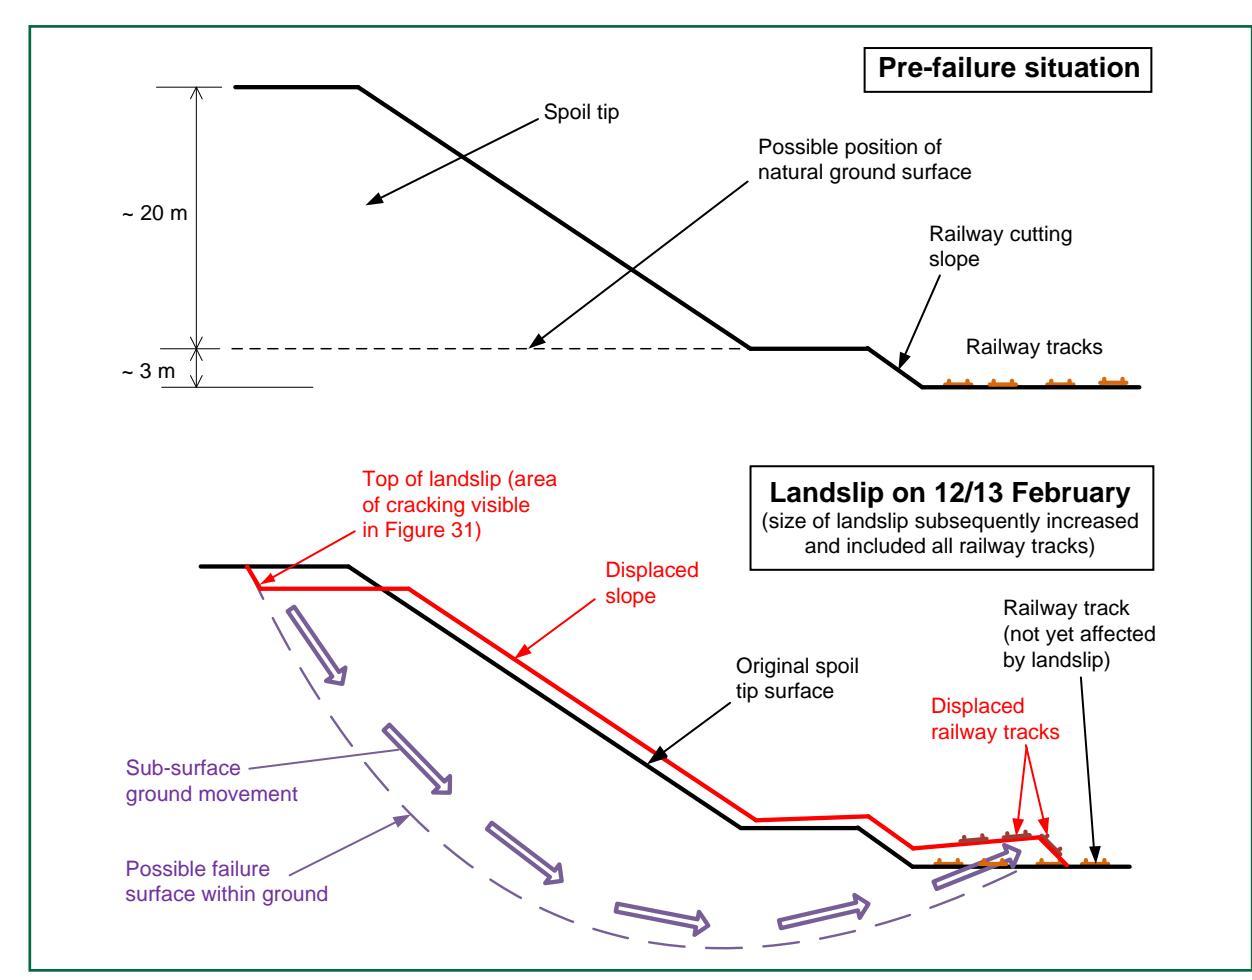
- 79 In the area of the landslip, the railway is running in a cutting up to three metres deep with a side slope of typically 1 in 1.4. When the landslip occurred, photographs seen by RAIB, coupled with desk study information provided by Network Rail, suggest that the nearest toe of the spoil tip was about 9 metres from the top of the cutting and the spoil tip rose about 20 metres above the toe with a side slope of around 1 in 1.5.

Figure 32: Hatfield Colliery: landslip geometry (cross-section)
