The derailments at Amsterdam Central Station on 6 and 10 June 2005

The Hague, 30 November (project numbers M2005RV0606-04 en M2005RV0610-02)

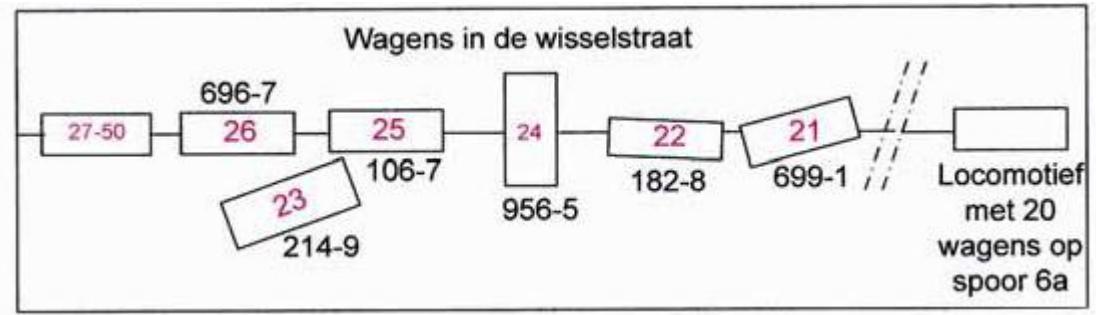
The derailment did not cause any casualties or injuries. However, there was considerable damage to both equipment and infrastructure. Wagon 23 collided with a post carrying an overhead wire causing the gantry which extended across six tracks to collapse, as a result of which a large section of the emplacement was no longer usable.

Illustration 1 Illustration showing the position of the wagons after the derailment (source: Inspectorate for Transport, Public Works and Water Management)

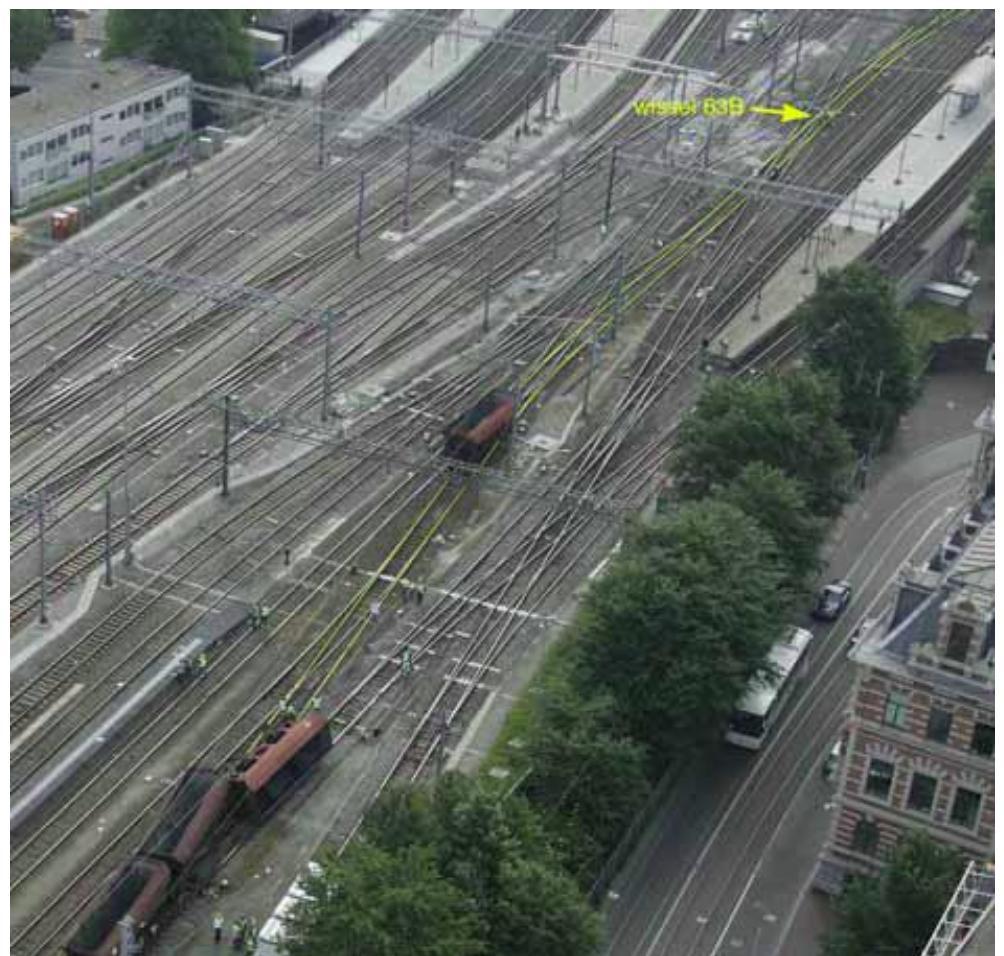
At twelve minutes past three in the morning of Friday 10 June 2005, an empty coal train derailed on the damaged set of points. The train consisted of an engine and 36 empty coal wagons. The rear three wagons derailed and one tipped over on its side. There were no casualties. However, there was damage to the equipment and the infrastructure. A number of points were also damaged.

Illustration 2 Defective set of points 63, track and final position of the derailed wagons

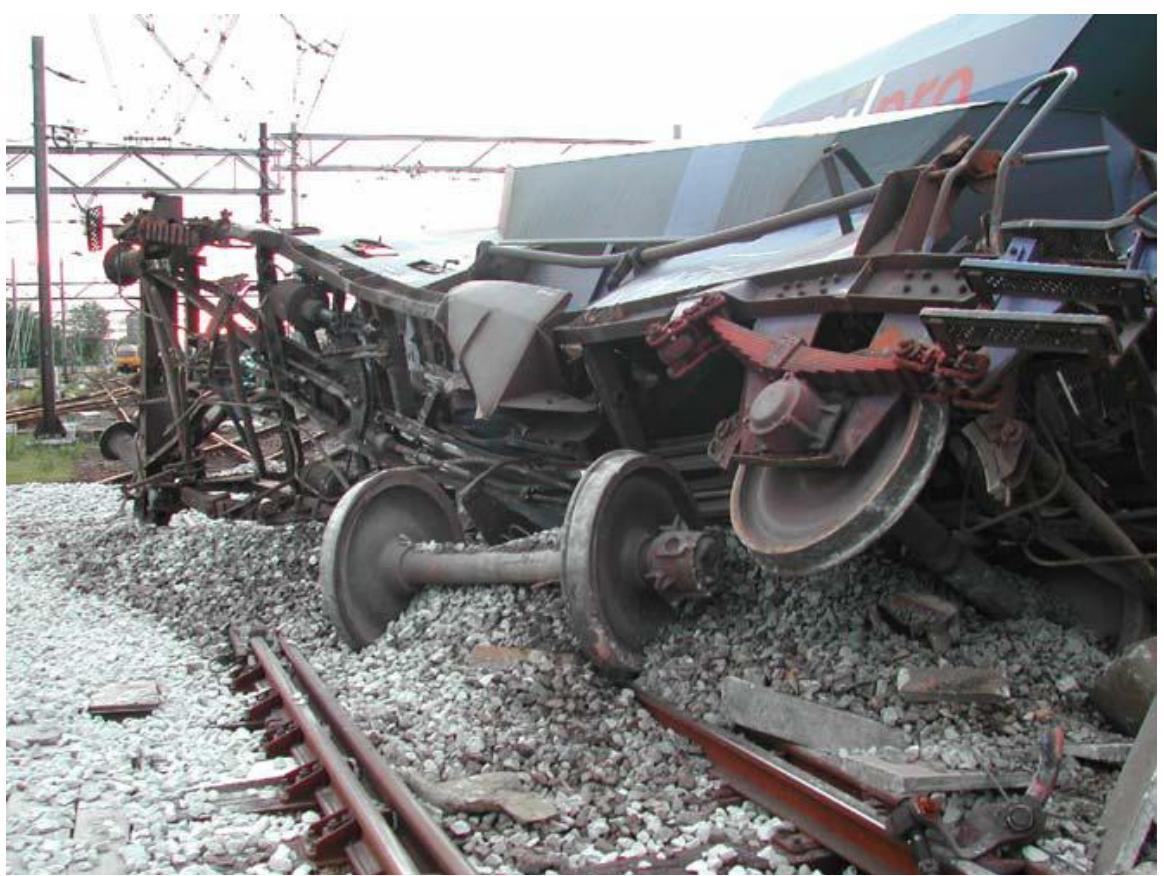
Illustration 3 Photo of the debris

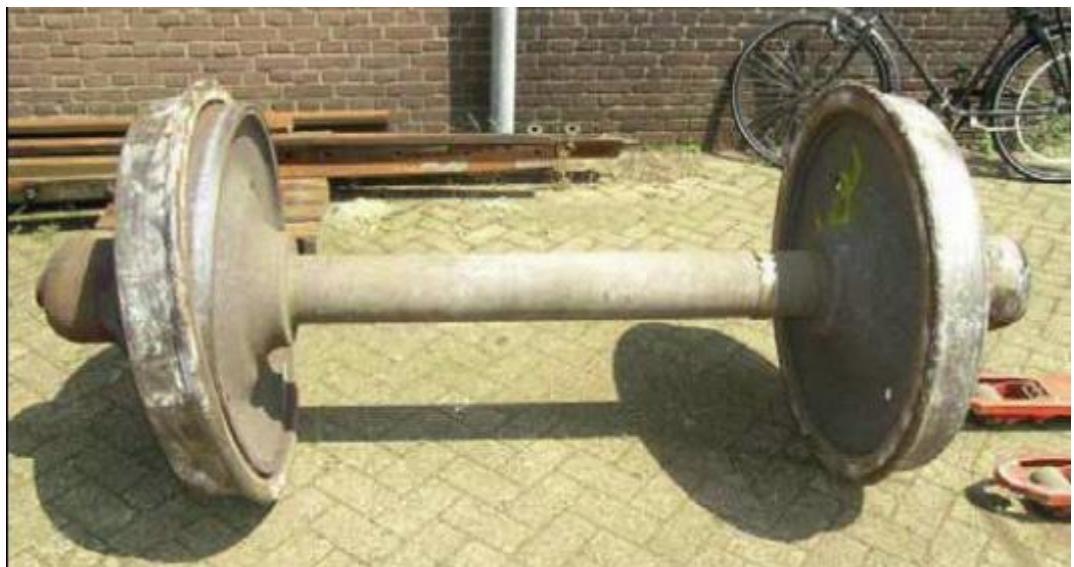
The Inspectorate for Transport, Public Works and Water Management concludes in its report that the derailment was the direct consequence of the loose and displaced tyre of the left wheel of the rear wheel set of wagon 22. The Inspectorate did not determine the underlying cause of the sudden loosening of the tyre. The other damage observed to the equipment and the infrastructure can be designated as consequential damage. According to the Inspectorate, a check of the data from measurements taken shortly after the derailment and data from the maintenance database show that no evidence has been found in the infrastructure which could have been the cause of the derailment.

Illustration 4 The rear axle of wagon 22 (Source: Inspectorate for Transport, Public Works and Water Management)

The Inspectorate for Transport, Public Works and Water Management investigated the possible cause of the derailment⁴. This investigation focused on, among other things, the equipment. The investigation into wagon 22 revealed that the tyre of the left wheel of the rear wheel set had moved away from the inner wheel. The tyre had partly come loose from the inner wheel. Closer inspection of the wheel in question revealed that the tyre clip (see paragraph 2.2 for an explanation of this term) was missing and that part of the tyre on the side of the tyre clip had disappeared. Part of what is known as the lip of the tyre was also missing. The fracture area of the tyre where the lip had disappeared was very rusty which would seem to indicate that the lip material had been missing for some considerable time (although it is not known how long). The tyre clip was not recovered from the scene of the derailment nor from the section of track the train had travelled along. However, part of a tyre clip was found on an entirely different track at the emplacement at Amsterdam Central Station. Investigations by AEA Technology showed that it was probably part of the wheel in question. If this is the case it means the tyre clip had become loose and had broken during an earlier trip.

- 1. Voestalpine Railpro is advised to develop the maintenance system for its railway equipment in such a way as to guarantee that the equipment continues to fulfil the applicable requirements. This includes a complete and clear registration of the state of repair of each vehicle.
- 2. The Inspectorate for Transport, Public Works and Water Management is advised to implement, as a priority, the plan described in the Second Framework Policy Document on Rail Safety in the Netherlands to maintain strict supervision of the maintenance and maintenance processes for goods equipment. In particular, the Safety Board recommends an improvement in the system of technical checks and regular maintenance which ensures that deficiencies such as the lack of wheel markings can no longer occur.

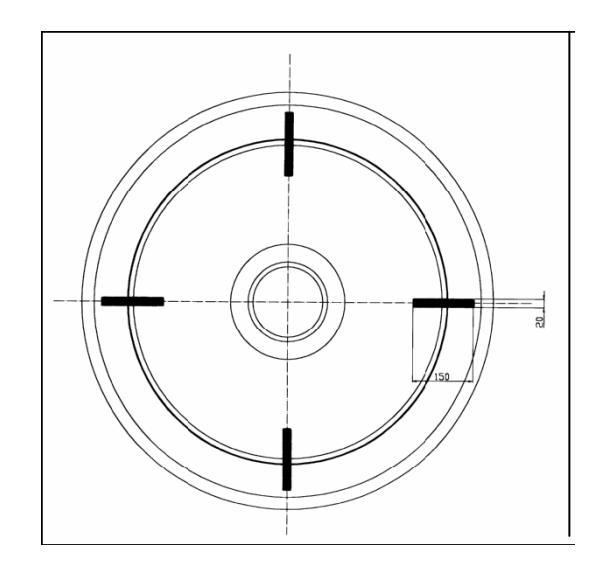
Position of the white check marks on tyres, Length 150 mm, width 20 mm.

A railway vehicle may not use the main infrastructure without any proper visible control markings on the tyres. In the past, the sound test (tapping the wheel) was done to ascertain whether a tyred wheel was defective in any way. Due to the increase in the number of solid wheels and the obligatory control markings, the sound test has only limited added value and, according to the Inspectorate for Transport, Public Works and Water Management, it was agreed (in around 1990) that wheel tapping was no longer obligatory.

It has been established that the control markings on the wheels were missing. These markings (four white painted stripes on the tyre and wheel) allow a loose tyre to be detected. The missing control markings, the excessively thin tyre and the missing tyre clip must have gone unnoticed during technical checks before departure and during earlier checks because the defects in question do not occur overnight. The system of technical checks before departure and the supervision thereof is evidently arranged in such a way that such aspects may structurally go unnoticed.

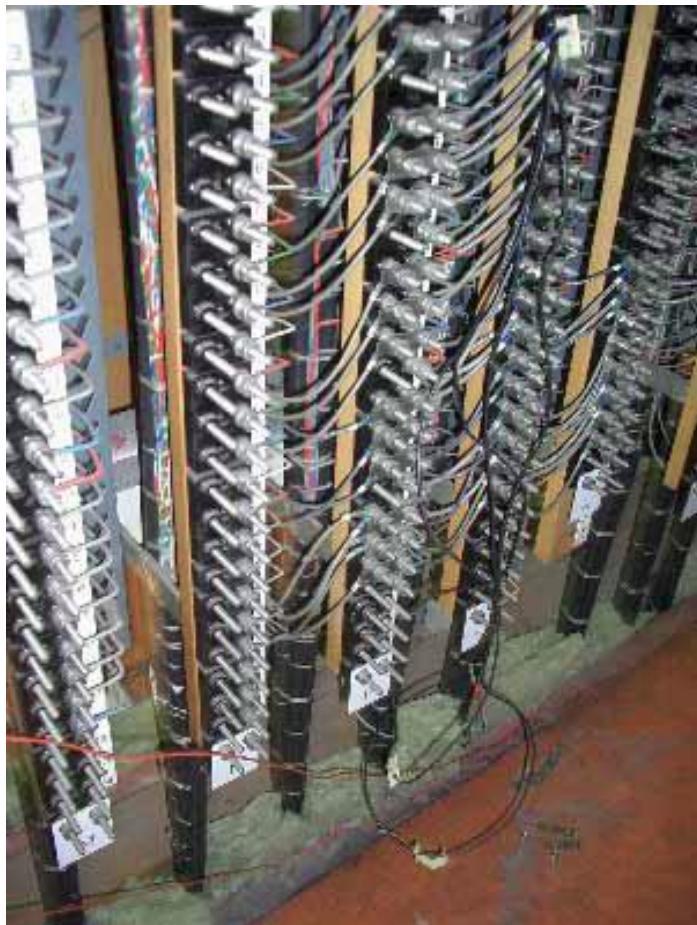
Nonetheless, in order to allow a set of points to be used in such a situation, it can be physically jammed in a position that allows them to be used safely. However, because the signs for the track in question cannot be turned to green as a consequence of the broken cable, either the train traffic controller must order each individual train to pass through a red light (which is a time-consuming process), or the warning signal in the operating system must be 'artificially' removed. The latter is done by installing a bridging element. The safety installation is then adapted in such a way (by attaching wires between the relay) that the system signals that the set of points are controlled to a certain side. However, this signal is no longer linked to the actual position of the set of points outside, but is an 'artificially' generated signal. If, for example, the set of points is manually placed in a different position, the system will continue to indicate the position chosen when fitting the bridging element. The train traffic controller only sees the signal that the set of points is in control (the signal that s/he would also see normally), and does not see that the signal is a result of a bridging element.

Illustration 2 The temporary connections are fitted in the relay housing using long black wires (Source of photo: Inspectorate for Transport, Public Works and Water Management).

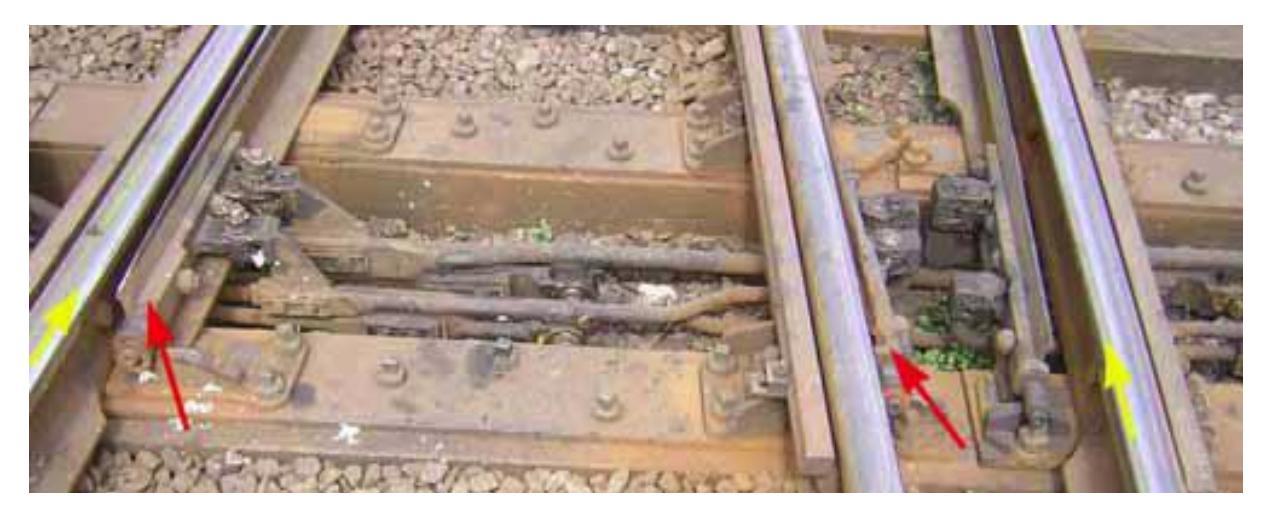
The train traffic controller allowed a number of trains to pass over this set of points on the assumption that these were in the right-hand position (as indicated by the system) while the set of points was actually in the left-hand position. As a result, the set of points was opened and damaged by the passing trains (see the following illustration).

Illustration 3 Set of points 63B in the position found directly after the derailment. The open tongues can be clearly seen.
