DUTCH SAFETY BOARD

# Collision between a passenger train and a man lift at Dalfsen

The Hague, December 2016 The reports issued by the Dutch Safety Board are open to the public. All reports are also available on the Safety Board's website www.safetyboard.nl

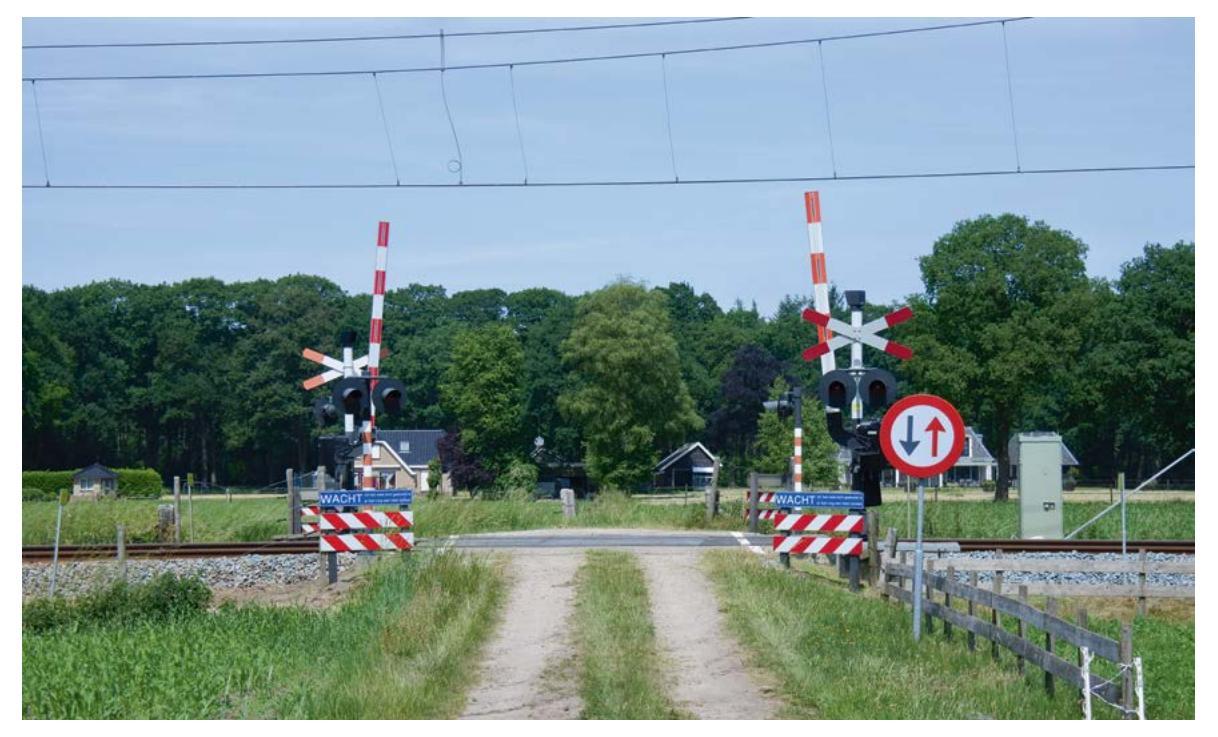
Figure 1: The level crossing where the accident occurred. Photo: Dutch Safety Board

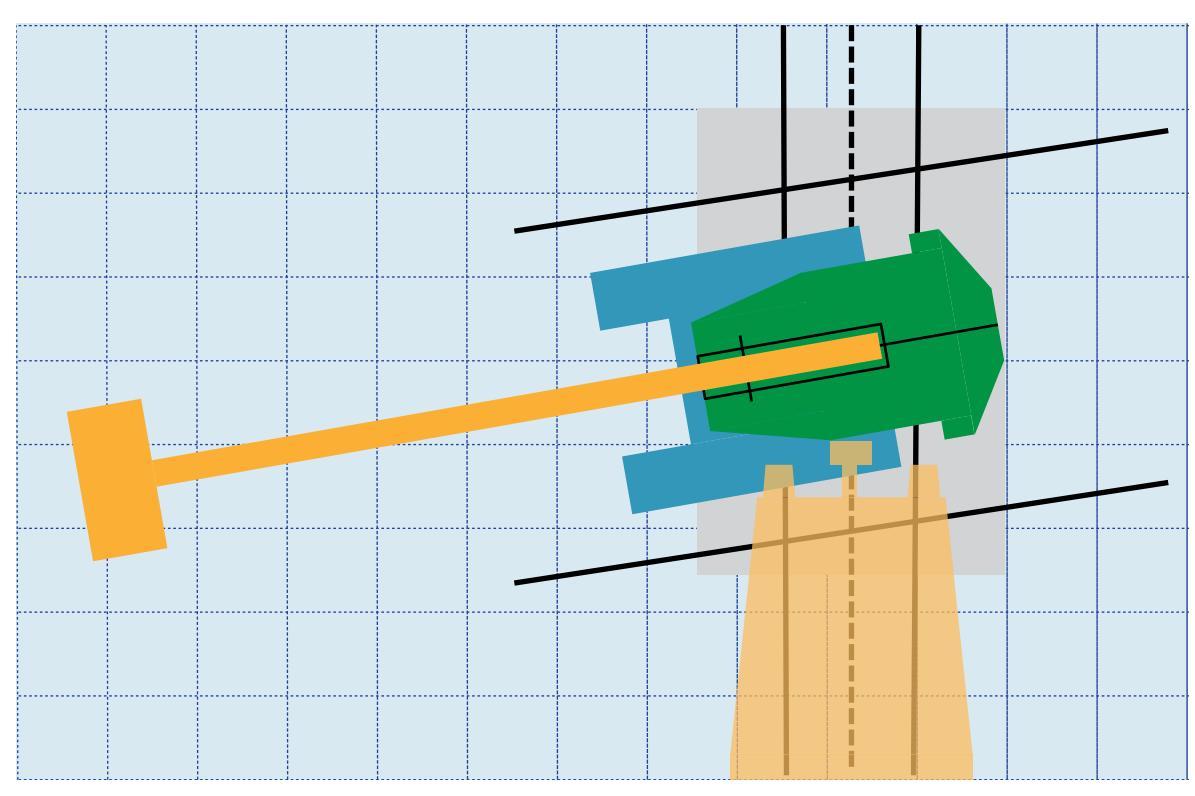
Figure 7 shows the positions of the train and the man lift at the start of the collision. The front of the train collided with the rear part of the left side of the man lift. During the collision, the train speed decreased to approximately 107 km/hour while the man lift was accelerated to approximately the same speed. In addition, the man lift and the front of the train were severely damaged.

Figure 7: The positions of the train and the man lift at the start of the collision.

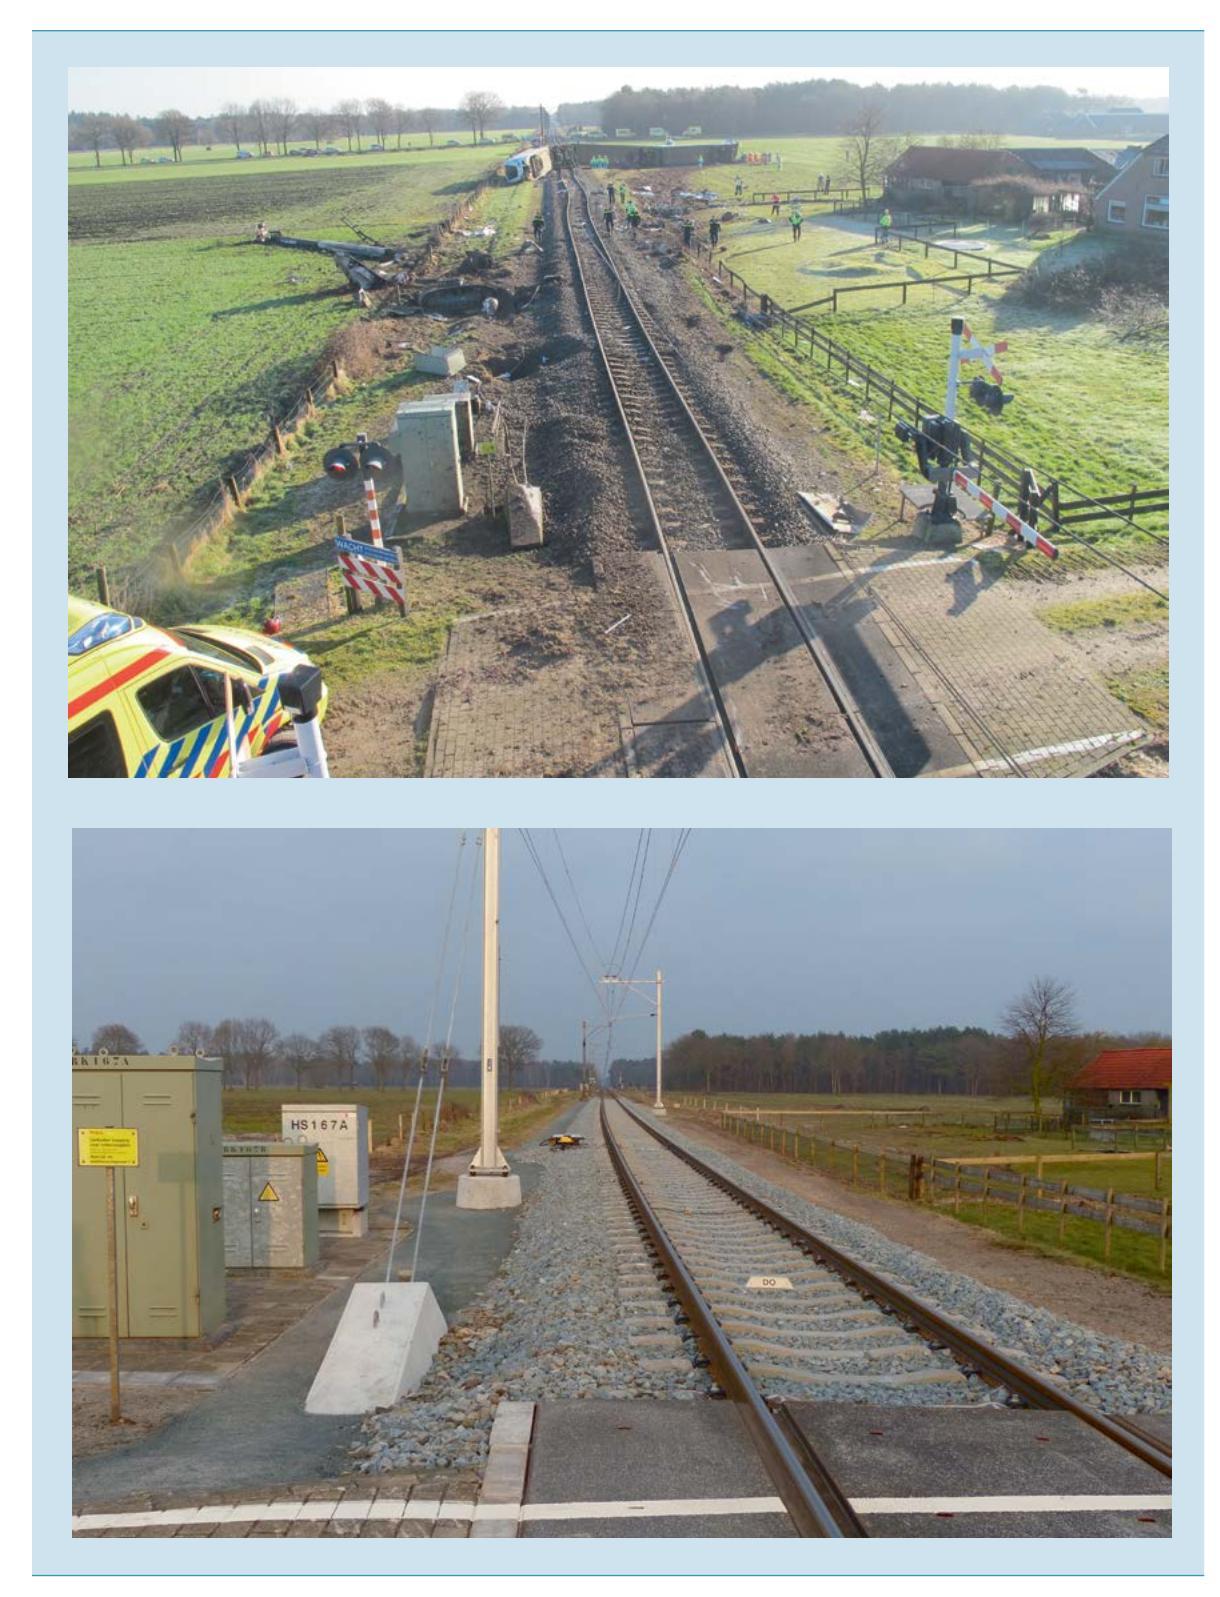
There was a secondary crash shortly after the train collided with the man lift. In this crash the man lift, which had accelerated to a speed of approximately 107 km/hour as result of the train colliding with it, crashed into an overhead lines pole which was standing approximately 15 metres to the east of the level crossing on the north side of the track. As a result of this secondary crash, the overhead lines pole - including the concrete foundations - was ripped from the ground and bent. The wreckage of the man lift and the overhead lines pole ended up a distance of 30 to 60 metres from the level crossing on the north side of the track (also see figure 8).

Figure 8: The upper photo shows the end situation, viewed from the train's direction of travel. In the foreground is the level crossing where the collision occurred; the man lift was crossing from right to left. The wreckage of the man lift and the overhead lines pole can be seen to the left of the track. The train was about 120-150 metres beyond the level crossing, approximately at right angles to the track, on the left-hand side. The lower photo was taken after the damage to the railway infrastructure had been repaired. The (replaced overhead lines pole can be seen in the middle of the photo. Photos: Police (upper), Dutch Safety Board (lower)

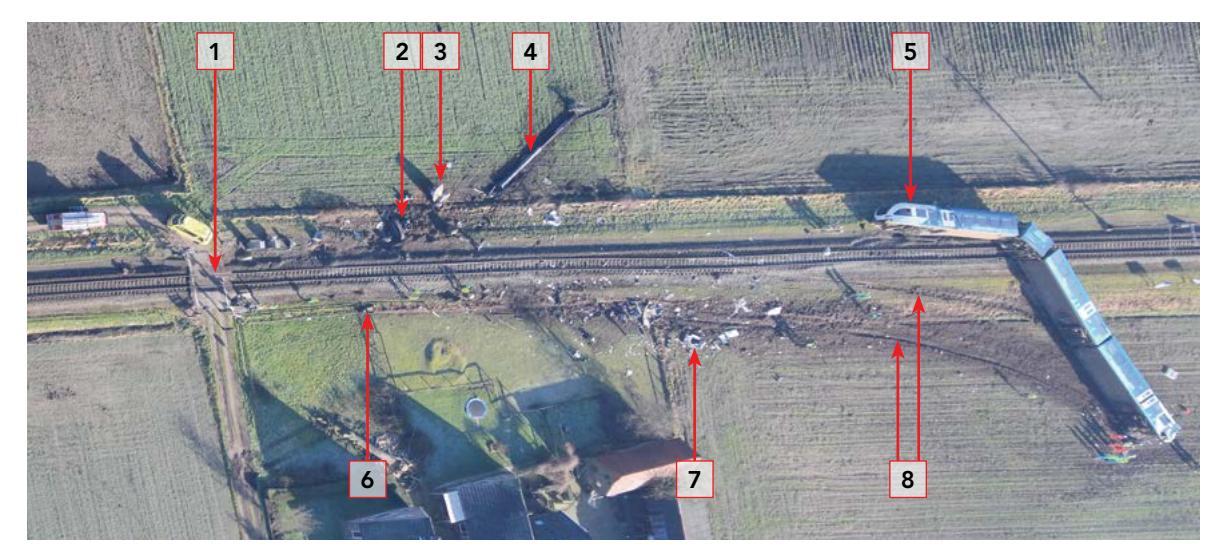
Figure 9: Final positions of the train and man lift wreckage. Photo: Police

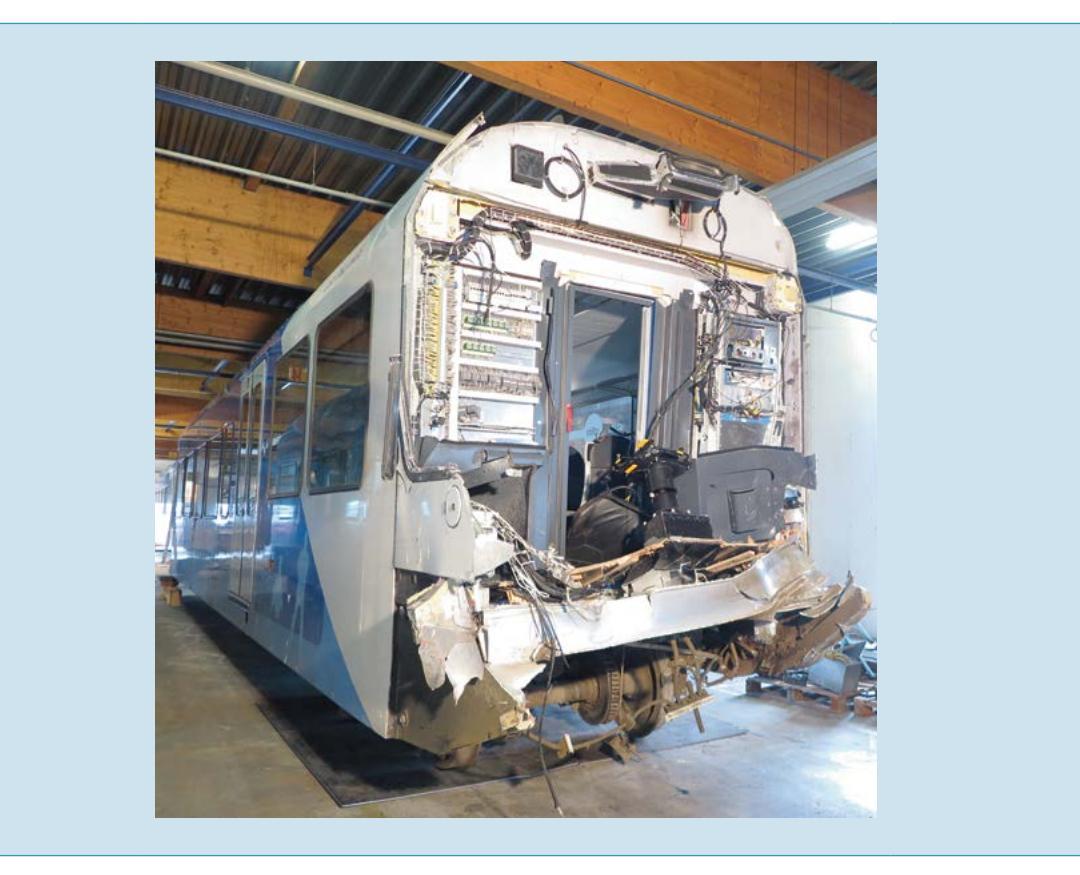
Figure 10: The driver's cab was totally destroyed in the accident. Photo: Dutch Safety Board

The consequences of the accident in Dalfsen were very serious in the sense that the train driver lost his life and the train was derailed and toppled over. The train driver died because the train cab was completely destroyed by the forces that were exerted on it during the accident. This was a relatively new type of train and the crashworthiness of the cab complied with the latest acceptance requirements. This means that trains have a specifically designed crash structure to withstand impacts of a specific magnitude. The train concerned was part of a series of trains which display defects in the welds in the crash structure. Train drivers were, therefore, once again reminded to flee the cab if a severe impact was imminent and seek refuge in the adjacent passenger compartment. The above begs the question why did the cab collapse in the accident in Dalfsen and to what extent did the weld defects play a role in this. The extent to which the train driver had an opportunity to leave the cab in good time is also relevant.

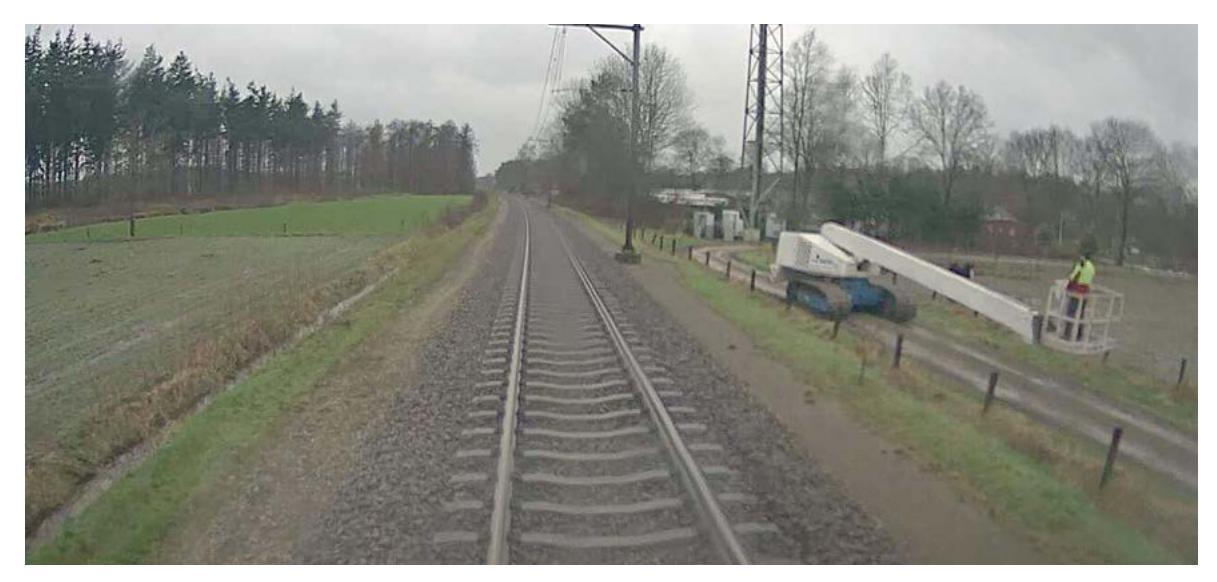
Figure 11: This photo shows the man lift during its journey the previous day to the location where it was used. The operator is in the man basket at the end of the boom, which is approximately ten metres long. The boom normally points backwards while driving. On its approach to the level crossing the boom was temporarily pointing forwards (see photo); prior to the crossing the boom was turned back to the rear. Photo: Arriva front camera, 22 February 2016

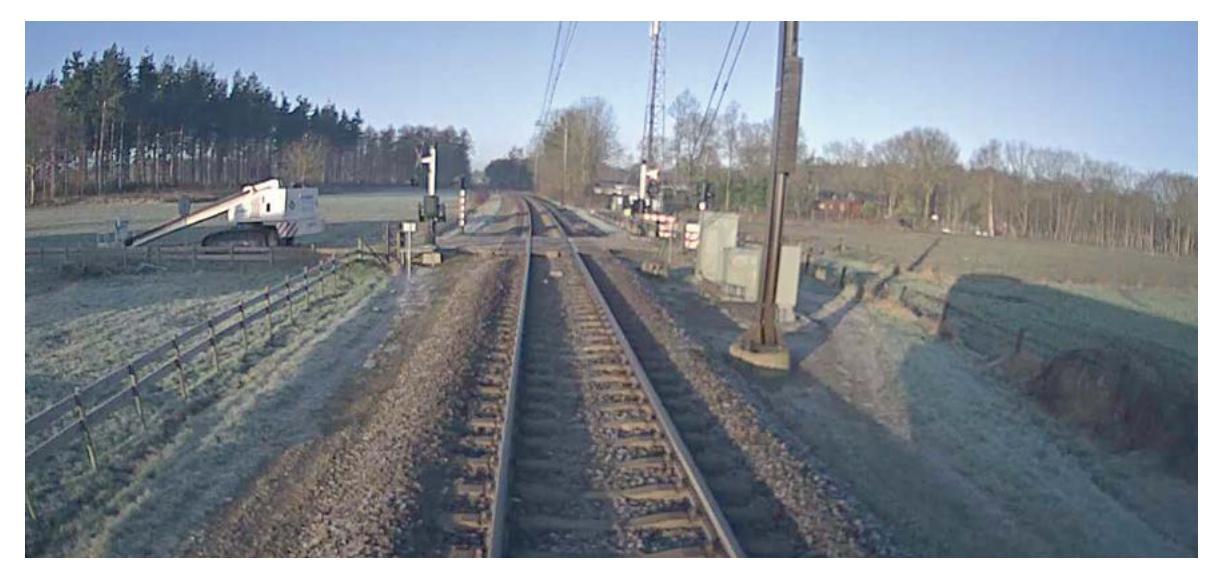
Figure 12: This photo (taken from the last train to pass prior to the accident) shows the position at which the man lift was parked prior to the return journey (close to the level crossing, with the boom still in a southerly direction). Photo: Arriva front camera

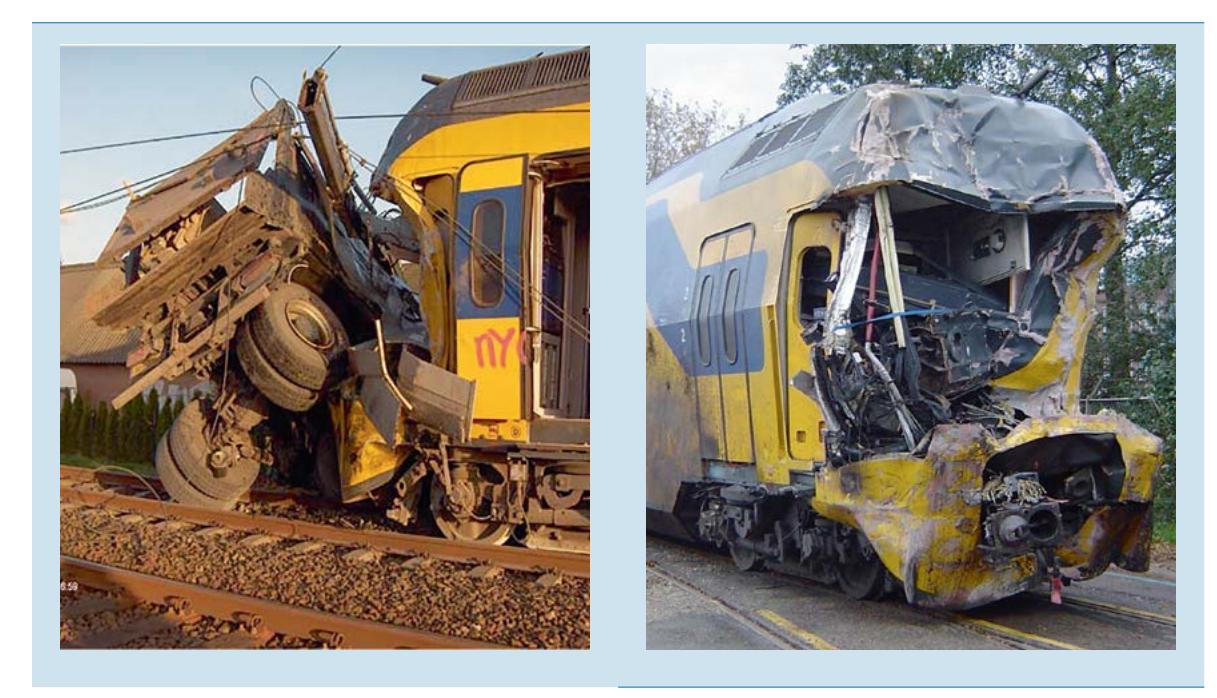
Figure 14: Wijhe (2005), train driver seriously injured as a result of level crossing collision with truck. Photos: IVW (left), Dutch Safety Board (right)

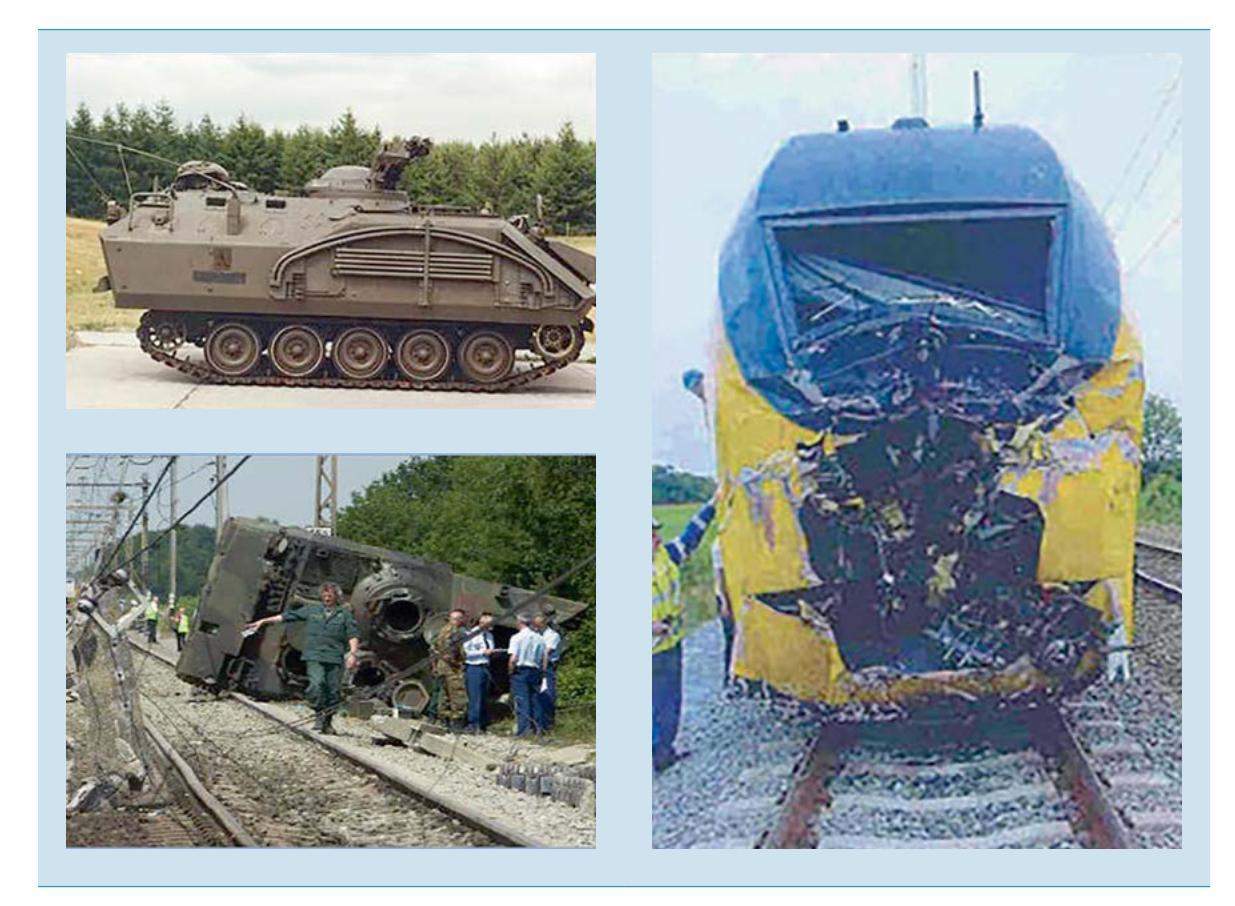
Figure 15: Assen (2003), driver of passenger train seriously injured as a result of level crossing collision with an armoured vehicle. Photos: TCOD-report "Botsing YPR met trein nabij Assen op 17 juni 2003"

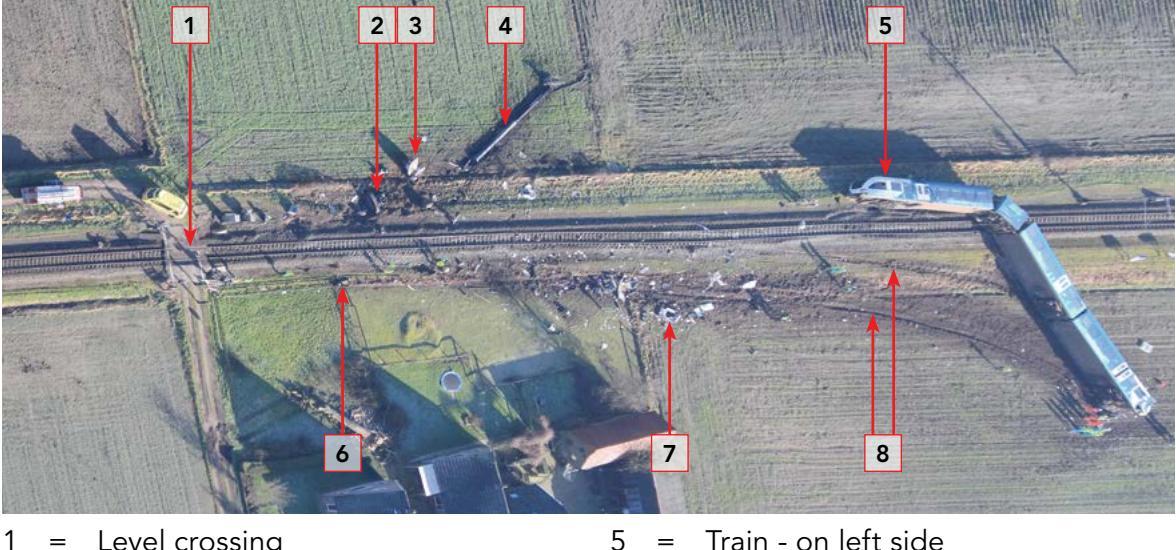
Figure 20: Final positions of the train and man lift wreckage. Photo: Police

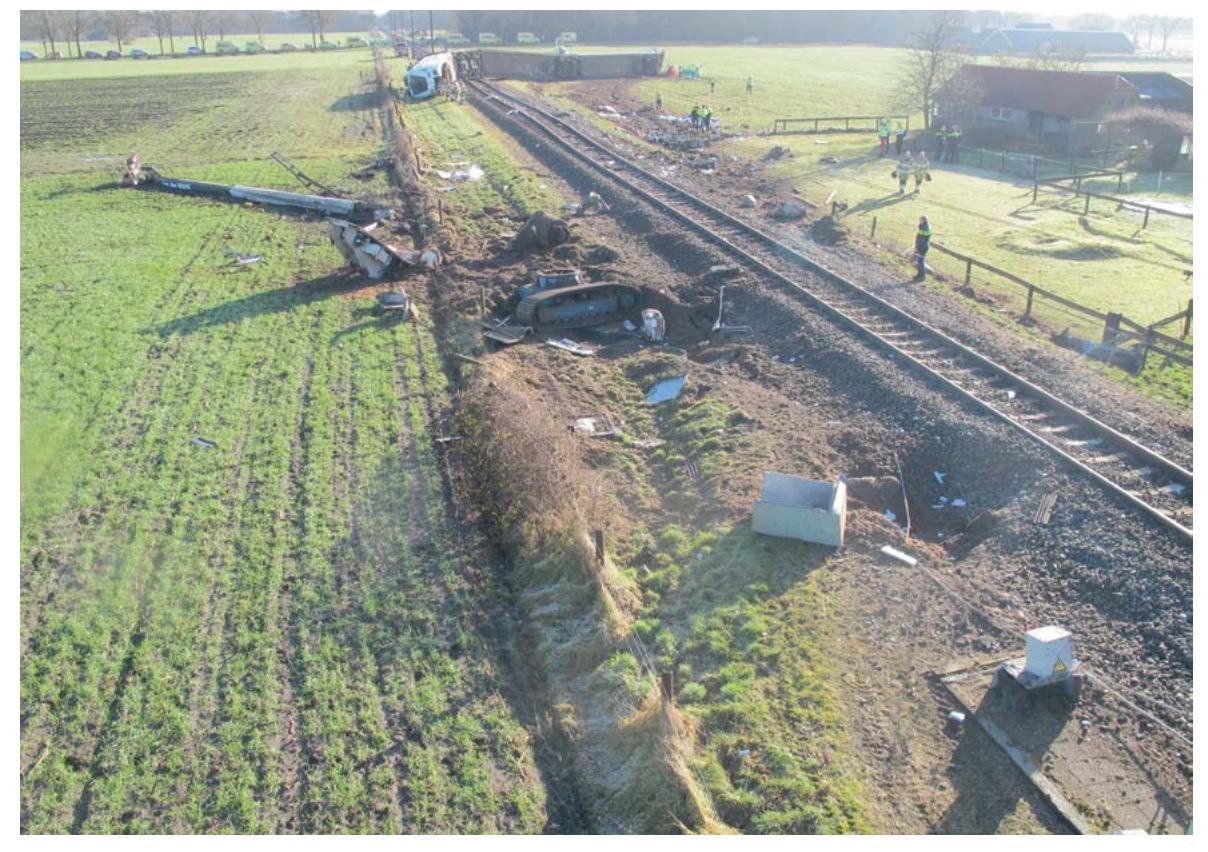
Figure 21: The final positions of the wreckage of the man lift and the overhead lines pole (on the north side of the track). The overhead lines pole was standing in the location where a hollow can be seen in the photo (at the bottom of the picture). Photo: Police

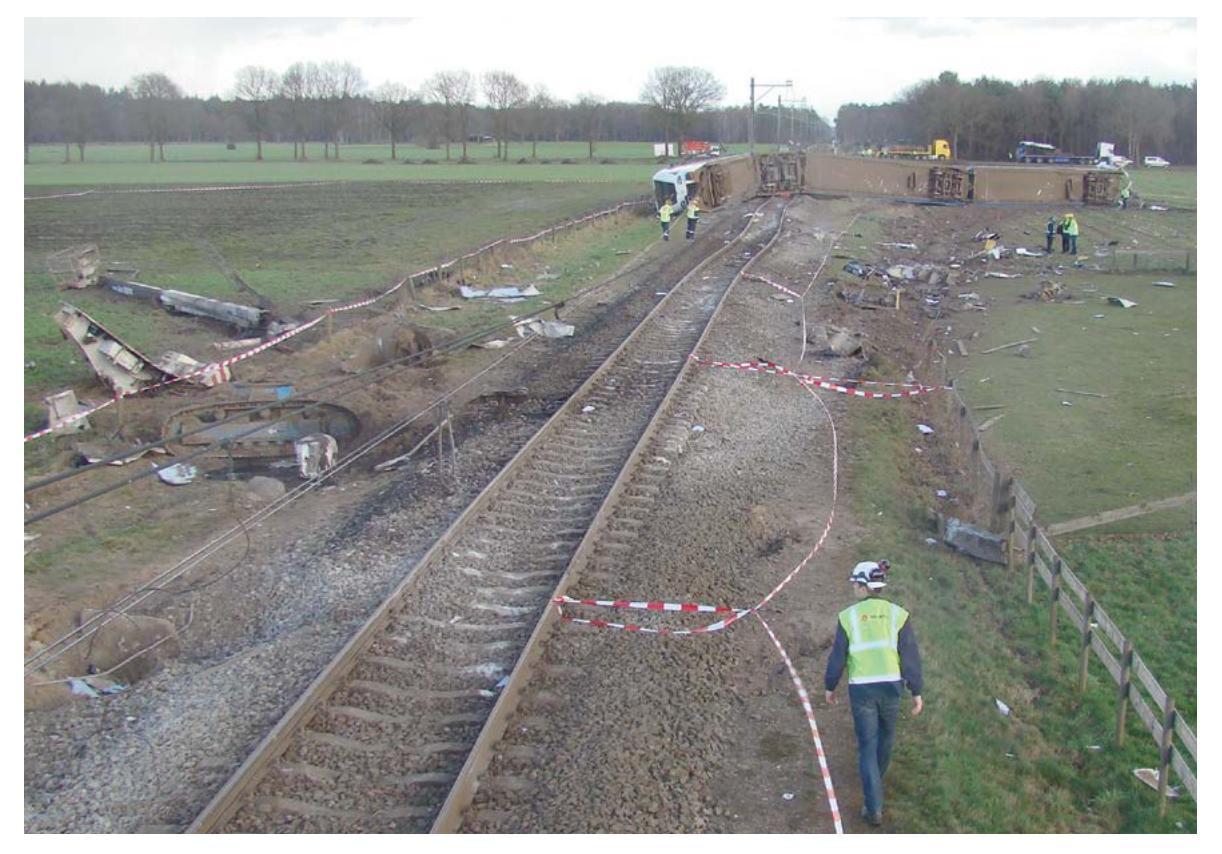
Figure 22: The final positions of the wreckage of the front of the train (on the south side of the track) and the damage to the railway infrastructure. Photo: Police

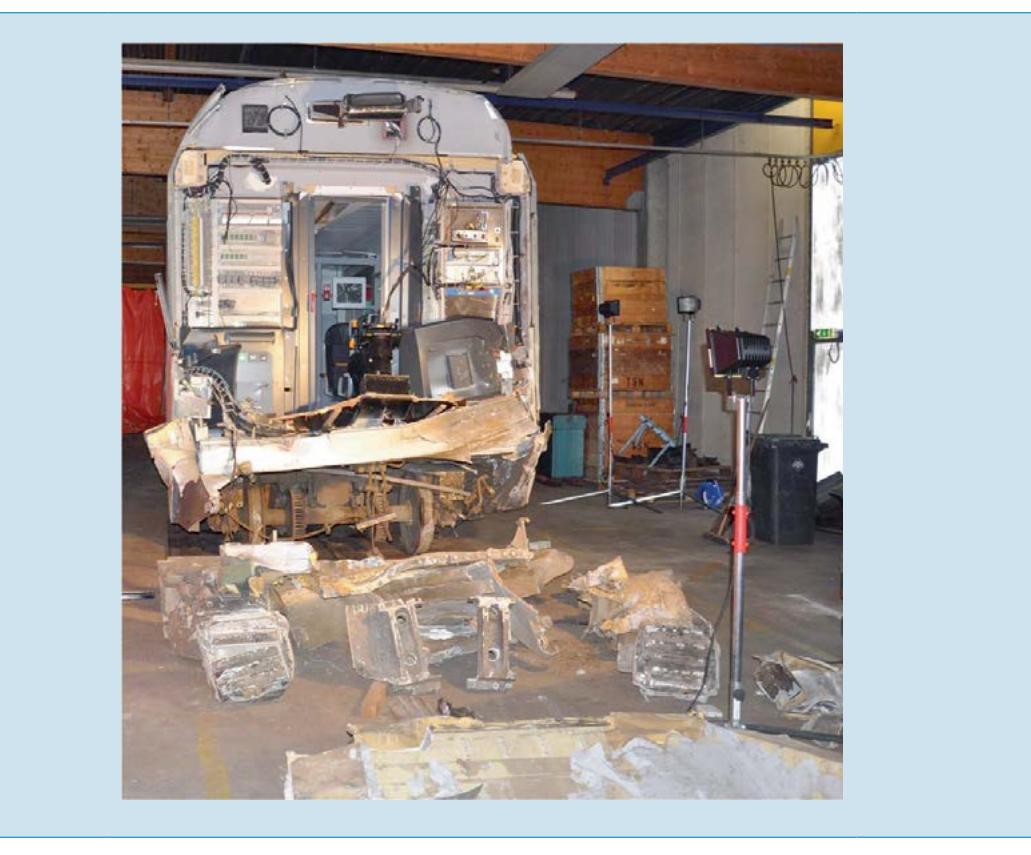
Figure 23: The damage to the front of the train. Photo: Dutch Safety Board

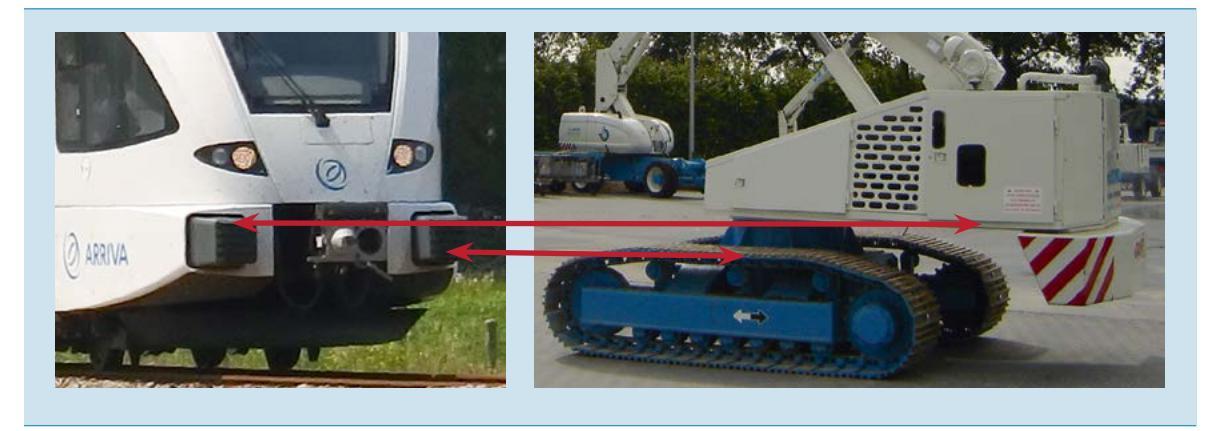
- The bottom part of the left crash buffer (approximately in the centre) came into contact with the side of the left caterpillar track.
- The top part of the right crash buffer came into contact with the side of the superstructure.
- At the start of the primary impact, the front of the coupler was in the open space between the caterpillar track and the contraweight.

Figure 24: These photos show which parts of the train and the man lift came into contact with each other in the primary impact. Photos: Dutch Safety Board (left), Man lift rental company (right)

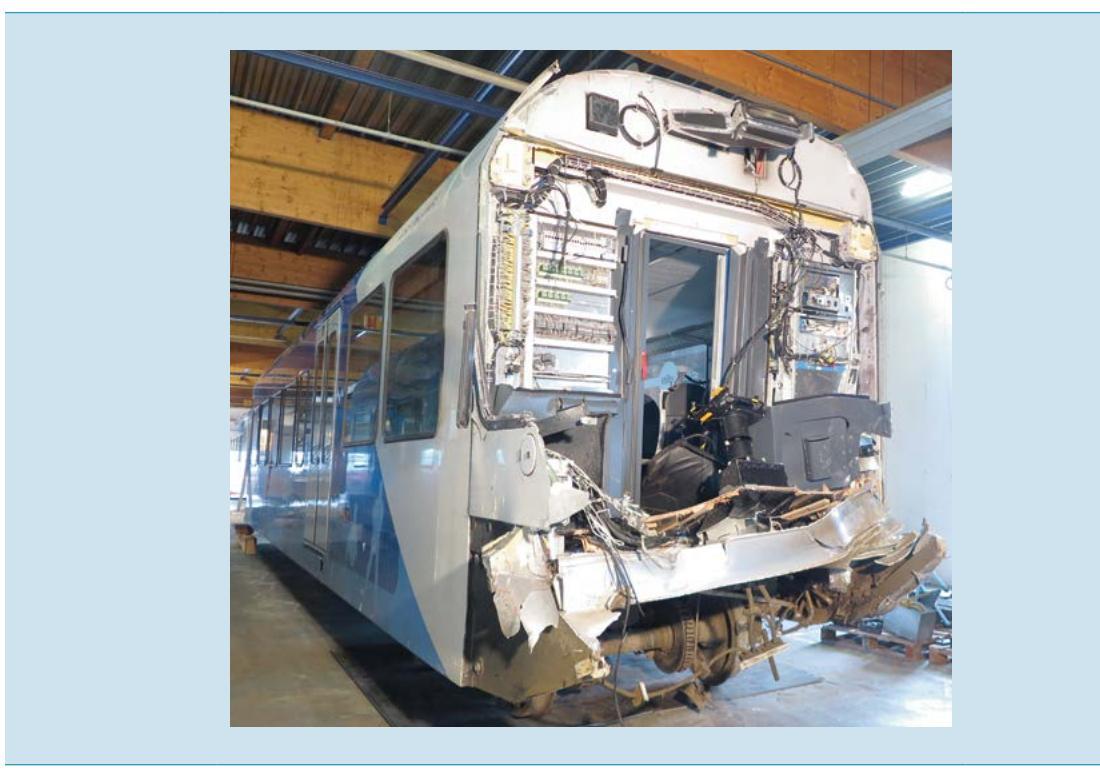
As a result of the collision, the cab was totally destroyed and separated from the front wall of the first carriage (see figure 26).

Figure 26: The driver's cab was totally destroyed by the collision. Photo: Dutch Safety Board

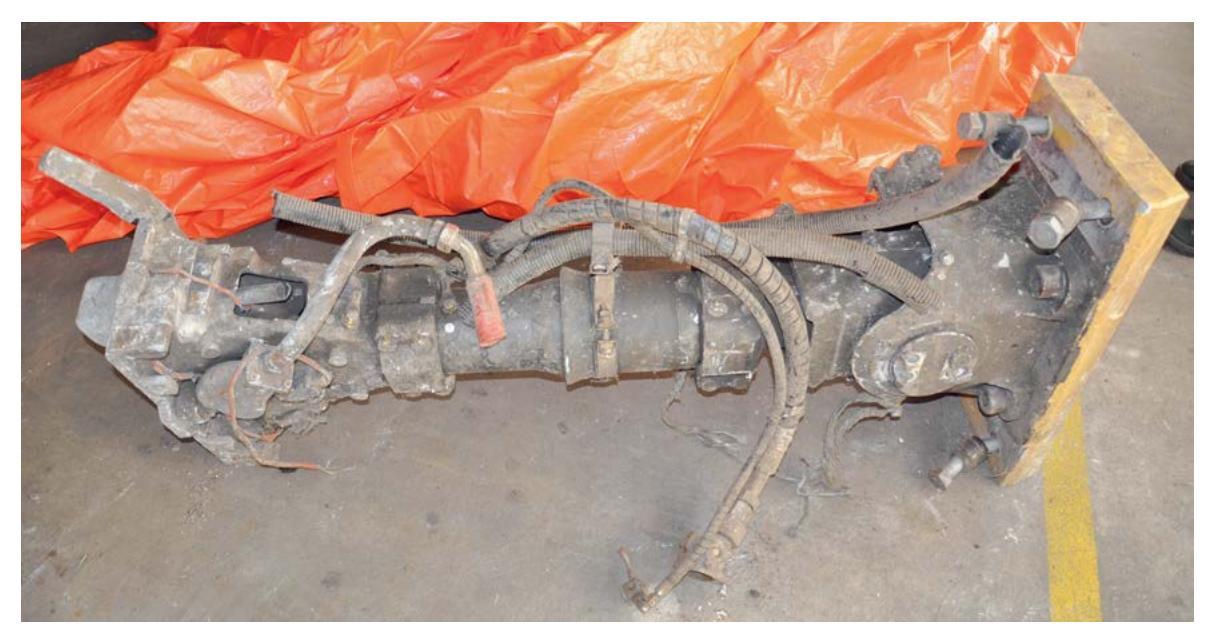
Figure 27: The automatic coupler was not significantly deformed. Photo: Dutch Safety Board

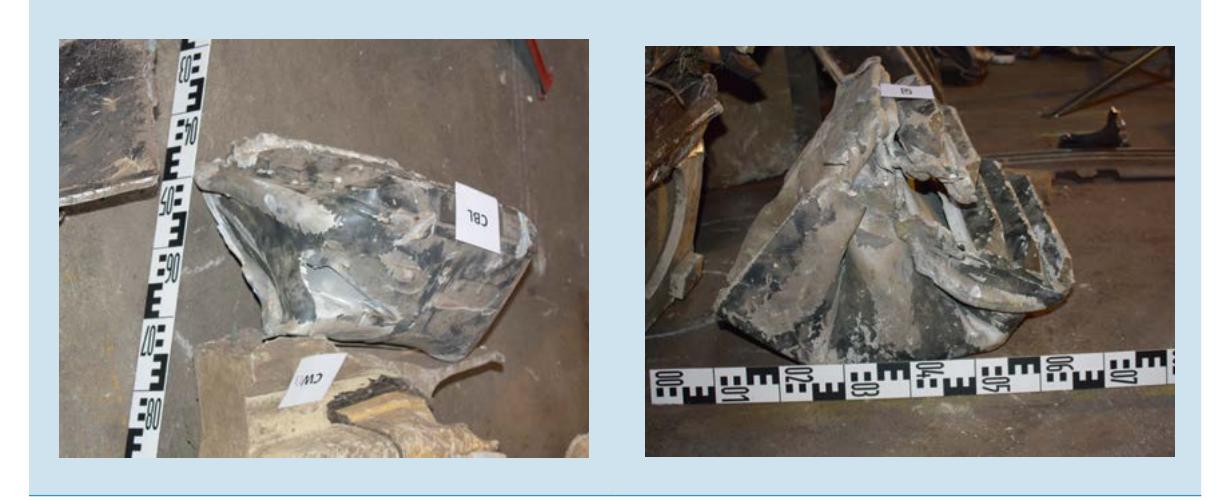
Figure 28: The severely deformed crash buffers. Photos: Dekra Rail/The Dutch Safety Board

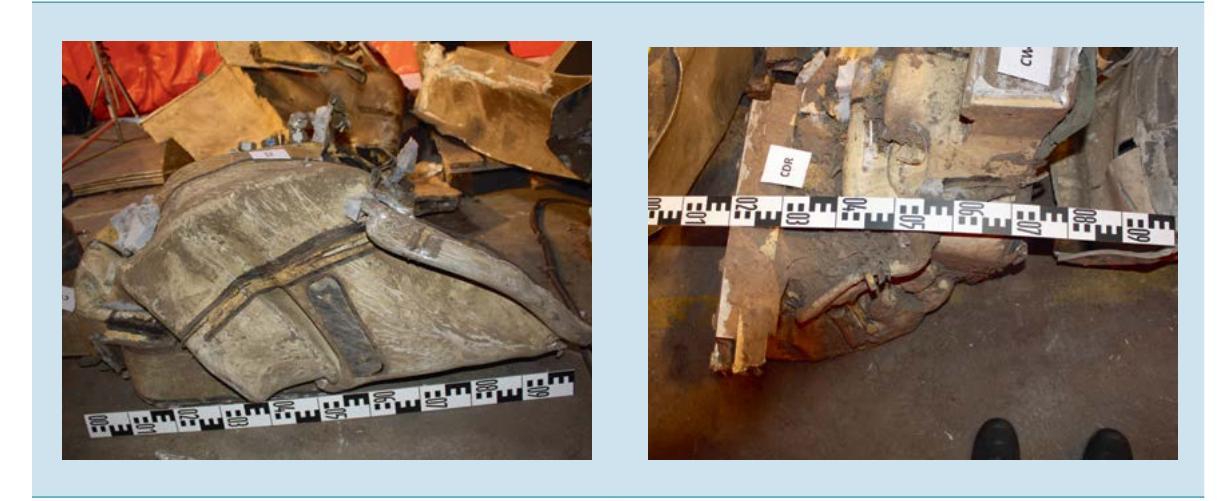
Figure 29: The severely deformed crash boxes. Photos: Dekra Rail/Dutch Safety Board

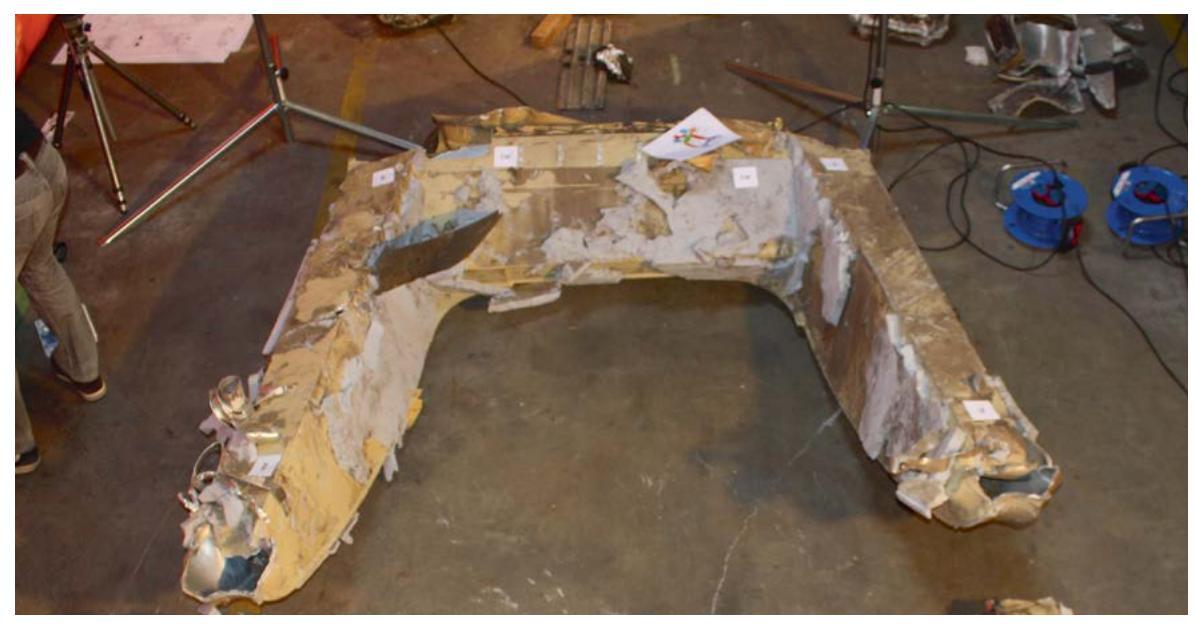
Figure 30: A-pillars and crash wall. Photo: Dekra Rail/Dutch Safety Board

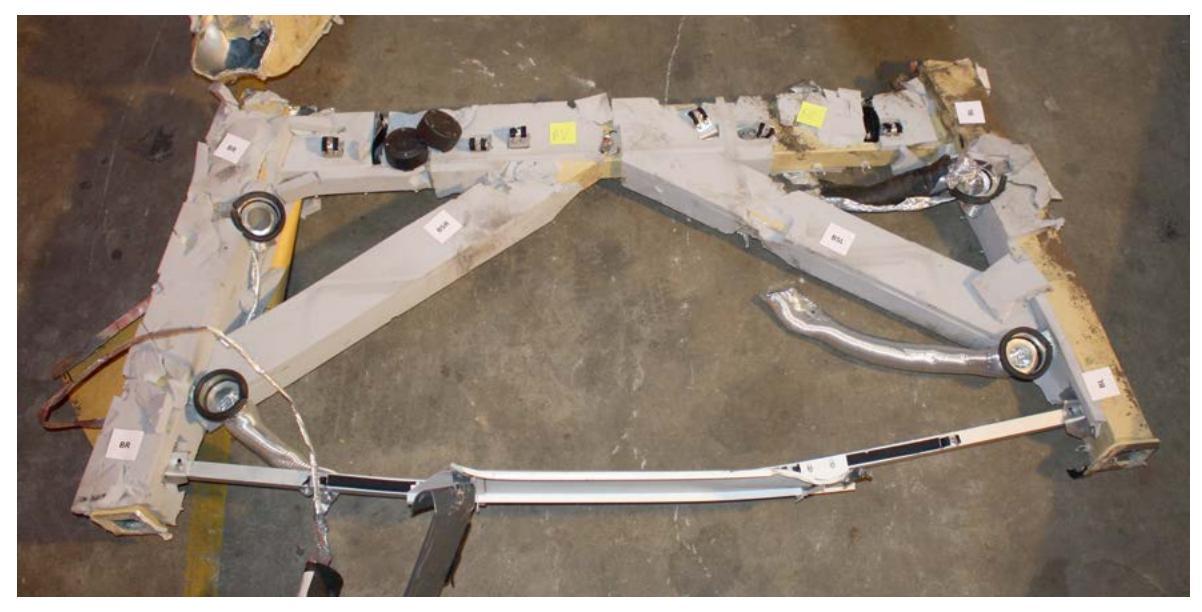
Figure 31: Top frame. Photo: Dekra Rail/Dutch Safety Board

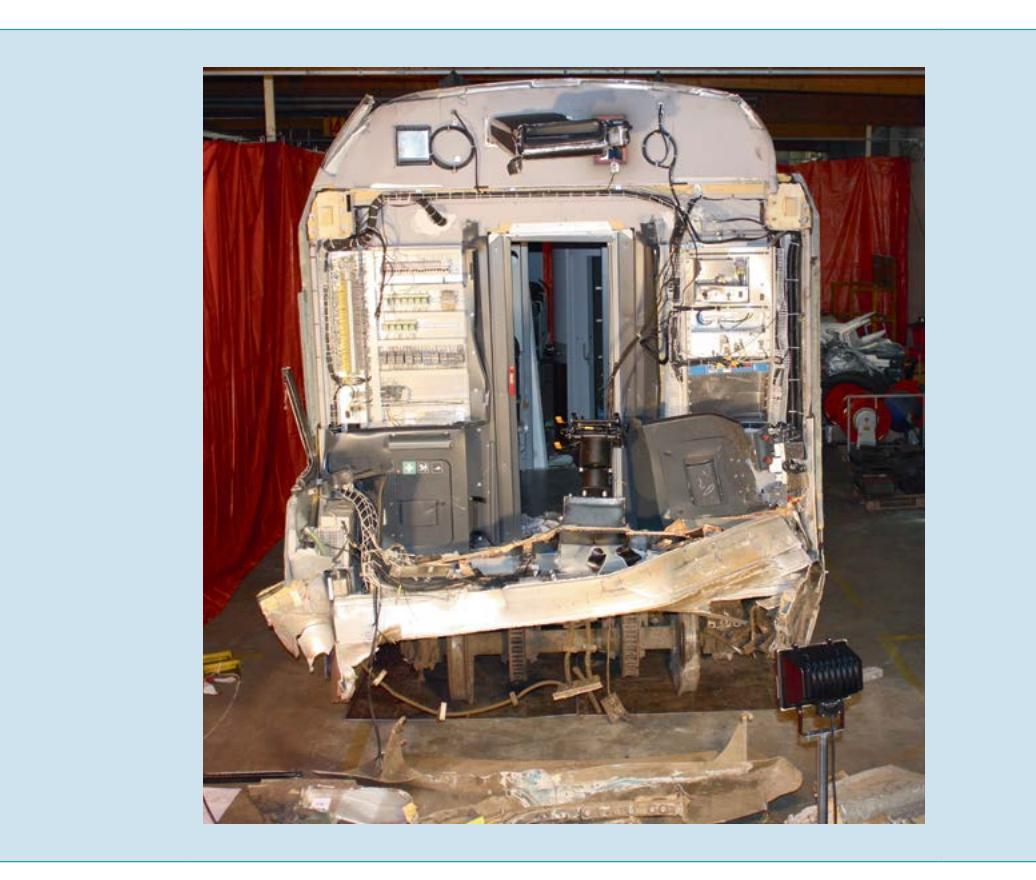
Figure 32: The front carriage is slightly twisted on the longitudinal axis in an anti-clockwise direction. Photo: Dutch Safety Board

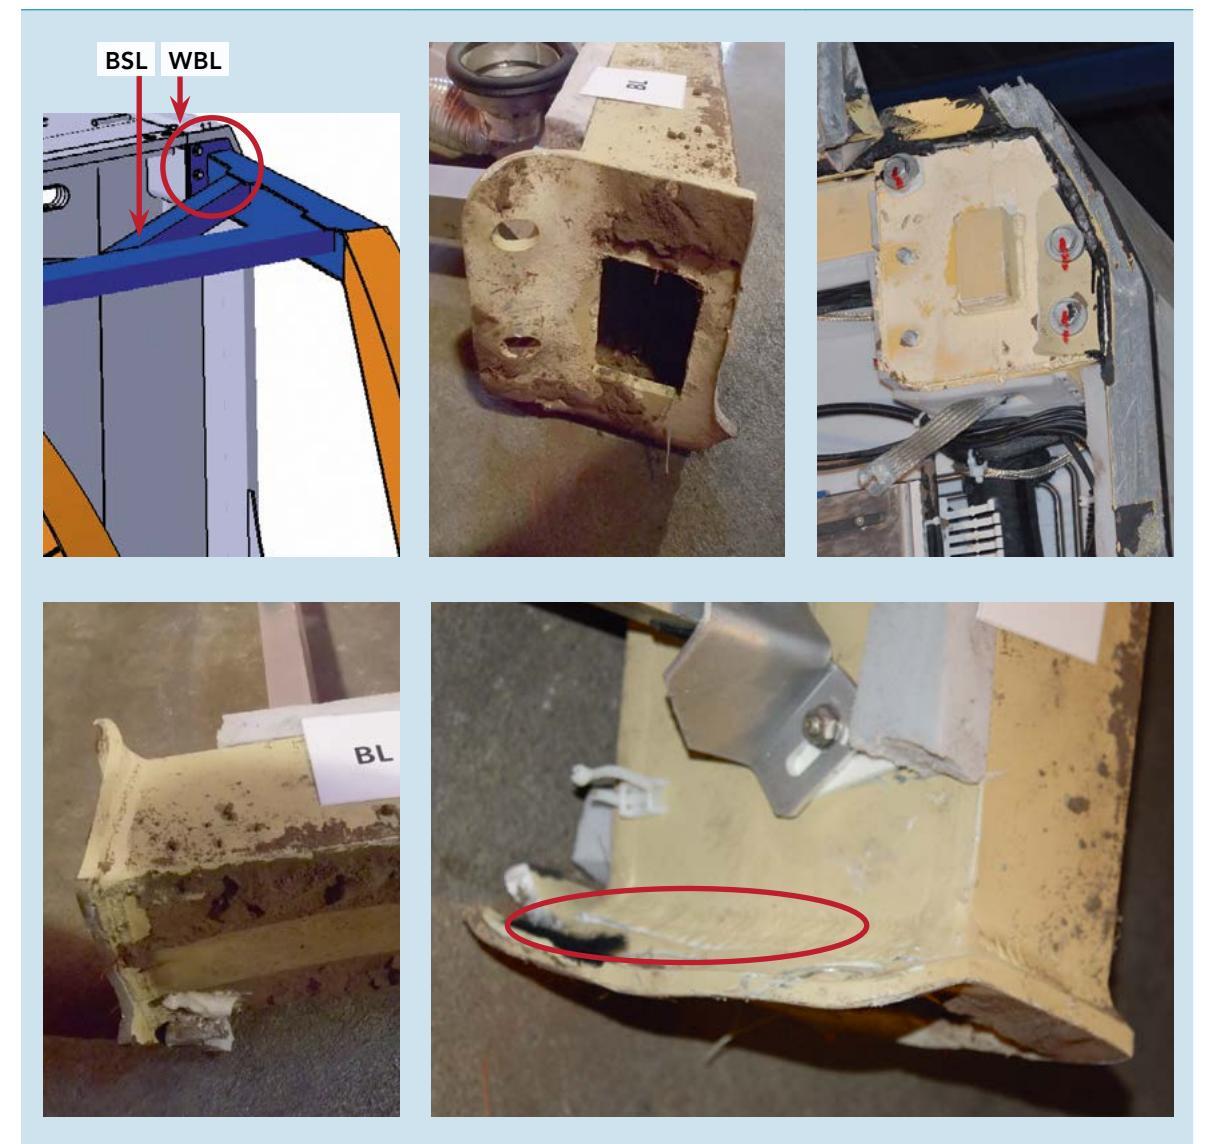
- There are impact fractures that go throuh the base material (alongside the welds).
- There are deformations alongside the broken surfaces.

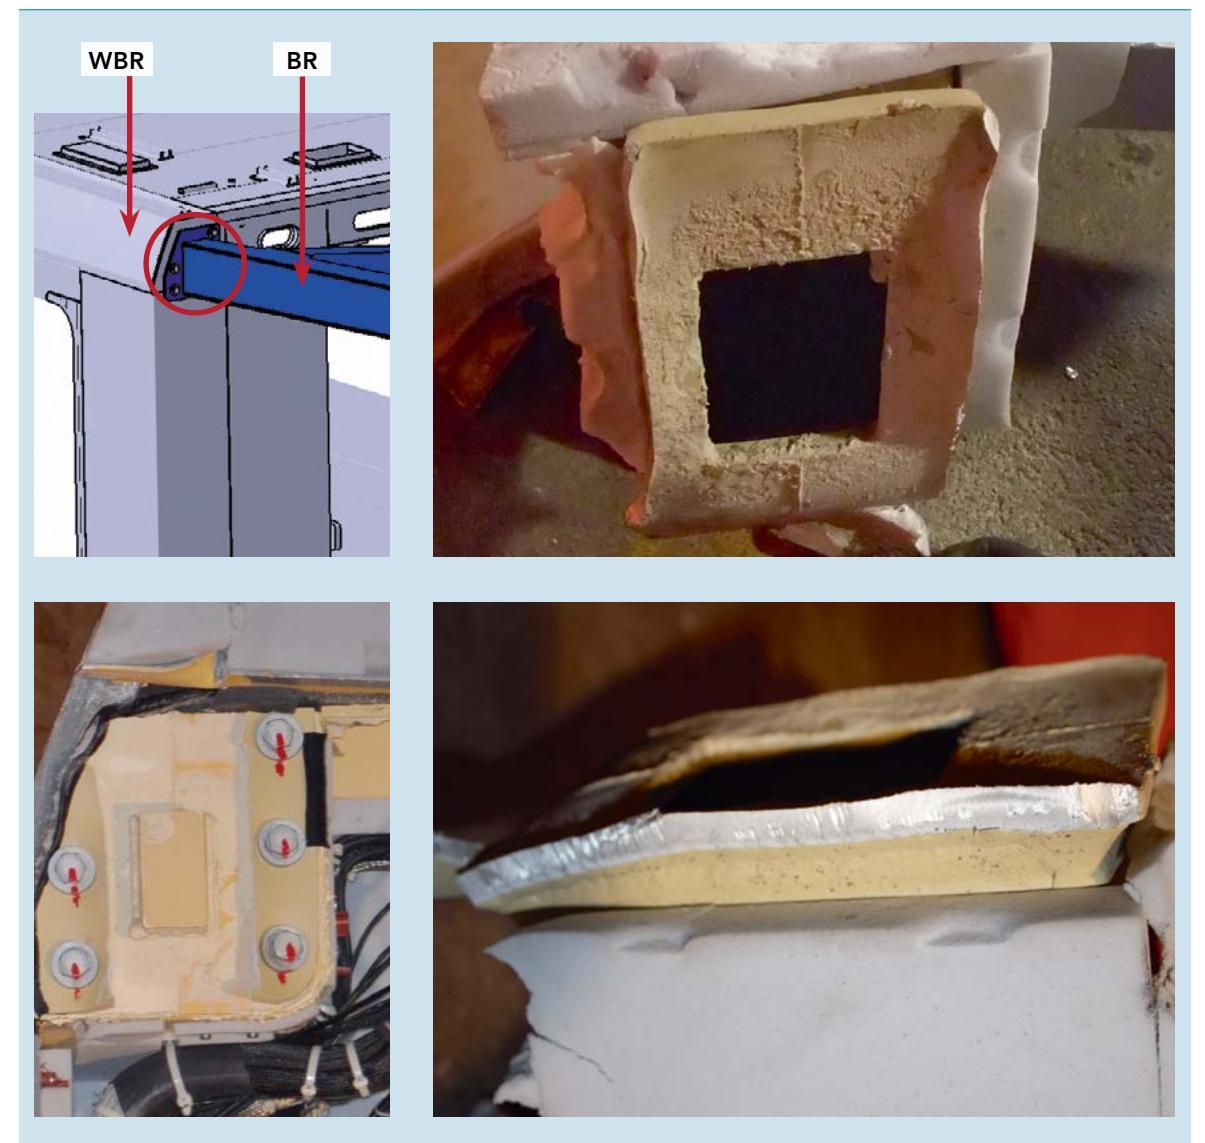
- There are impact fractures that go throuh the base material (alongside the welds).
- There are deformations alongside the broken surfaces.
