DUTCH SAFETY BOARD

# Collision between a passenger train and a man lift at Dalfsen

The Hague, December 2016 The reports issued by the Dutch Safety Board are open to the public. All reports are also available on the Safety Board's website www.safetyboard.nl

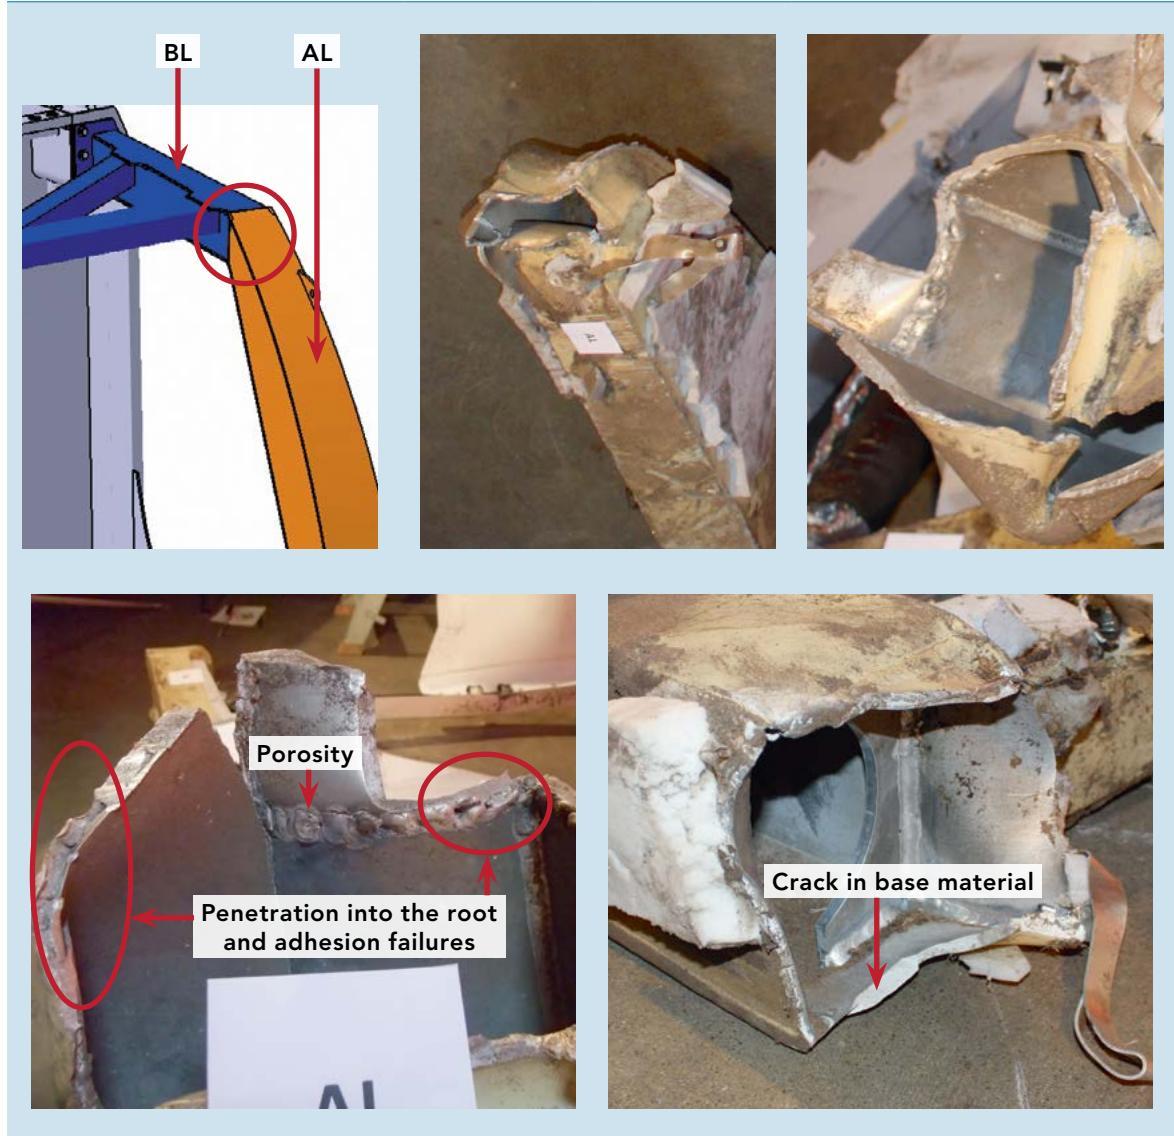
- There are impact fractures that go partly through the base material and partly through the welds.
- There are deformations alongside the broken surfaces.
- The broken welds show incomplete penetration during welding, adhesion failures and porosity.

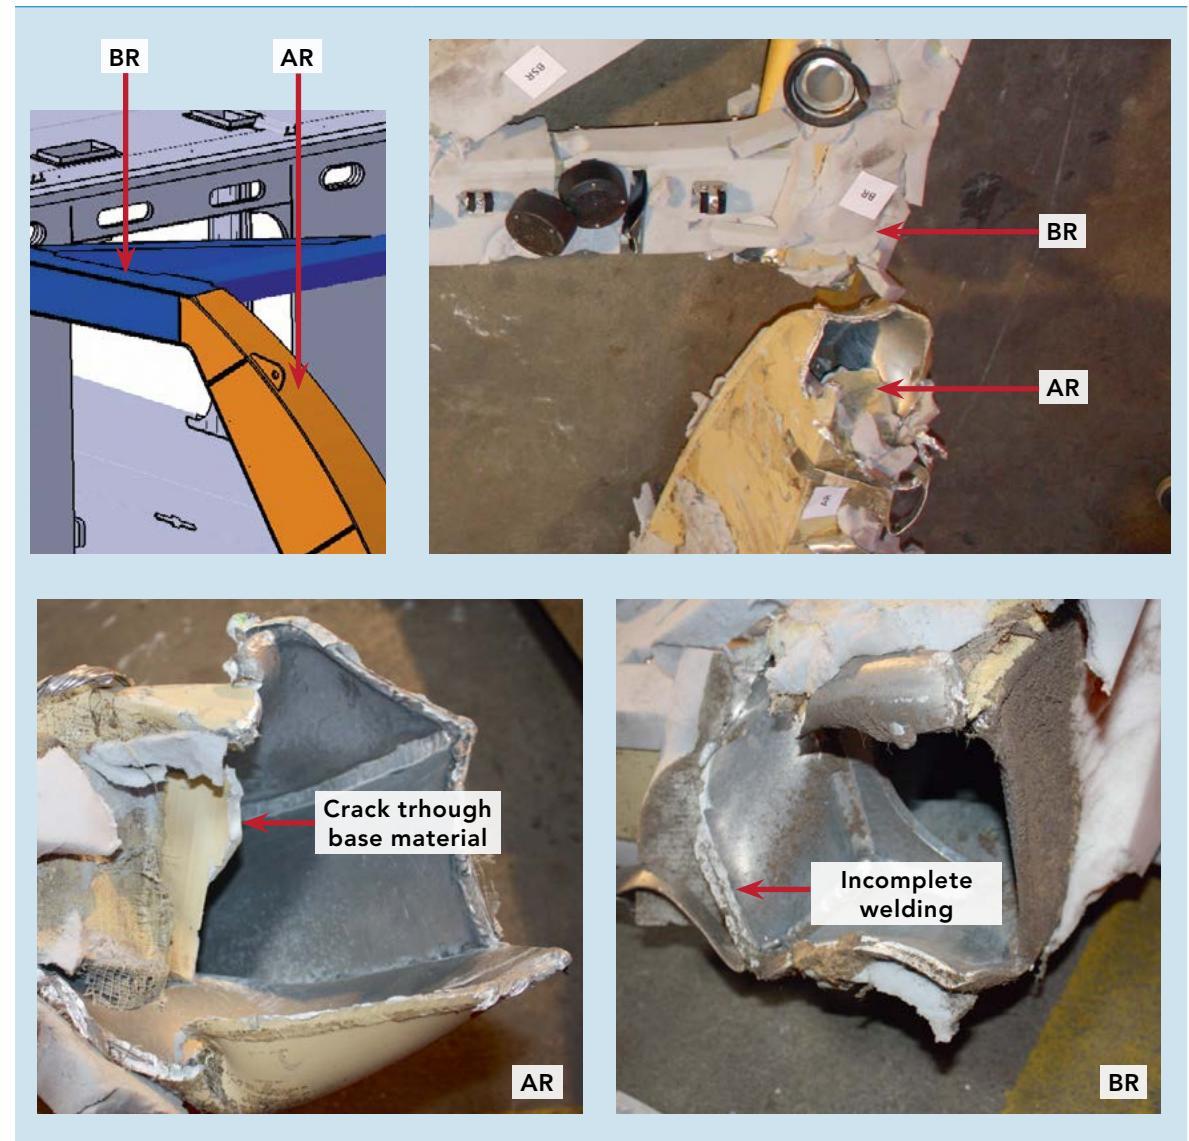
- There are impact fractures that go partly through the base material and partly through the welds.
- There are deformations alongside the broken surfaces.
- The broken welds show incomplete penetration during welding, adhesion failures and porosity.

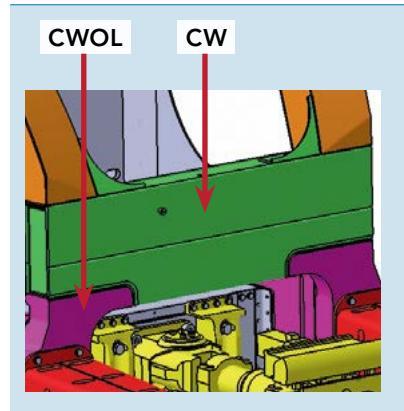
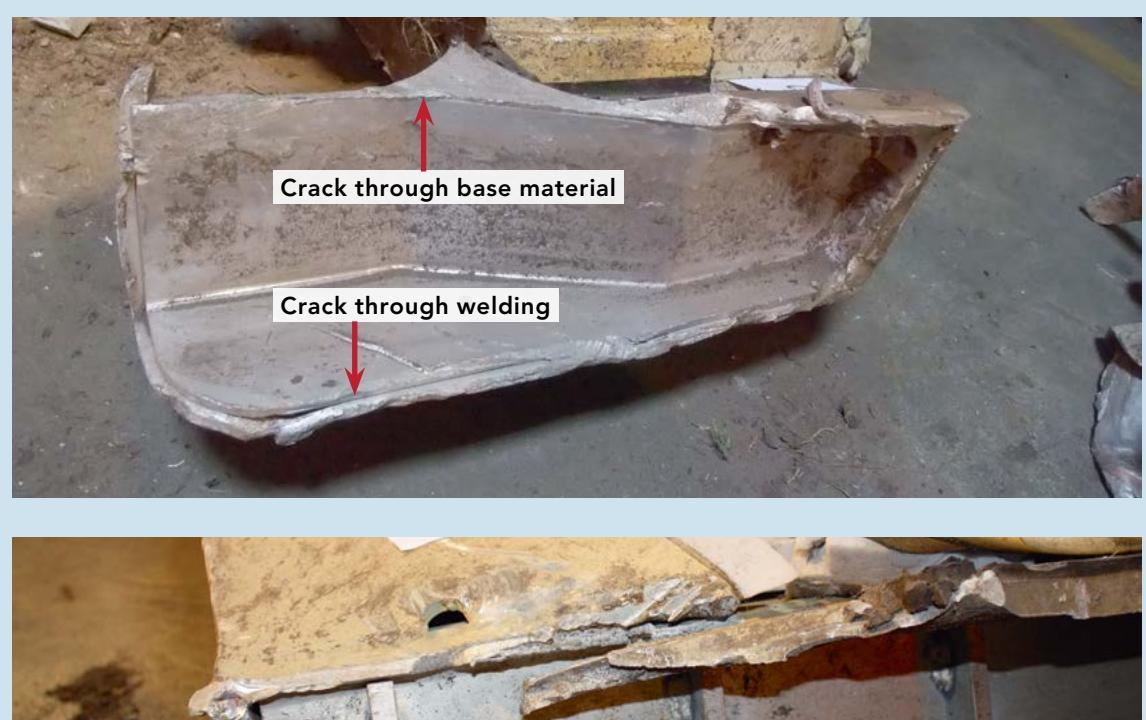
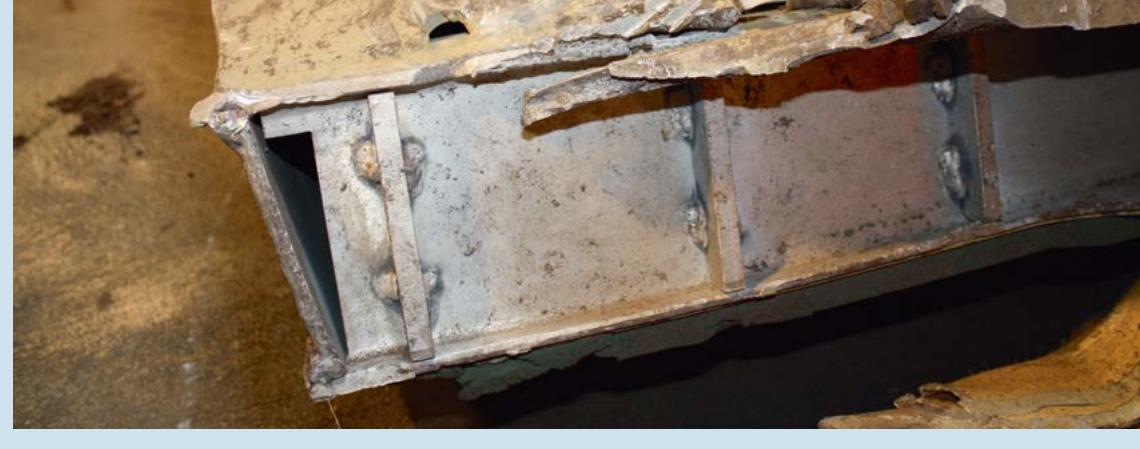
Figure 39: Assessment of the collapse of the left-hand crash wall/connector joint. Photos: Dekra Rail/Dutch Safety Board

- There are impact fractures that go partly through the base material and partly through the welds.
- There are deformations alongside the broken surfaces.
  The broken welds show incomplete penetration during welding, adhesion failures and porosity.

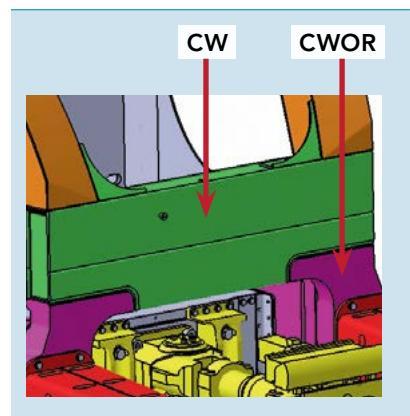
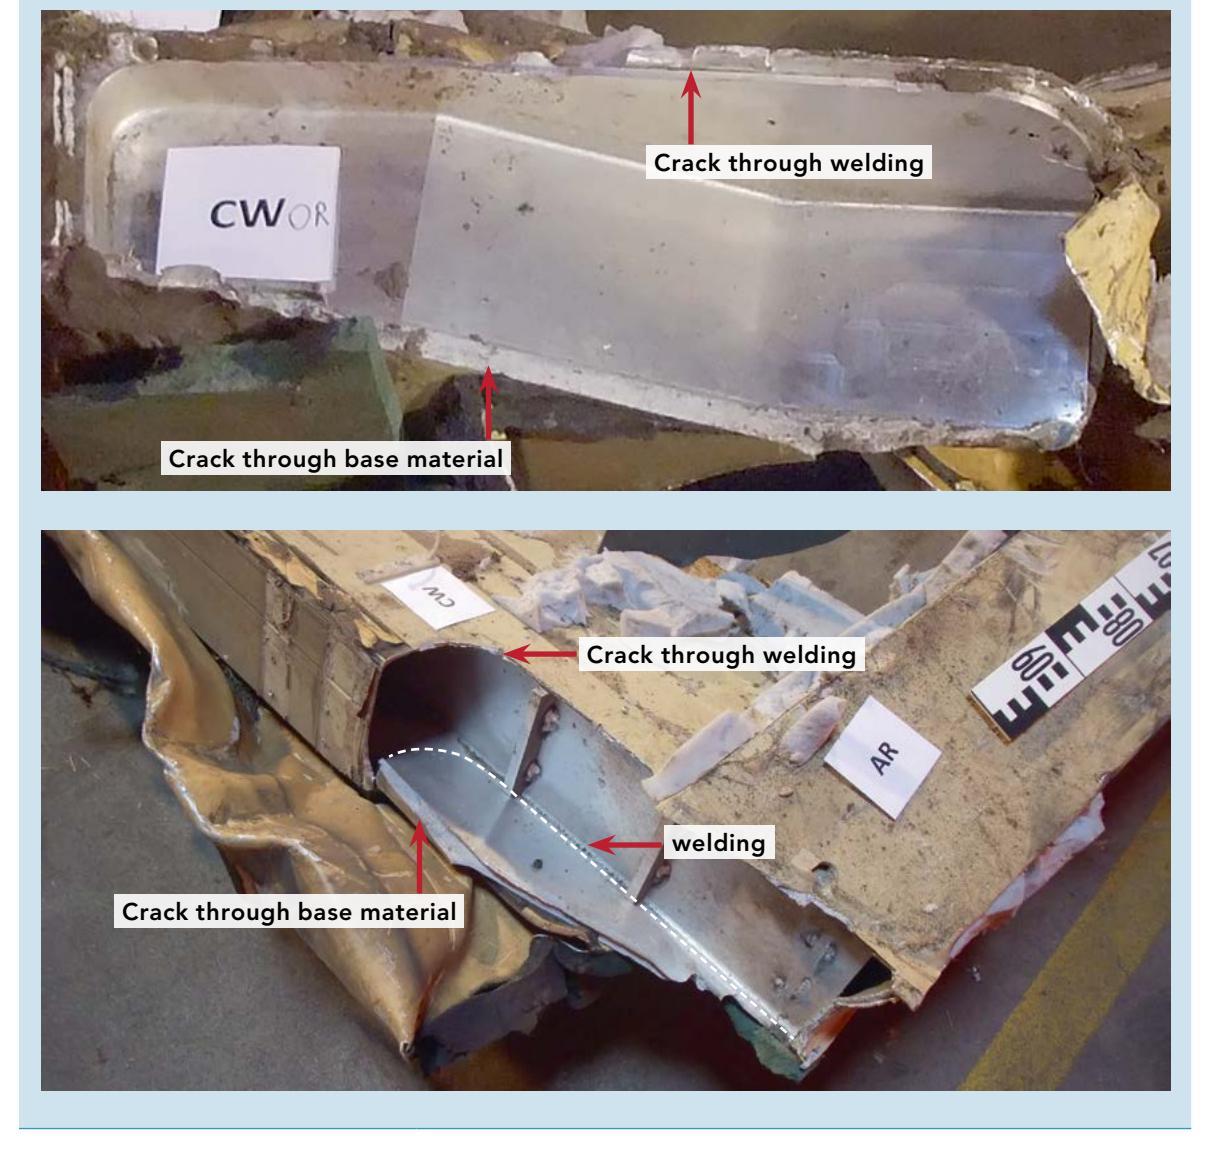
Figure 40: Assessment of the collapse of the right-hand crash wall/connector joint. Photos: Dekra Rail/Dutch Safety Board

- There are impact fractures that go partly through the base material and partly through the welds.
- There are deformations alongside the broken surfaces.
  The broken welds show incomplete penetration during welding, adhesion failures and porosity.
