## **Rail Accident Report**

Collision and derailment at Neville Hill 13 November 2019

Report 13/2020 November 2020 This investigation was carried out in accordance with:

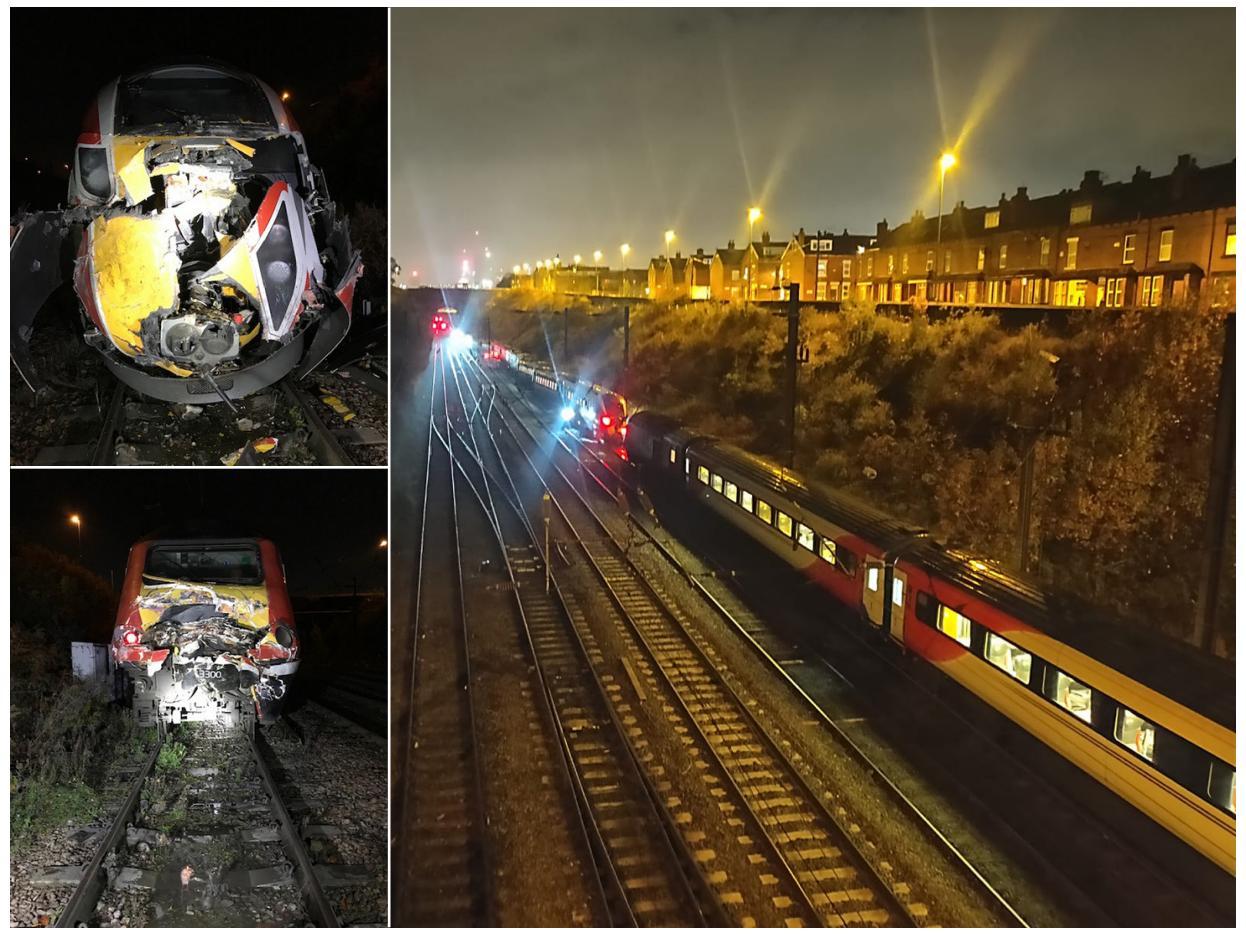
- 5 The colliding train was a 9-coach class 800 set, part of the Intercity Express Programme, operated by London North Eastern Railway (LNER). Its leading end suffered significant damage during the collision (figure 2). The second train was a High Speed Train (HST) set comprising 9 coaches and a class 43 locomotive at each end. It was also operated by LNER. The trailing class 43 locomotive also suffered significant damage (figure 2).

- 6 As a result of the collision, the trailing bogie of the second and third vehicles and the trailing wheelset of the fourth vehicle on the class 800 train, derailed to the right in the direction of travel.

Figure 2: The class 800 train (top) and HST set (bottom) involved in the accident and the crash scene to the right (images courtesy of Network Rail)

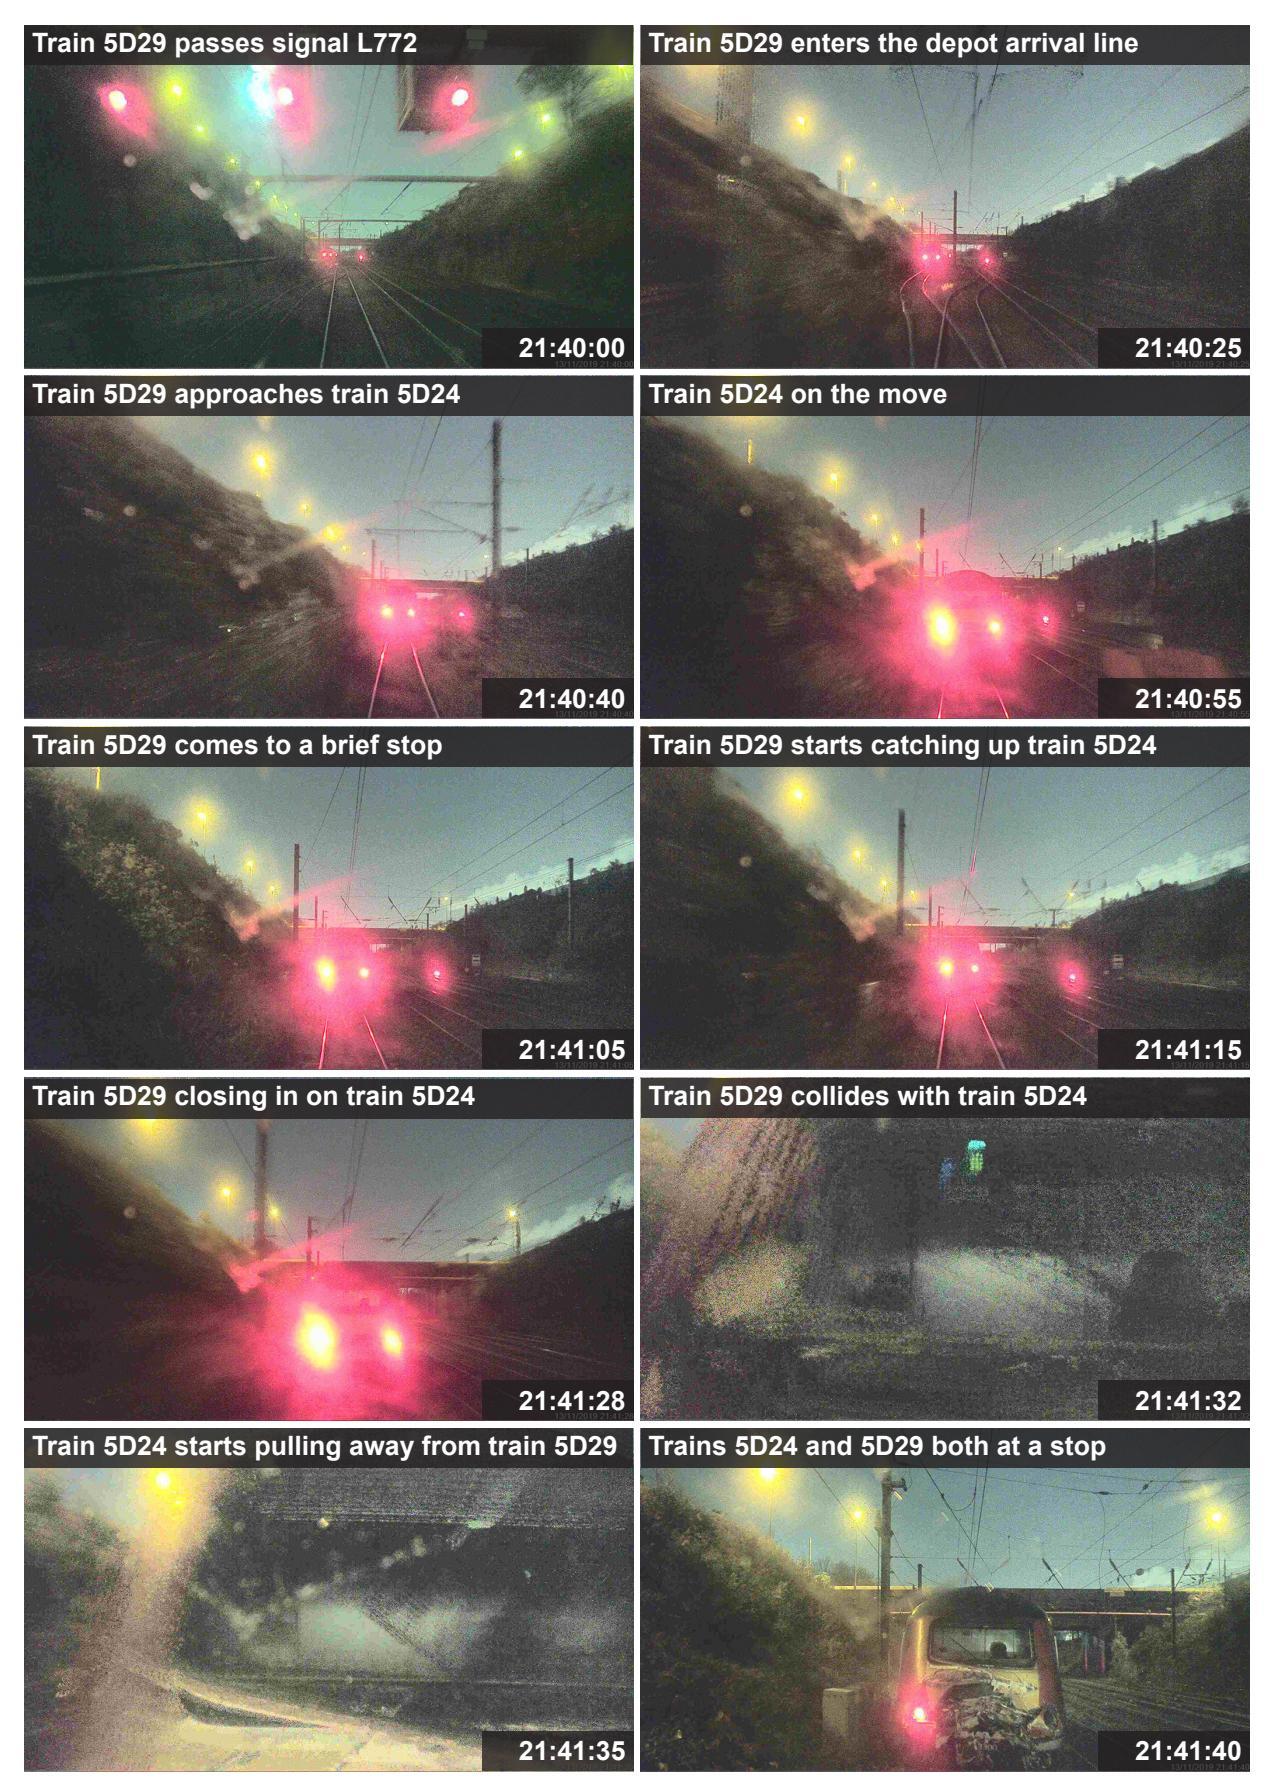
Figure 5: FFCCTV footage from unit 800109

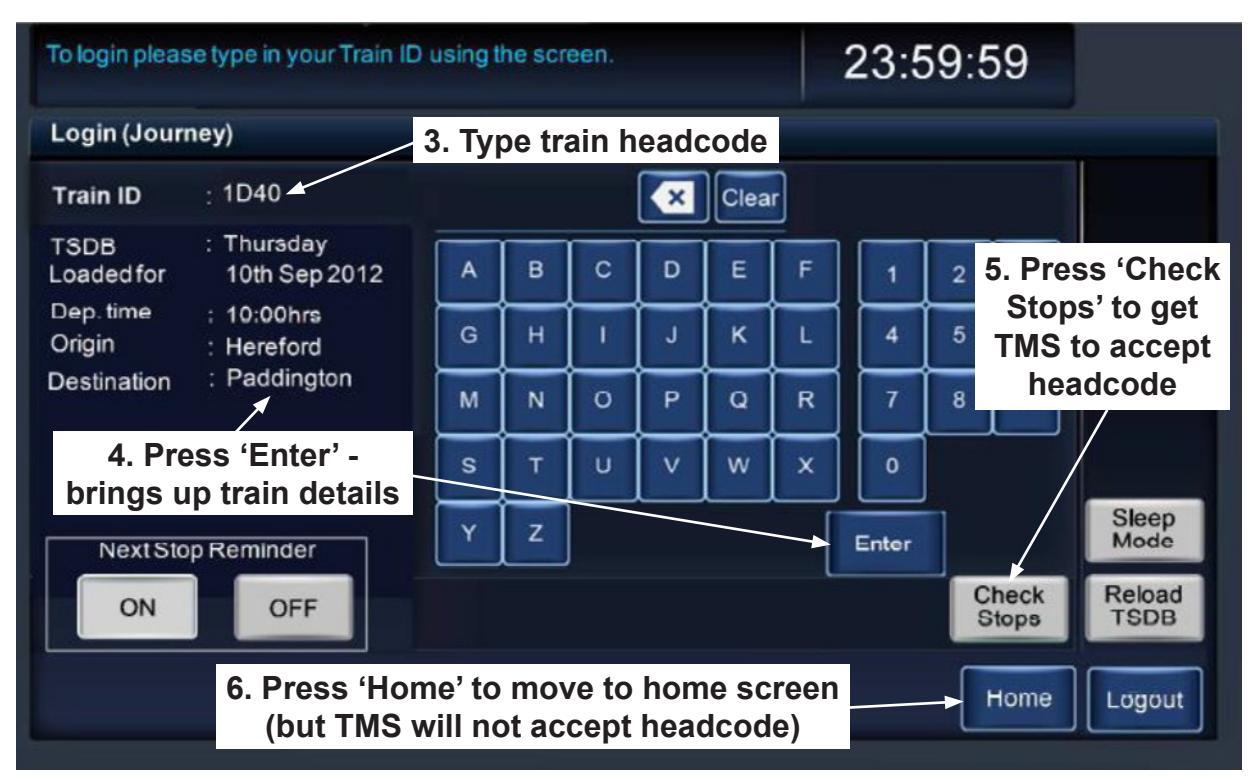
Figure 7: TMS headcode screen

- 66 LNER trained its drivers that pressing CHECK STOPS would allow a driver to check the station stops for the journey ahead. The driver operating instructions identified this as a step in the cab setup process. LNER also trained its drivers that pressing HOME on the headcode screen would take the TMS to the home screen with the headcode having been accepted. This was the method used by the driver on the night at Leeds station. LNER did not understand that CHECK STOPS had to be pressed for the headcode to be accepted.

LNER should review, and make any necessary changes to, its procedures, training, and associated materials and aids (including the TMS app and simulator) to confirm that they prepare drivers to correctly interact with the TMS on its IETs. It should also review the TMS touch screen displays to make sure that they clearly reinforce the correct processes. In particular, these activities should include consideration of the method of entering a headcode and any issues raised by Recommendation 1 (paragraph 141.2.a).i).

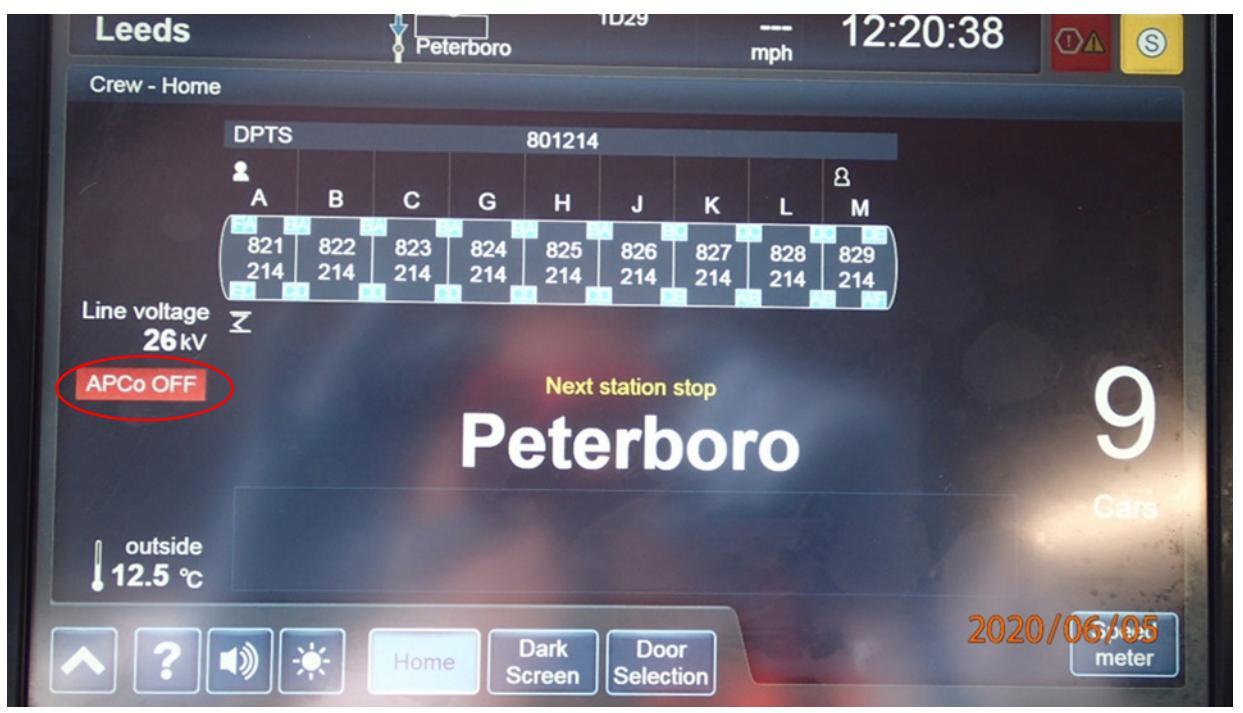
75 However, at the start of November 2019, the TMS software was updated to provide an indication of an APCO isolation on the home screen (figure 8). As part of the update, a driver also received a warning that APCO was isolated when starting a train using the master switch.

Figure 8: APCO isolation on TMS home screen

76 The driver was unaware of this new feature because he had not been briefed by LNER on the introduction of the software update. LNER and Hitachi have an engineering change process for managing and briefing such changes, which normally results in briefing updates being provided to drivers. However, in this instance, it appears that the importance of this information was lost in the vast array of changes introduced in this particular software update. It is possible that, if a more thorough description of the change had been included in Hitachi's engineering change pack, its relevance would have been more easily identified.

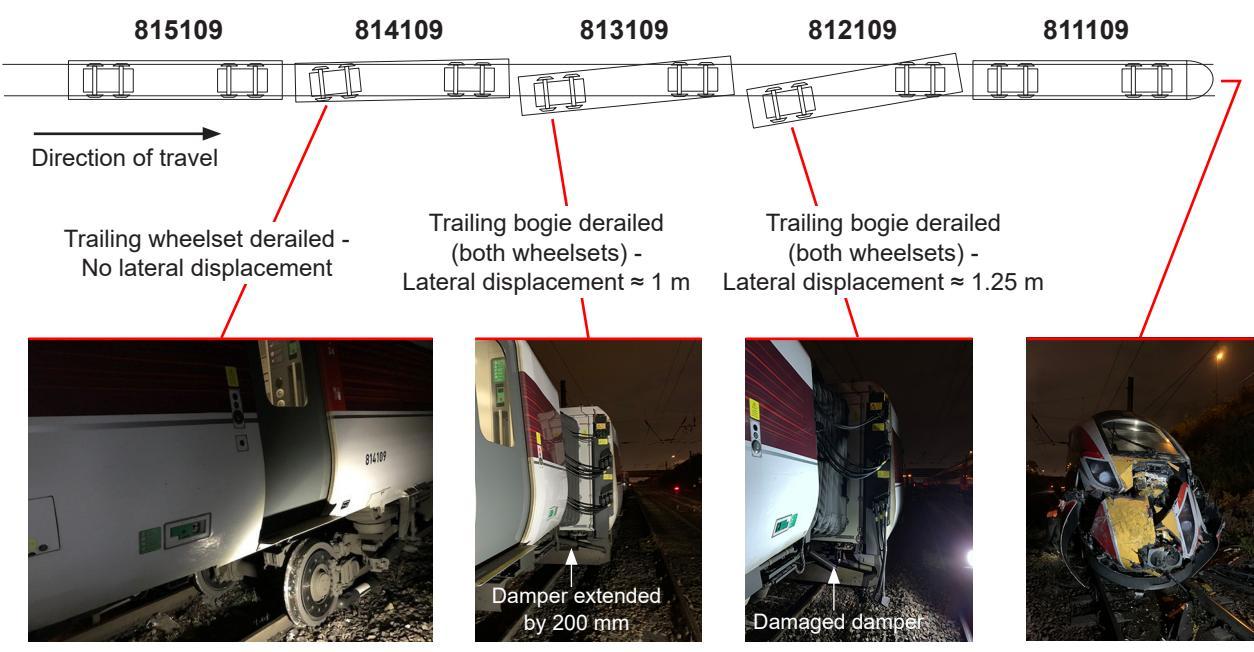
88 RAIB examined the trains at Neville Hill shortly after the accident. The leading end of the IET and the trailing end of the HST both suffered structural damage at the point of collision. The couplers of an IET are formed of two coupler halves. They are designed to collapse and absorb energy in the event of a collision which takes place at speeds high enough to generate sufficient forces between vehicles. The energy absorption is achieved on each half by the coupler shank and coupler pin being forced into a cylinder of smaller diameter and deforming it as a result (figure 16). The examination revealed that none of the IET couplers had started collapsing in this accident. 89 The trailing bogie of the second and third vehicles and the trailing wheelset of the fourth vehicle on the IET, derailed to the right in the direction of travel as a result of the collision. Figure 9 shows the lateral movement of the vehicles during the collision as witnessed by the marks left by the couplers on the vehicle structures. The extent of the derailment (up to 1.25 metre of lateral displacement on the second vehicle) would have been sufficient to significantly infringe the swept path of a vehicle travelling on an adjacent line, assuming a typical gap between adjacent running lines (known as the 'six-foot'), as shown in figure 10.

Figure 9: Schematic showing extent of derailment during collision (not to scale)

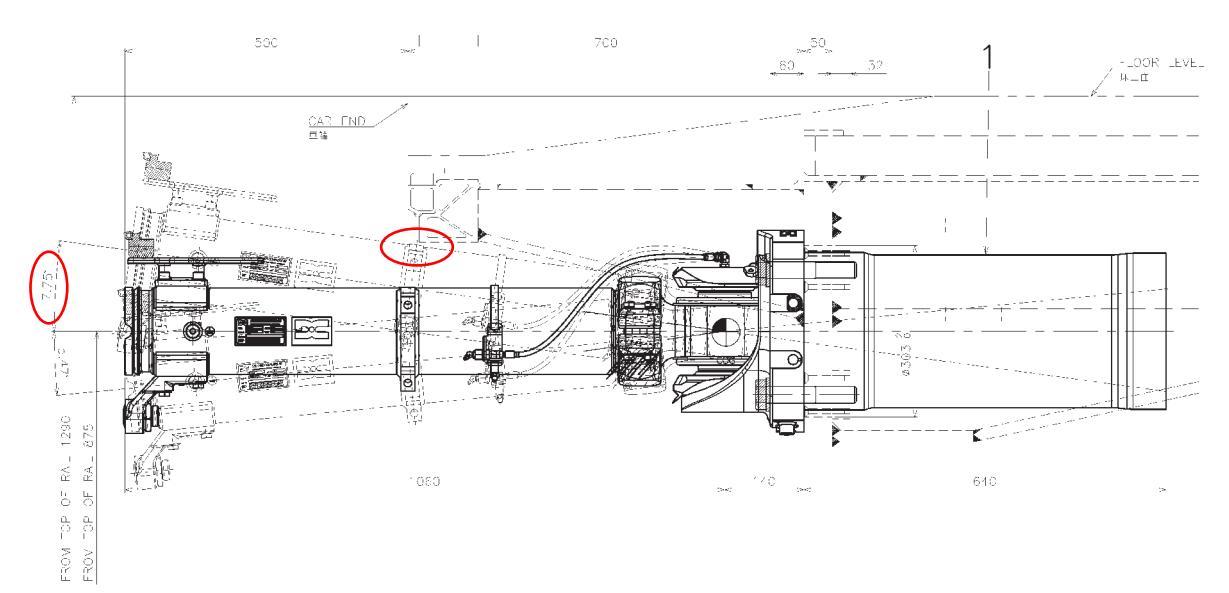
Figure 11: Coupler pitch up movement and limit due to coupler contacting the carbody (courtesy of Hitachi)

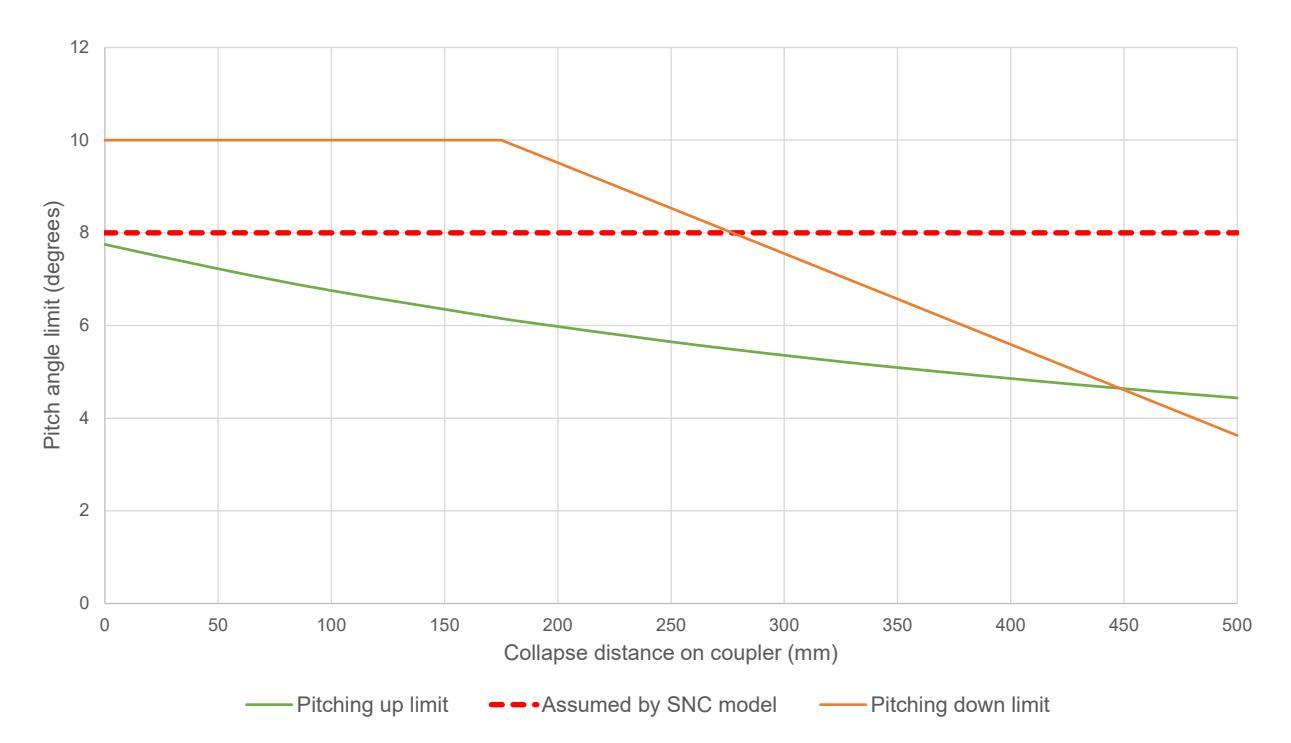
Figure 12: Graph showing how the pitch limits change as the inter-vehicle coupler collapses<sup>12</sup>

$<sup>^{\</sup>rm 12}$  Each coupler half can collapse by up to 500 mm. The inter-vehicle gap is 1000 mm.

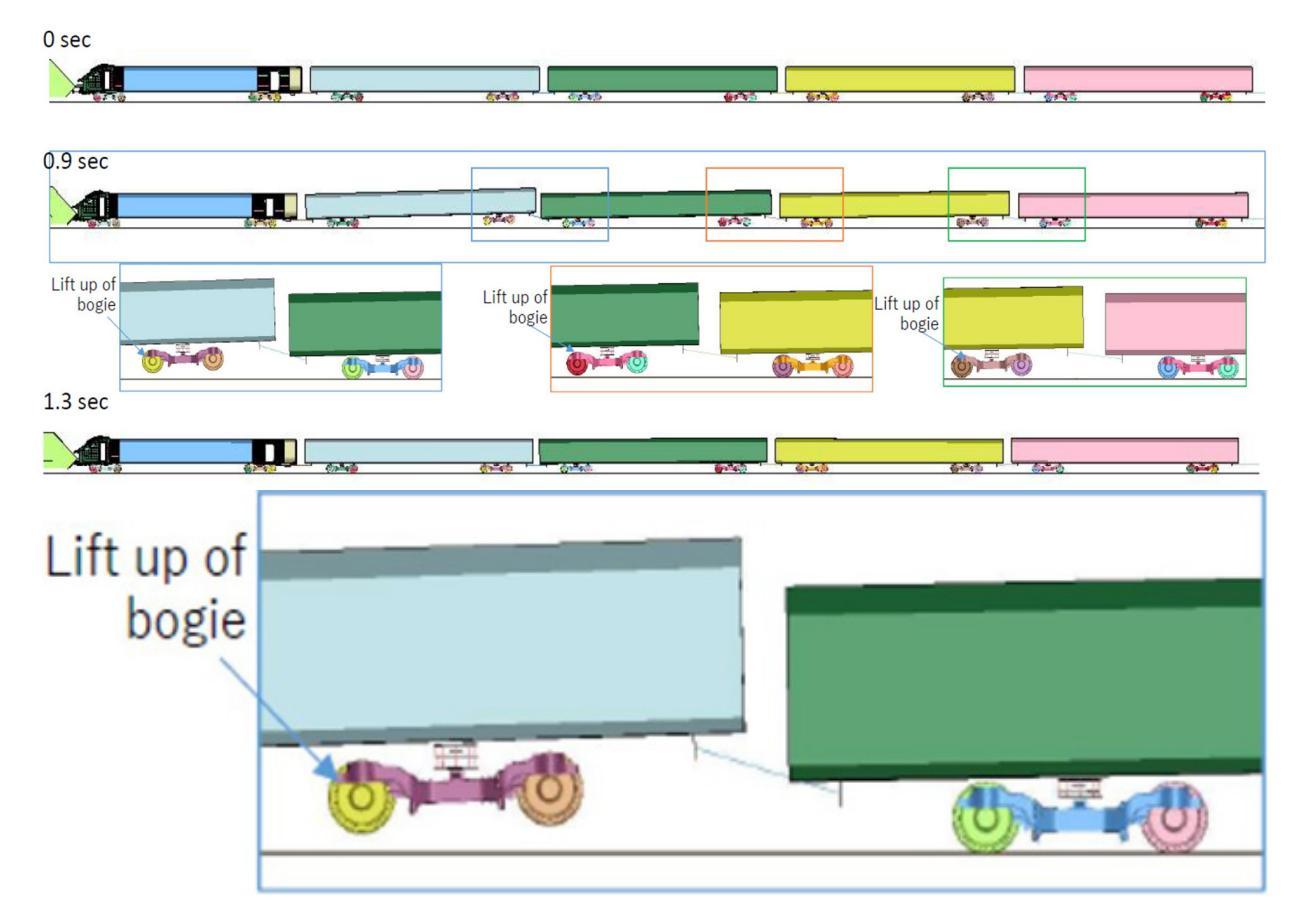
- 98 Figure 13 shows the results from the 3D simulation at the relative collision speed of 10 mph (16 km/h). The amount of deformation on the class 43 power car and at the leading end of the IET was checked to ensure that it was representative of what had been experienced during the accident. As shown on figure 13, the trailing bogies of vehicles 2, 3 and 4 on the IET were predicted in the simulation to lift up above the railhead during the collision.
- 99 Figure 14 shows the predicted lateral displacement on the first five vehicles. The trailing bogies of vehicles 2, 3 and 4 were predicted in the simulation to derail to the right during the collision. Vehicle 5 was predicted to remain guided by the rails.

Figure 13: Output from collision and derailment simulation – sequence of events (courtesy of Hitachi)

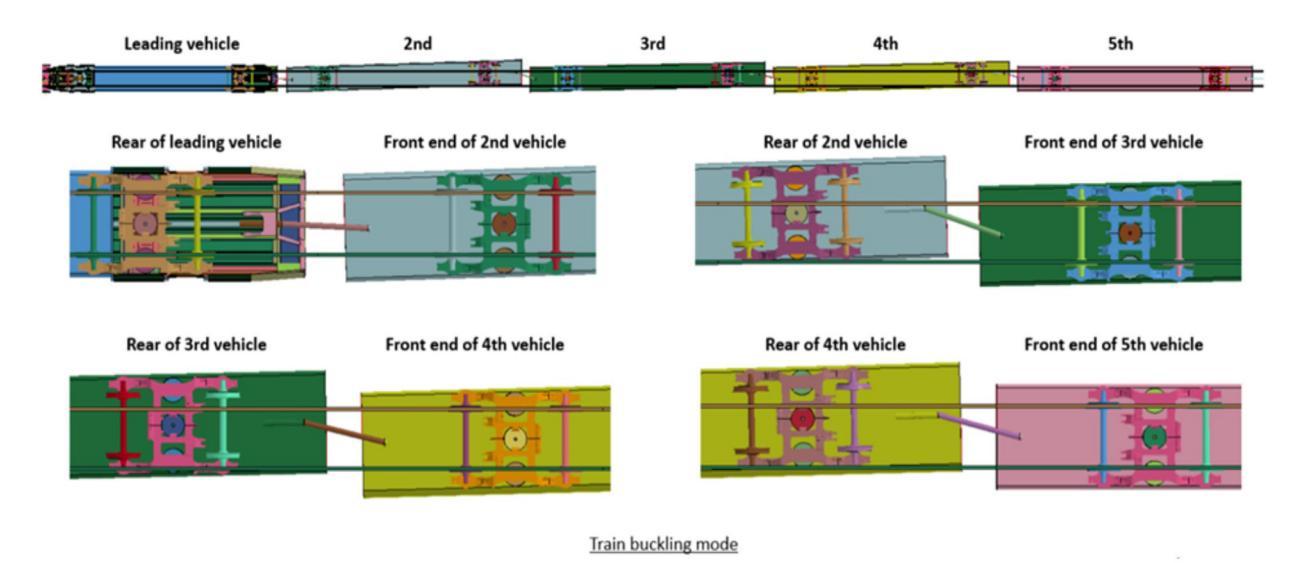
Figure 14: Output from collision and derailment simulation – bird's eye view (courtesy of Hitachi)

100 The Hitachi 3D model predicted that the leading couplers of the HST and IET would deflect each other sideways during the collision. This generated yaw movement on the leading vehicle which was then transferred to the other vehicles. Overall, the Hitachi 3D model predicted vertical and lateral displacements on all vehicles which were consistent in magnitude and direction with the observations on site.

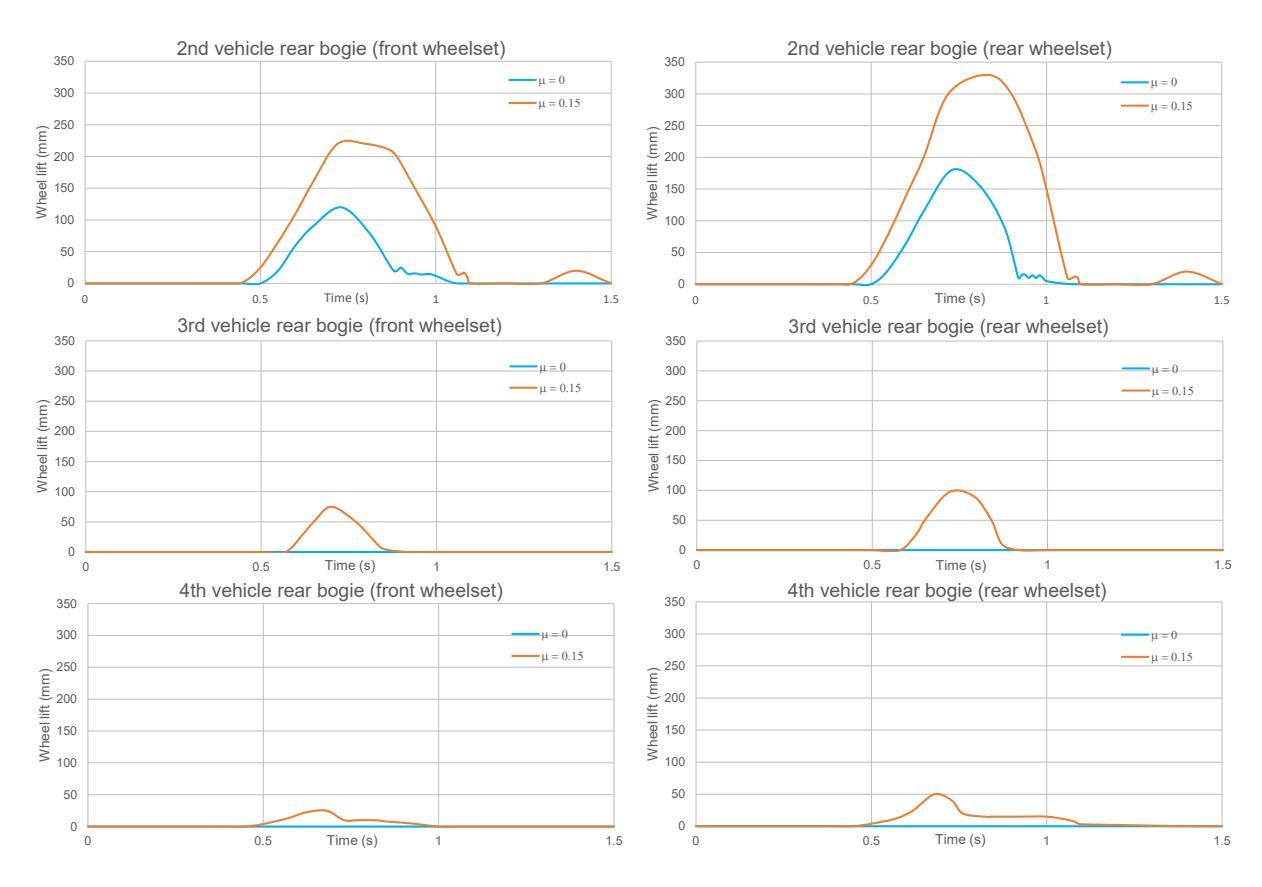
#### 105 Braking increased the likelihood of derailment following the collision.

- 106 Figure 15 shows the predicted amount of wheel lift for the leading and trailing wheelset of the trailing bogie of vehicles 2, 3 and 4 for different coefficients of friction at the wheel-rail interface. These results show that the amount of wheel lift predicted in the 3D model was dependent on the amount of friction at the wheel-rail interface in the model (representing the amount of braking). In the case of zero friction (representing an unbraked train), only the trailing bogie of vehicle 2 was predicted to lift vertically. As modelled friction was increased, so did the amount of wheel lift on vehicles 2, 3 and 4. This is due to the additional vehicle body pitching introduced by braking.
- 107 The effect of braking on the degree of lateral displacement was not investigated.

Figure 15: Output from collision and derailment simulation – wheelset vertical lift (courtesy of Hitachi)

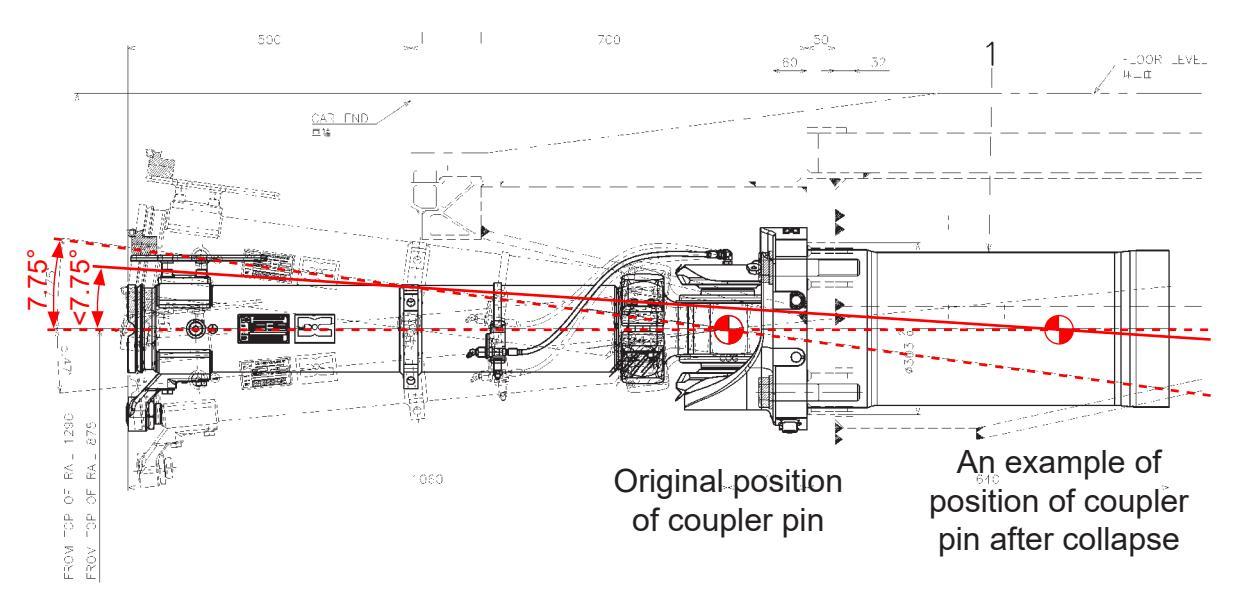
110 At 22.5 mph (36 km/h), the inter-vehicle couplers were predicted to collapse significantly, which reduced the angle that the couplers can freely pitch and yaw (figure 16). The original 1D models had been set with a constant +/-8° pitch limit (and +/-24° yaw limit) which was only accurate for the cases where the couplers did not collapse. The model with the 22.5 mph (36 km/h) collision speed was rerun initially with a constant pitch limit of +/-6° (and +/-6° yaw limit) and then with a constant pitch limit of +/-5° (and +/-5° yaw limit) representing increasing levels of coupler collapse.

Figure 16: Effect of coupler collapse on pitch freedom
