# **Rail Accident Report**

Derailment at Santon near Foreign Ore Branch Junction, Scunthorpe 25 January 2008

Report 10/2009 April 2009 This investigation was carried out in accordance with:

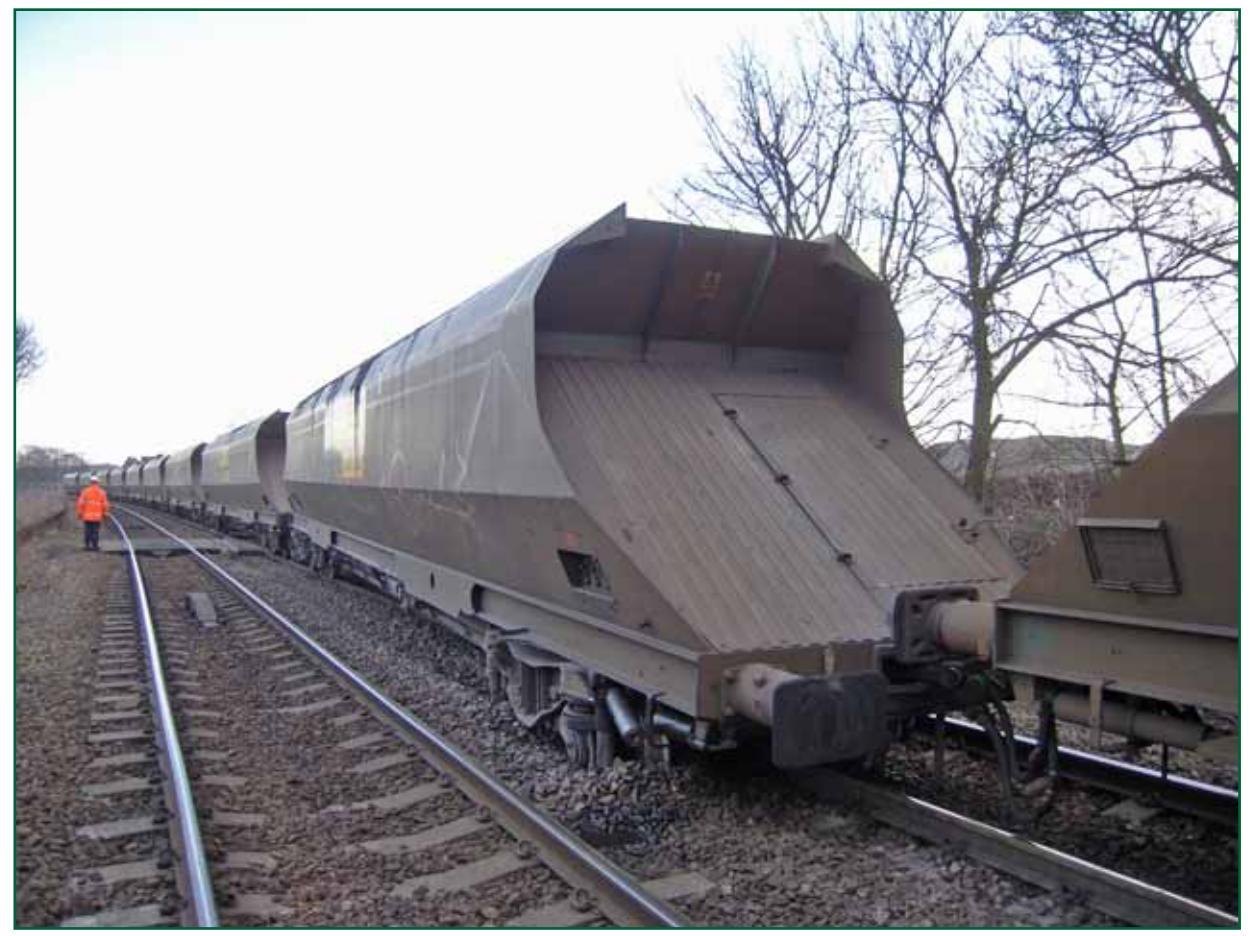
Figure 2: The tenth wagon of 6M49 derailed

- 19 No one was injured in this accident. The derailed wagon suffered damage to its leading bogie, and about 1400 metres of track, including two sets of switches, signalling equipment and a level crossing, required repair or replacement.
- 20 The derailed wagon deviated to the right and ran derailed foul of the *up* line. A train travelling in the opposite direction on the up line could have collided with this wagon, with the possibility of more severe consequences.

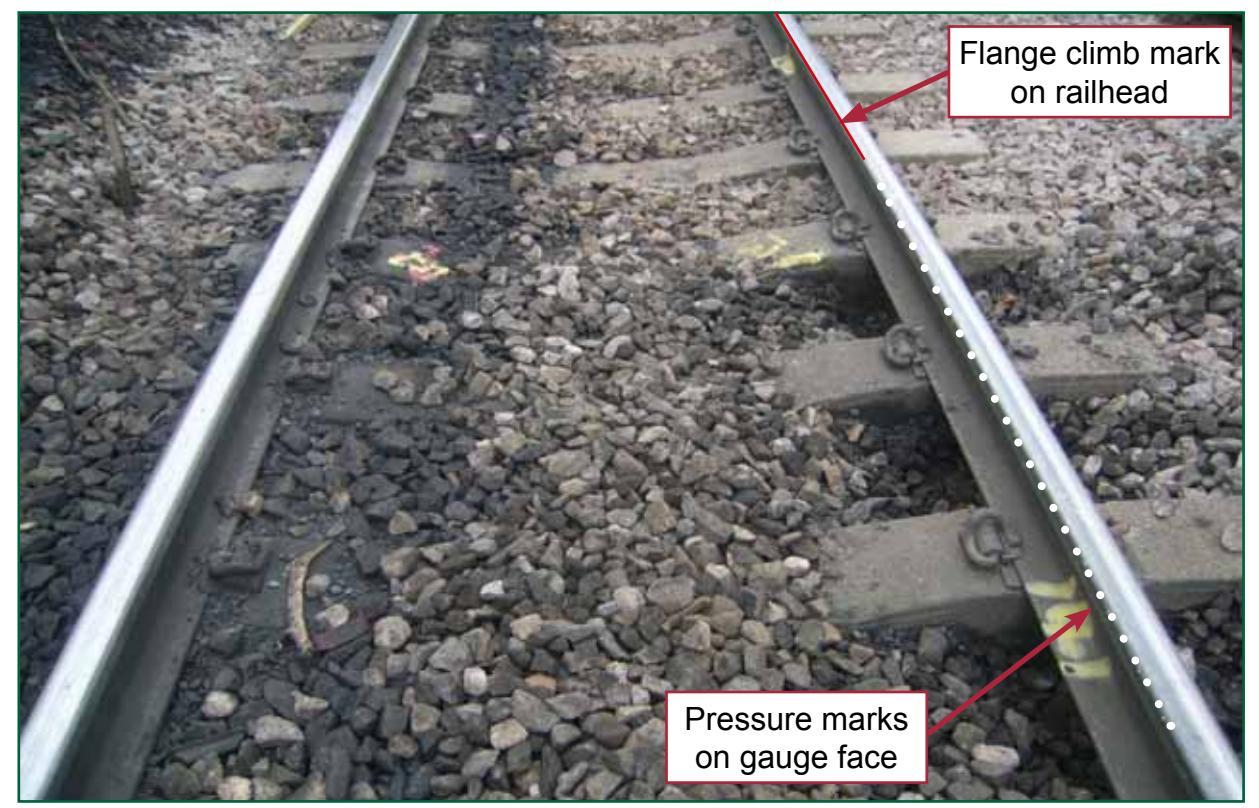
51 Marks on the railhead showed that a wheel flange had climbed onto the six-foot railhead at 26 miles 13 yards. The exact point where it started to climb was not clear, as over a distance of about 2 metres, there were many pressure marks on the gauge face, see Figure 6. These marks indicated that other wheels had begun to climb.

Figure 6: Pressure marks and flange climb mark on the railhead looking in the direction of travel

- 52 The flange mark showed the wheel ran on the railhead for approximately 6.8 metres, before dropping in to the six-foot and running on rail fastenings and sleepers. Corresponding *tread corner* marks on the *cess* rail showed the left-hand wheel derailing.

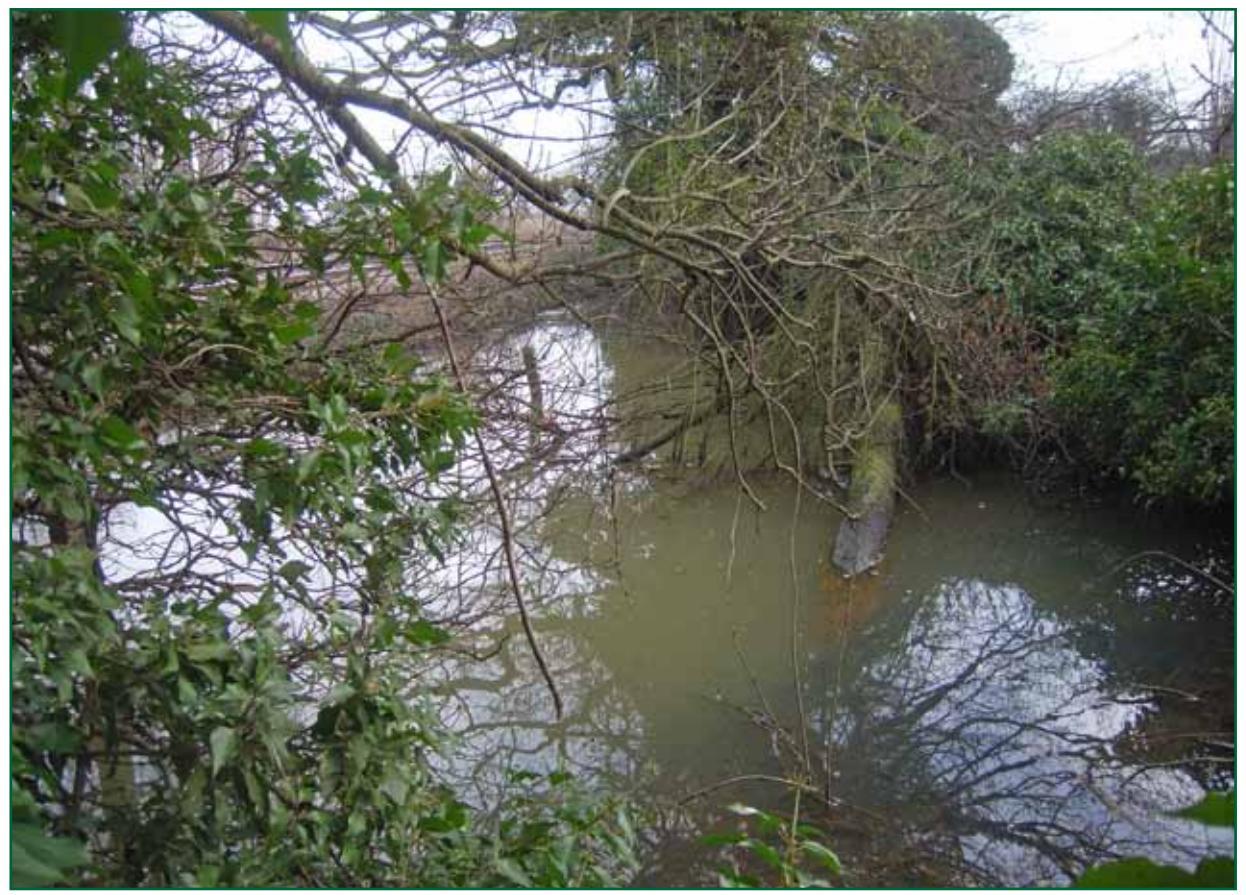
- 58 Further up the gradient towards Scunthorpe, at around 25 miles 78 chains, a large volume of water was pooled next to the down line cess, see Figure 7. The drains on the adjacent road were blocked and water had breached the side of the road and was collecting in this area.

Figure 7: Water pooled next to the down line's cess

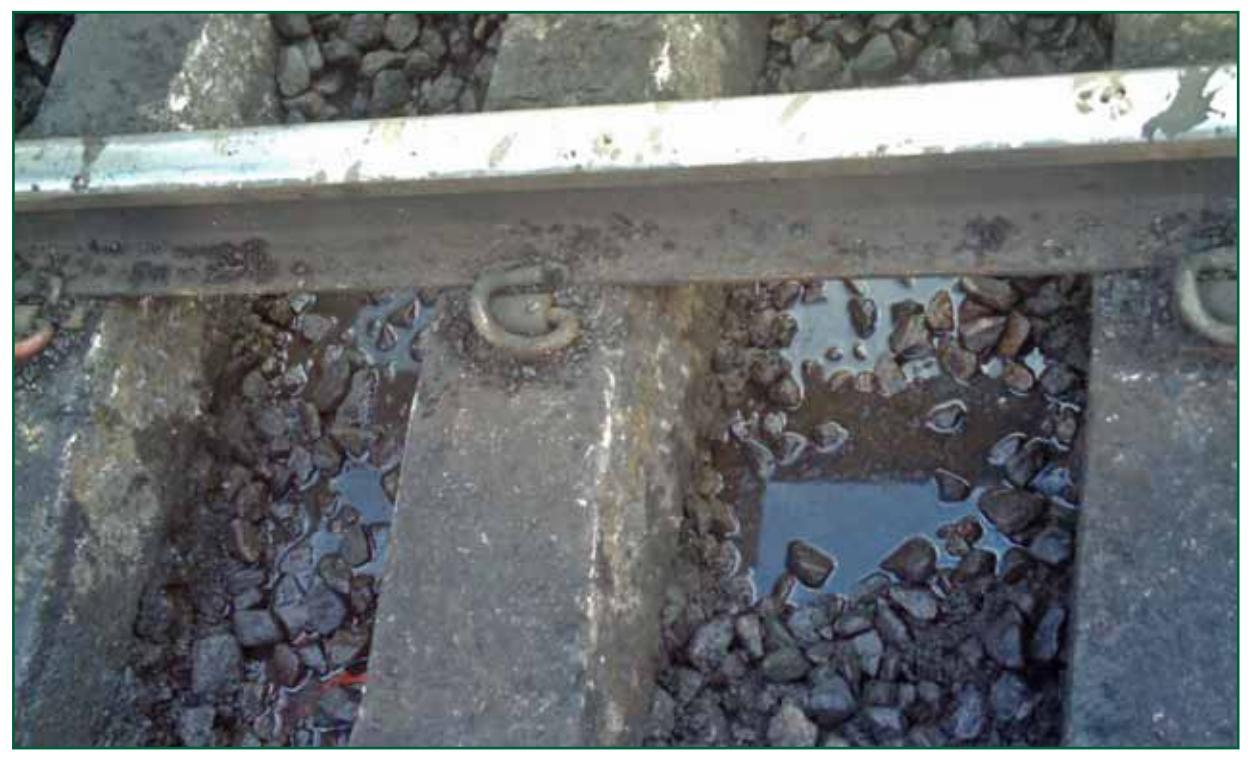
59 Although there were no signs of water on the surface, when Network Rail staff dug out some ballast in the *cribs* to install *void meters* as part of the post-accident track survey, they found water below sleeper bottoms, particularly towards the cess side. On the following day, Network Rail dug out all of the ballast in the cribs over the point of derailment. Water was again found under the cess side rail and in the four-foot towards the cess side, see Figure 8. They did not find any water on the six-foot side of the track.

Figure 8: Water under the cess rail (photograph courtesy of Network Rail)

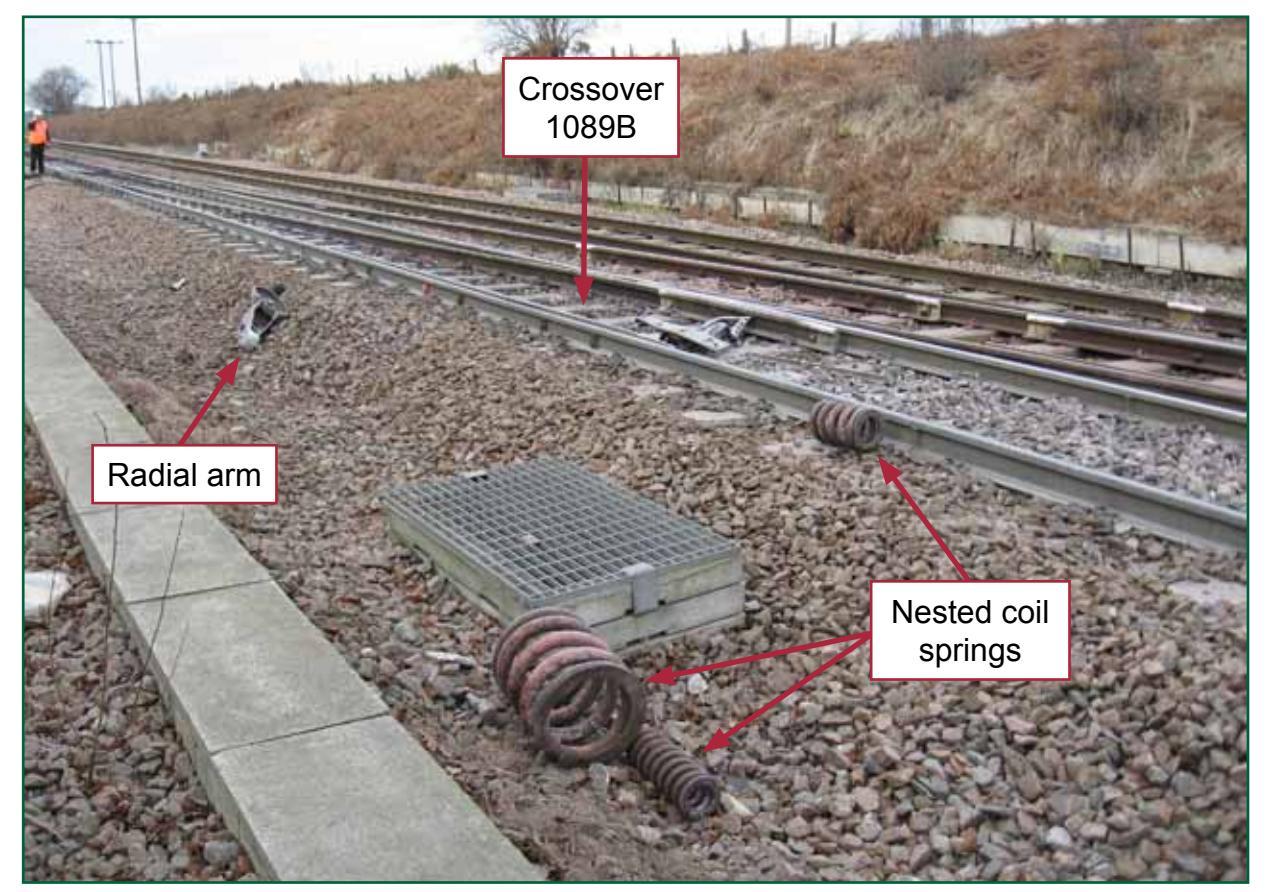
- 72 The *radial arm* for the trailing left-hand wheel was detached from the front bogie. On site, this radial arm and the *nested coil springs* for the trailing left-hand wheel were lying in the cess close to *trailing* crossover 1089B at Foreign Ore Branch Junction, see Figure 9. The two *huck bolts* that attach the radial arm to the bogie frame were found 176 metres and 232 metres after the crossover. There was no evidence on site or from the post-accident examinations of wagon 370 157 to suggest that there were any pre-existing suspension faults.

Figure 9: Detached wagon suspension components next to crossover 1089B

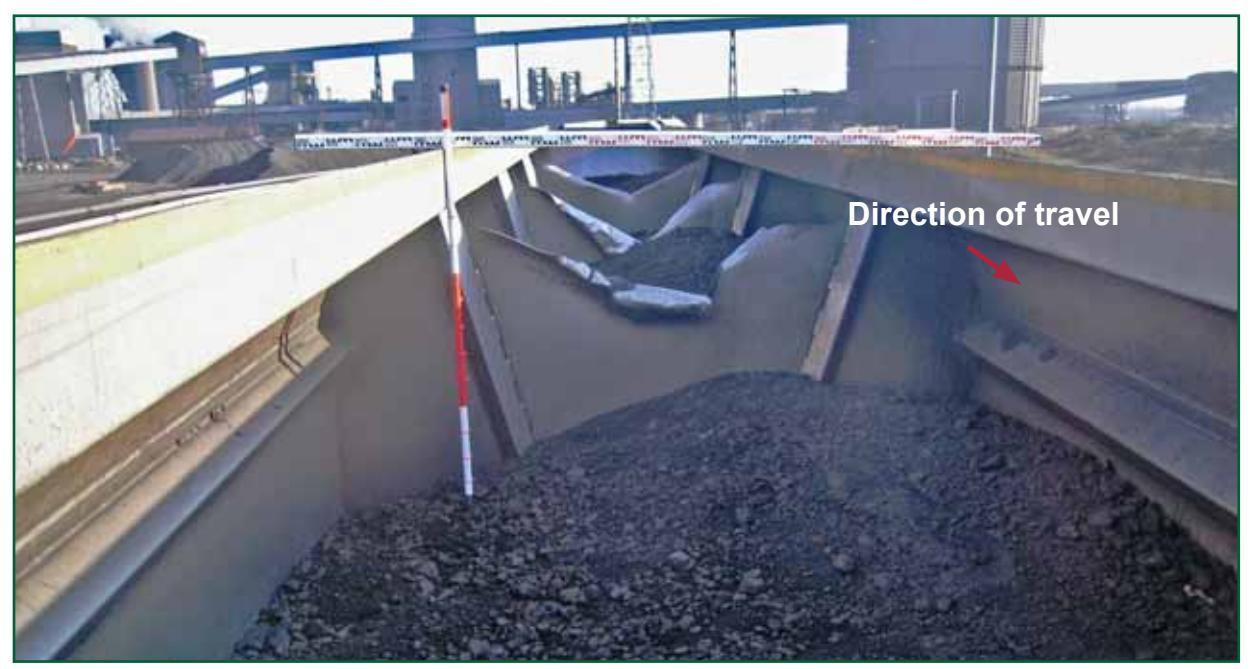
- 73 The load on each wheel of wagon 370 157 was measured at North Lincoln sidings in Scunthorpe on 8 February 2008; it had a gross laden weight of 84.1 tonnes. The wheel loads for wagon 370 110, which had been following wagon 370 157, were also measured; it had a gross laden weight of 85.5 tonnes.
- 74 Visual examination of the coal in wagon 370 157 indicated that the load was not evenly distributed. It was offset to the left-hand side (Figure 10).

Figure 10: Coal load in wagon 370 157 - the damage to the compartment partitions is most likely to have occurred during loading by bucket loaders and played no part in this accident.

75 The coal mostly consisted of very small pieces and dust. It was very wet and water was dripping out from underneath the wagon. Coal slurry was streaked down the right-hand side of the wagon.

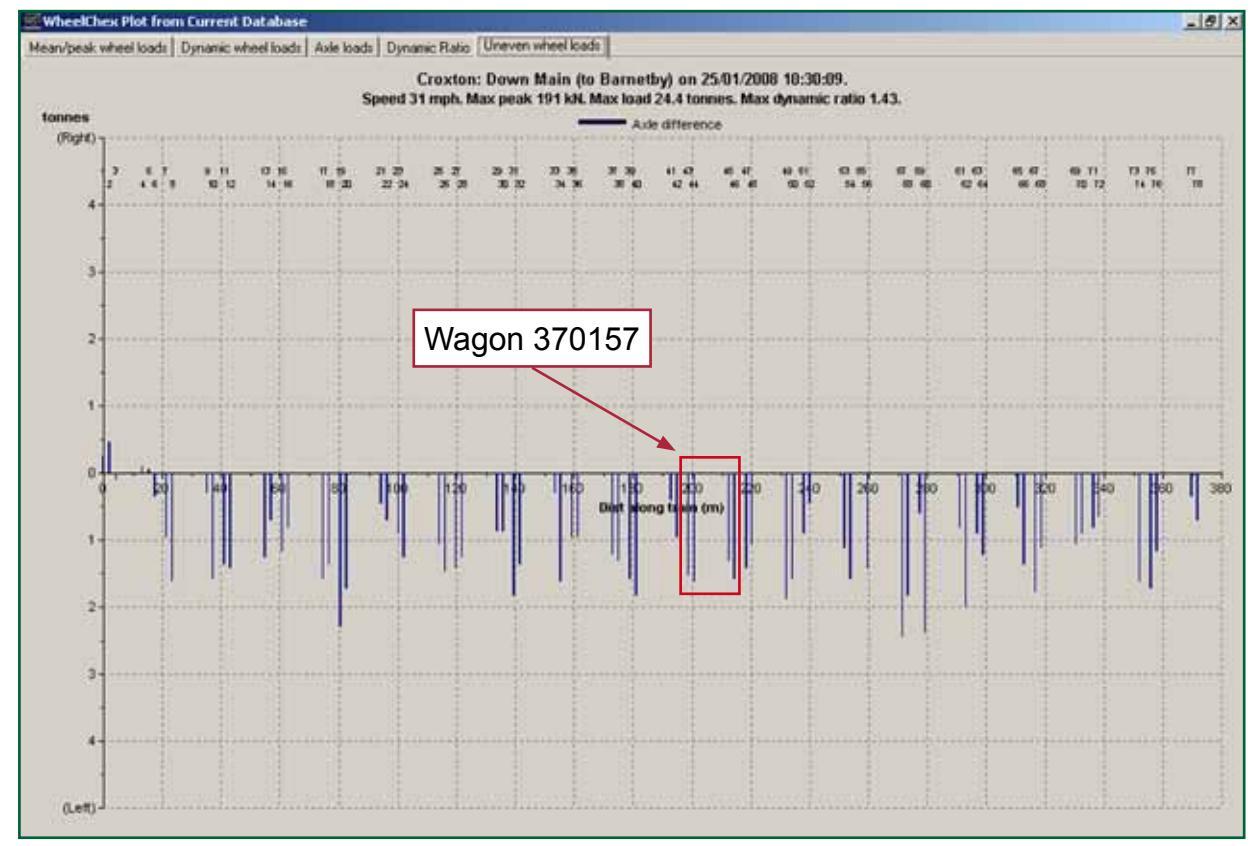
- 77 At 10:30 hrs on 25 January, train 6M49 passed over Network Rail's WheelChex monitoring site at Croxton, on the down goods line between Immingham and Wrawby Junction. Figure 11 shows the uneven wheel loads report for train 6M49.

Figure 11: Wheelchex uneven wheel loads report for train 6M49

- 78 Wagon 370 157 (denoted as axles 43 to 46) is highlighted. All of the axles for the HHA wagons show an imbalance to the left-hand side of the train whereas the locomotive (denoted as axles 1 to 6) does not. The RAIB used the static wheel load measurements from undamaged wagon 370 110 (paragraph 73) to corroborate the dynamic weight measurements from WheelChex. The two sets of wheel load measurements were all within 6.5% of each other. The WheelChex measurements were further corroborated by comparing the gross laden weights of 15 other wagons from train 6M49 against those recorded at Rugeley Power Station before being discharged. The two set of measurements were all within 1% of each other.

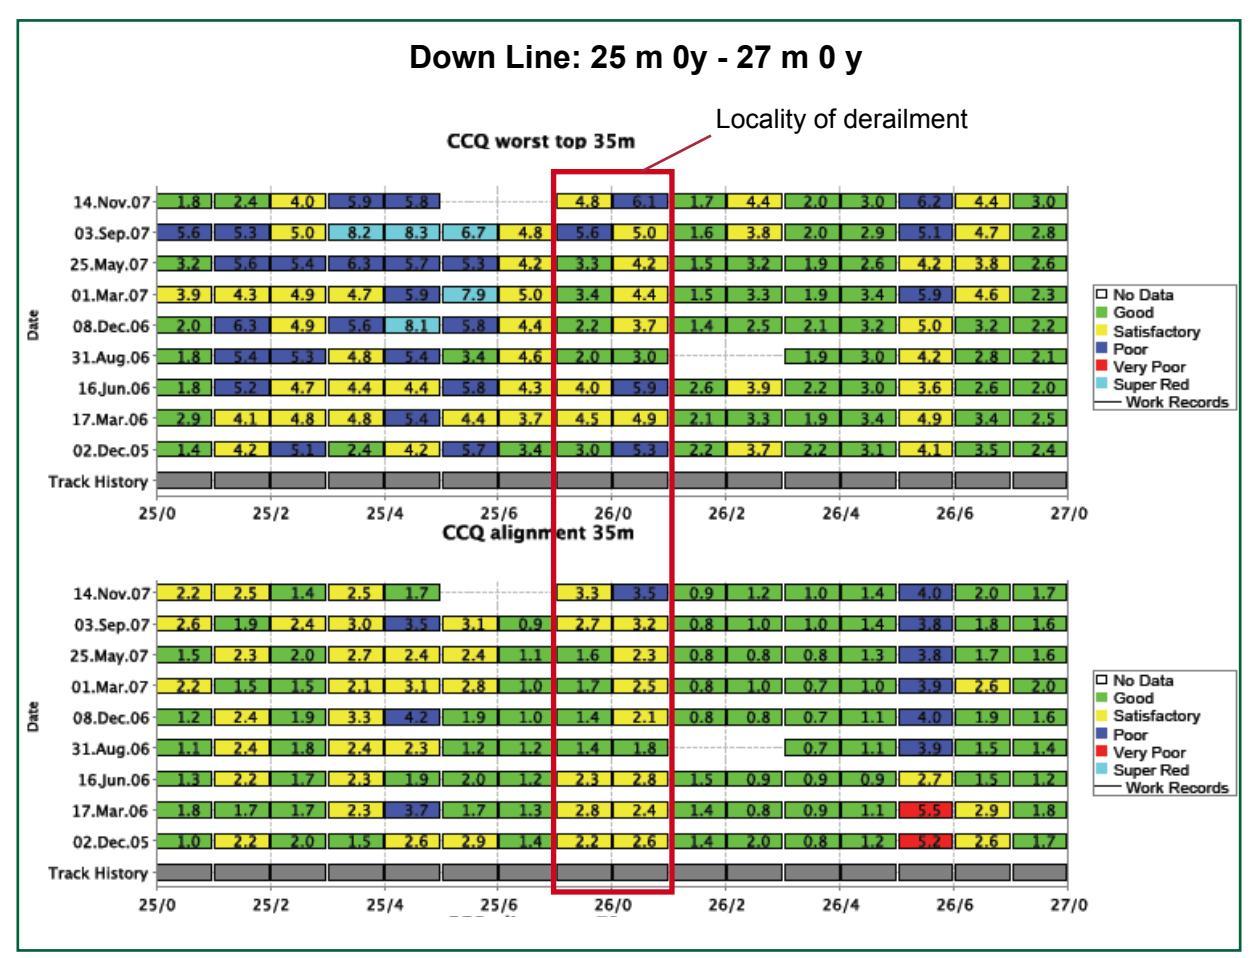
113 The point of derailment was close to the boundary between the two eighth mile sections at milepost 26. The vertical and lateral alignment standard deviation values for these sections had been steadily increasing since the track geometry recording run in May 2007, moving them from the good band to the satisfactory or poor bands. Neither eighth mile section had reached a target value which would have triggered the local maintenance team to carry out remedial actions to improve the track quality.

Figure 14: The standard deviation chart covering the point of derailment

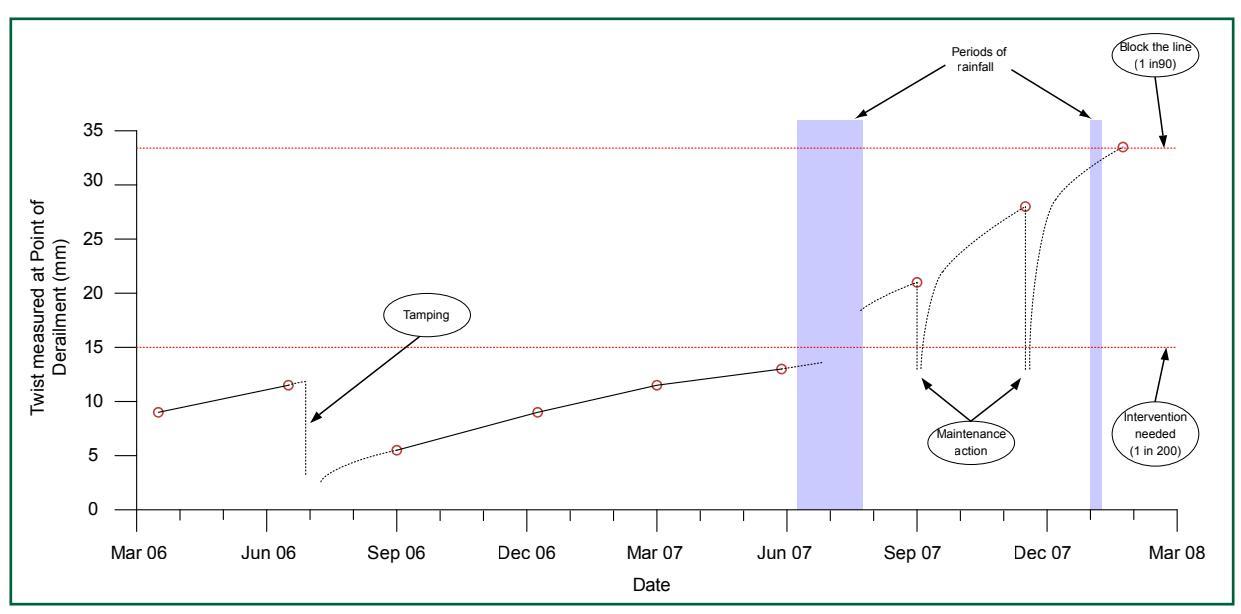
Figure 17: Change in track twist at point of derailment over time

196 The deterioration in cant indicates that the formation under the cess rail was deteriorating at a much greater rate than that of the six-foot rail. This is corroborated by the majority of track defects found during visual inspections being with the vertical alignment of the cess rail rather than the six-foot rail. Also, when the ballast was dug out from the cribs after the accident, water was found under the cess rail but not the six-foot rail (paragraph 59). The cant and the lack of a ballast shoulder on the cess side of the track provided a path for water to flow underneath the cess rail rather than the six-foot rail. The rapid deterioration of the track geometry due to water in the trackbed was a probable causal factor.
