Rail Accident Report

Derailment at Porthkerry, South Wales 2 October 2014

> Report 10/2015 August 2015

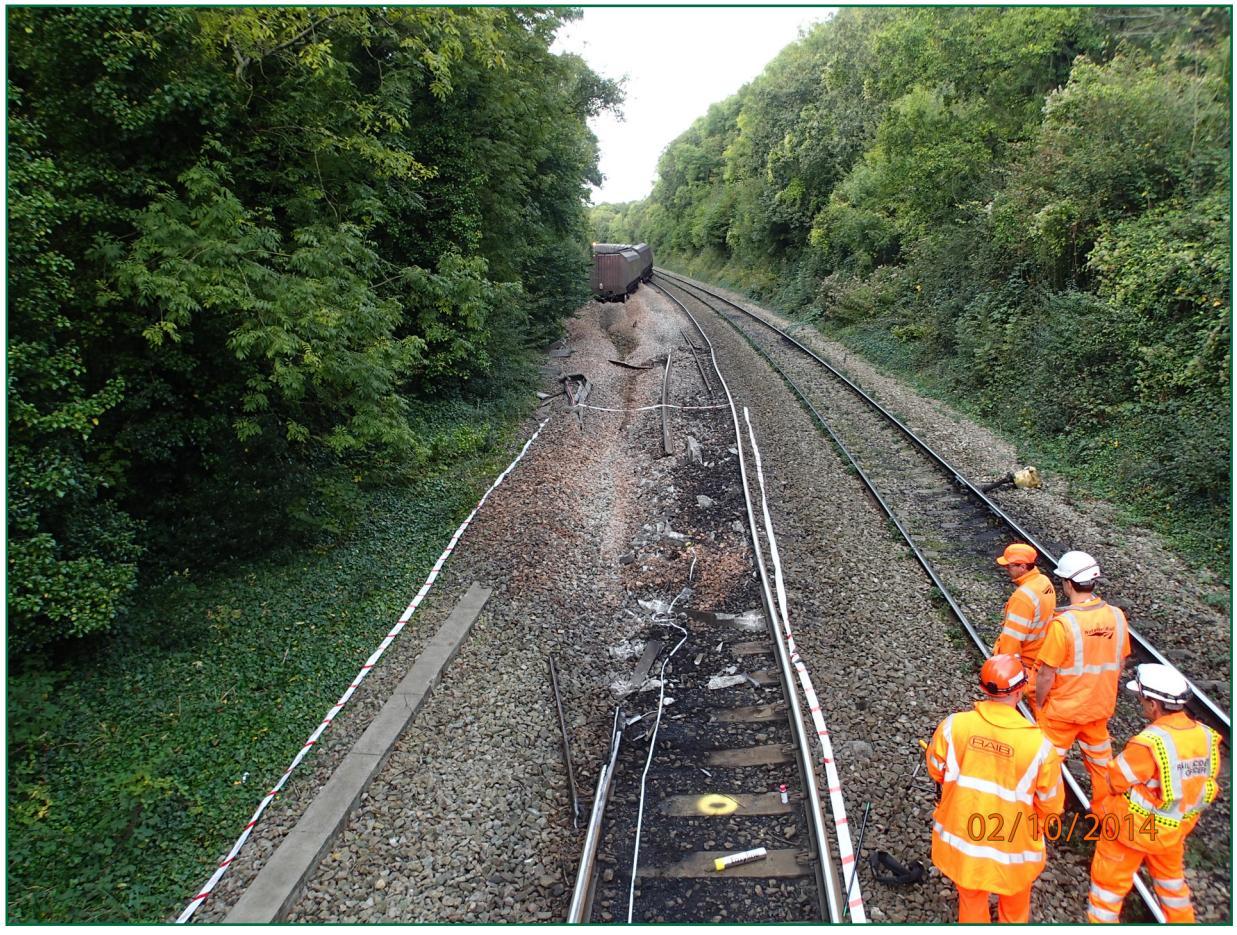
3 At 02:30 hrs on Thursday 2 October 2014, a loaded coal train derailed at Porthkerry, between Barry and Rhoose on the Vale of Glamorgan line in South Wales (figure 1). The last two wagons in the train were derailed when the rail beneath them collapsed (figure 2).

Figure 2: Overview of derailment site

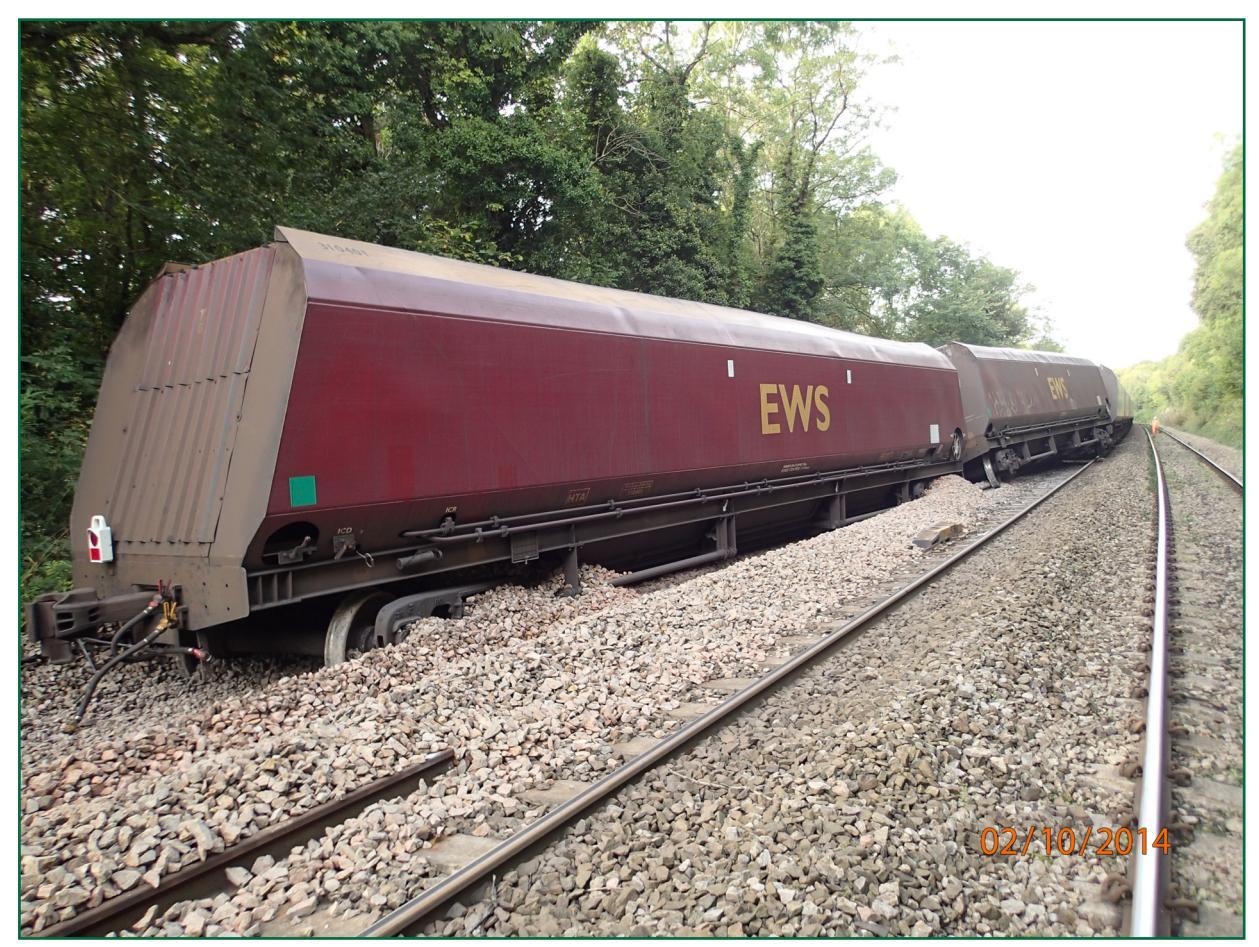
Figure 4: Derailed HTA wagon

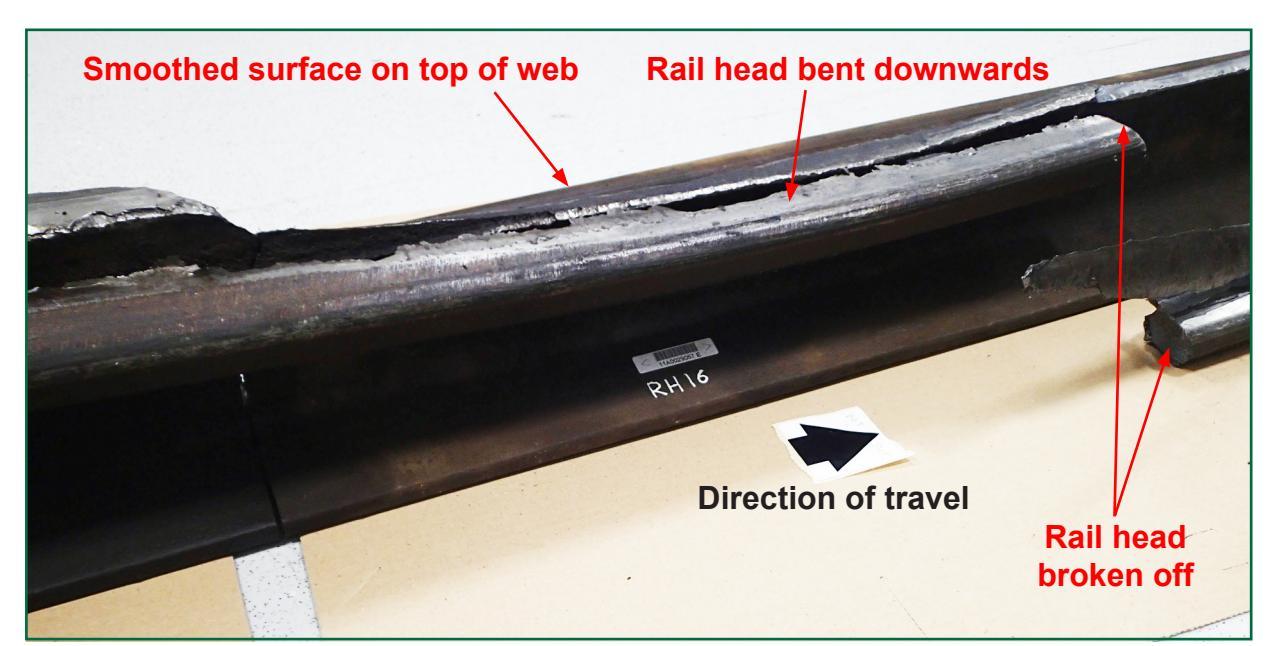
26 As the wheels ran on the exposed web of the rail, it was left with a smooth surface (figure 6) and the gauge side of the rail head was bent downwards. At the end of this section of rail, the gauge side of the head broke away in several pieces. The whole rail section failed at this point and some wheels struck the exposed end of the next piece of rail, breaking off three more pieces.

Figure 6: Fractured section of rail, showing smoothed surface of fractured web

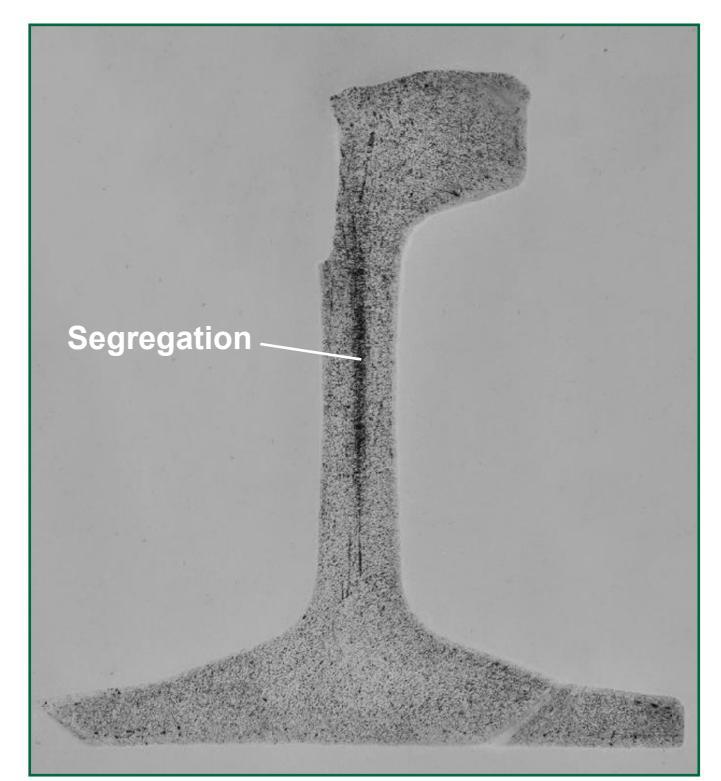
- 70 The presence of impurities in steel can be revealed by making a *sulphur print* of the surface of a cut section. This shows sulphide compounds in the steel which can reveal *segregation* within the metal. The metallurgist produced a sulphur print of a section of this rail (figure 9) which showed that there were distinct signs of segregation of the metal in the centre of the web which extended up into the head.

Figure 9: Sulphur print of rail showing segregation in web extending up into head (image courtesy of Serco Rail Technical Services)

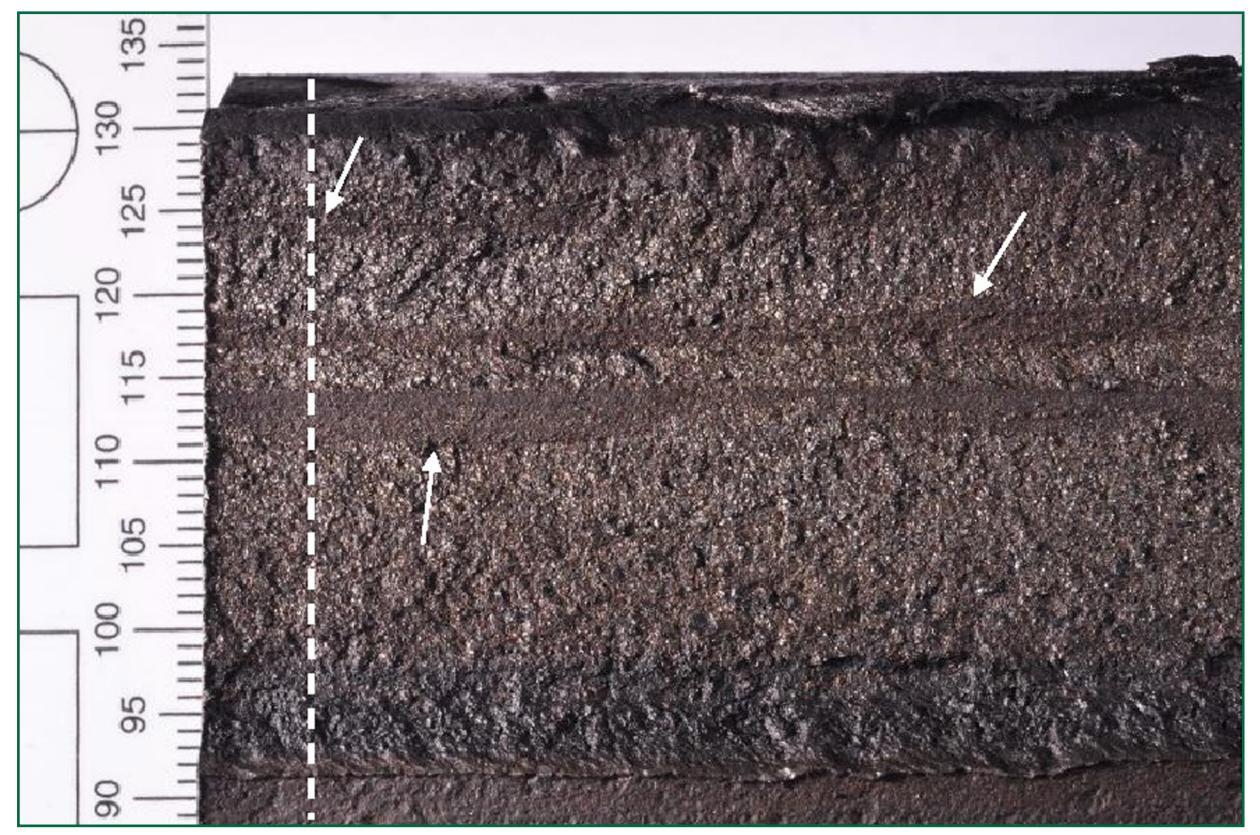
- 71 Examination of the fracture face of one of the sides of the VLS fracture showed indications of multiple defects in the steel oriented in the rolling direction of the rail (figure 10). This is consistent with impurities in the steel at manufacture being elongated along the rail as it was rolled.

Figure 10: Fracture face of VLS crack showing multiple defects (arrowed) oriented in the rolling direction (image courtesy of Serco Rail Technical Services)

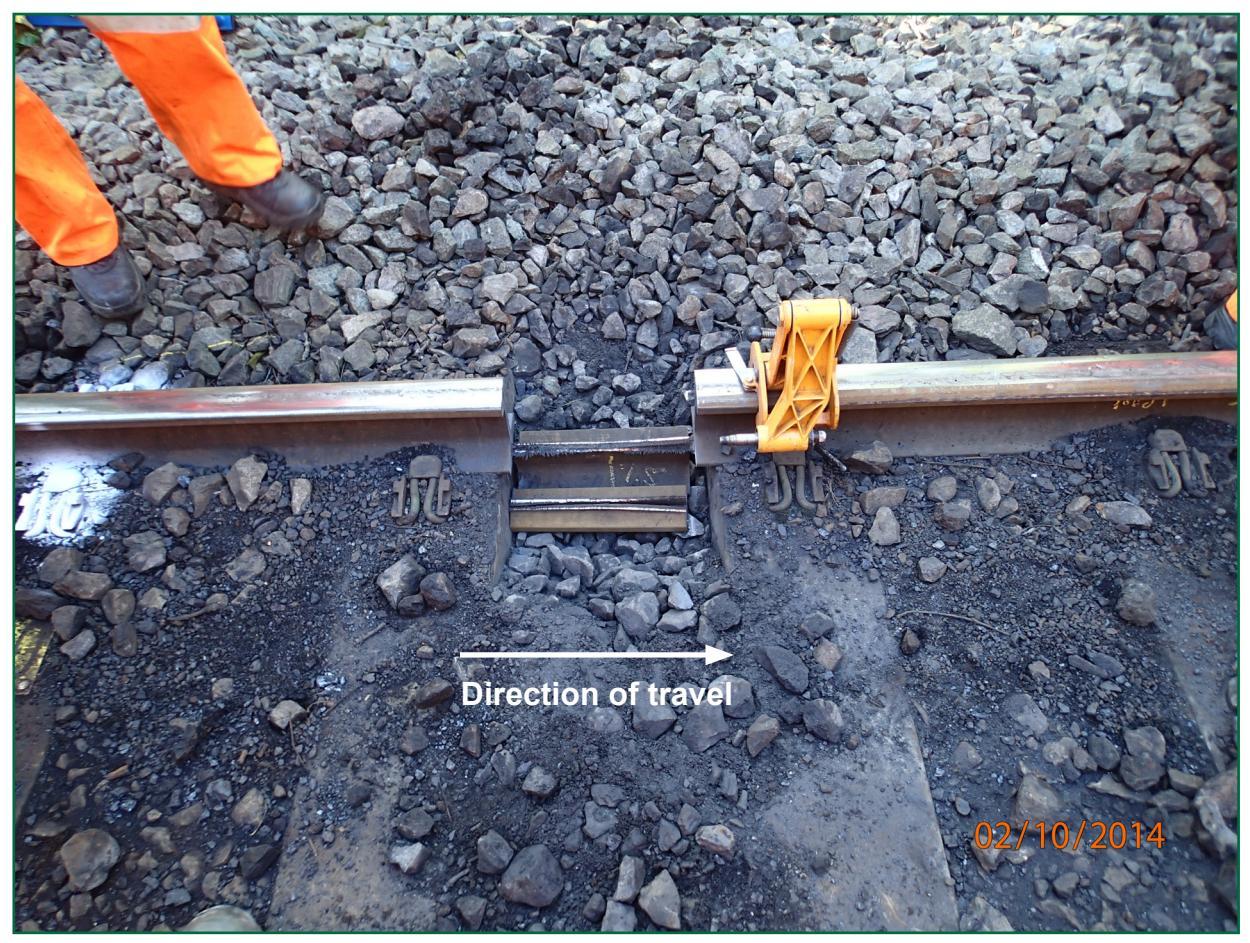
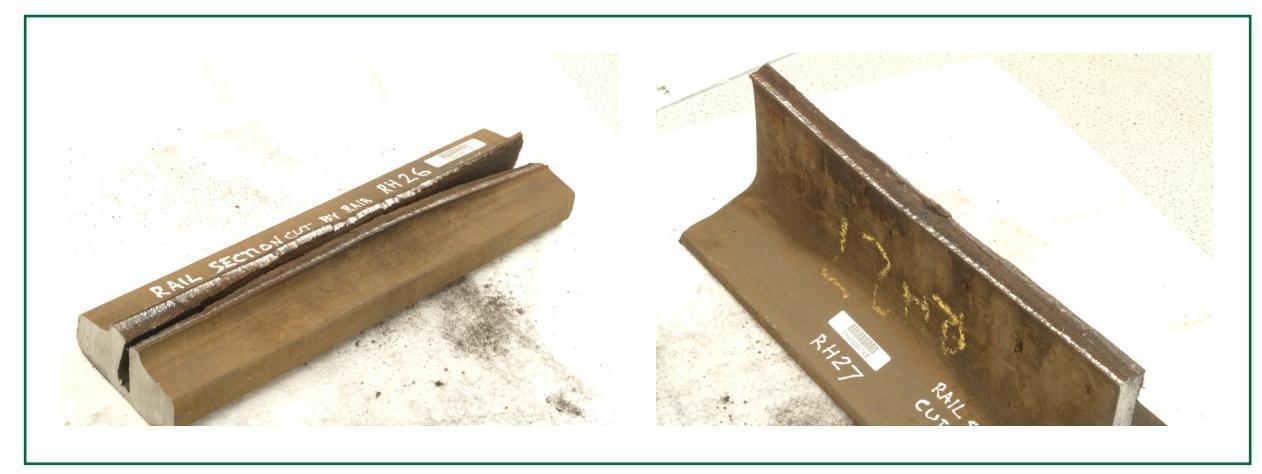
72 The position of the split within the rail cross section was evident in several places where the rail had completely broken. In addition to these breaks, there was a length of rail each side of the broken area where the split had opened up within the rail head but had not yet led to complete failure. The RAIB asked Network Rail to cut out a short length of apparently undamaged rail on the approach to the point of derailment (figure 11). This revealed that the piece of rail cut out was in two pieces, with fractures between the head and web at the *upper fillet radius* (figure 12). The cut ends of the rail revealed the extent of the split in the head (figure 13).

Figure 11: Apparently intact rail on the approach to the point of derailment

Figure 12: The two pieces of rail seen in figure 11

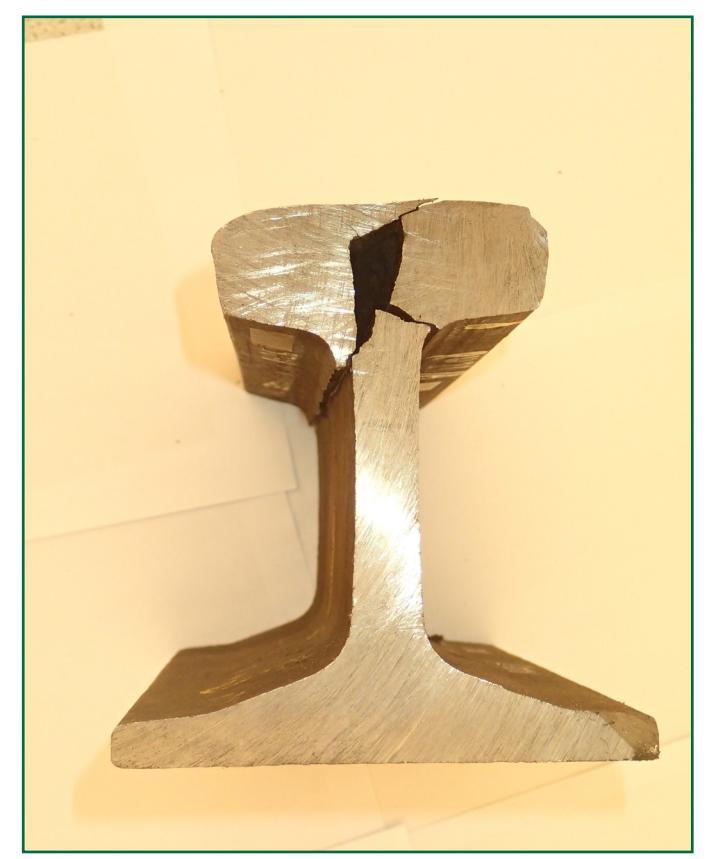
Figure 13: Cross-section of rail showing extent of VLS

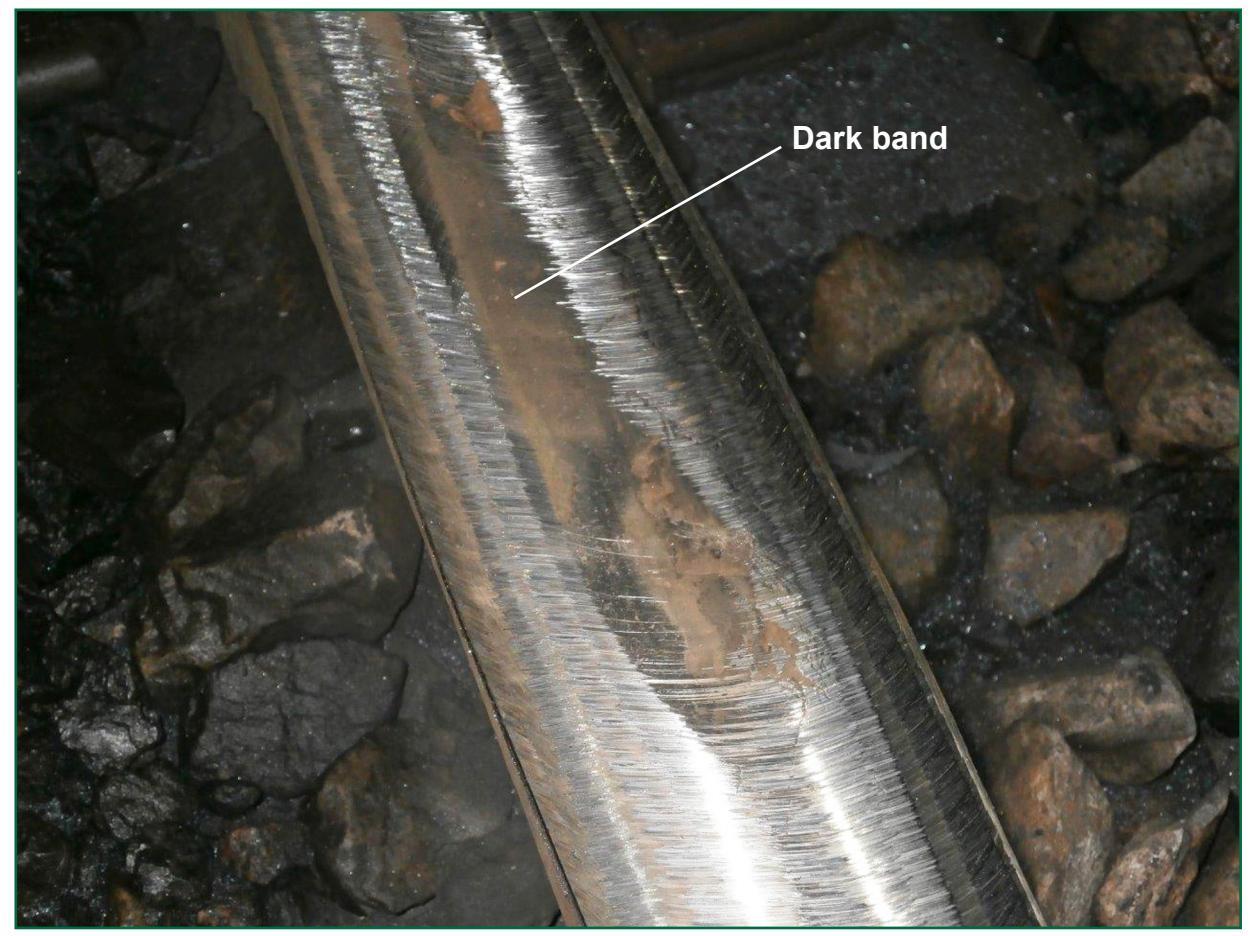
- 110 The RAIB obtained copies of the photographs taken by Harsco and they show the condition of the rail after the grinding work. One of the photographs (figure 16) shows a dark band in the centre of the rail head which is a sign that the head was starting to collapse into the void formed by the VLS.

Figure 16: Photograph of left-hand rail taken by Harsco after grinding on 30 August 2014 (dark area shows where rail had started to collapse)

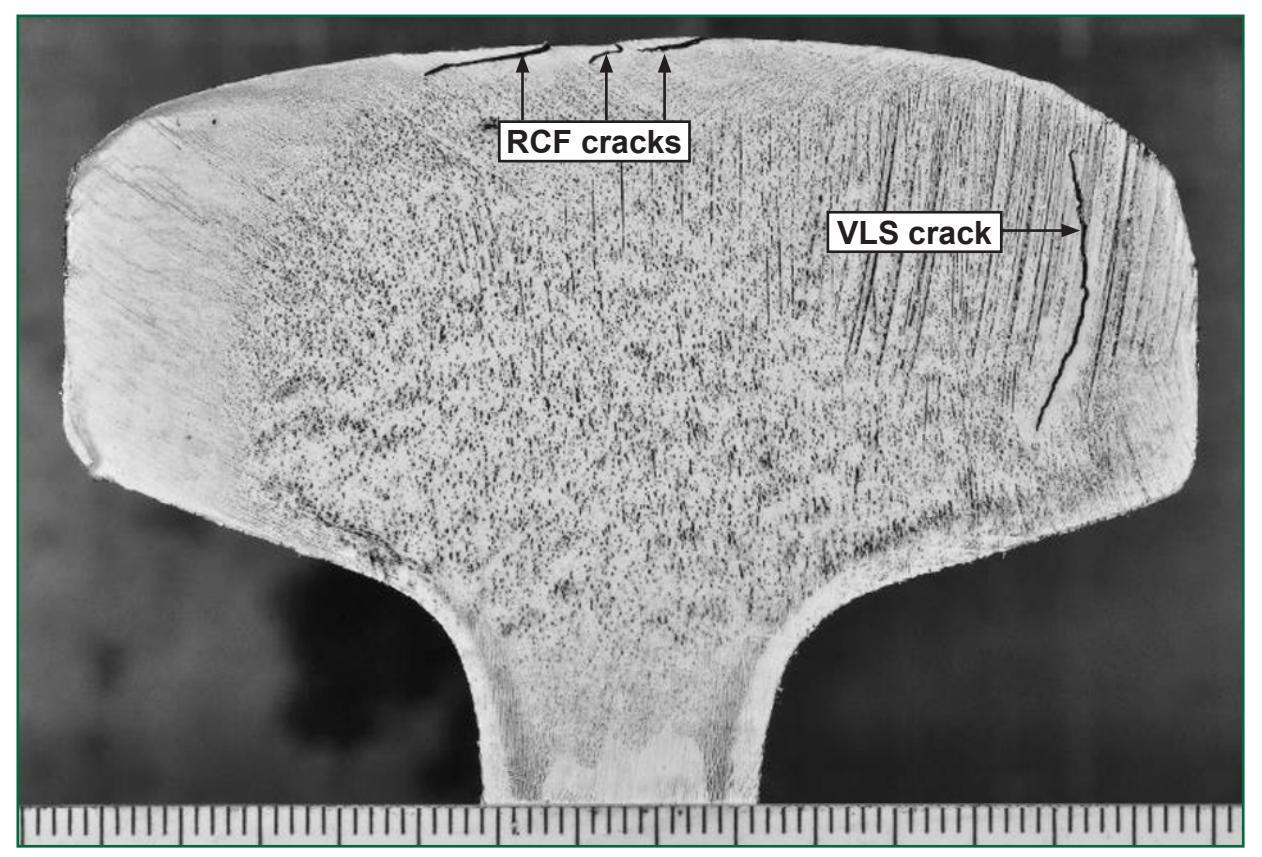
Figure 17: Magnetic particle inspection of the rail cross section at the start of the VLS section (image courtesy of Serco Rail Technical Services)

113 The rail samples recovered by the RAIB only contained one piece of 'unbroken' rail where the crack had reached the surface. This crack was difficult to see with the naked eye and was only evident after magnetic particle inspection had been carried out.
