Rail Accident Report

Fatal accident at Tyseley depot 14 December 2019

> Report 09/2020 October 2020

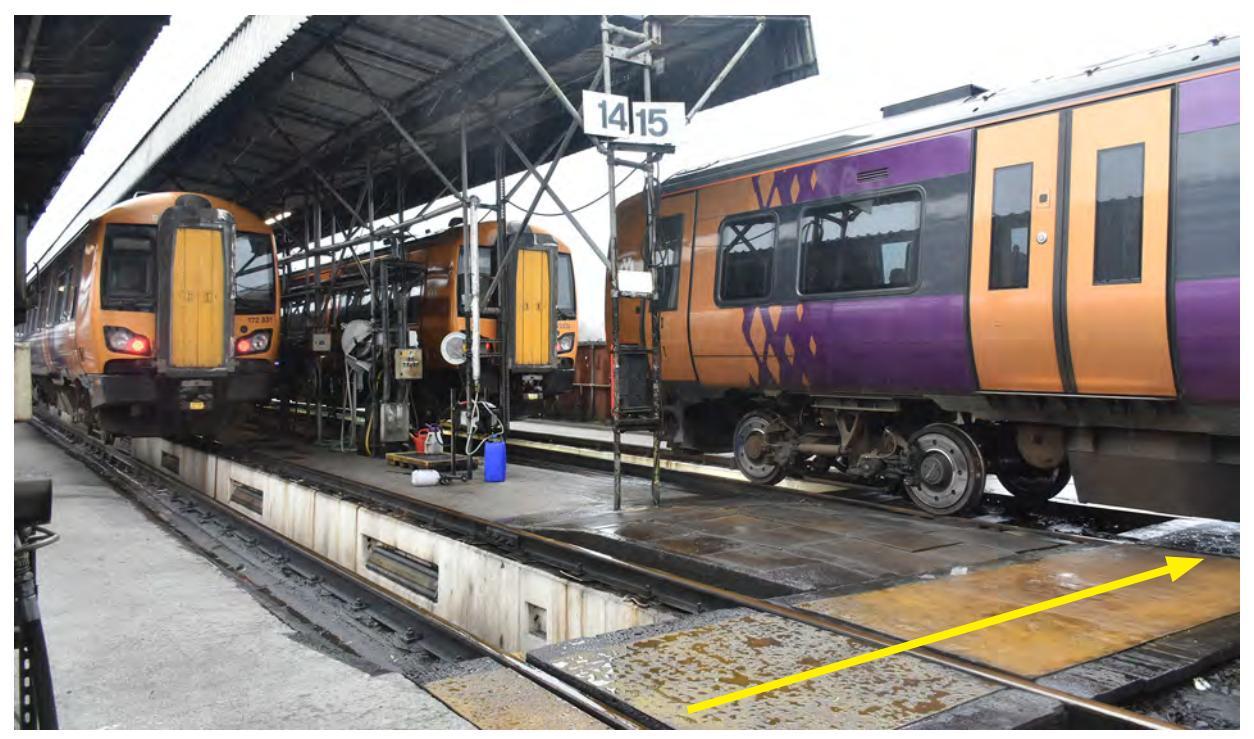
64 Unit 172344 (paragraph 23) arrived at Tyseley depot at approximately 19:15 hrs on the night of the accident. The North End Shunter directed the train onto number 15 siding. However, because another unit was already occupying the fuel pit, unit 172344 was stabled in a way that meant it obstructed the AWR which crossed number 15 siding (figures 8a and 9). Although a gap remained between unit 172344 and this other train, there is an inspection pit⁶ immediately to the south of the obstructed AWR which would have prevented Driver A from crossing there.

Figure 9: Trains positioned as at the time of the accident during the RAIB reconstruction. The obstructed walking route across number 15 siding is indicated.

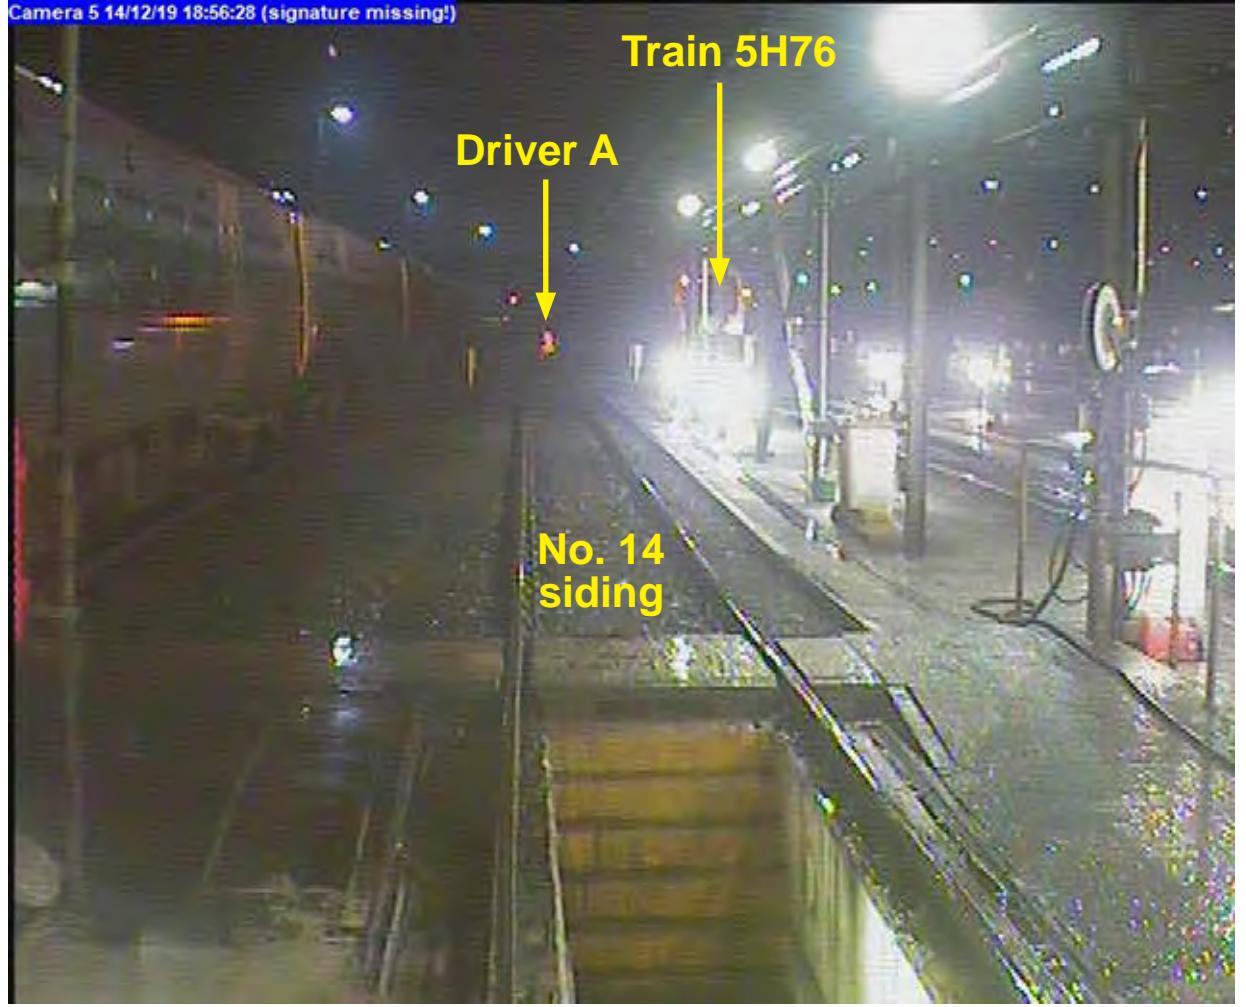
- 66 As he brought train 5H76 onto the depot and left the cab, Driver A would have had a clear view of the trains stabled on number 15 siding (figure 10), and he would have been able to see that a train was blocking his most direct route to the stairs. It is probably the case that his subsequent choice of route across the yard to the stairs was influenced by this knowledge.

Figure 10: CCTV still from camera mounted on the rear of a train stabled on number 14 siding within the fuel pit area. View is looking towards the north. Driver A is indicated, along with his train (5H76) stabled on number 13 siding.

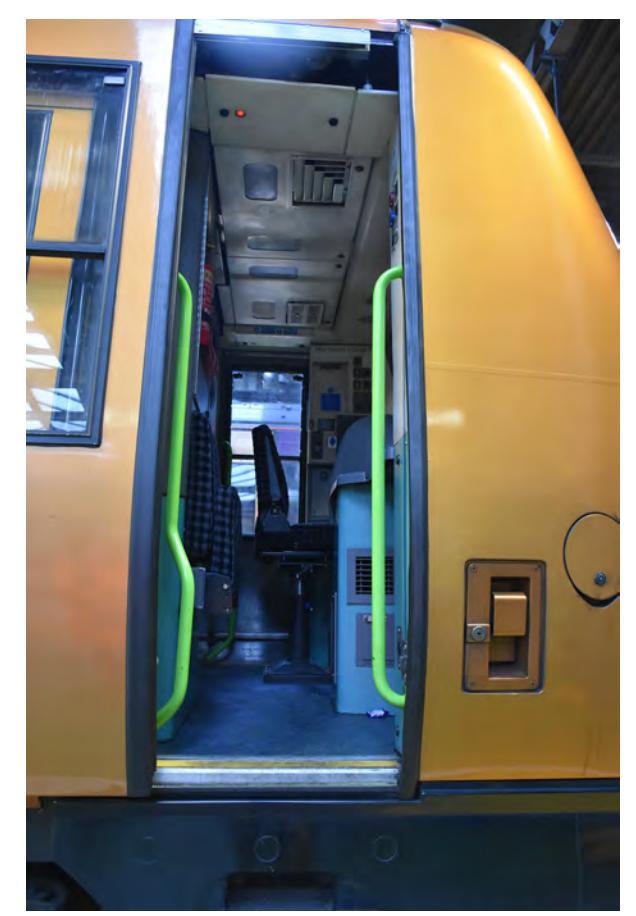
- 72 Driver A chose to leave train 5H76 by the non-driver's side cab door. Had he left the train by the driver's side door, he would have got down onto a wide and well-marked AWR which runs between numbers 12 and 13 sidings (paragraph 62). It is possible in this event that he would have continued to follow this walking route and crossed over the yard to reach the stairs via the south end of the fuel pit. This would have avoided him attempting to pass through the gap between the trains on number 15 siding.
- 73 There is no requirement that drivers should use a specific door when leaving trains. Observations by RAIB suggest that many drivers prefer to use the non-driver's side to enter or leave this type of train, as this avoids the obstruction presented by the fixed driver's seat (figure 12).

Figure 12: Class 170 cab, viewed looking in from non-driver's side

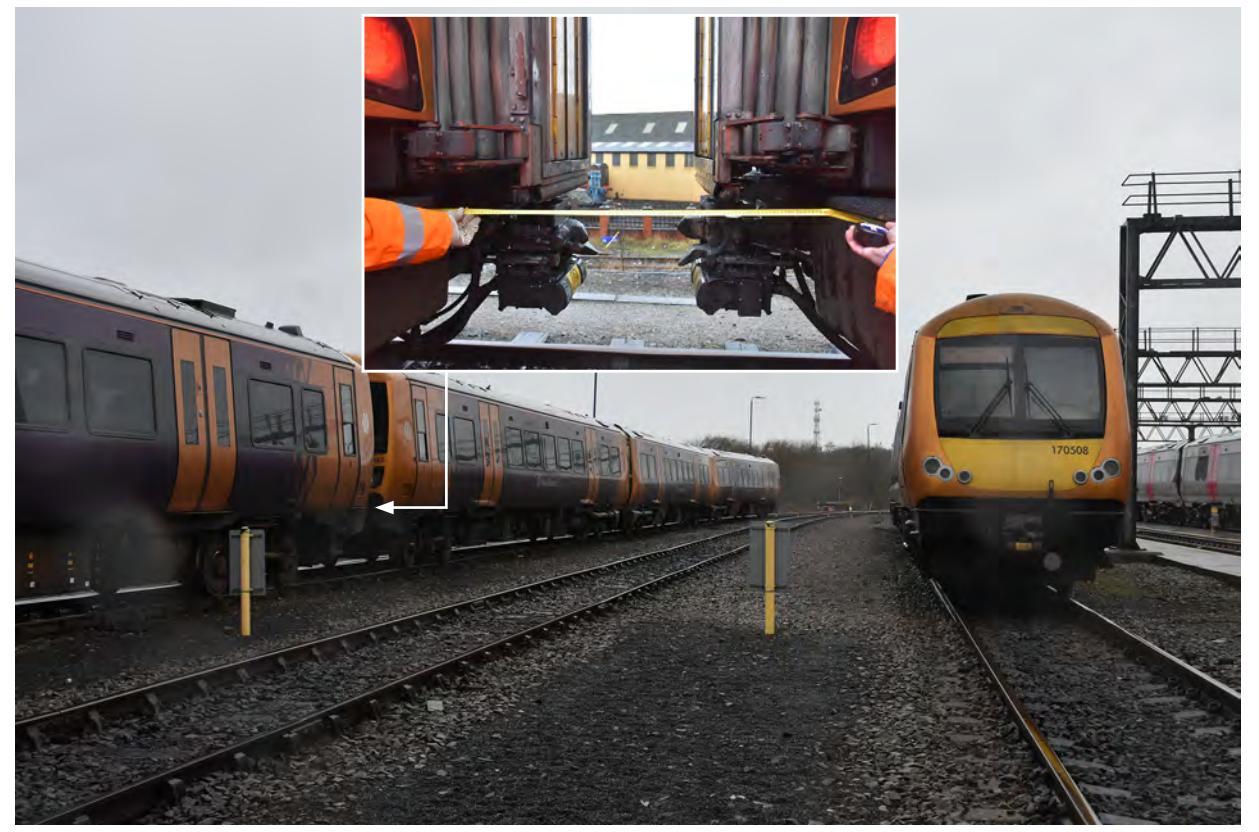
Figure 13: Trains on number 15 siding as positioned during the RAIB reconstruction. Inset shows the gap between the two Class 172 units

83 The reconstruction (which was carried out in daylight), showed that it was very unlikely that Driver A would have been able to see Driver B in the cab of unit 172343 after Driver A left train 5H76. Driver A's visibility of Driver B would probably have been further reduced on the night of the accident, because of the weather conditions and because the interior light in the cab of unit 172343 was not on at the time of the accident.

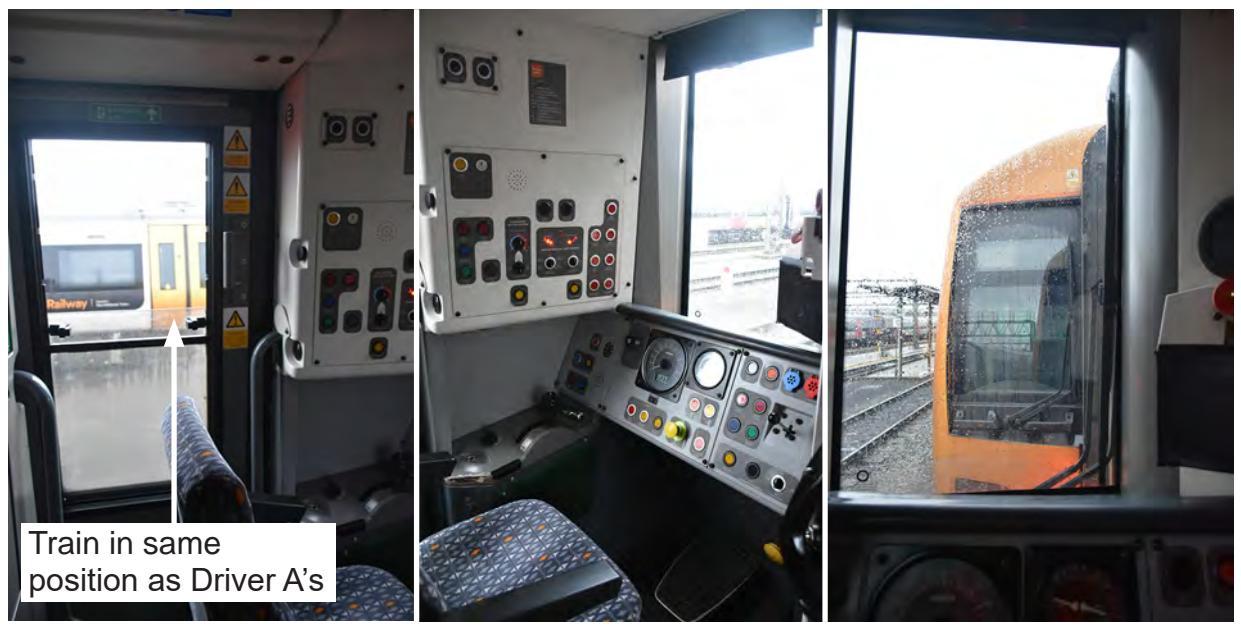
102 The RAIB reconstruction of the accident (paragraph 81) showed that Driver B would have been unable to see Driver A as the latter crossed from number 13 siding towards the gap between the two stabled trains. This is because a control panel in the Class 172 DMU cab (figure 14) would have obscured Driver B's view out of the cab in the relevant direction.

Figure 14: Views from Class 172 DMU cab, taken during the RAIB reconstruction. A train representing 5H76, from which Driver A alighted, is indicated. This train was positioned on number 13 siding.
