Accident involving a rail grinding train in Stavoren, the Netherlands, on 25 July 2010

The Hague, September 2011

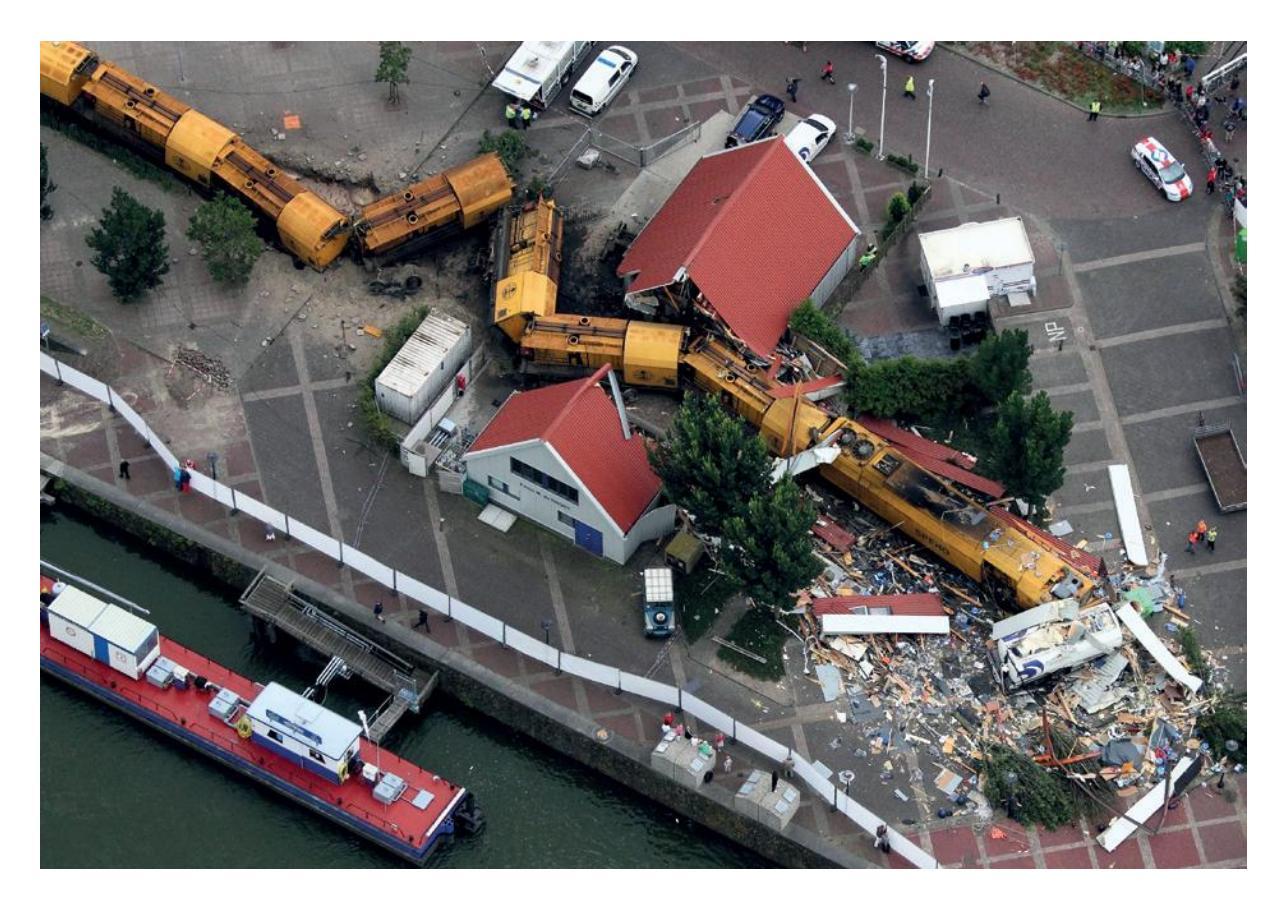
The accident occurred when the rail grinding train arrived at Stavoren Station at around 23.30 hours. Due to the fact that the rail grinding train braked too late, it drove at a speed of approximately 80km/h through a buffer stop located at the end of the line. On account of its high speed the train only came to a halt approximately 70 metres further on. After colliding with the buffer stop, the train first crashed into a parked tanker, which was empty, and then shot straight through the premises of a shop.

*Figure 1: This photograph shows the situation shortly after the accident. The train was driving from left to right. The railway terminus is located just outside the left frame of the photograph. The photograph shows that the train, with the tanker in front of it, has ploughed straight through the shop premises. (Source: National Police Services Agency, KLPD).*

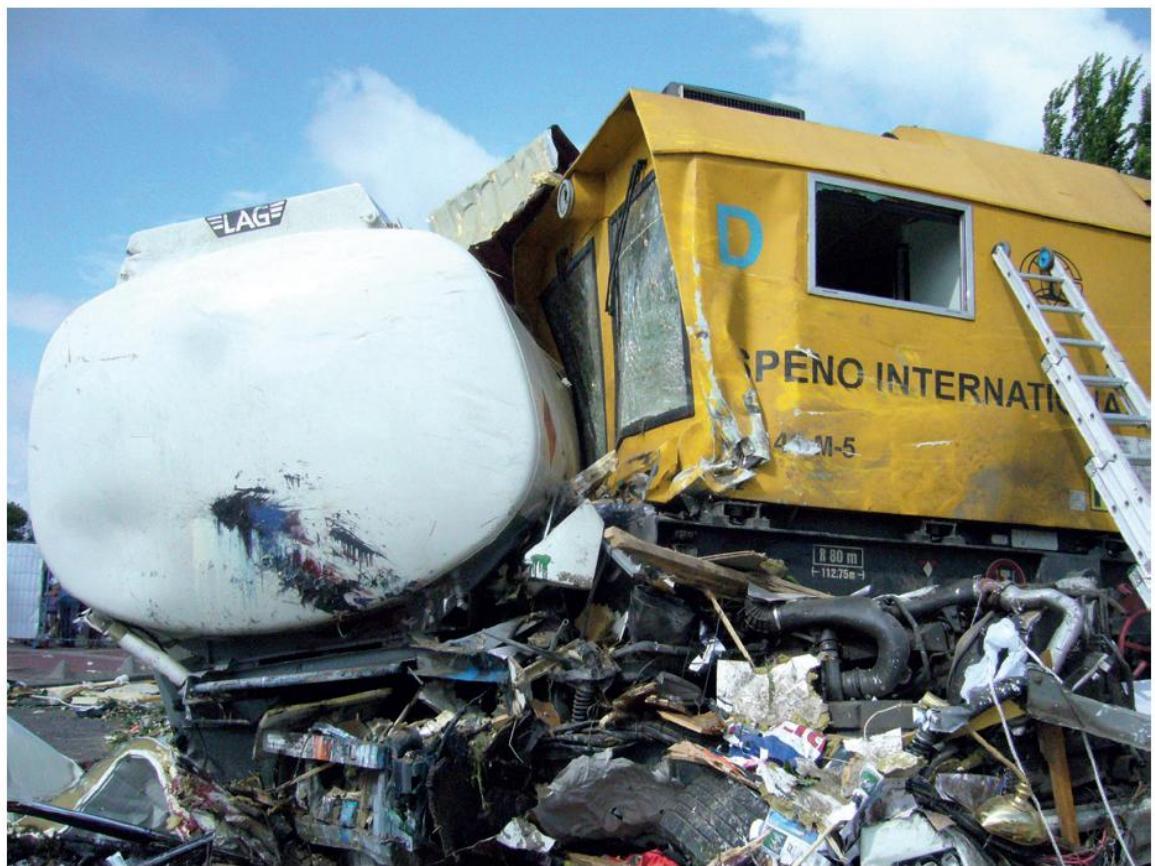
*Figure 7: Front of rail grinding train RR48M-5 after the crash with the tanker in front that had been pushed through the shop.*

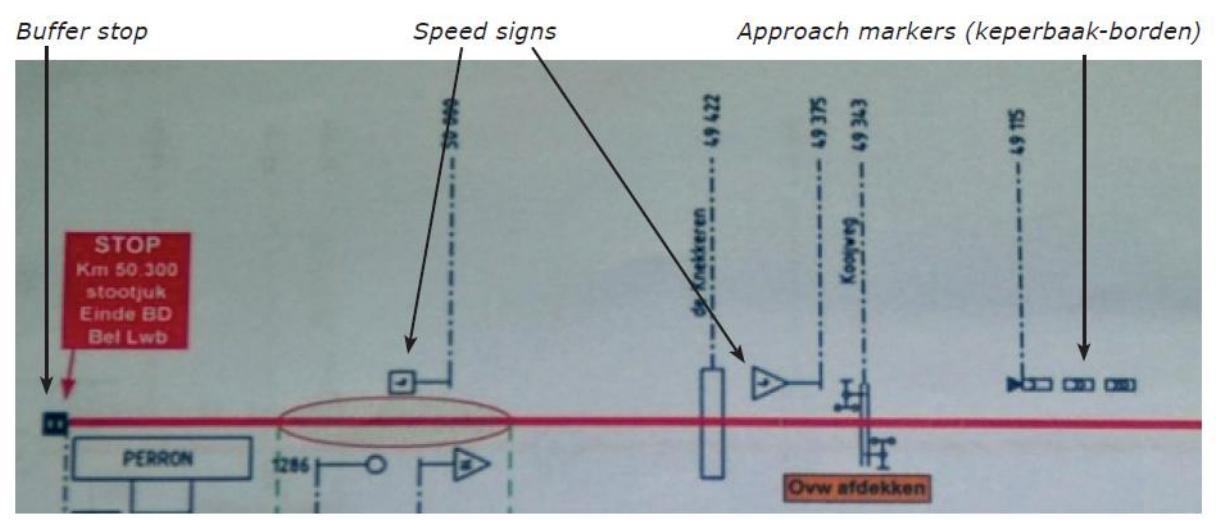
*Figure 9: Part of the visual instructions (track layout plan) used by the train driver. The track layout plan shows the speed limit signs that were no longer present. It also shows the approach marker (keperbaak). The track layout plan furthermore states that it must not be used as a safety document.*

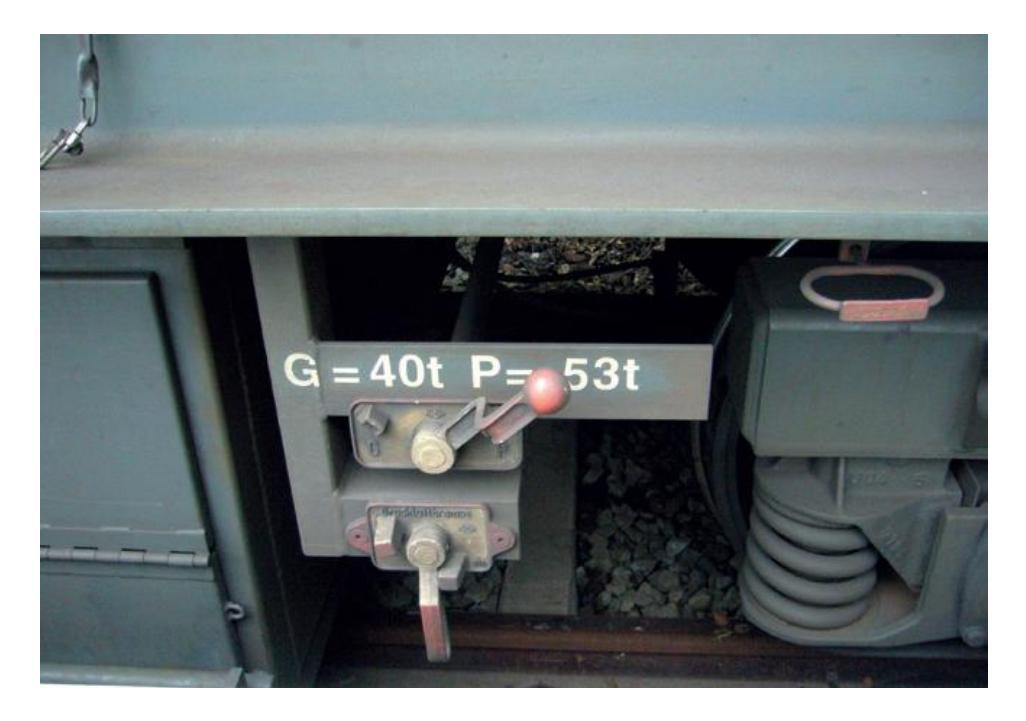
*Figure 16:* This photograph shows the two brake levers that feature on the units of the rail grinding train (in their correct position).

After the accident, all nine units of the rail grinding train were examined to find out whether the brake levers were in the correct position. The levers on five train units were found to be in the correct position. The levers on three train units were found to have broken off after the accident, making it impossible to determine their position; the remaining part of one of the levers was found in position G, whereby it should be noted that the position of this particular lever is likely to have changed during or as a result of the accident. The front unit of the train had sustained such severe damage that it was not possible to determine the position of the brake levers.

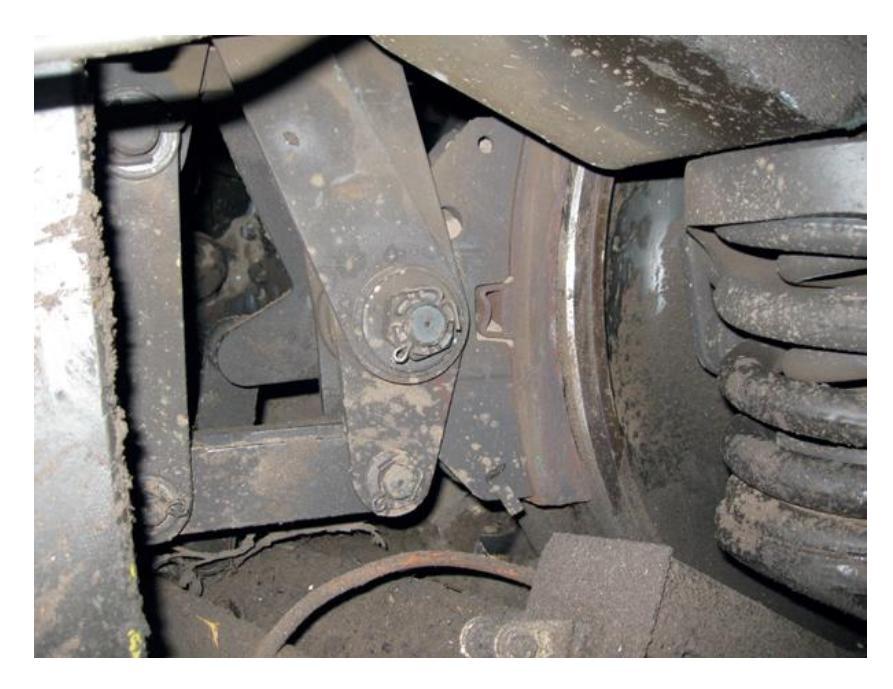
The two rear units of the rail grinding train were virtually undamaged, which allowed the Safety Board to perform a thorough inspection of these units. It was established that the brakes on two of these units were in good condition. As a result of the damage sustained by the train it was difficult to inspect the brakes on the other units, however there was no evidence to suggest that the brakes on these particular units were not in good condition. It was established that the brakes on the wheel sets that had not sustained damage or had sustained limited damage had been 'pulled' (see figure 17).

Figure 17: This photograph shows that the brakes on the front train unit had been 'pulled'.

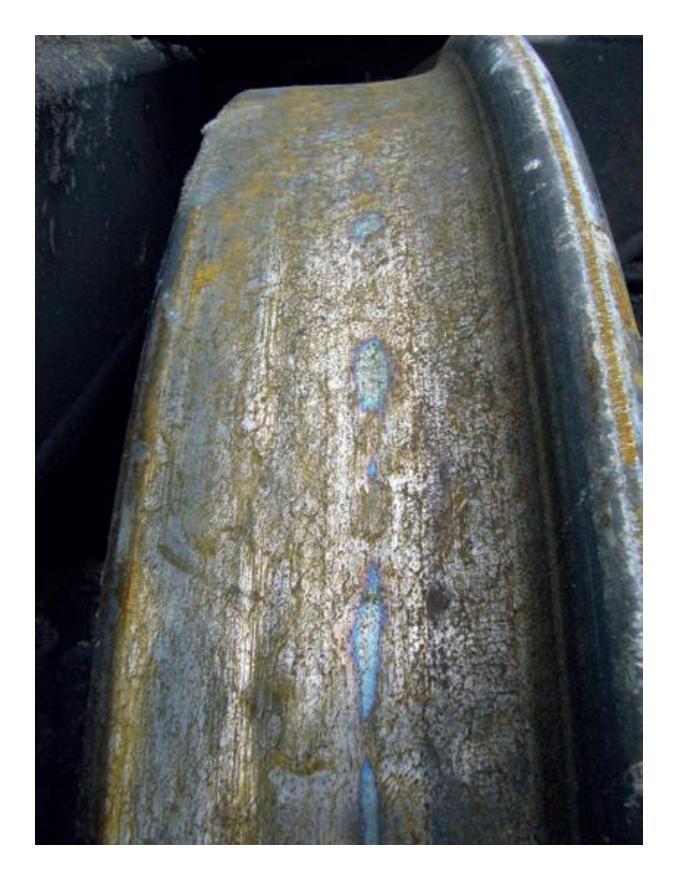
Skid marks were found on the wheel treads. There were hotspots on a number of wheels (see figure 18); these are created by excessive overheating and indicate that the train braked heavily.

Figure 18: Hotspots on the wheel treads

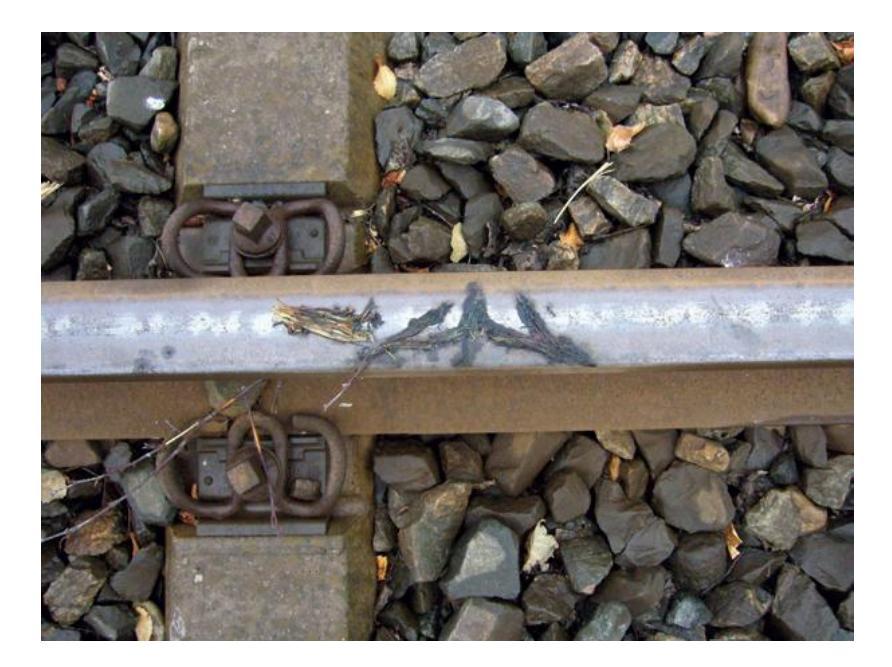
The remains of leaves were found on and alongside the rails (see figure 19). These leaves were from trees (which had shed their leaves because of the dry weather) in the surrounding area, and from trees that had been pruned near the platform. The remains of the leaves on top of the rails were found to have been compacted; they were partly charred, which was caused by the high temperatures that occurred during braking.

*Figure 19: This photograph shows part of the skid marks and the remains of leaves found.*

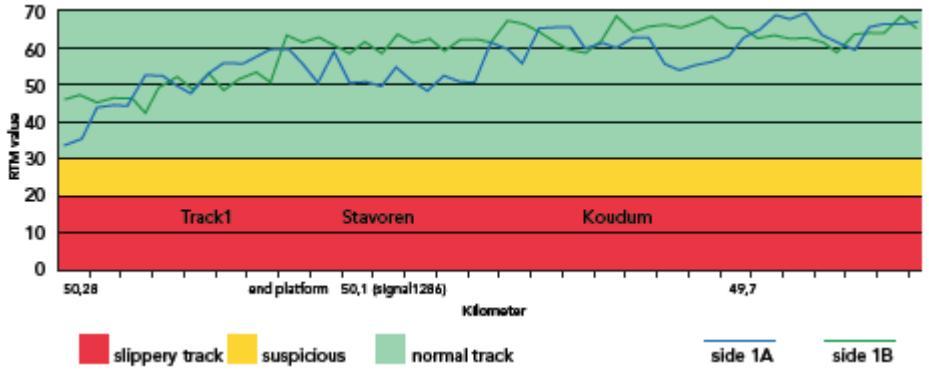
Figure 20: Results of the skid measurement

The measurements revealed that level of skid resistance of the rails was normal and that the rails were not 'slippery'. The skid resistance level of the rails on the last 20 metres of the track section was also measured in wet conditions; normal values were also established on this section.

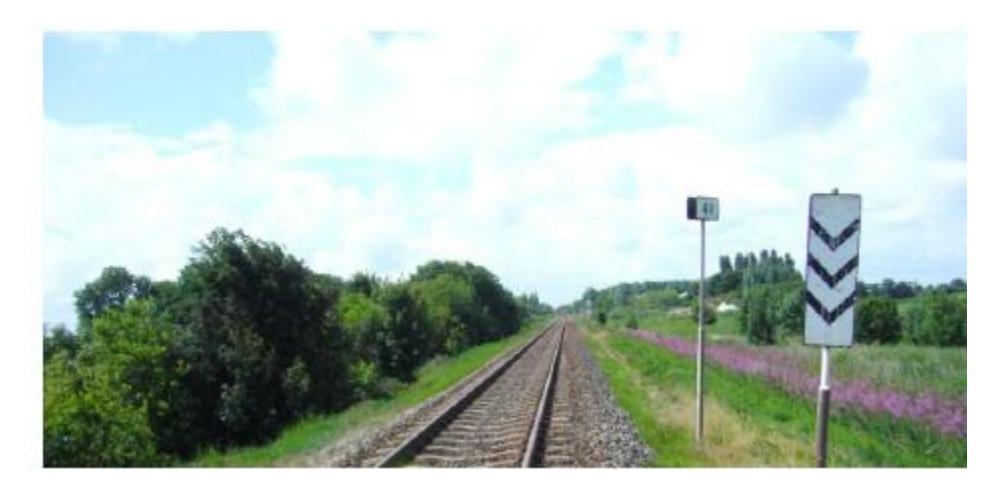
- The speed restriction signs (313 and 314) indicated on the track layout plan were not present.
- Location markers:
  - A kilometre sign mounted on a high post was located at 49.0km; the sign was placed a short distance after the first approach marker and was turned at an angle of 45 degrees (see figure 21). No kilometre sign was present at 49.5km. However, a kilometre sign was present at 50.0km but had been turned at an angle of 90 degrees (as a result of which it was not readable from the train cabin).
  - A hectometre sign (49.2) was located at 49.343km (at the level crossing shortly before Stavoren), and another hectometre sign (50.3) was located next to the platform.

Figure 21: This photograph shows the small 49.0 km sign.
