**REPUBLIC OF BULGARIA**  
**NATIONAL AIR, MARITIME AND RAILWAY TRANSPORT, ACCIDENTS**  
**INVESTIGATION BOARD (NAMRTAIB)**

**FINAL REPORT**

**Investigation of accident – fire in locomotive № 91520044060-9, serviced fast train № 8650  
between the stations Stara Zagora – Kaloyanovets on 01.07.2025**

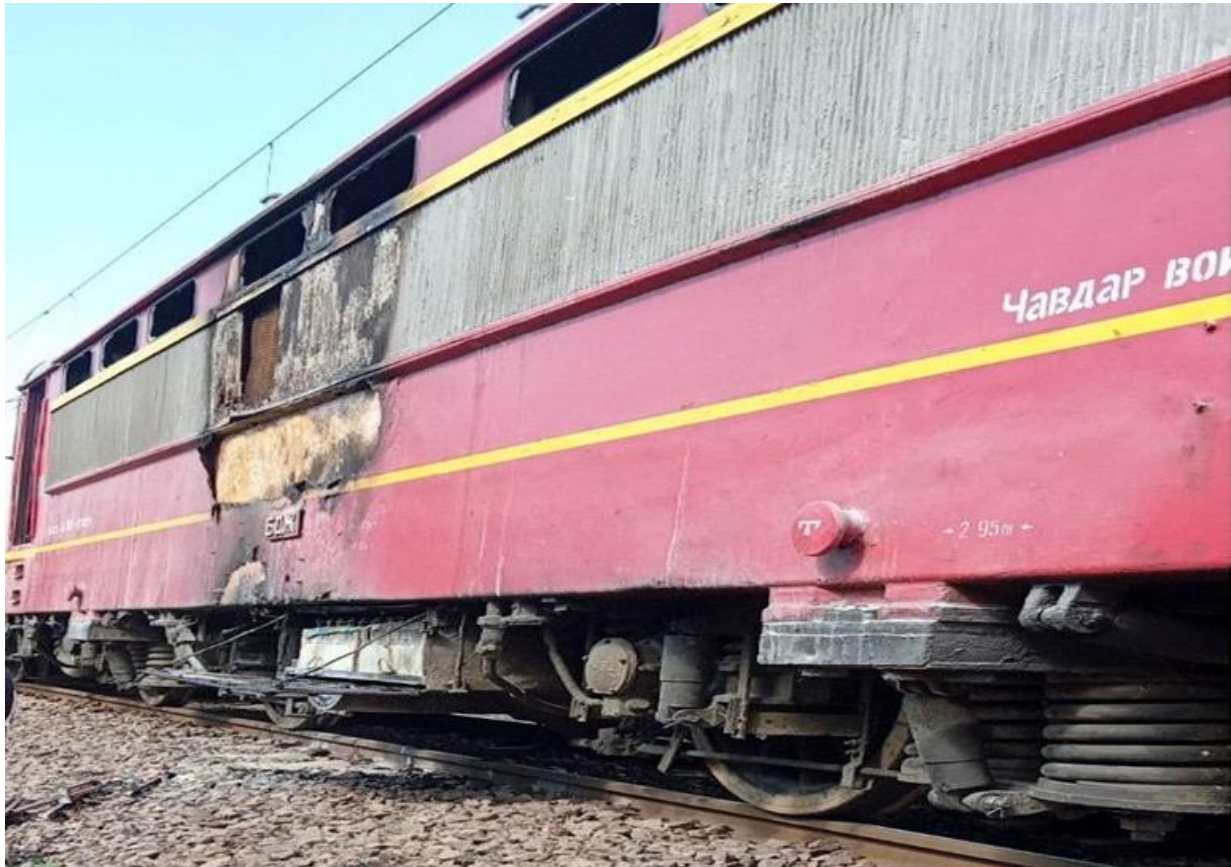
**Fig. 1.1. Fired locomotive № 91520044060-9, serviced FT № 8650.**

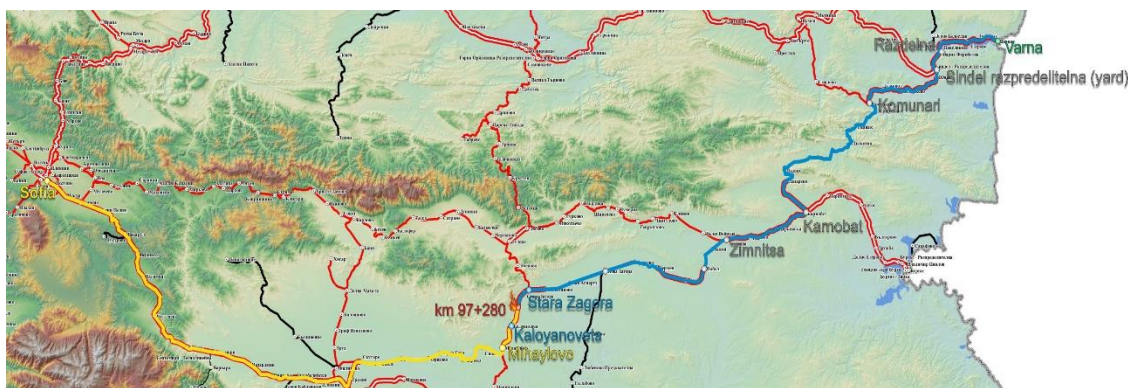
**Fig. 3.2. Route of FT № 8650 and place of the accident**

On 01.07.2025 at 13:09 p.m. FT № 8650 run along the Stara Zagora – Kaloyanovets on track No 2 in Sofia direction. At 13:10 p.m. the engine driver after seeing fire and smoke in the under body shell fan of the locomotive undertook stop of the train in the interstation at km 97+280 (fig. 3.2).

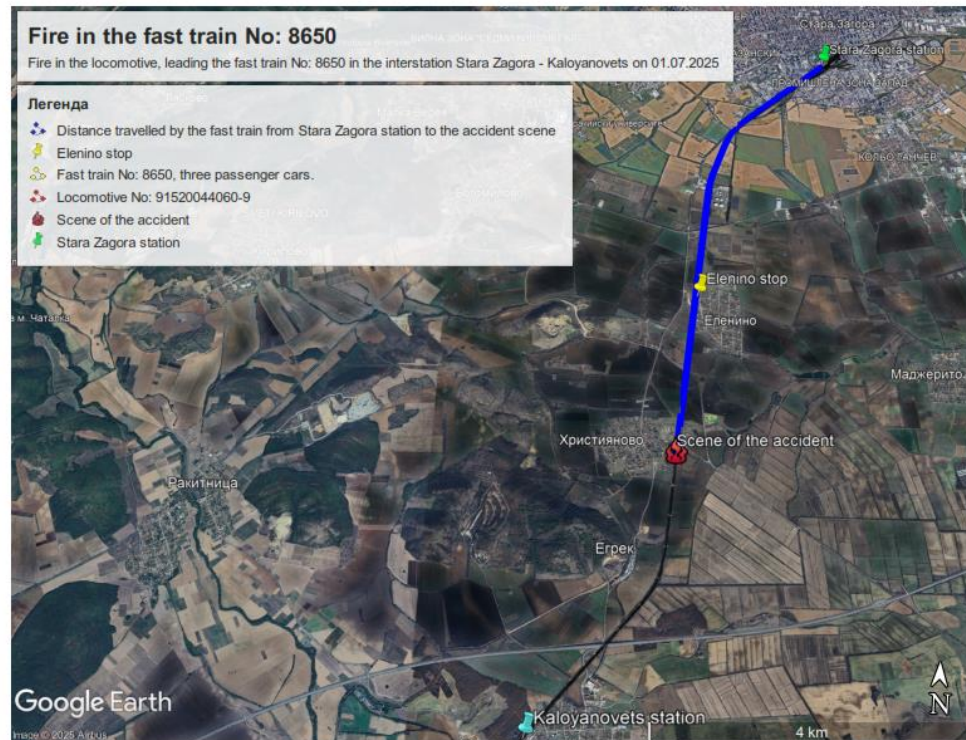
**Fig. 3.3. GPS location of the accident at km 97+280 along Stara Zagora – Kaloyanovets interstation.**

Geographic width: 42°20'41.50"N

Geographic length: 25°35'38.88"E

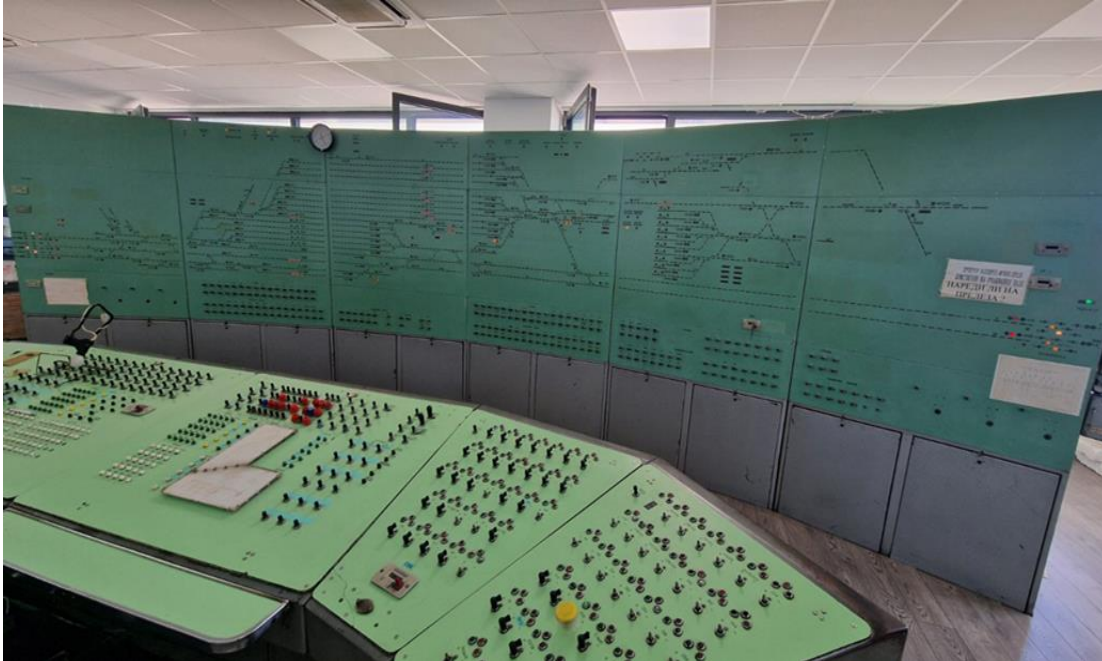
**Fig. 3.6. RRI Stara Zagora station with type, Russian block with route shunting“.**

Stara Zagora station is equipped with RRI type, Russian block with route shunting” – functioning (fig. 3.6);

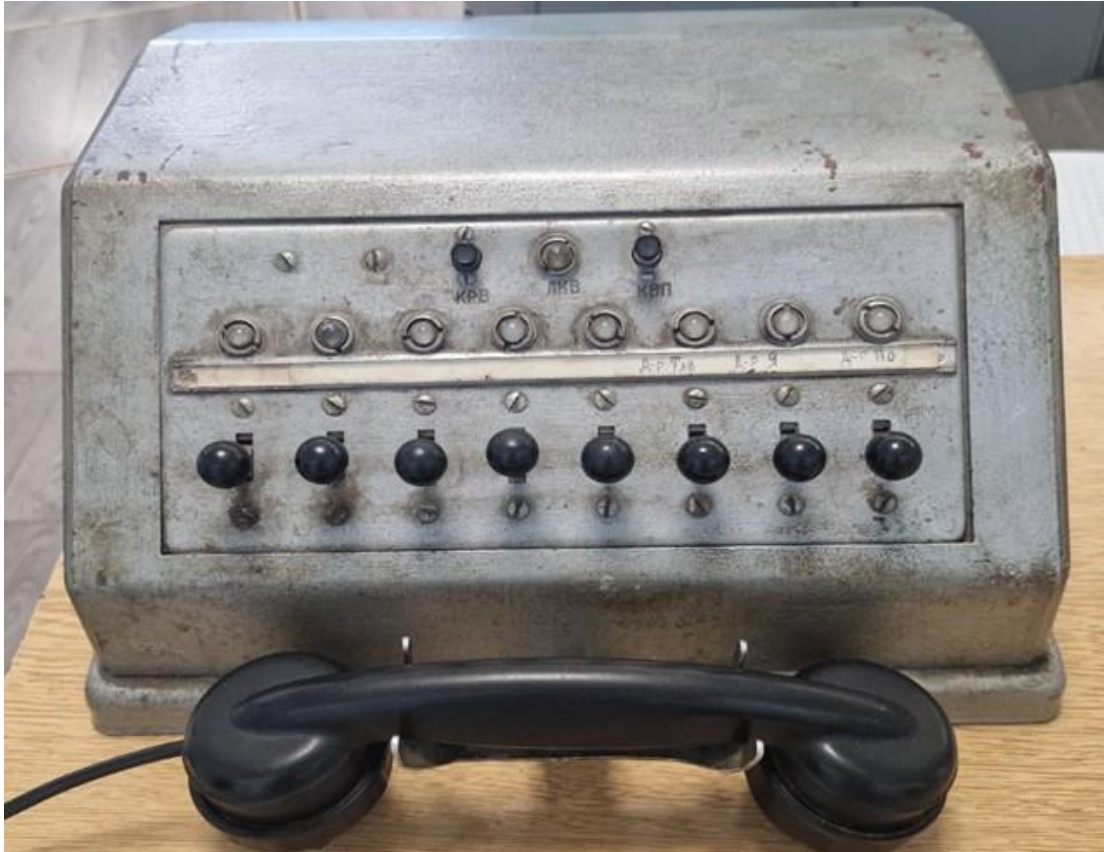
**Fig. 3.8. Communication means type UKSS-8**

The communication connections in Stara Zagora and in Kaloyanovets station are performed via UKSS-8 in both stations are ensured official GSM apparatuses for emergency necessities.

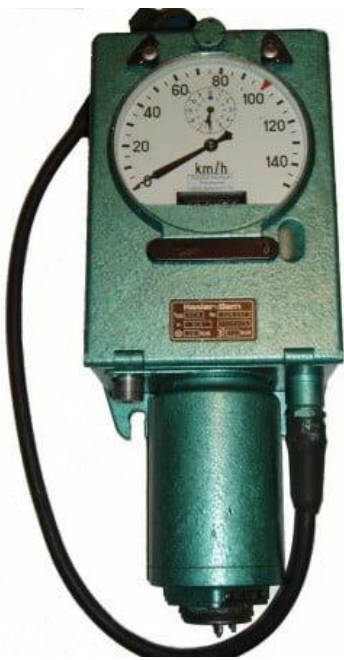
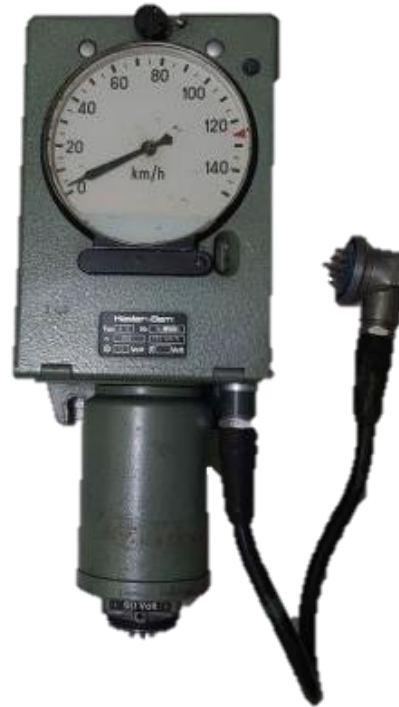
**Fig. 4.1.** Tape tachograph

**Fig. 4.2.** Tachometer

Locomotive No. 91520044060-9 is equipped with a "Hasler" type speedometer installation, which consists of a three-phase alternating current collector converter (geber), driven by one of the locomotive's axles. The resulting three-phase voltage with variable frequency, depending on the speed of movement, drives the mechanical speedometer synchronous electric motors mounted to it. One speedometer is installed in each of the locomotive's cabs: the recording device (tape tachograph) RT9 in cab No. 1 (Fig. 4.1) and the non-recording device (tachometer) A16 in cab No. 2 (Fig. 4.2). The two speedometers have a range of 0÷150 km/h.

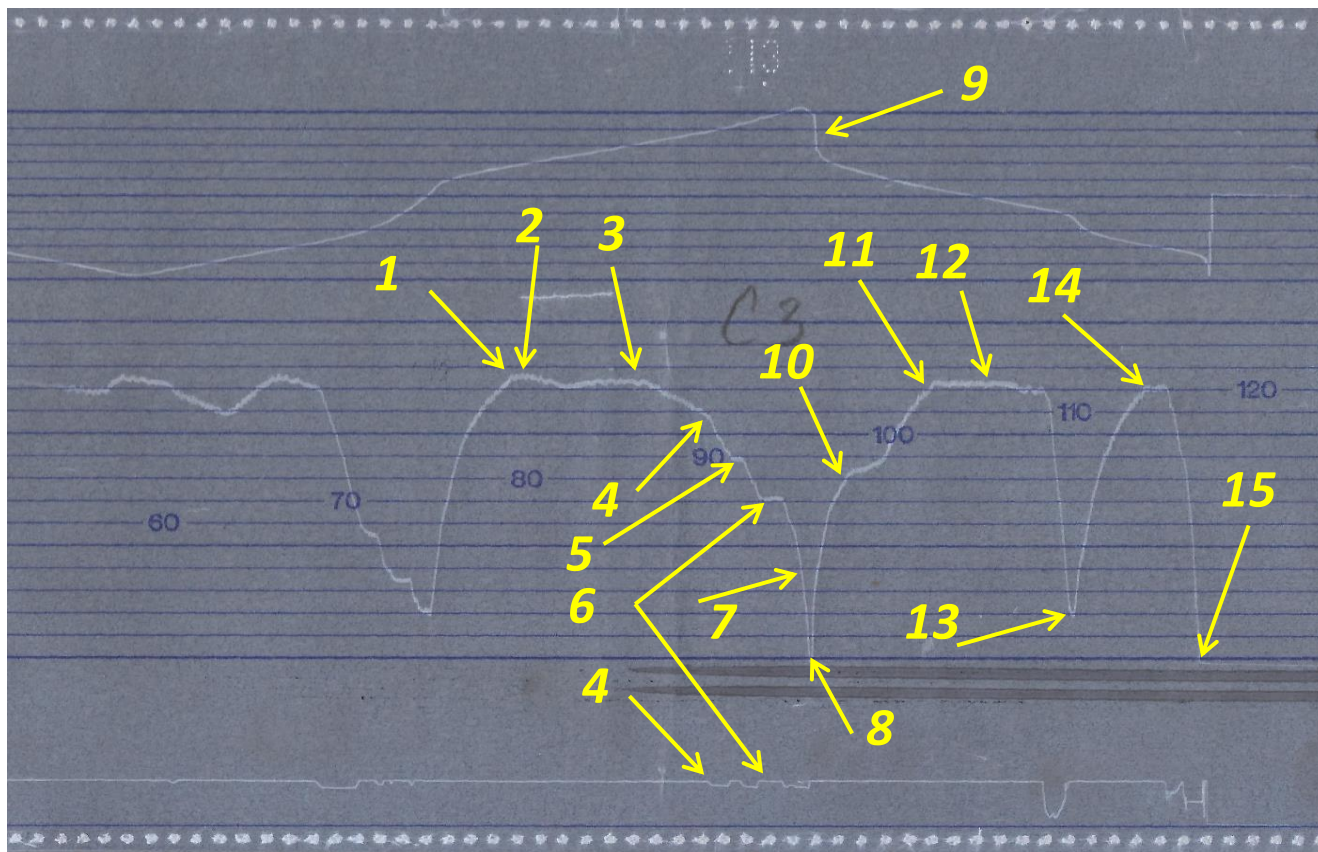
**Fig. 4.5.**

reaching 58 km/h (Fig. 4.4, pos. 14). The locomotive driver performed a gradual reduction in the speed of movement through several gradual holds and then completely released of the automatic train brake, and ultimately at 12:55:00 the speed reaches 19 km/h, immediately after which it begins to increase, reaching a value of 125 km/h after 1.9 km at 12:56:40 p.m., 1.40 minutes after the start of acceleration (Fig. 4.5, pos. 1). After reaching a speed of 125 km/h, the train moved in traction mode from 12:56:40 p.m. to 12:57:00 p.m. for 1.20 minutes and travelled 2.8 km (Fig. 4.5, item 2). At 12:57:00 p.m., the locomotive driver switched off the traction mode, the locomotive run by inertia and the speed started to decrease (Fig. 4.5, item 3). At a speed of 108 km/h, the driver activated the automatic train brake, reducing the pressure in the main air duct by about 0.8 bar and the speed started to decrease at a faster rate, reaching 88 km/h in 500 meters for 20 seconds (Fig. 4.5, item 4). That was followed by a full release, in which the speed was maintained at 88 km/h and a new gradual hold after 10 seconds with a duration of 20 seconds, with the train traveling another 450 meters with a speed reduction to 70 km/h (Fig. 4.5, pos. 5). That was followed again by a full release of the automatic train brake, in which the train travelled 500 meters with a speed of 71 km/h (Fig. 4.5, pos. 6). At 12:59:30 p.m. the locomotive driver initiated a new hold with the automatic train brake, that time the speed from 70 km/h decreased to 0 km/h in 20 seconds, traveling 500 meters (Fig. 4.5, pos. 7). The automatic train brake was released after the train stopped and arrived at Stara Zagora station at 13:00:20 p.m. (Fig. 4.5, pos. 8).

FT No. 8650 stayed at Stara Zagora station for 2.05 minutes from 13:00:20 p.m. to 13:02:25 p.m. (Fig. 4.5, pos. 9). It departed from Stara Zagora station at 13:02:25 p.m., accelerated to 82 km/h in 55 seconds for 820 meters (Fig. 4.5, pos. 10). That was followed by acceleration, but at a lower rate from 82 to 88 km/h for 700 meters for 30 seconds and again increasing the acceleration rate from 88 to 122 km/h for 1.2 km for 40 seconds (Fig. 4.5, pos. 11). After reaching a speed of 122 km/h at 13:04:40 p.m., the train moved at an almost uniform speed for 1.8 km in 55 seconds (Fig. 4.5, pos. 12). At 13:05:30 p.m., a two-fold change in the speed between 120 and 116 km/h was registered, after which at 13:05:50 p.m. the locomotive driver activated the automatic brake to the quick hold position, the speed began to decrease sharply over 600 meters in 30 seconds, and at 13:06:20 p.m. it reached 18 km/h (Fig. 4.5, pos. 13). At 13:06:00 p.m., the driver released completely with the brake valve the automatic train brake and switched the locomotive to traction mode, because of which the speed at 13:06:30 p.m. began to increase, and at 13:08:00 p.m., after 1,570 km in 1.5 minutes, it reached 120 km/h (Fig. 4.5, pos. 14).

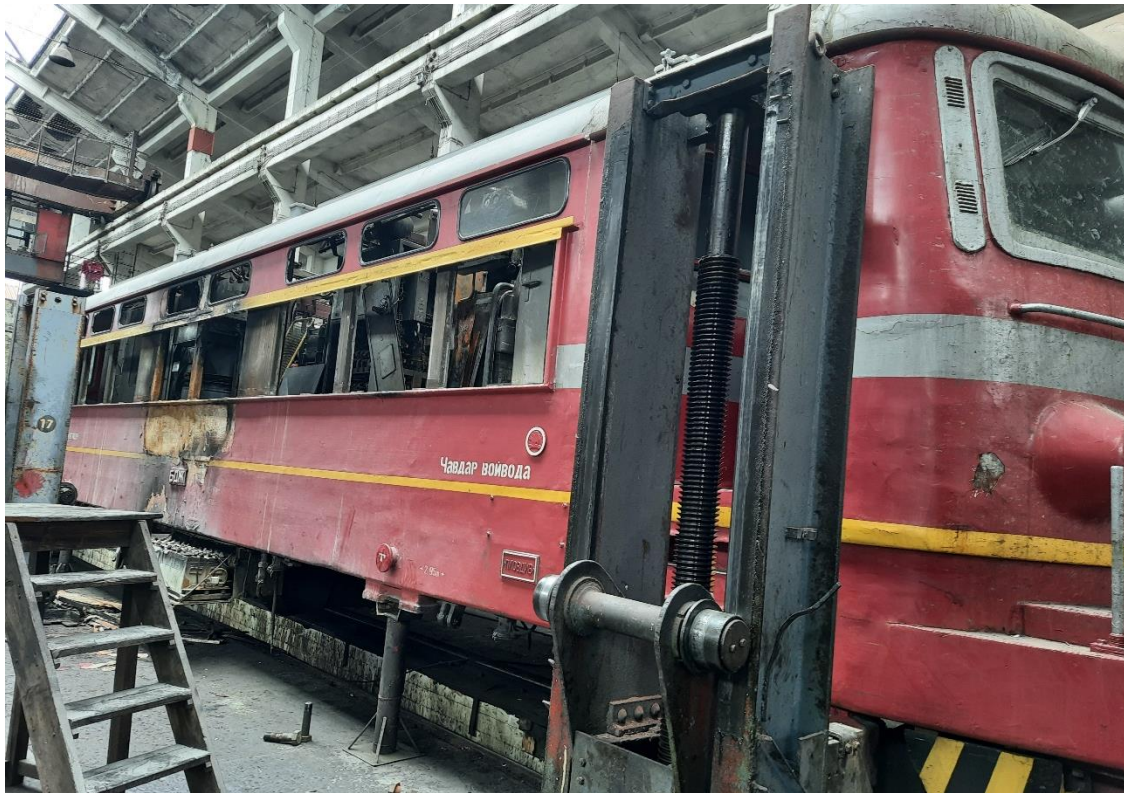
**Fig. 4.6.**

During the inspection was found, that the burnt middle part of the right longitudinal side of the

locomotive on travelling direction above the battery cabinet (Fig. 4.6). The fire spread to the engine compartment passageway, burning the floor covers and the operating cables located underneath them (Fig. 4.7). Cables connected to the traction transformer (Fig. 4.8) were burned, as were devices from the rectifier unit of the first traction group (Fig. 4.9). The greatest damage was caused under the locomotive frame, in the area of the under-body shell horizontal fan. According to the marks left by the fire, it was evident that the highest temperature developed in the area of the fan housing, the terminal box and the floor metal sheet through which the cable bundles passed into the engine compartment (Fig. 4.10). During the inspection, it was found that the burns on the cables were due to an external fire and the cause of the

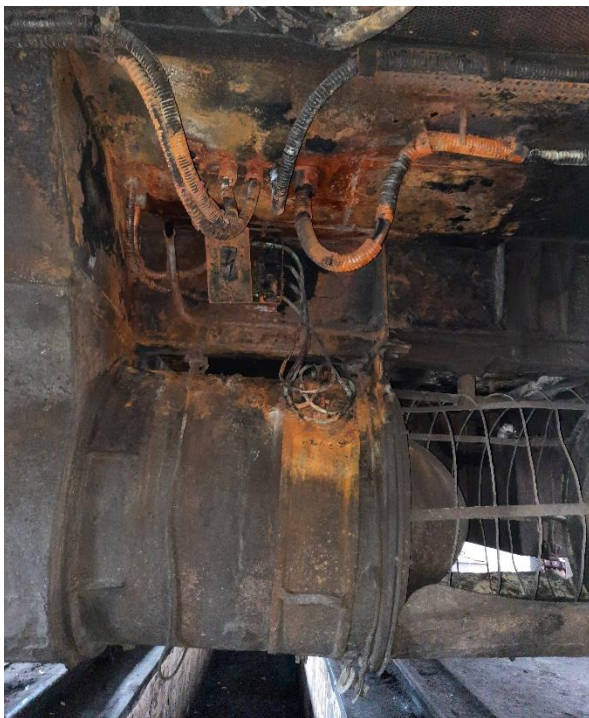
**Fig. 4.11.**

ignition could not be found in them (Fig. 4.11). Then the attention was focused onto the mechanical part of the brake system and in particular to the brake pads of the locomotive.

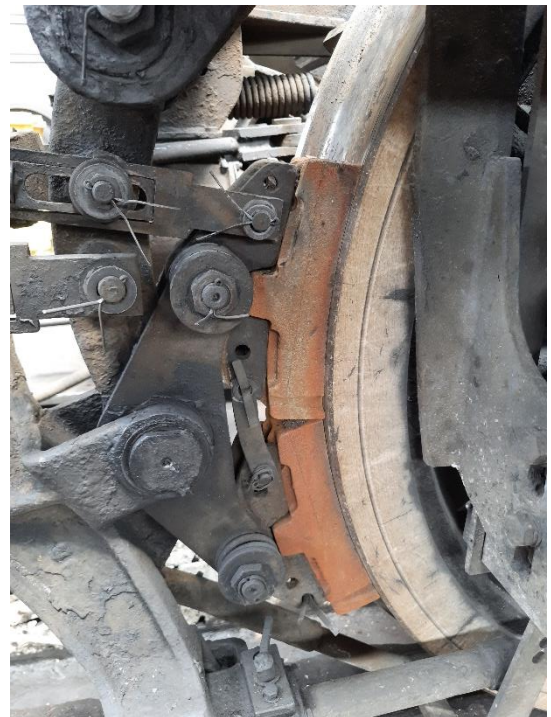
**Fig. 4.12.**

On the other hand, however, the friction units of the locomotive are thermally overloaded, which was established during the inspection of the burned locomotive (Fig. 4.12). It was from the thermally overloaded blocks that pieces began to break off, which were swirled by the air during the movement of the locomotive and fell on the housing of the under-body shell fan, where they initially ignited the dirt accumulated on it, and subsequently the cables located in the immediate vicinity. Further development of the fire was a matter of time for the fire to pass into the engine compartment and spread there as well.

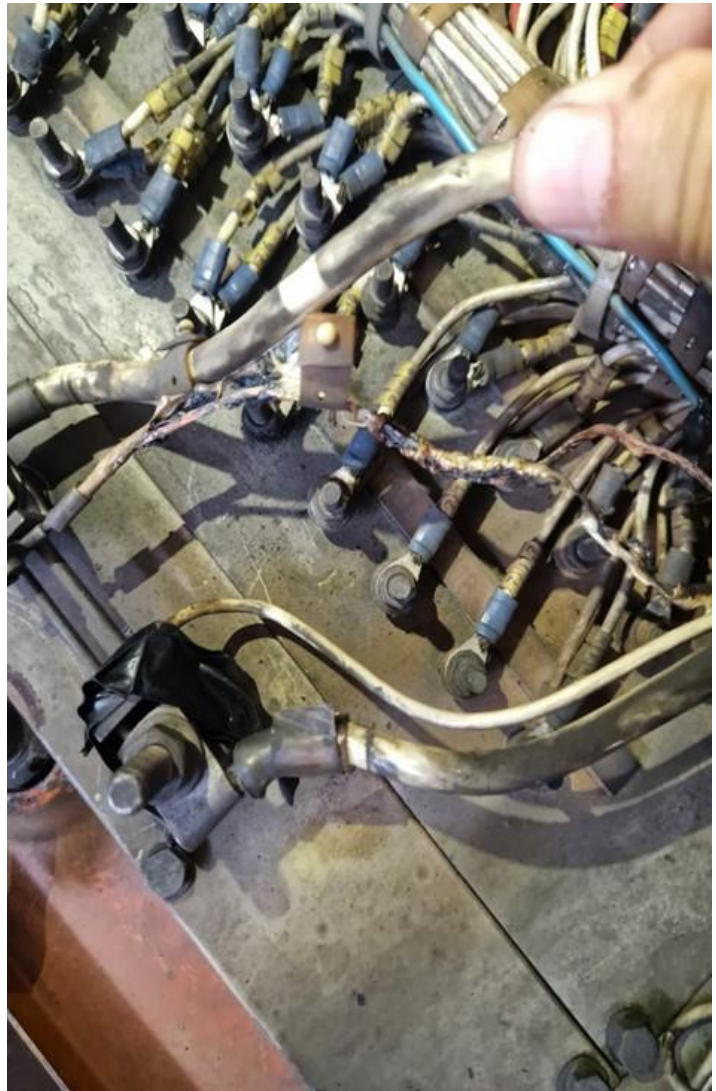
**Fig. 4.15.** Burnt conductor 873.

1. Occurrence of a short circuit of low voltage cables in a piano type multiple unit system in the first locomotive control cabin. When checking the terminal board of the multiple unit system, a burnt

cable was found on conductor 873 and its connections with conductor 869 for powering the battery shown in Fig. 4.15.

The figure shows that the short is in the conductor itself and there is no broken insulation of the other conductors of the multiple unit system. It was found that there was no blown fuse.

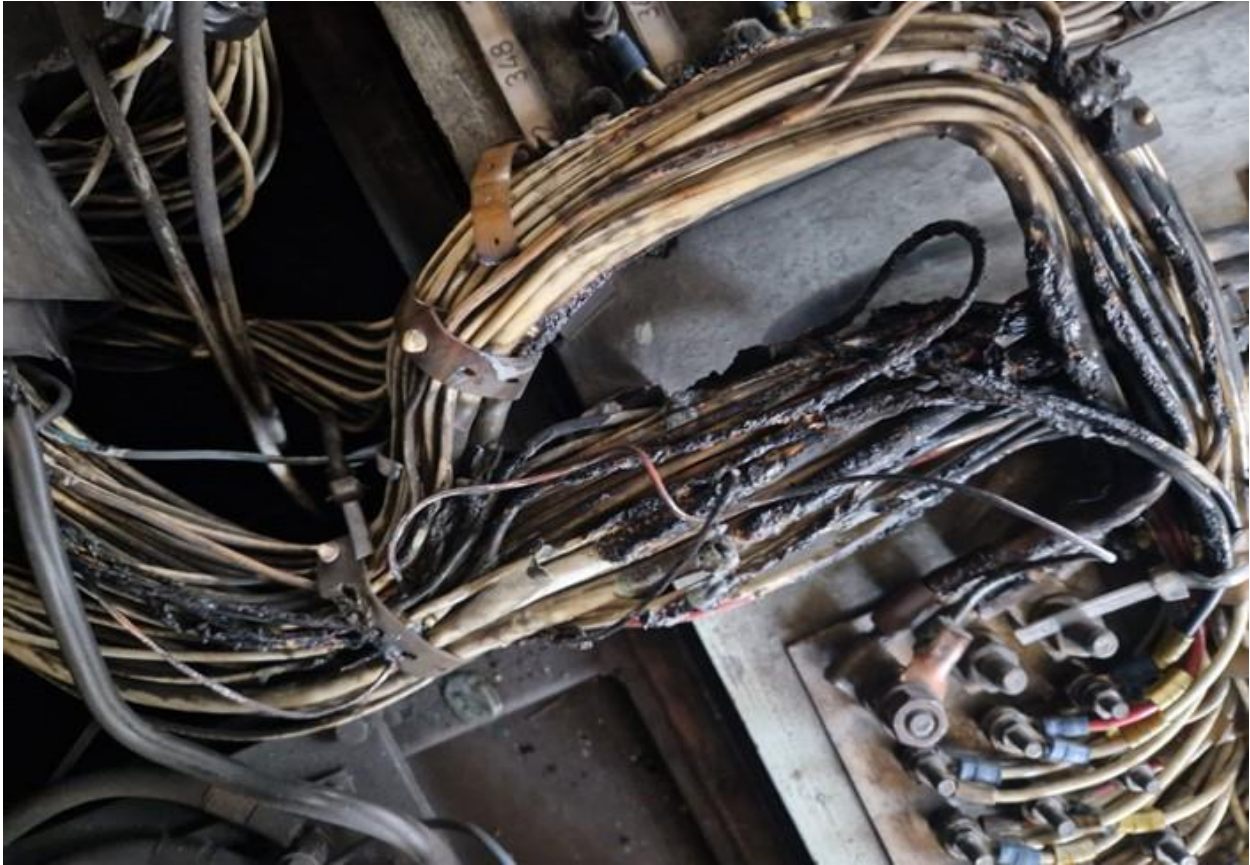
2. Occurrence of a short circuit in wire 870 – the main positive wire of the locomotive. As it can be seen from Fig. 4.16 there are burnt cables but not to the copper core. That was unlikely to be a possible cause of the locomotive fire. From the interrogation of the locomotive crew and the readings of the ammeter on the charger, the operating current was about 40A. The ammeter remained in that state. It was too large to power the locomotive's operational circuits with a voltage of 48V.

**Fig. 4.16. Burnt cables on conductor 870.**

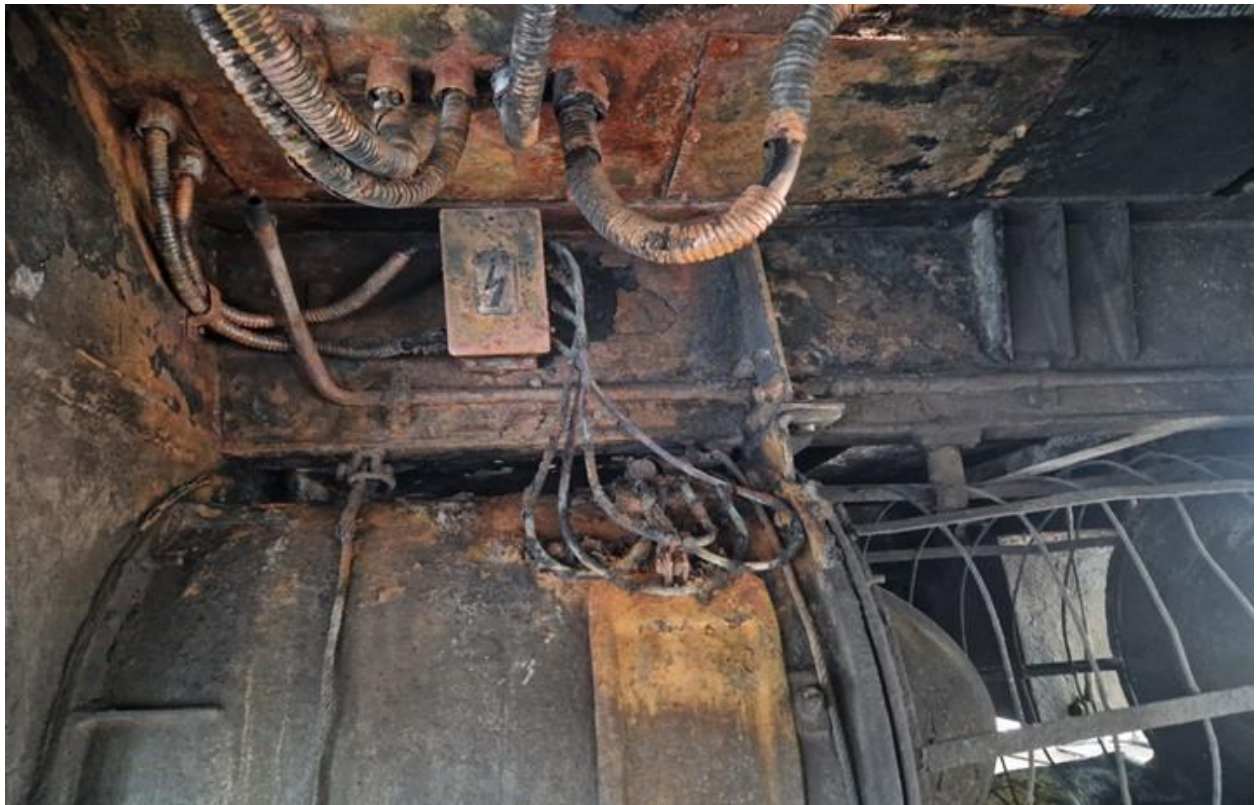
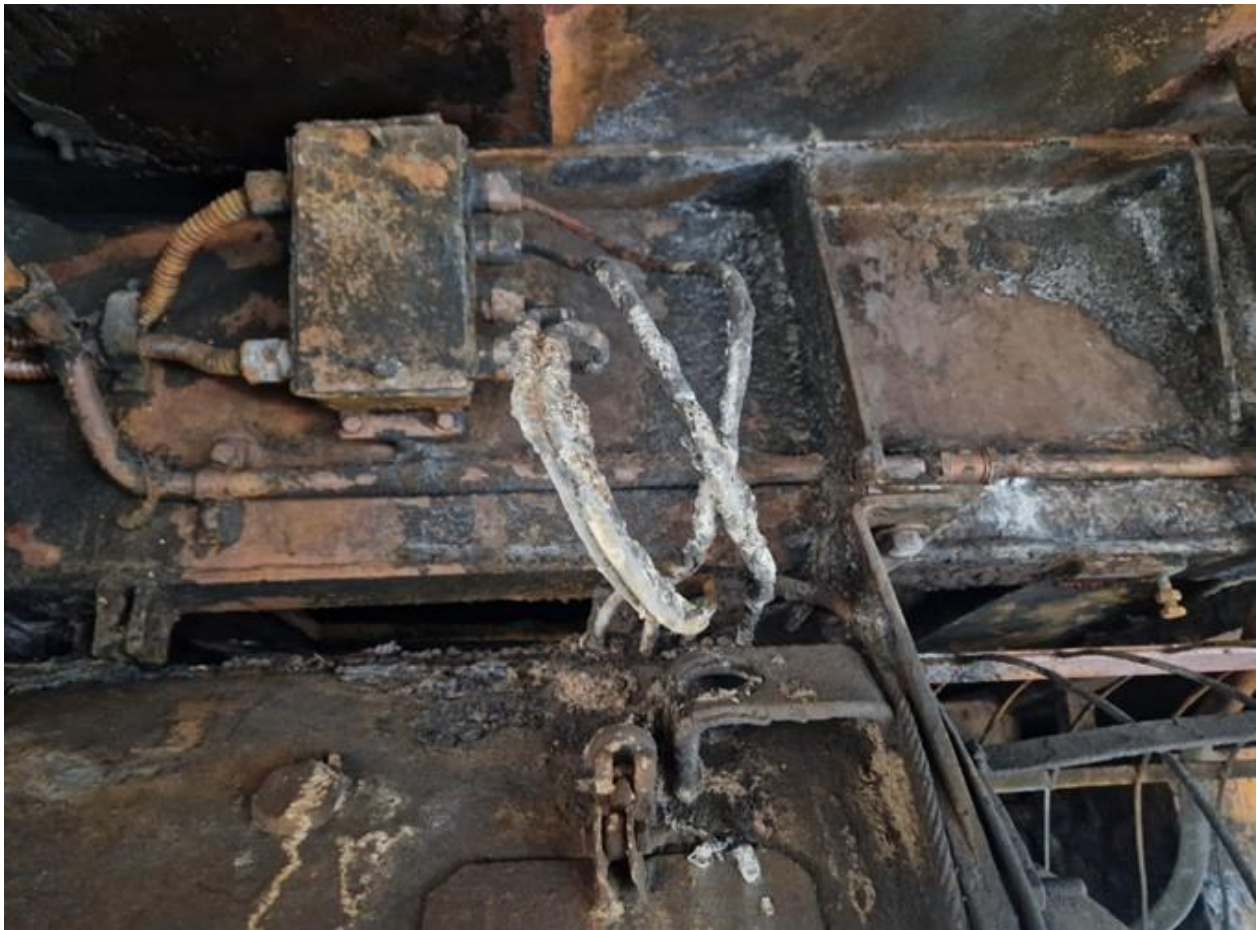
Figure 4.17 and 4.18 shows completely burnt insulation of the power cables which, through a terminal box, supply power to the under-basket fan motor 231 for cooling the rectifier unit.

**Fig. 4.17. Power supplying cables on the engine-fan, supplied by the terminal box.**

**Fig. 4.18. Power supplying cables of first under body shell engine fan.**

- Recommendation 6 proposes that BDZ PP EOOD place the power cables for supplying the under-carriage motor fans in metal corrugated pipes;

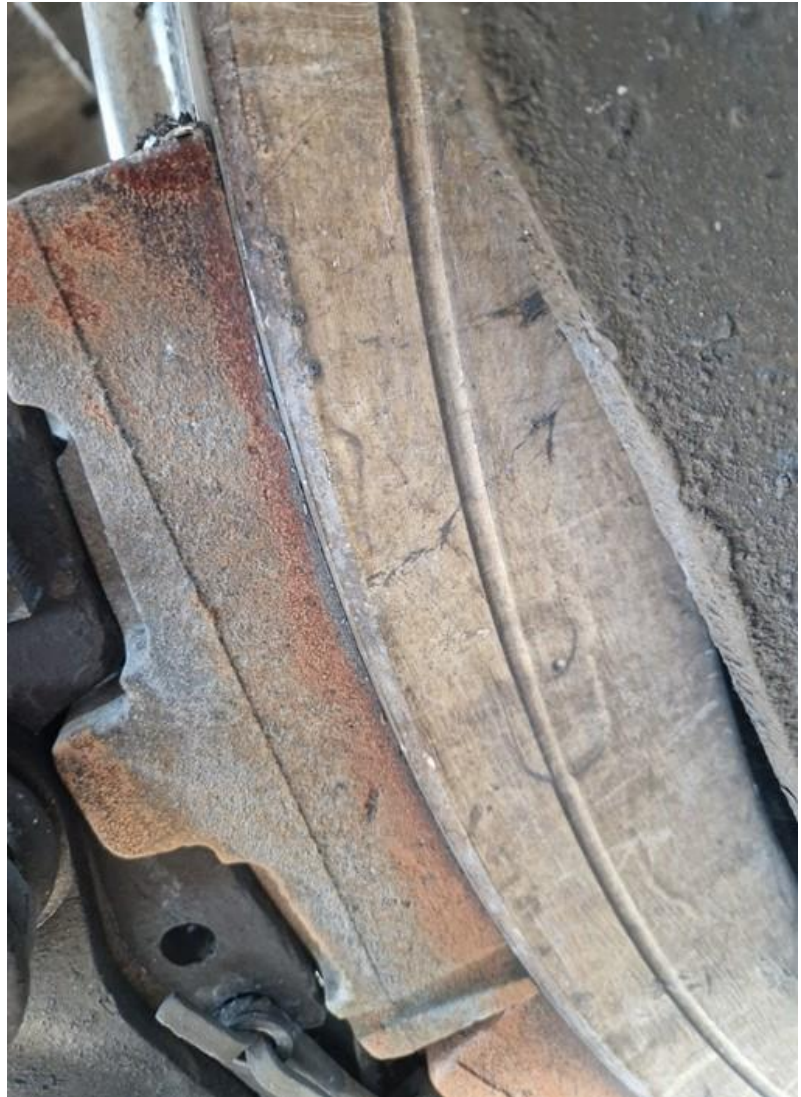
**The second cause** is more likely. When the locomotive was moving by inertia, it stopped with its pads, as seen in Fig. 4.19. They were slightly gray. As it can be seen from the figure, the bluing is in the middle, which makes it possible to assume that the pad did not contact the entire surface. Most likely, it sparked.

On the ceiling of the locomotive's body shell, dust often accumulates, and under the transformer and around the under-carriage fans with an admixture of oil. It is highly flammable. As it can be seen from Fig. 4.19, the power cables were not placed in a metal corrugated pipe, the power cables to the box were placed in metal corrugated pipes. As a result of sparking of the pads when the locomotive stopped, it led to the ignition of the accumulated oil dust. The power cables of the first undercarriage engine fan have collected enough oil dust. As the driver explained, he saw a flame from there. Thanks to their intervention and the quick arrival of the fire truck, the damage to the locomotive is minor.

**Fig. 4.19. Condition of the locomotive pad.**

- Recommendation 5 proposes that BDZ PP EOOD retrofit the traction rolling stock with composite or sintered brake pads in order to prevent sparks, which leads to a reduction in harmful emissions into the air and noise during movement;

- Recommendation 7 proposes that BDZ PPEOOD regularly clean the deposits under the traction transformer and the locomotive body shell during locomotive repairs.
