**Joint Network Secretariat
Urgent Procedure Task Force
Broken wheels**

**Agreement of the TF on
short term mitigation measures**

28th July 2017

Task Force Broken wheels – Proposal Short Term measures Summary

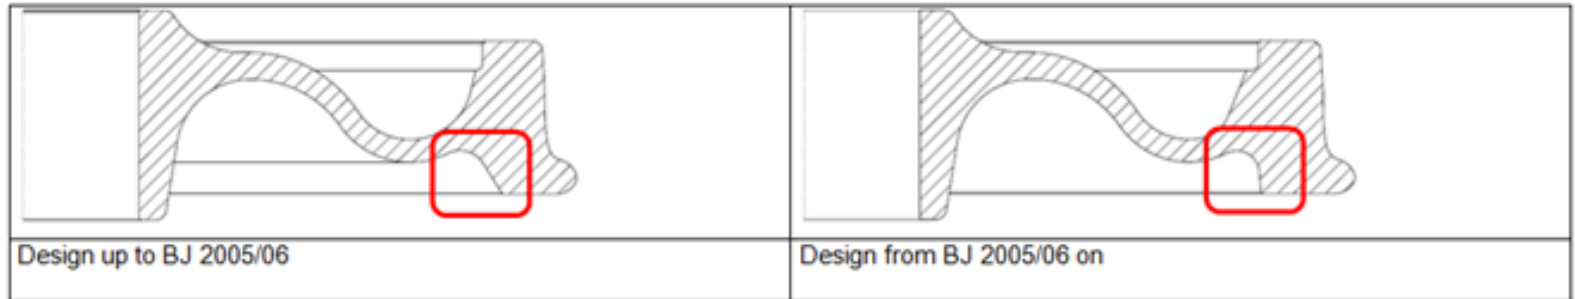
ZDB 29 Designs

The wheel types BA 314 / ZDB 29 were produced in two versions.

The new version (build after 2006) was up to now **not** affected by relevant failures and can therefore be excluded from the special measures for wheel types BA 004 and ZDB 29 / BA 314.

Wheelset type 314 / ZDB 29 with a slope under the wheel flange (probably produced until 2005/2006)

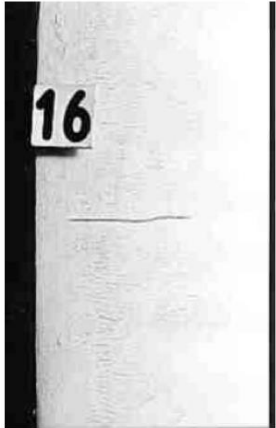
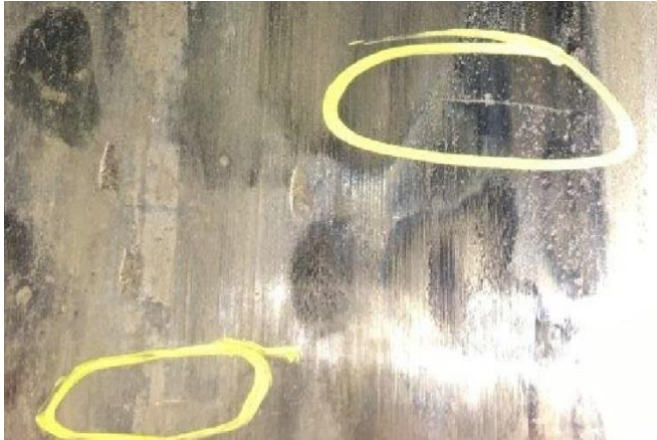
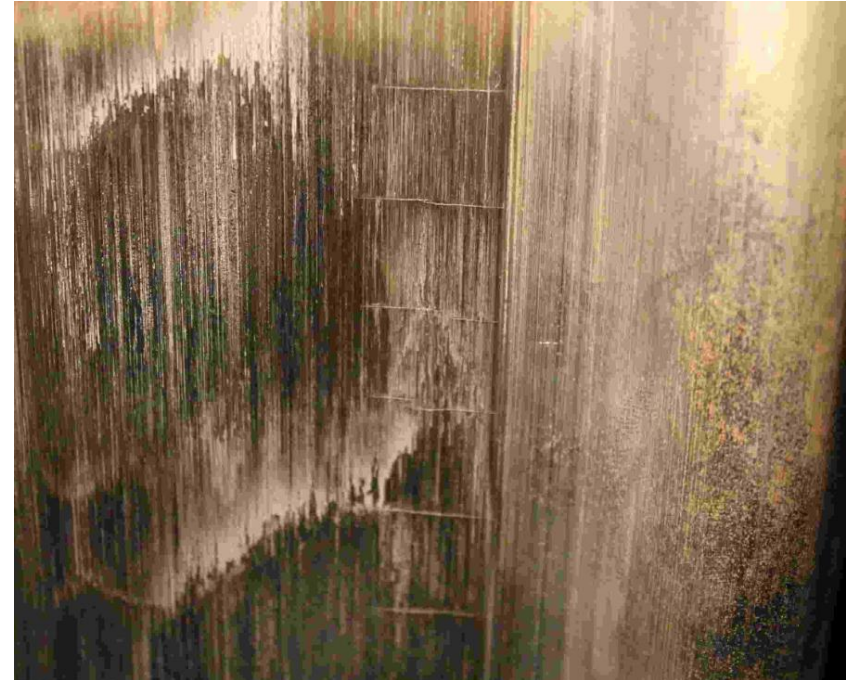
Description: The tread exhibits cracks at an angle of approximately 90° to the circumference of the wheel and have a typical length of 30mm or more. Transverse cracks generally develop at the surface in either straight or slightly crooked lines and can penetrate radially (usually of thermal origin in these cases) or branch out in a circumferential direction (usually of mechanical origin in this case). They occur individually and can be distributed at several points around the circumference. [EN 15313, §C.2.6]

Transverse crack revealed by magnetic particle testing [EN 15313, §C.2.6]

* single cracks on the wheel tread ("isolated transverse cracking" cf. EN 15313 §C.2.6 and 6.2.3.4) – Criteria: see slide 8

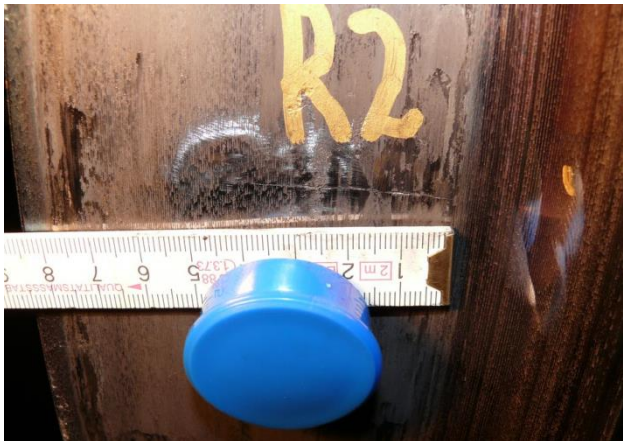
Example for single cracks on the wheel tread by visual inspection

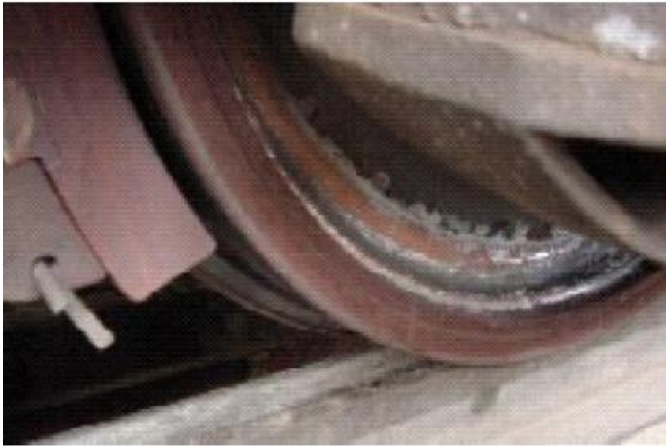
Description: This type of defect occurs only in tread-braked wheels. When suitable coatings are used, the paint becomes clearly burnt in the rib/web transition radius when the temperature exceeds approximately 300 °C. The paint in this area then becomes cracked and peeling. The brake blocks are often melted to some extent. Build-up of metal and characteristic colouring can be seen on the tread. The rim may also become a bluish colour.

If the problem is not detected immediately the rim/web transition can gradually assume a rusty appearance with shades between greyish-brown and brown covering the whole circumference. [EN 15313, §C.3.2.2]

Overheating affecting the wheel rim/web transition [EN 15313, §C.3.2.2]

** any indication of thermal overload of the wheel (burnt paint, excessive wheel deformation, cf. EN 15313 §C.3.2.2 and 6.2.4.3) – Criteria: see slides 9 and 10

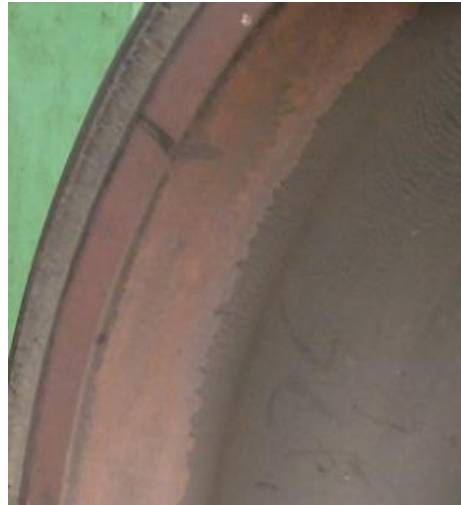
Old and fresh burnt paint

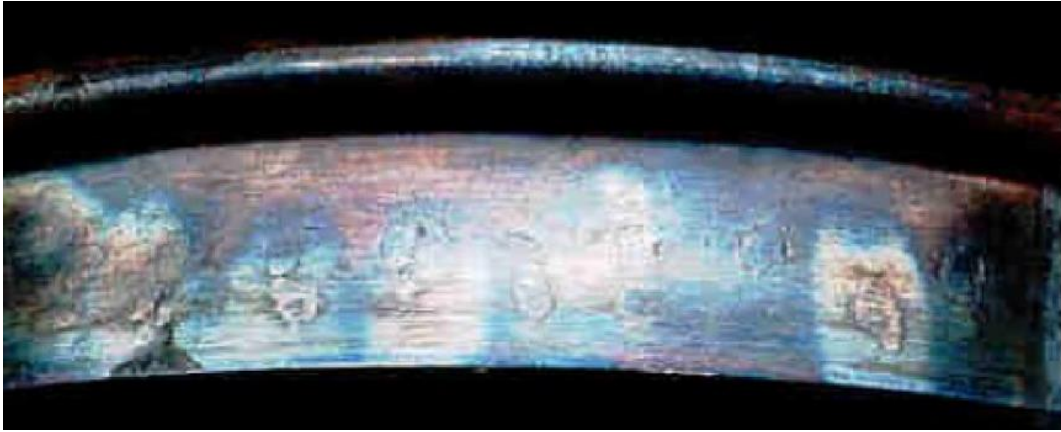
colouring on the tread
