Joint Network Secretariat

Normal Procedure Task Force

Broken wheels

Final output

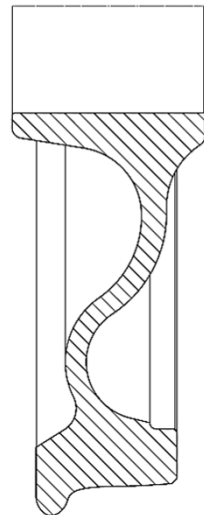
crack in the web

BA314 / ZDB29 (with a slope under the wheel flange)

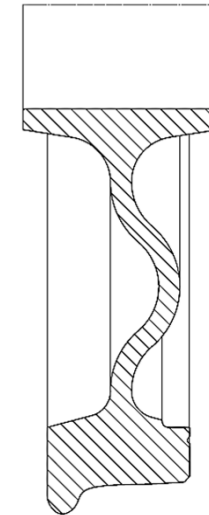
crack in the rim

BA 004

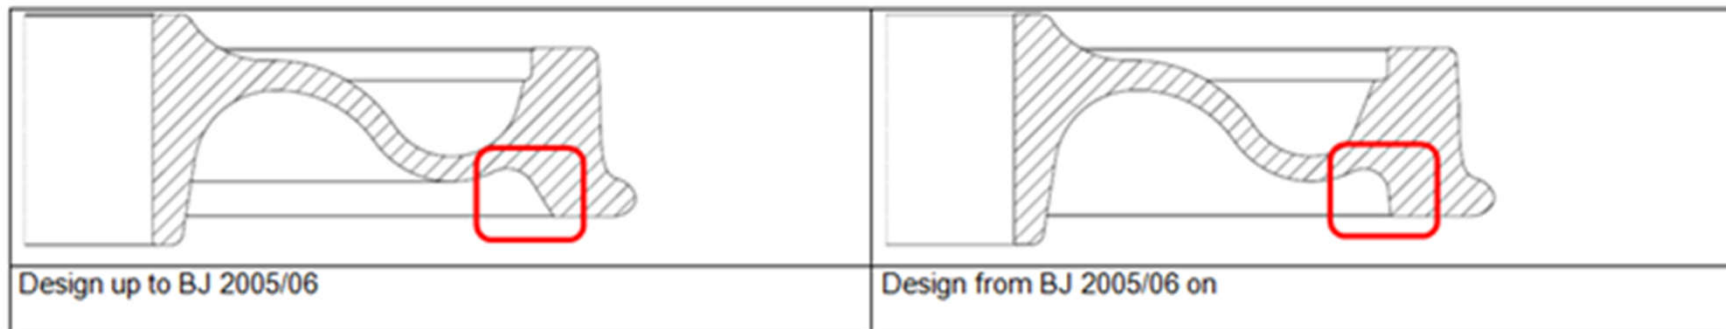
Wheelset type BA 314 / ZDB 29 with a slope under the wheel flange (probably produced until 2005/2006)

The new version (build after 2006) is **not** affected by relevant failures and can therefore be excluded from the special measures for wheel types BA 314/ ZDB 29.

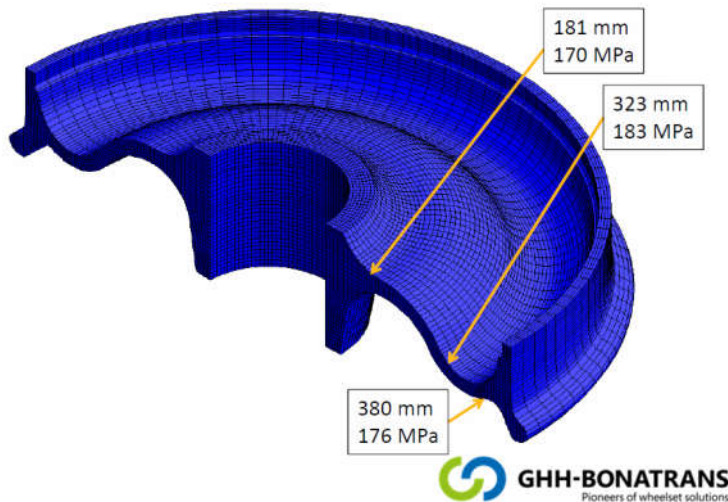
Wheel with slope - old design

- Position of critical point is in web on radius 323 mm on outer side.
- maximal stress amplitude in critical point of wheel web is 183 MPa.
- Stress amplitude in the area of crack (in inner side of web on radius 380 mm) is 176 MPa.

Conclusion: Change of design (without slope) reduces stresses in the web and in particular in the area of the crack initiation.

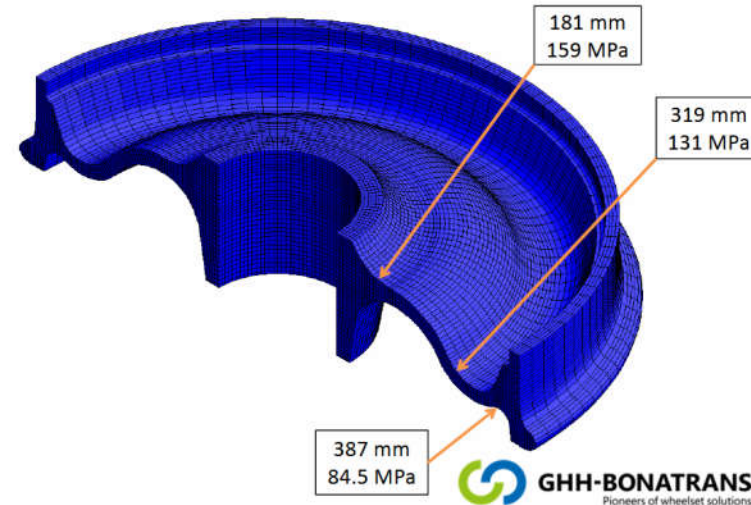
Wheel without slope – new design

- Position of critical point is in transition between hub-web on radius 181 mm.
- maximal stress amplitude in critical point of wheel web is 159 MPa.
- Stress amplitude in the area of crack (in inner side of web on radius 387 mm) is 84.5 MPa.

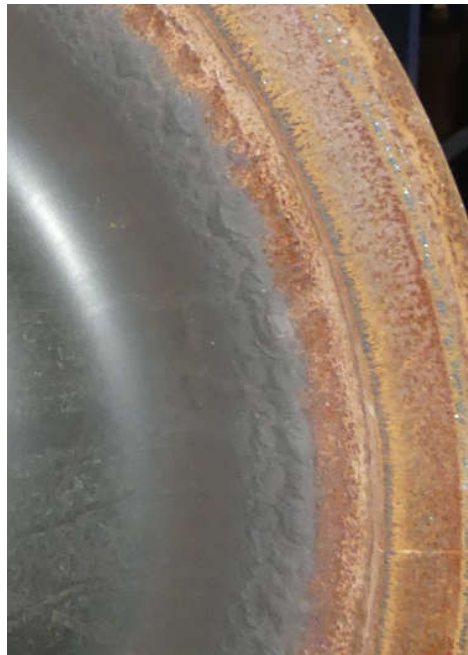
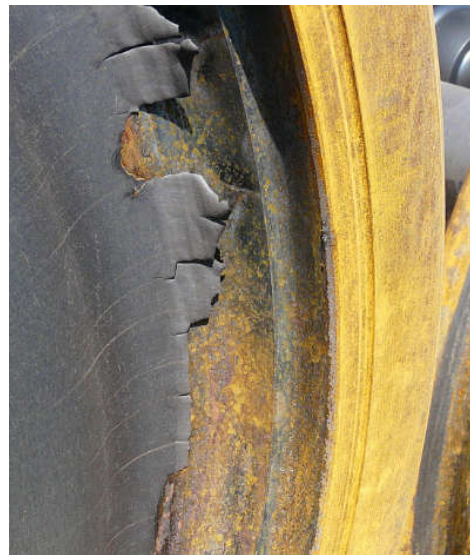
Paint shall be clearly burnt => paint in this area shall present cracks/ peeling / bubbles (no direct dispersion)

- Test with wheel accordance UIC 510-5 or metal plate heating up in furnace or burner
- Boundary conditions, like roughness and treatment of the wheel and thickness of the paint
- if needed: heating up ramp necessary (e.g. 15 min 200°, 15 min 250°, 15 min 300° with each 5 min heating up time)

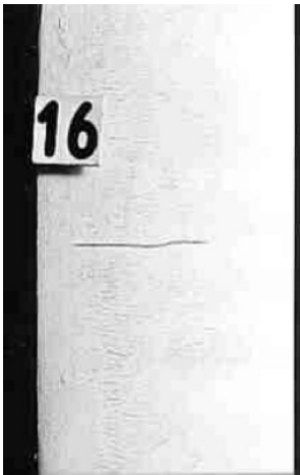
Description: The tread exhibits cracks at an angle of approximately 90° to the circumference of the wheel and have a typical length of 30mm or more. Transverse cracks generally develop at the surface in either straight or slightly crooked lines and can penetrate radially (usually of thermal origin in these cases) or branch out in a circumferential direction (usually of mechanical origin in this case). They occur individually and can be distributed at several points around the circumference. [EN 15313, §C.2.6]

Transverse crack revealed by magnetic particle testing [EN 15313, §C.2.6]

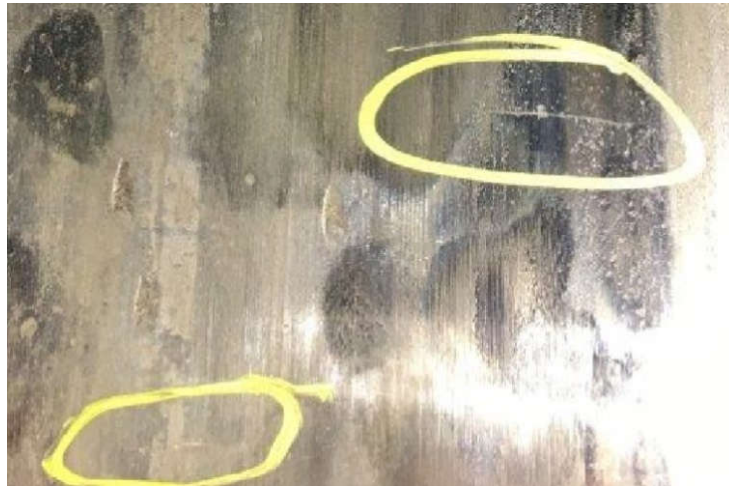
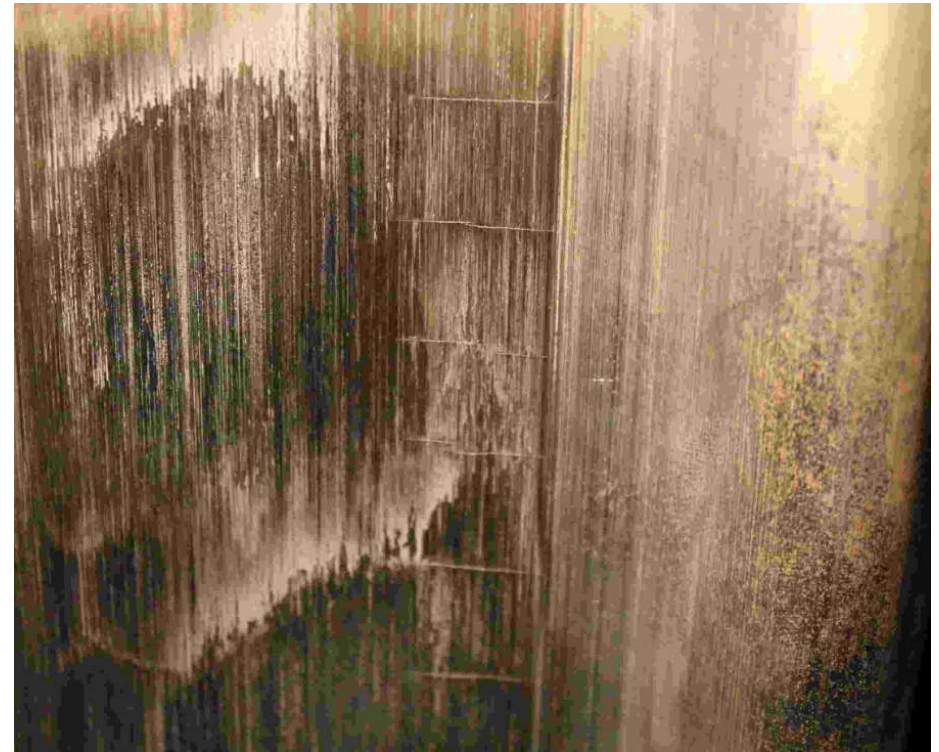
Example for single cracks on the wheel tread by visual inspection

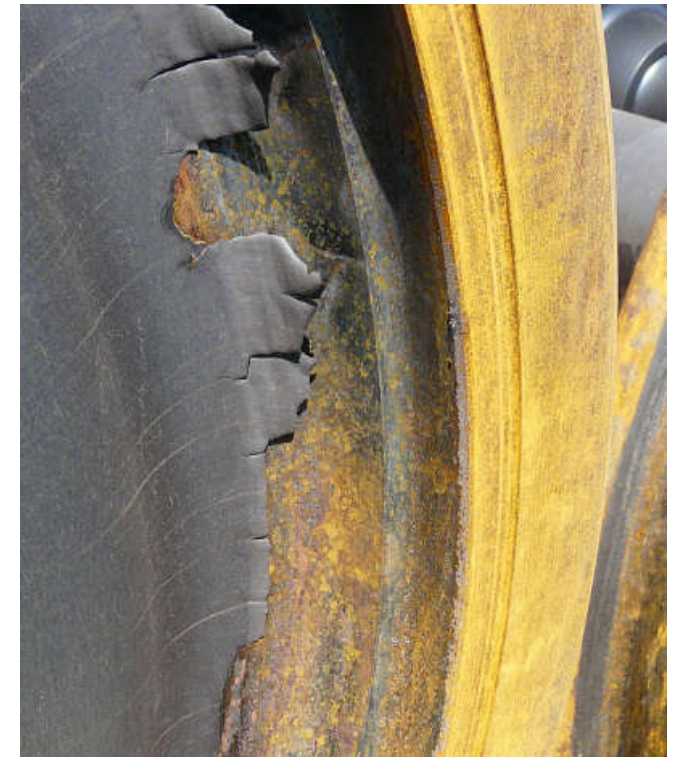
Flanging brake blocks may be an indication of thermal overload.

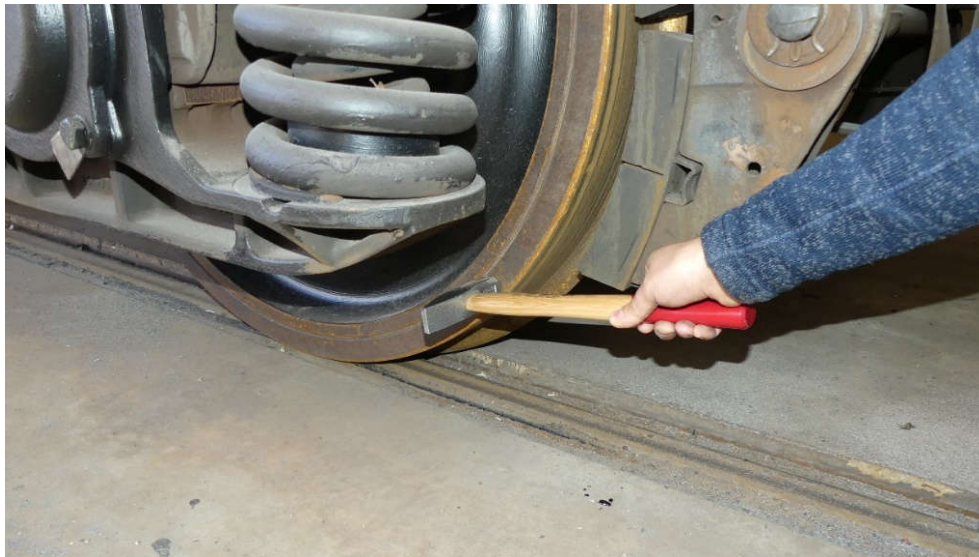
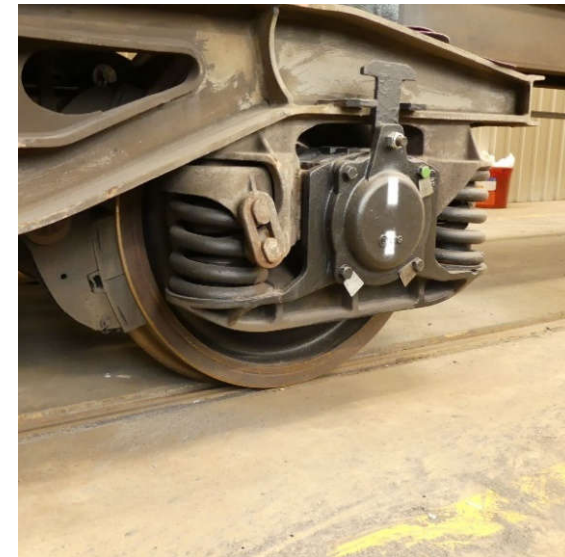
- The test on the 12 o'clock position (upper position of the wheel) sounds always thud/ damped.
- Wheelsets with applied brake blocks or not fully released brake blocks sound also thud/ damped. In this case the full release of the brake blocks has to be checked.
- In case of a thud / damped sounding wheel it is necessary to inspect the whole wheel more carefully.

Hammer/ sound test can be adapted in special cases as additional method to detect cracked rim/ broken wheels.
