TRANSPORTATION SAFETY BUREAU

# **FINAL REPORT**

# 2007-0462-5 RAILWAY INCIDENT

Kaba station 15 December 2007

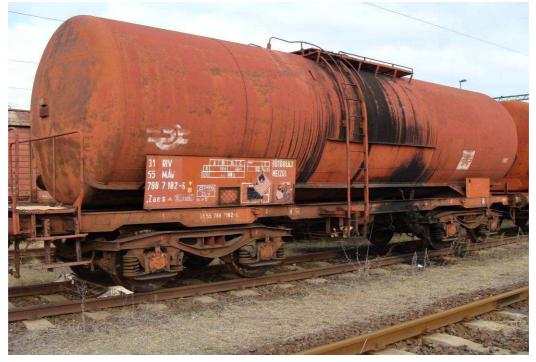
Figure 4: The wagon involved in the incident

Presumably between 14 hours 30 minutes and 15 hours 30 minutes on 15<sup>th</sup> December 2007, two children climbed up on top of the Zaes tank wagon (registration no. 31 55 788 7182 - 6) stored on track XII of the private-sidings at Kaba station. One of the children suffered an electric shock.

According to information received from Regional Centre of MÁV Zrt. Infrastructure Management, the wagon involved in the incident had been stored permanently on track XII of Kaba station for five years.

**BA2007-462-5-01:** In order to reduce the number of accidents in which the involved persons suffer electric shock as a result of climbing up on permanently stored wagons, the IC recommends MÁV Zrt. that these wagons should be stored on tracks without overhead contact lines or the contact lines should be off voltage. The wagons should also be kept at physically fenced off areas.

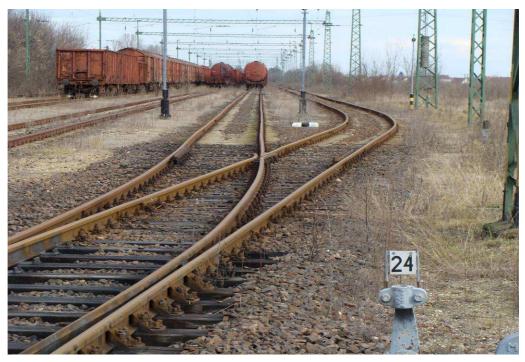
Figure 3: The site of the incident

Track XII. Of Kaba station is used to store freight wagons permanently. This track is not physically closed from unauthorised personnel.

It was established in the course of the investigation that the wagons permanently stored on track XII of Kaba station are out of use. The wagons on this track are only moved (by electric engines) once or twice a year.

Wagons stored permanently at the station are not closed off from unauthorised personnel.
