2008-201-5

On 8th May 2008, a passenger train collided with a car at an LC between Csorna and Rábatamási stations – at Farád stop. The LC was protected with warning lights and was operating normally. The driver of the car died in the accident.

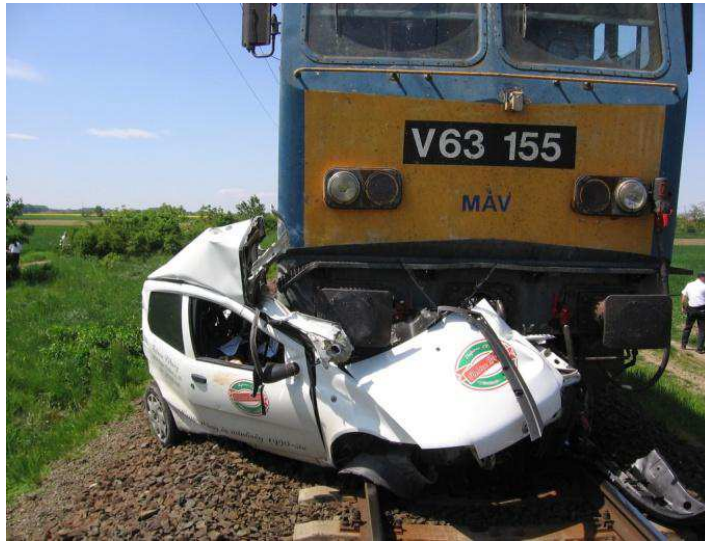
The LC's warning lights were operating normally and were clearly visible (from the road) at the time of the accident.

The accident occurred due to human factors; the car drove into the LC regardless of the Stop signal.

The so called „visibility triangle” was not ensured at the LC, however, the warning lights (indicating Stop) were clearly visible. This shall be taken into consideration as the lack of adequate „visibility triangle” at the LC increases danger. Therefore the LC should be secured by different methods/technical solutions.

The LC was protected as prescribed in the relevant regulations. Nevertheless, the degree and way of protection shall be reviewed considering transport safety aspects.
