MINISTRY OF TRANSPORT
ROMANIAN RAILWAY AUTHORITY – AFER
ROMANIAN RAILWAY INVESTIGATING BODY

INVESTIGATING REPORT

on the derailment of the freight train

no. 42612, belonging to the Romanian Railway Freight Company “CFR Marfa” SA

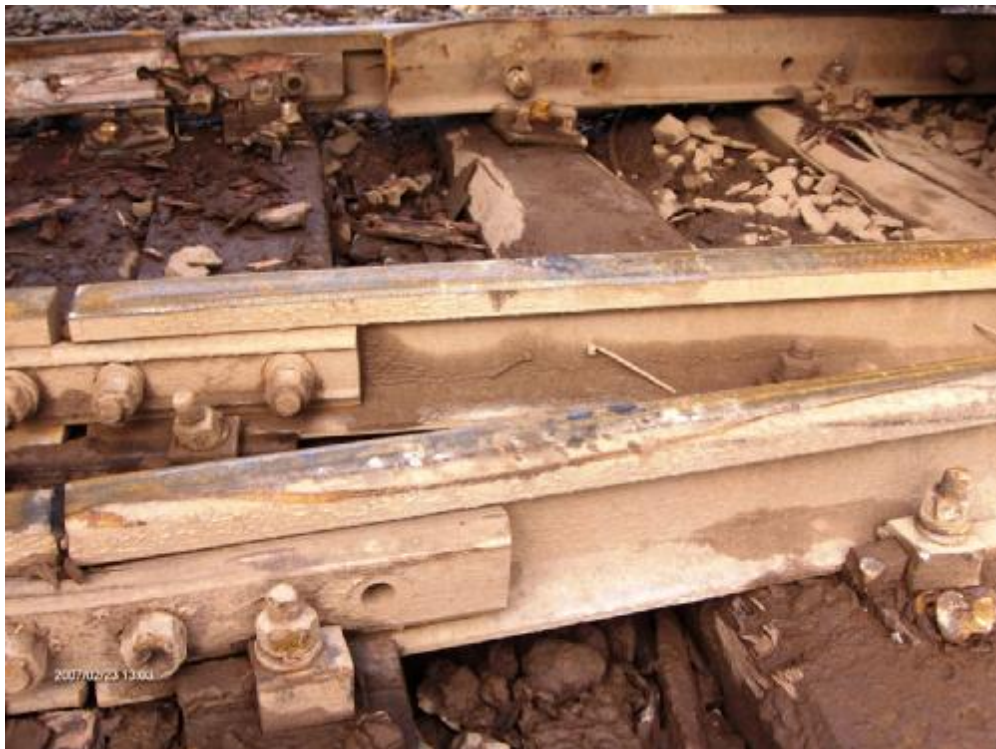
Figure 3 – Lingofolium joint destroyed

- because of the running of those 4 derailed wagons, the track was gotten out of shape, so that the following 4 wagons, respectively the wagons no. 51226074, 57655482, 57653420 and 57585952, derailed too, then the train braked because of the air losses in the main pipe, caused by the unbiding of the autocoupler.

- at wagons 217,91 lei representing the checking of those 8 wagons.
- at the track 196,81 lei representing the replacement of 2 lignofolium fish plates and of 3 wooden sleeper SB

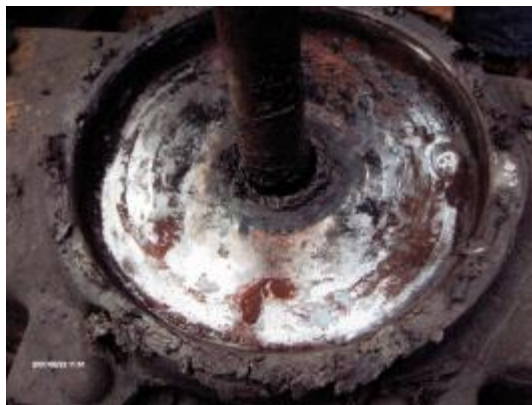
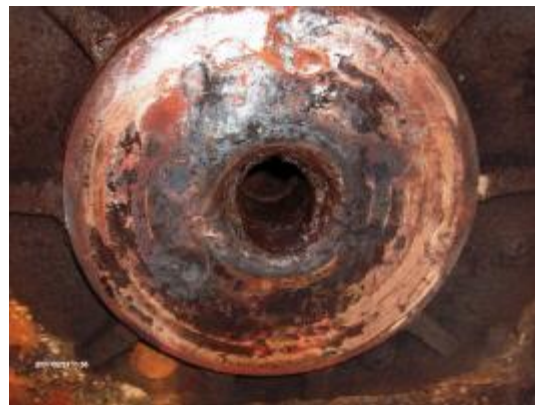
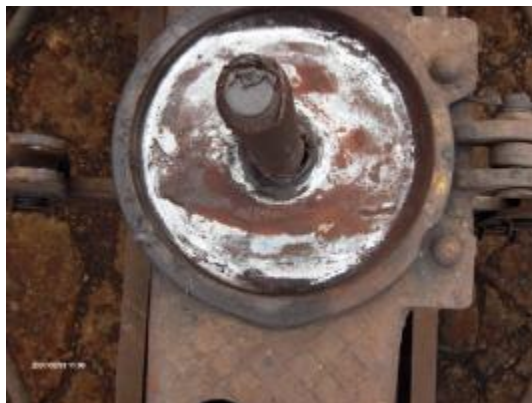
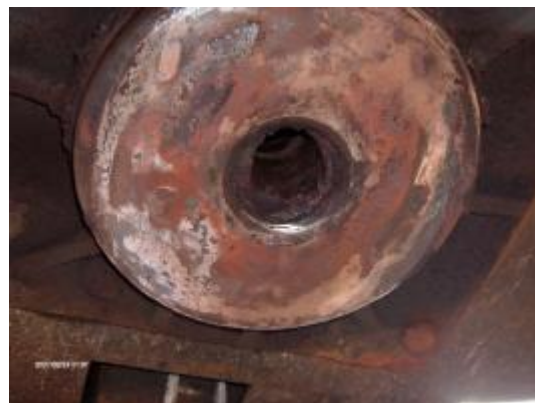
Figure 4 – The centre casting from the first derailed vagon

- plane centre casting without wear plate, with well marked traces of friction and lack of material (about 3 mm on 2 surfaces of about 40 x 50 mm) from the superior centre casting, and the shoulder of the inferior centre casting got out of shape about 5 mm because of the friction in the ribs of the superior centre casting to the left side of the direction of traffic.

- at the inferior centre casting there is a well marked contact surface of about 40x50mm, with depths of 2 -3 mm;
- vii. the centre casting ensemble from the second bogie in the direction of traffic:

- a. plane centre casting, without wear plate, with well marked traces of friction and with a burrs of about 40 mm and with a depth of 5 mm (without to specify where);

- b. wears in the superior centre casting of about 2 mm to the right side of the bogie frame;

- i. lack of lubrication at the centre casting. So the Ukrainian regulations concerning the lubrication with graphite vaseline YCca ГОСТ 3333 – 80 (or substitutes, that is vaseline with 10% graphite or vaseline processed ЛЗ – ЦНИИ) of the centre casting ensemble at the placing of the bogie under the wagon were not complied with;
- ii. the tyre breadth from the first bogie wheels of the wagon was 130 mm, with 3 mm under the minimum value stipulated in the annex 5, point 2.3 from PPV.
- iii. the clearances at the friction stones on the diagonal of the wagon were 0.

The conclusion of this theoretic study is that between the lubricated centre casting and the non lubricated centre casting, the control force P1 increase with 6,03% and the safety coefficient against the derailment (Y/Q report) increases with 0,02, so one can establish that the non lubrication of the centre casting is a favoring factor and not a direct cause of the wagon derailment.
