**MINISTRY OF TRANSPORT,
INFORMATION TECHNOLOGIES AND COMMUNICATION**

**SPECIALIZED UNIT FOR INVESTIGATIONS OF ACCIDENTS AND INCIDENTS IN
RAILWAY TRANSPORT**

FINAL REPORT

**a railway accident investigation - a collision between diesel locomotive № 07065 and Rail
Maintenance Car-33 in Kaspichan station on October 14, 2019**

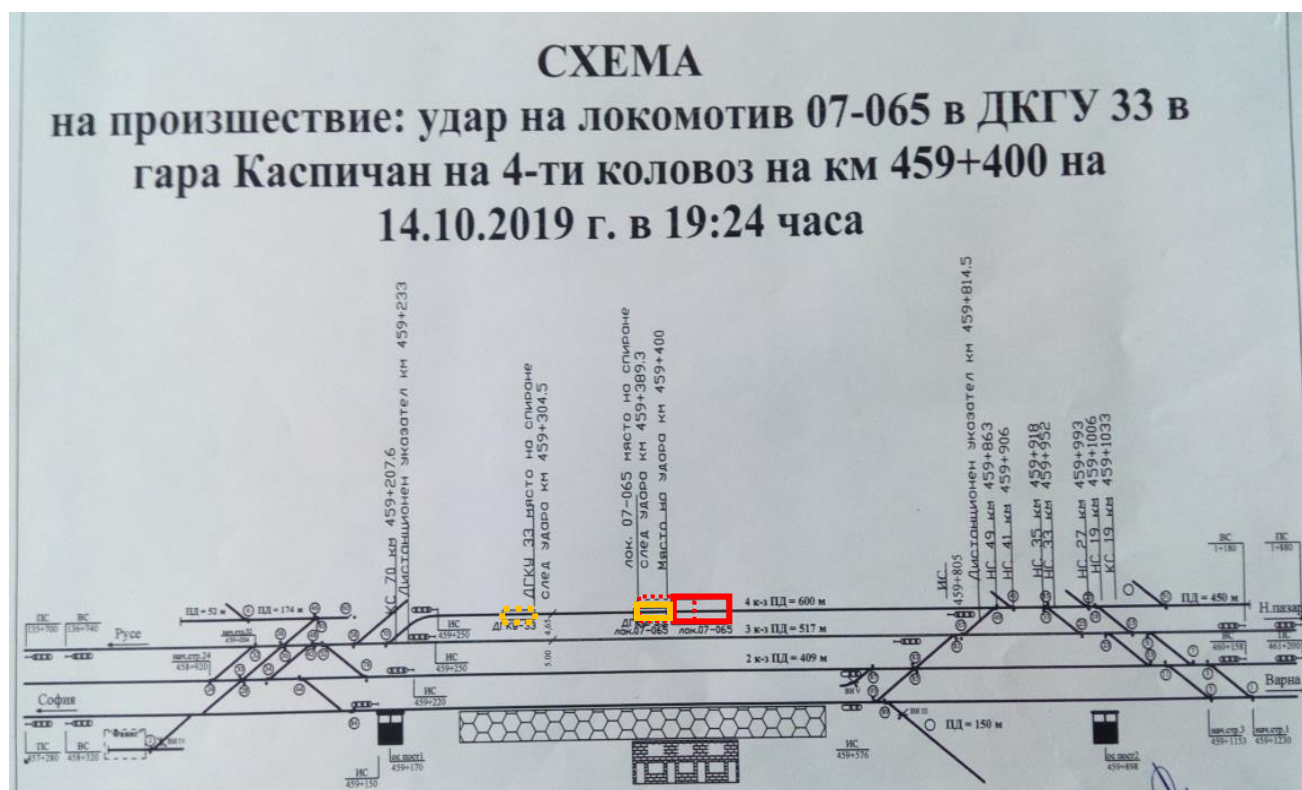
Fig. 1

The main reason for the accident is the peculiarity in the control of locomotive № 07065 from the rear cabin, which limits the visibility of the locomotive brigade, thus they have not seen the Rail Maintenance Car-33 which has been stopped on 4-th track and subsequently they have hit at the speed of 21 km/h.

- the location of locomotive 07065 at the moment of impact;
- the location of locomotive 07065 after the impact;
- the location of Rail Maintenance Car-33 at the moment of impact;
- the location of Rail Maintenance Car-33 after the impact.

1. It is proposed to the railway enterprises BDZ Freight Transport EOOD and SE NRIC to familiarize the personnel directly engaged in OMT, operation, station and maneuvering activities with the contents of the report by an extraordinary briefing.

2. It is proposed to BDZ Freight Transport EOOD to issue a motorman license indicating the railway infrastructure for which he has been certified and the rolling stock entitled to drive in accordance with the requirements of Directive 2007/59 / EC.

3. It is proposed to SE NRIC to update "Instruction № 13 / June 29.2006 for joint work between Kaspichan Station and Kaspichan OP" when moving locomotives from the post to the station and vice versa.

4. It is proposed to BDZ Freight Transport EOOD to supplement the "Rules for the management of the transport activity in the transport planning and operational management" in Section VII "Operational interaction in the transport management " with a text obliging the operational sector in OMT to pass the operational decisions to the immediate contractors.

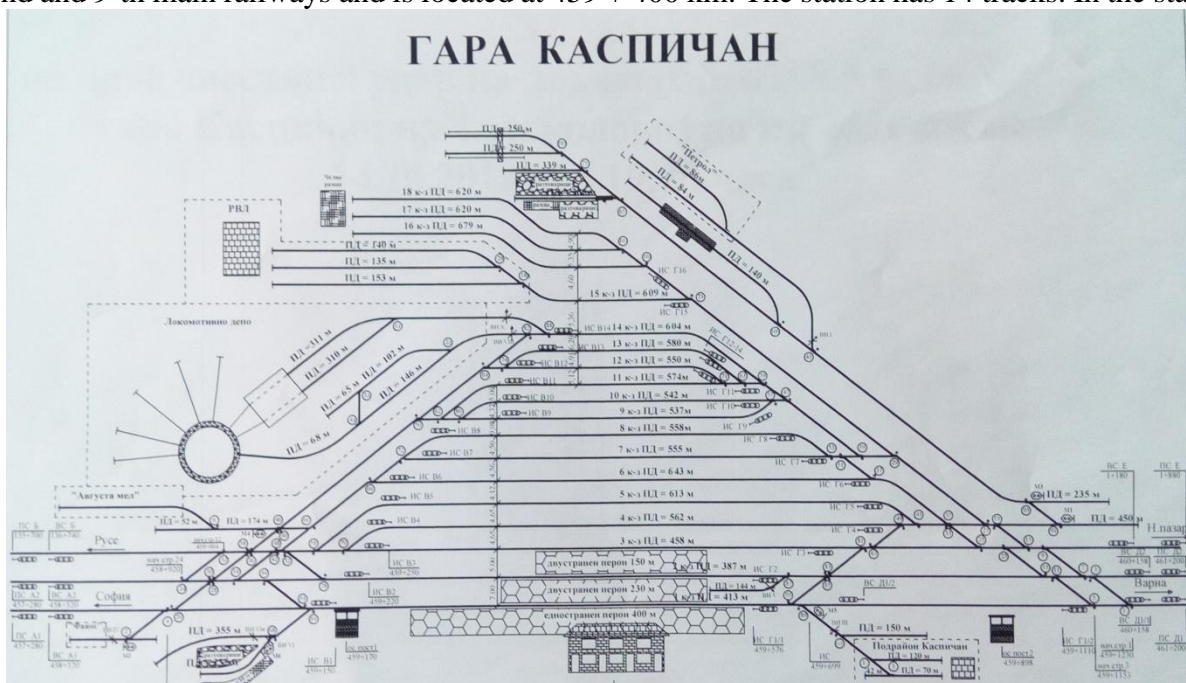
Fig. 2. Scheme of the tracks at Kaspichan station

The event takes place on 4th track in Kaspichan station. Kaspichan Station is a hub for the 2nd and 9-th main railways and is located at 459 + 400 km. The station has 14 tracks. In the station

there is an outfit post for locomotives of BDZ Freight Transport EOOD (Fig. 2).

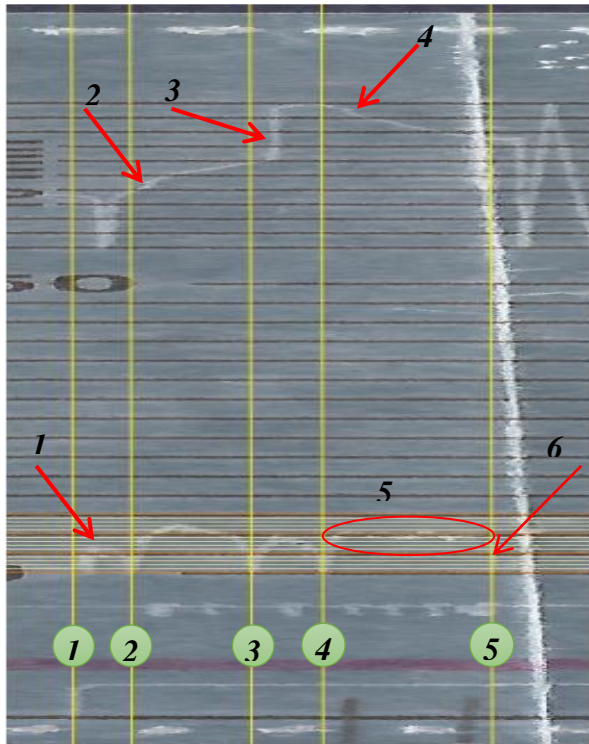
Fig. 8.

- 2 Markers;
2. Positions.

ready to move in either direction (Sofia or Varna) (Fig. 8, pos. 1, from marker 1 to marker 2). At 19:15 hrs it is handed over by the depot master of OP Kaspichan to post № 1 of Kaspichan station for its exit on a station track (Fig. 5, Fig. 6). After a stay of 30 seconds (Fig. 8, pos. 2) and a signal from the post switchman at post № 1 and at 19:14 hrs locomotive № 07065 moves along 14th track to its exit signal in the direction of post № 2 (Fig. 7 from position B to position C), reaching up to 24 km/h and traveling 450 meters (Fig. 8 from marker 2 to marker 3). At 19:15 hrs, the locomotive stops and stands at a forward distance on 14th track for 3.5 minutes (fig.8, pos. 3). About 20 seconds before 19:20 hrs, it moves off (Fig. 7, from marker C to marker D), accelerates to 20 km/h and stops 20 seconds after 19:20 hrs, traversing 270 meters (Fig. 8, from marker 3) to marker 4) to turn point № 27 and change the direction of movement. After a stand of about 20 seconds - a time that is not enough to change the cabin, (Fig. 8, pos. 4) the locomotive re-starts (Fig. 8, from marker 4 to marker 5), and very quickly (for about 50 meters) reaches a speed of 21 km/h, at which it moves approximately 100 meters, then decreases to 19 km/h and traverses at about 50 meters, accelerates again to 21 km/h, traverses 50 meters, decreases to 18 km/h, traverses 100 meters, accelerates to

21 km/h, traverses 100 meters, decreases to 16 km/h, accelerates to 20 km/h (Fig. 8, pos. 5) and after passing 120 meters at 19:23 hrs drops sharply from 20 km/h to 0 km/h, the chart speed is strictly vertical with no trace of heel due to a retention of the brake of the locomotive (fig. 8, pos. 6), i.e. this is the moment of the impact of the locomotive in the standing Rail Maintenance Car-33. This is evidence that the motorman of locomotive № 07065 has not taken any action to reduce the speed and has not held any of the brakes of the locomotive, in other words, he has not seen the stopped Rail Maintenance Car on 4-th train track until the last moment. This can only be due to the complete lack of visibility in the direction of movement, i.e. or there has been a total darkness over the station, which is not the case according to the witnesses, or both motormen have not been in the forward-facing cabin and have not seen at all the standing on 4-th track Rail Maintenance Car-

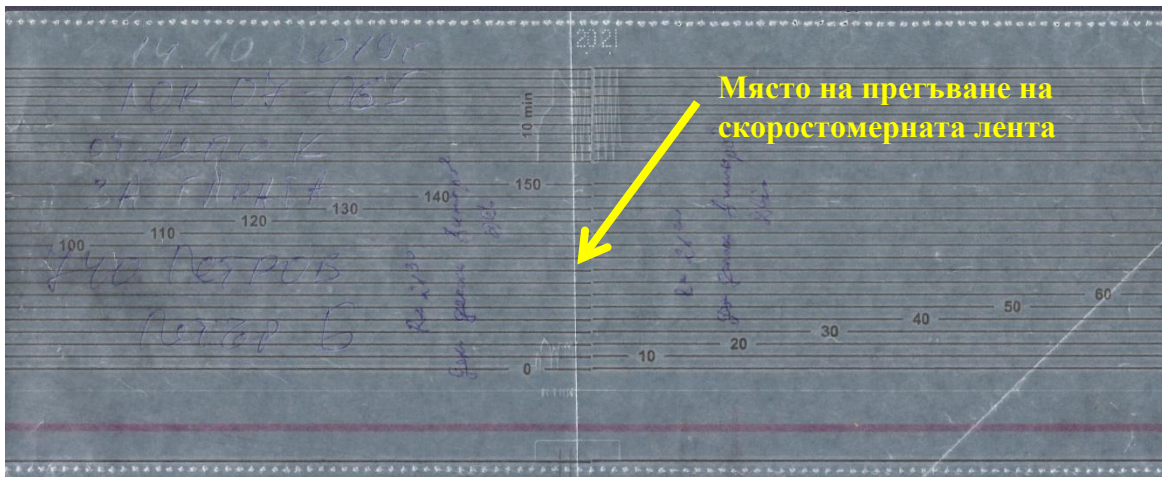
Fig. 9.

33. The speed tape of locomotive № 07065 is folded exactly at the stop point of the locomotive, which made it extremely difficult for the experts to decipher and analyze the locomotive's movement (Fig. 9).

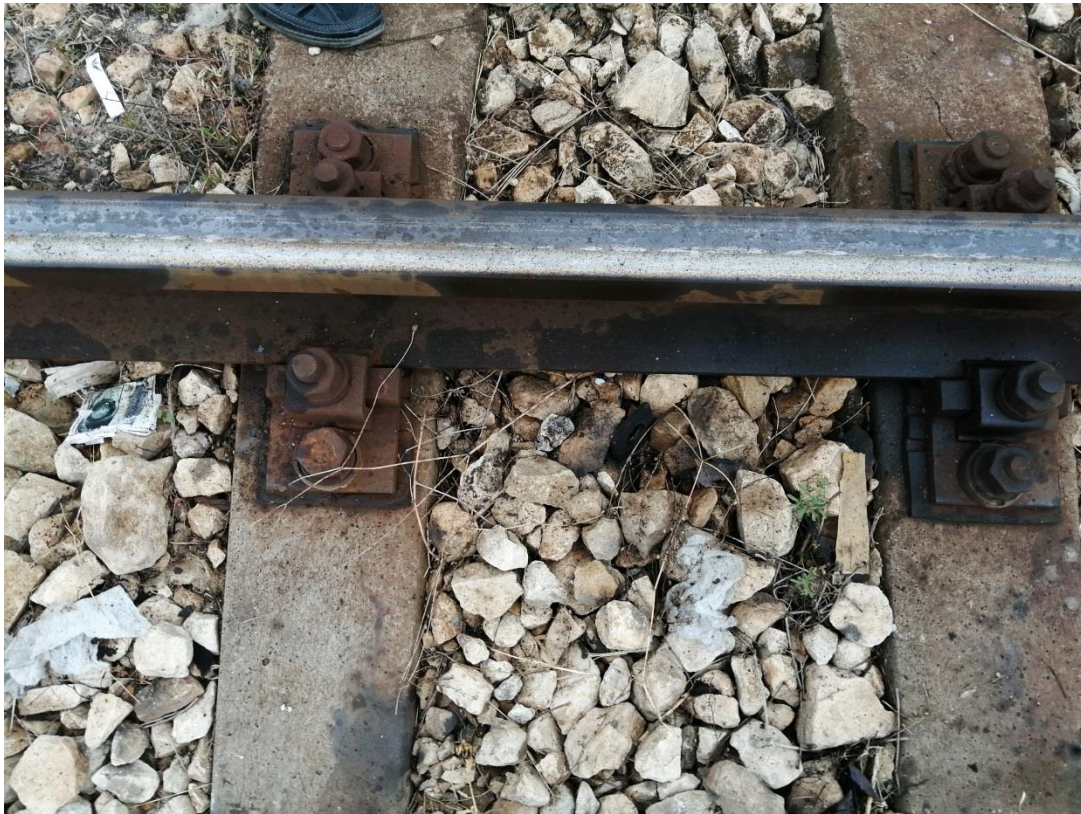
Fig. 12.

- Rail Maintenance Car-33 is parked on 4-th track of Kaspichan station, opposite the reception building. The machine has stood on a hand brake applied (confirmed by the tracks left by the wheels of the vehicle sliding on the rails after the impact - Fig. 12), as according to its motormen, Rail Maintenance Car-33 has been parked with over-buffer lights on, but according to oral indications to other duty officers this is not true;

- The motorman assistant of Rail Maintenance Car-33 motor tractor, seeing the approach of the locomotive and having been informed that both vehicles will travel together to Sindel-distribution station, exits the control cabin of his machine and stands on the platform under the crane system, getting ready to hitch to the approaching locomotive. After finding that locomotive № 07065 is not slowing down, he starts shouting and waving his hands instead of giving a stop signal with an electric torch and a pocket whistle;
