Number.: 375-11/2009/20

Date: 28 August 2009

FINAL INVESTIGATION REPORT INTO A RAILWAY ACCIDENT – THE COLLISION OF MAINTENANCE TRAIN NO. 90433 WITH TMD-44 MOTORISED RAIL VEHICLE (DRAISINE) ON THE CLOSED GROSUPLJE – KOČEVJE RAILWAY LINE

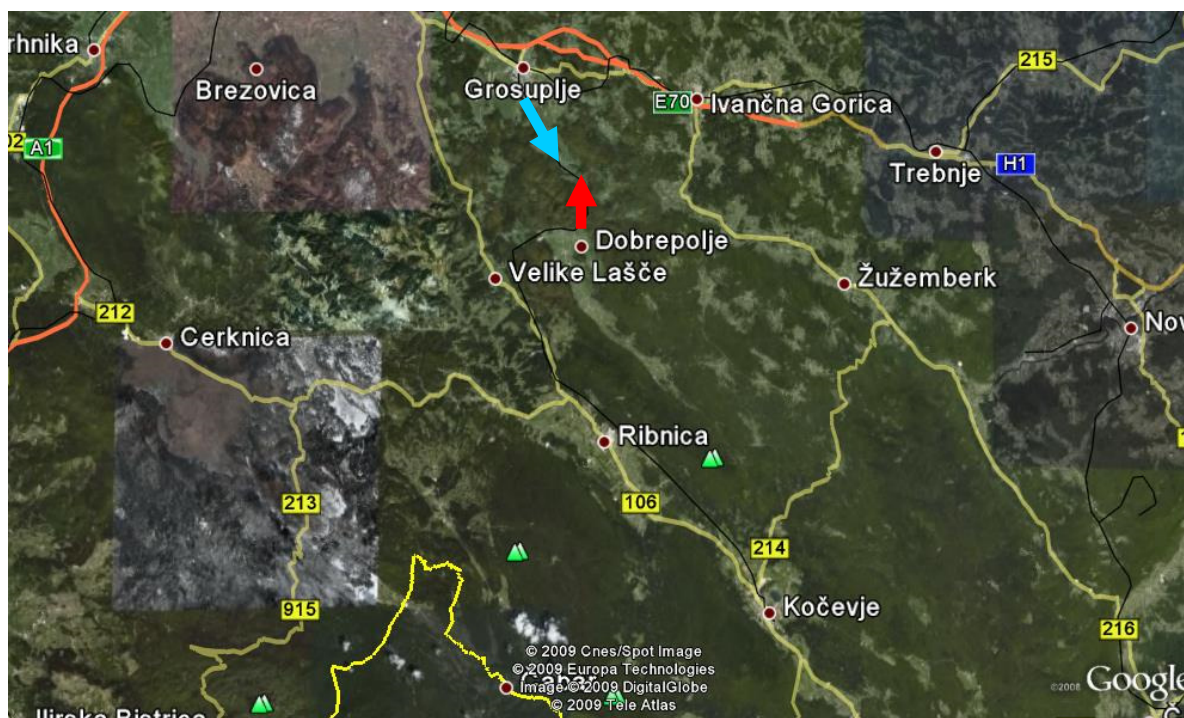
On 11 March 2009 at 14:04, there was a head-on collision involving maintenance train no. 90433 and motorised rail vehicle (draisine) TMD-44 on the closed, single-track Grosuplje – Kočevje railway line.

Maintenance train no. 90433 was travelling from the direction of Grosuplje towards a working site located on a closed railway line, while motorised rail vehicle (draisine) TMD-44 was travelling from the direction of the working site in front of the Dobropolje station towards the Grosuplje station. The maintenance train and the motorised rail vehicle (draisine) collided on the closed, single-track Grosuplje-Kočevje railway line, at km 3+480. The train and the rail vehicle collided at approximately the middle of the second left-hand curve of three bends, viewed from the direction of Grosuplje; given the shape of the land through which the railway passes, the first and the third left-hand curves are not at all clearly visible. The railway line was constructed at the foot of a hill rising, at the site of the collision, above the railway line at an angle of approximately 30°. The first right-hand curve preceding the site of the collision – viewed from the beginning towards the end of the railway line – from the direction of Grosuplje towards Kočevje, which is also the travelling direction of the maintenance train, has a radius of R-252 m, while the next left-hand curve the approximate middle of which is the site of the collision of the maintenance train and the rail vehicle, has a radius of R-209 m, and the next, third right-hand curve from which the motorised rail vehicle (draisine) was travelling, has a radius of R-221m. Because of the curves with such a small radius and on account of vegetation – the railway line passes through a wooded area in this section – the respective crews in the maintenance train and in the motorised rail vehicle (draisine) noticed the vehicle travelling from the opposite direction only moments before colliding.

Figure no. 1: Blue arrow indicating the travelling direction of the maintenance train, red arrow indicating the travelling direction of the motorised rail vehicle (draisine)

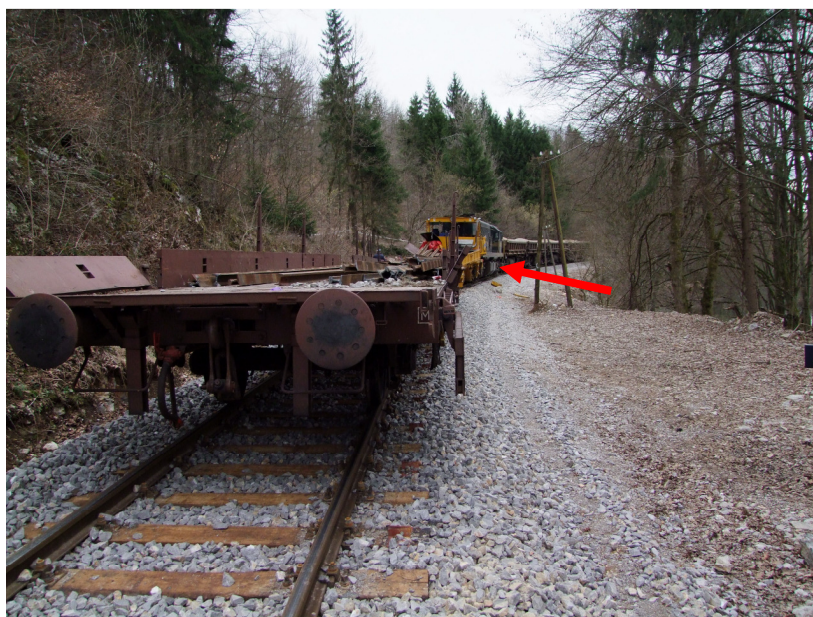
At km 3+480, maintenance train no. 90433 collided, at 14:05, with the oncoming TMD-44 motorised rail vehicle (draisine) that was returning to the Grosuplje station after loading tracks at the working site.

Figure no. 2: View of the place of collision of maintenance train and motorised rail vehicle (draisine), marked with red arrow

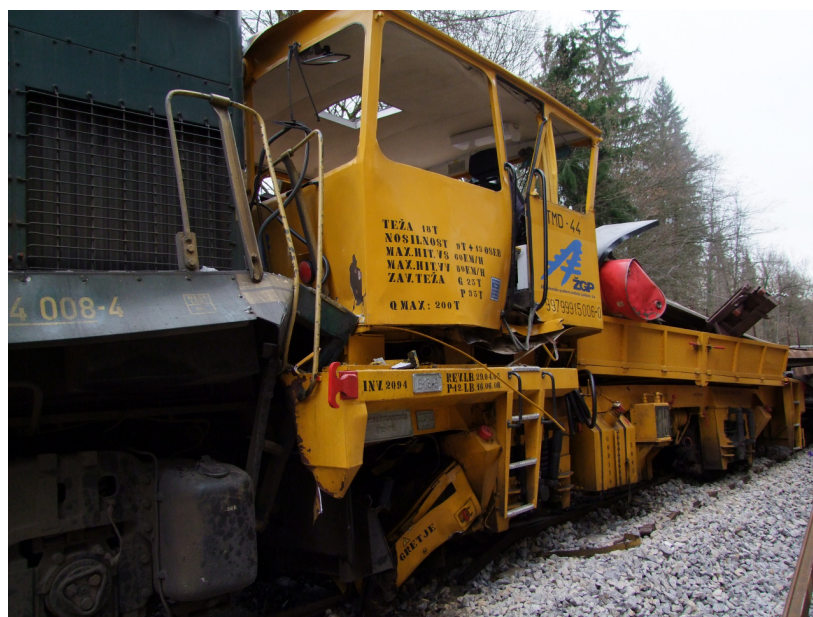
Damage occurred in the collision on the maintenance train locomotive, TMD-44 motorised rail vehicle (draisine) and both Kgs-z wagons. The maintenance train locomotive of the 644-008 series sustained heavy damage to its front, as did individual elements of the diesel engine. During the collision, the TMD-44 motorised rail vehicle (draisine) derailed with the second axle in the travelling direction; the vehicle was completely destroyed, the cab lost shape, longitudinal carriers bent, the loading surface lost shape and there were several motor oil and hydraulic oil leaks. The first wagon Kgs-z placed immediately behind the motorised rail vehicle (draisine) derailed with its first axle in the travelling direction. The wagon was greatly damaged; its front got raised onto the TMD-44 loading space. The second Kgs-z wagon's loading area is damaged as well as its front and sides.

Damage was caused to the locomotive of the maintenance train, the TMD – 44 motorised rail vehicle (draisine) and both Kgs-z wagons. The front of the maintenance train locomotive of the 644-008 was badly damaged as well as individual elements of the diesel engine. The motorised rail vehicle (draisine) TMD – 44 derailed during the collision with its second axle facing the travelling direction; the vehicle is totally wrecked, the driver's cab lost its shape, longitudinal carriers are bent, the loading surface lost its form, motor oil and hydraulic oil are leaking from the vehicle at several spots. The first Kgs-z wagon placed immediately behind the motorised rail vehicle (draisine) derailed with the first axle facing the travelling direction and shows extensive damage; during the collision its front was raised onto the loading space of the TMD-44 motorised rail vehicle (draisine). The second Kgs-z wagon's loading space as well as its front and sides are damaged.

Figure no. 3: Consequences of the collision of maintenance train no. 90433 and TMD-44 motorised rail vehicle (draisine)
