## REPORT

following the investigation of the incident happened on the 26th of January 2019  
in the underground Depot BERCENI,  
belonging to SC TMB „METROREX” SA

TYPE OF EVENT	Incident — (art. 8, point 2.2)
DATE AND HOUR	The 26th of January 2019, 09:54 o'clock
LOCATION	Underground Depot BERCENI
TRANSPORT UNDERTAKING	SC TMB “METROREX” SA
INFRASTRUCTURE	SC TMB “METROREX” SA
RAILWAY MANUFACTURER	CONSTRUCCIONES Y AUXILIAR DE FERROCARRILES S.A.
ACTIVITY	Shunting
CONSEQUENCE FOR THE PERSONS	1 injury
TYPE OF REPORT	FINAL
PUBLICATION DATE	The 23rd of January 2020

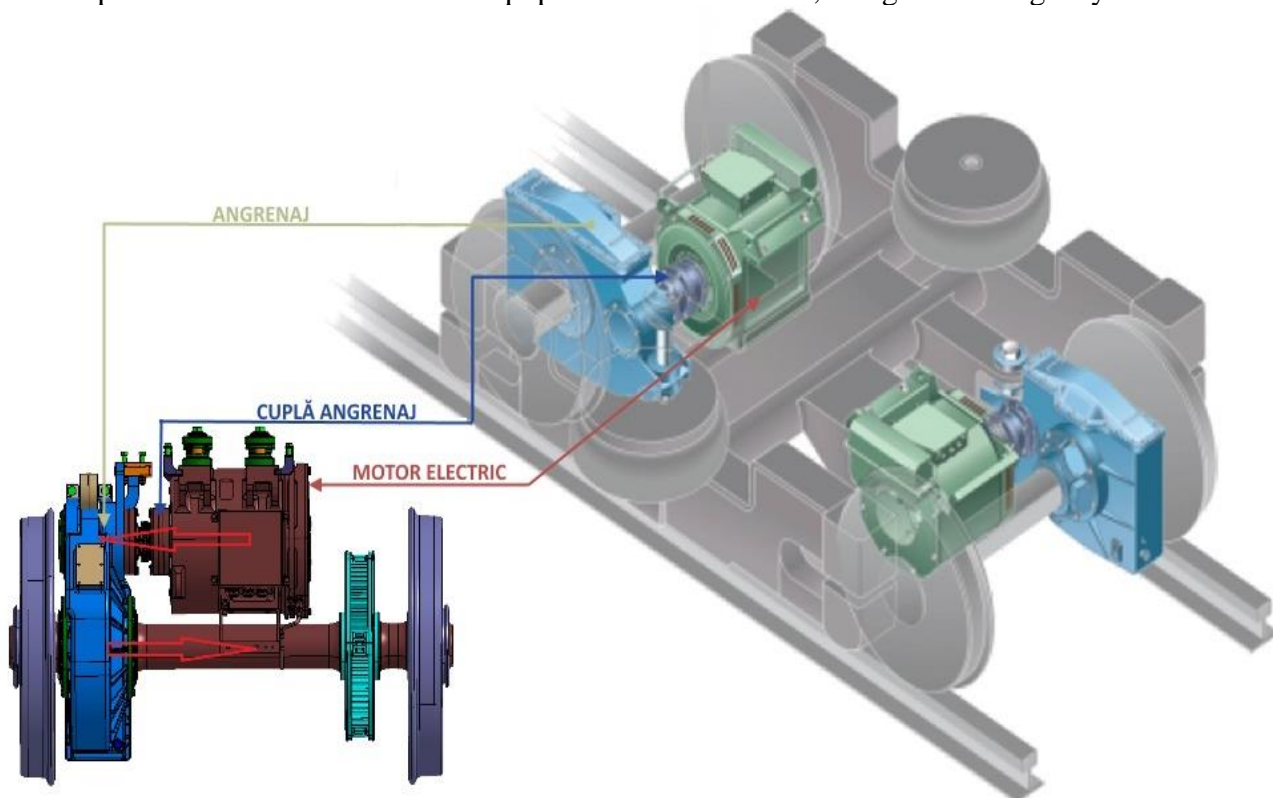
fig.7 – motor bogie and layout of the electric engines

From the construction of the ensemble motor bogie, one can observe that for the forward movement of the bogie, the turning direction of the electric engine is opposite to the sense of the axle engaged. The driving axle is mechanically joined to the rotor of the electric engine M through a kinematic coupling whose transmission from the engine rotor is made through the reducer and the coupling.

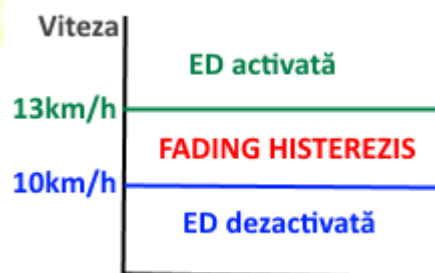
Figure 9 – fading process of the electric brake at the train CAF

- decreases under **10 km/h**, the electric brake is off after a second (considered a minimum necessary time for the pneumatic brake comes in service), and when
- exceeds the value of **13 km/h**, the electric brake becomes active firm (to see the figure 9).

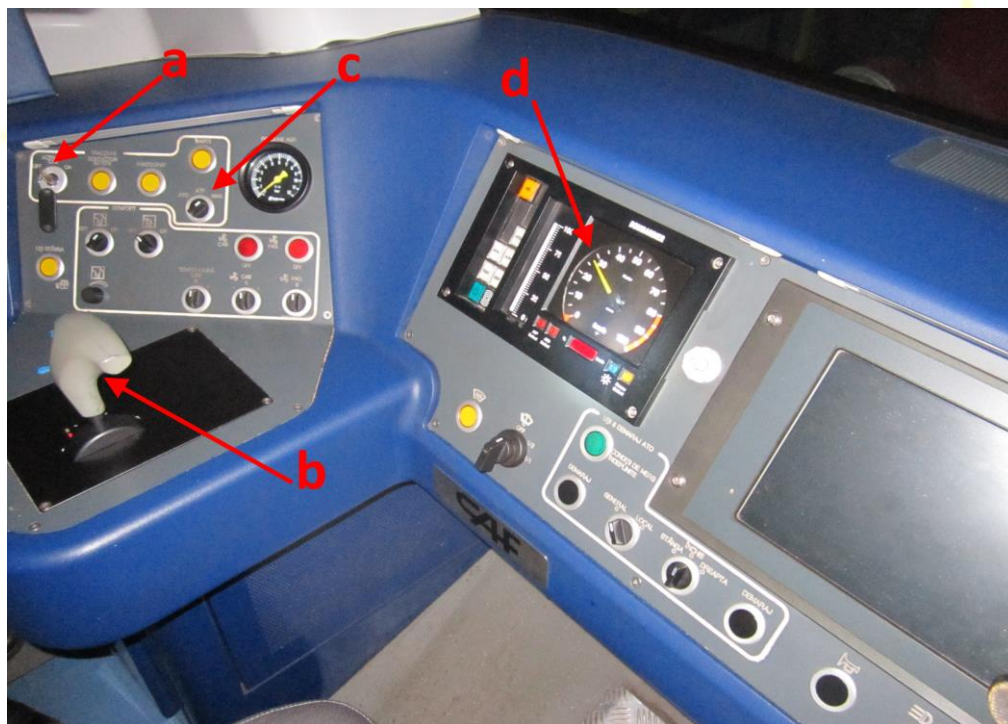
Figure 17 – left on-board display from S.TEM no.2322

- a. key for putting in operation was into the contact in position **OFF** (inactive cabin);
- b. on board controller was on, neutral” (the train has not commanded either traction force or braking);
- c. the switcher of the selection of the vehicle operation way on, **SHUNTING”**;
- d. indication of 28km/h speed at which the records stopped;

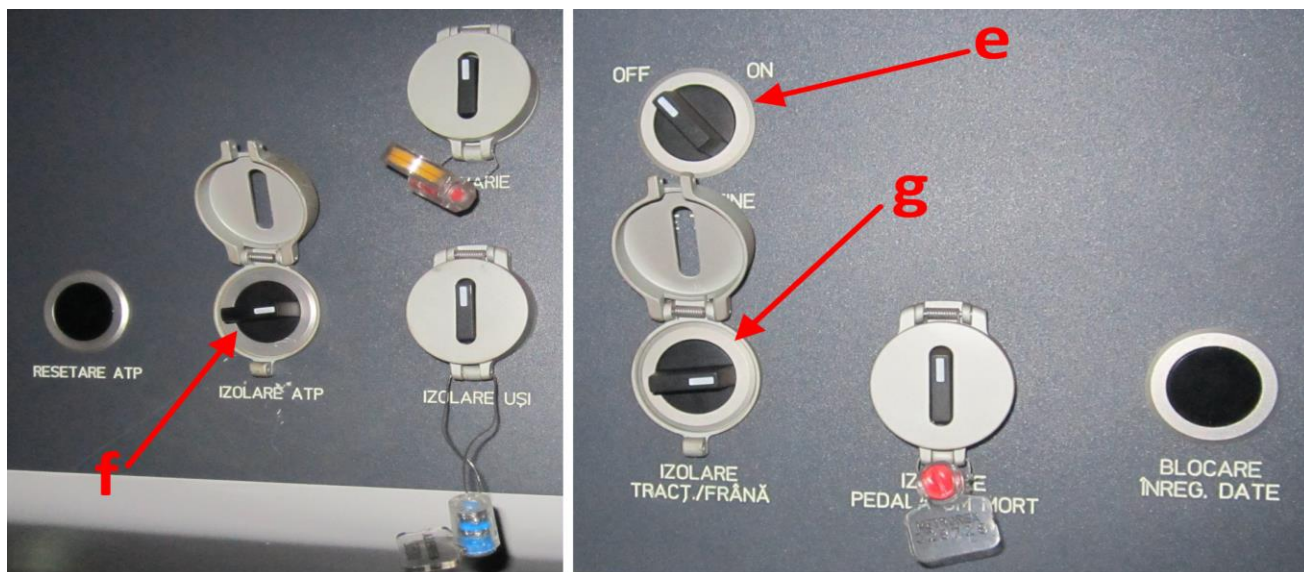
Figure 18 – the on-board panel above the driver seat in S.TEM no.2322

- e. switcher for, **ISOLATION ATP”** with the seal broken and put on, **ON”** (ATC system is made disable, to see figure 18);

- f. the switcher, ISOLATION TRACTION/BRAKE” with the seal broken and on, ON” (to see the figures no.18 and 19);
- g. the button of the emergency brake not pressed.

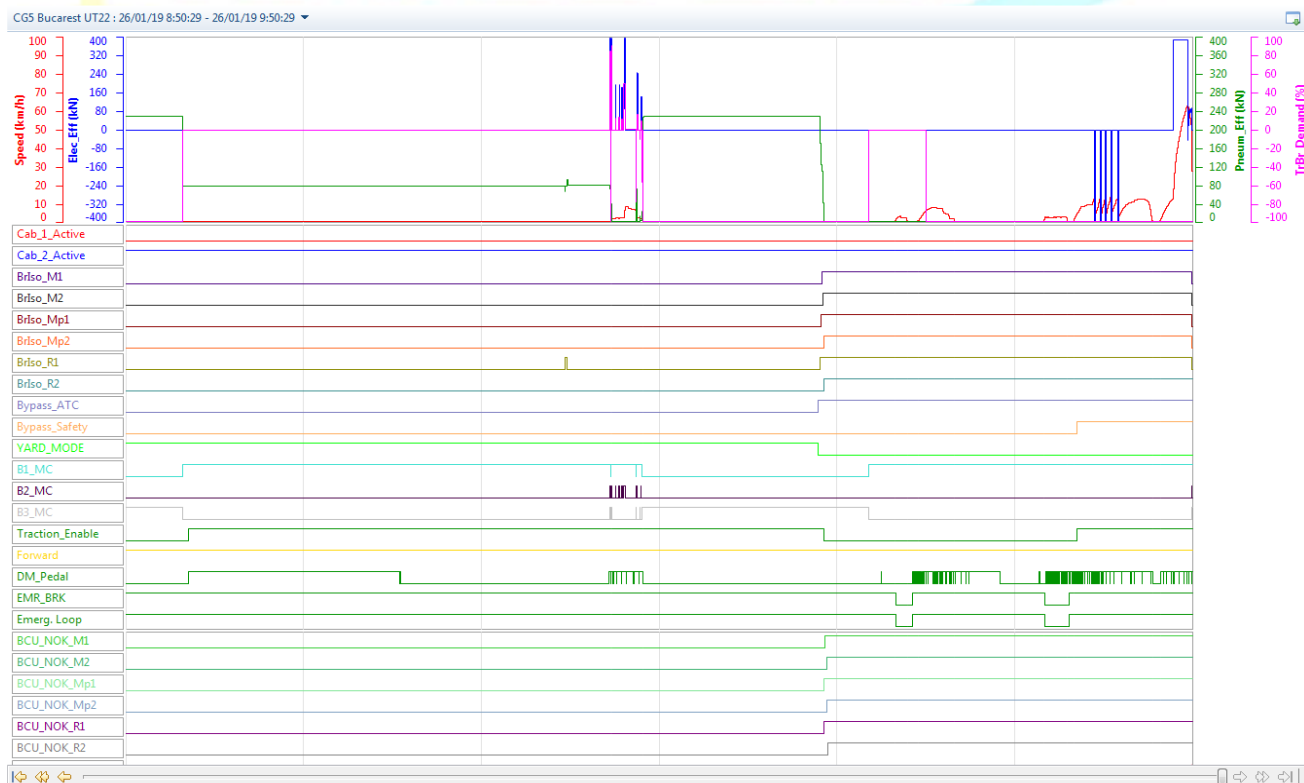
Figure 19 – records diagram TEM no.1322-2322

Following the downloading of the records from TCMS of TEM no.1322-2322 resulted a sequence of the signals stipulated in the figure 18:

For the reading and interpretation of the records from the diagram stored in TCMS one used the next abbreviations:

**CONCLUSION:** *the button for Isolation Traction/Brake was switched from "OFF" to "ON" (the traction, safety and emergency loops were bypassed) and the traction conditions were activated;*

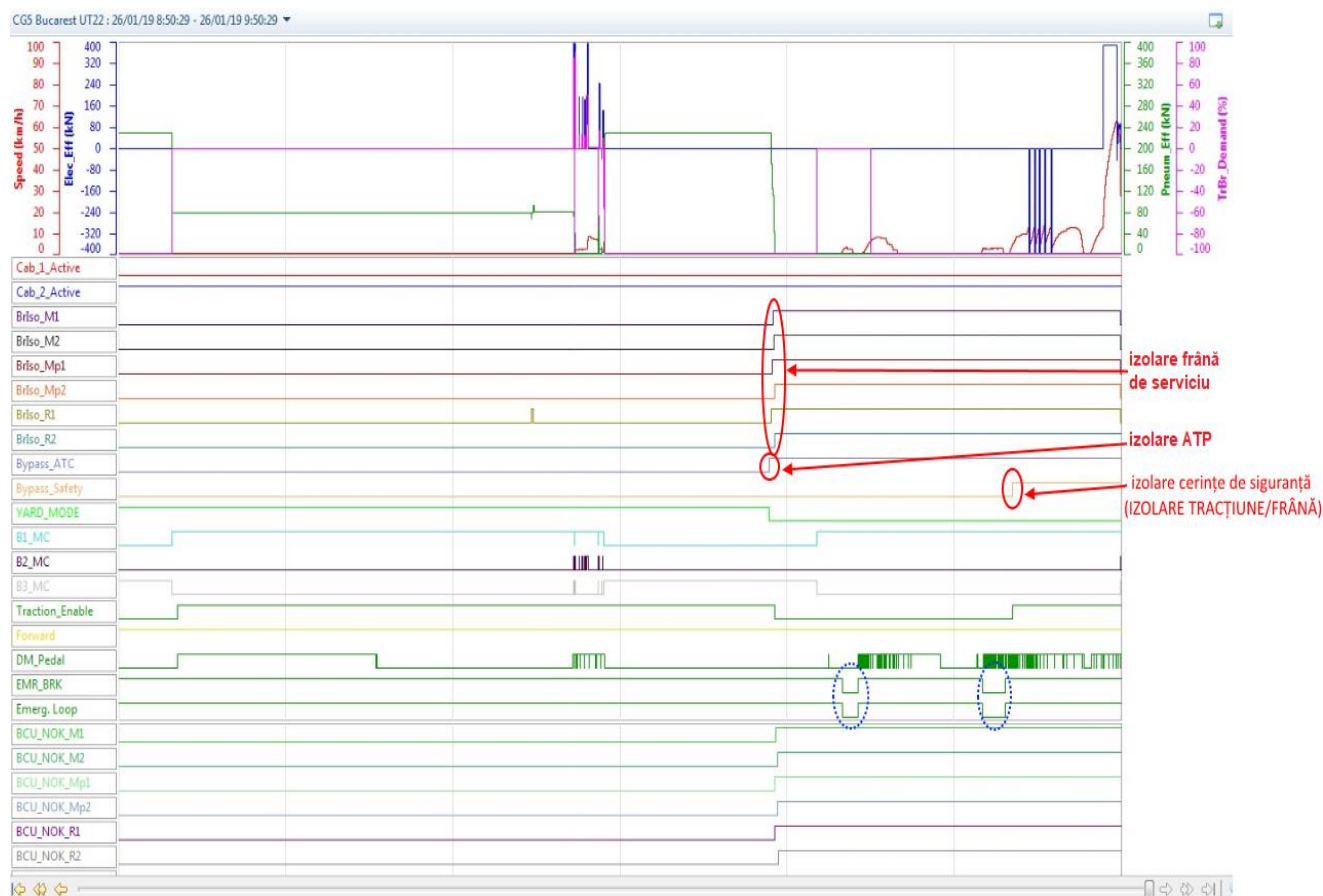
Figure 20 – recordings of the human operator actions

provisions from [NI.5], section 5 "Operation in emergency conditions" chapter 5.10.3 *Coupling with shunting locomotive*. According to the provisions of chapter 5.10.4 *Operation with a coupled rake of vehicles from [NI.5]* it was established that the maximum hauling speed is 40 km/h as well as the hauled rake of vehicles does not apply any traction or braking effort.

At 08:44:32 o'clock, with the introducing of the key and activation of the cabin S.TEM no.2322, the software logic of the vehicle established like reference the cabin R2, respectively the direction "FORWARD" to the direction of the cabin R2. With the setting of the operation direction of TEM BM3-CAF, after putting the switcher for operation way and moving up of the pantograph on „MAN”, in accordance with the table of operation ways stipulated at points 4 and 5 from the chapter **B.2.3.7. Vehicle operation**, TEM could run upon the commands received from MC up to the front of the signal X8H, where it was stopped for its coupling with the locomotive LDH.

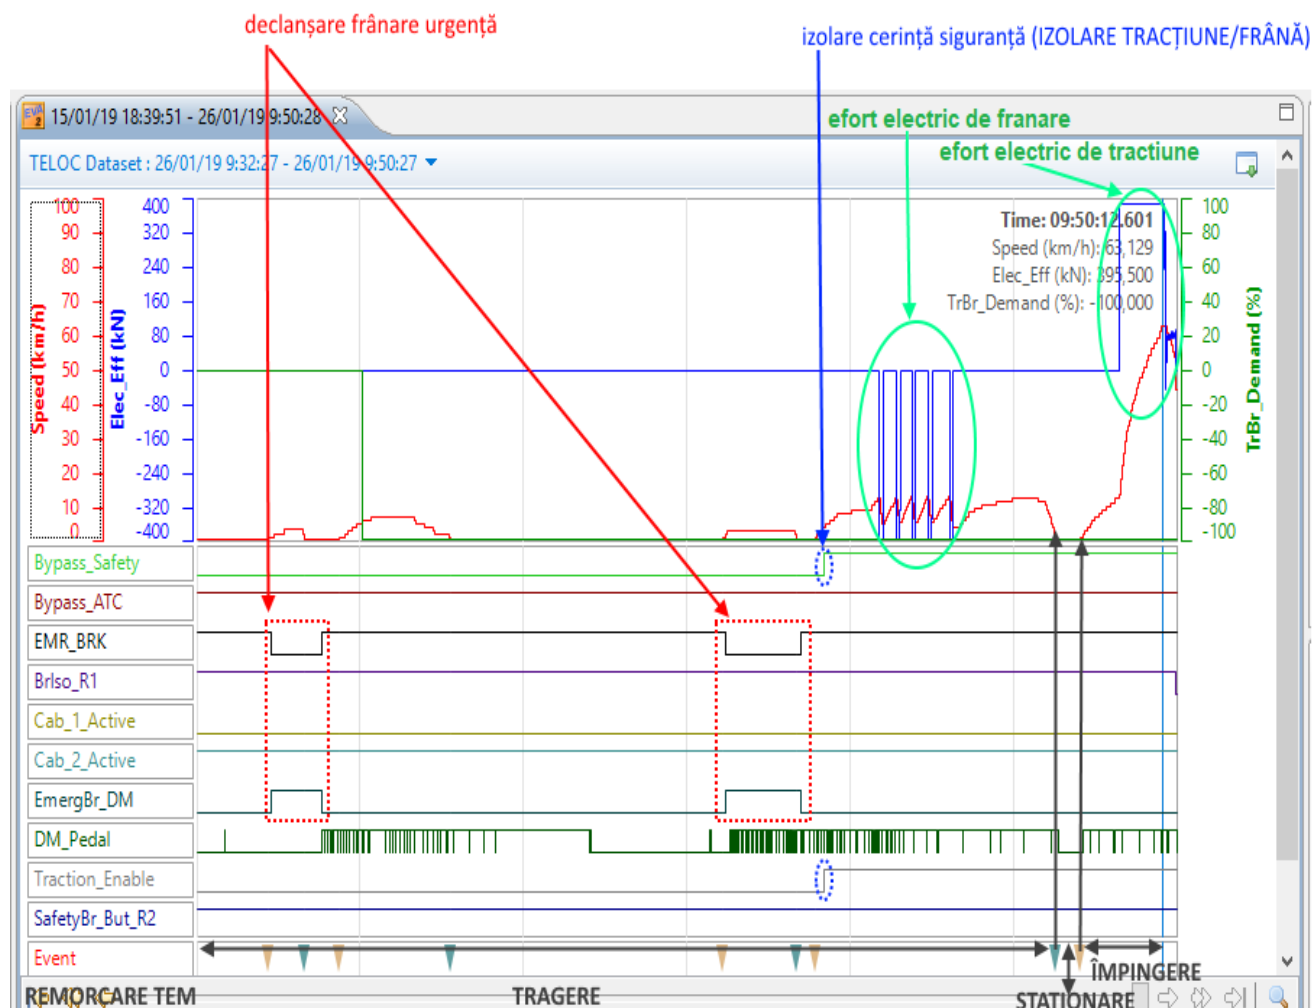
Figure 22 – detail from the recordings in TCMS with the actions of the human operator

”1”, leading to the activation of the traction, although the service brakes rested isolated.

Before switching the button „ISOLATION TRACTION/BRAKE” from OFF to ON, when the speed 6,009 km/h was reached, the vehicle records the changing of the signal **TrBr\_Demand** from ”0” to ”-100%”, that is a request for maximum braking.

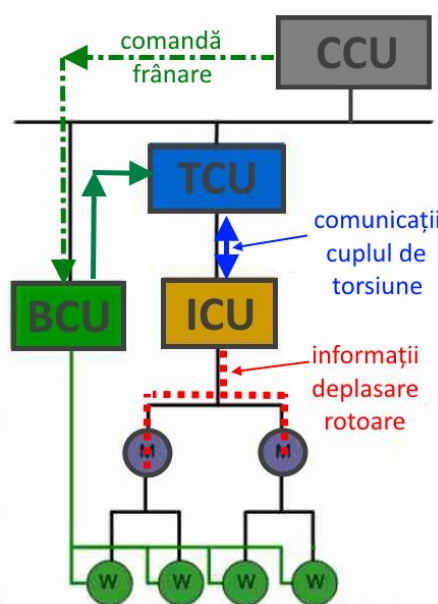
Figure 24 – communications between the equipment of TEM no.1322-2322

Then, the speed of the rake of vehicles began to increase, following the traction effort of the locomotive LDH, up to about 13 km/h, the phenomenon repeated four more times until the rake of vehicles arrive in the station Dimitrie Leonida, the circuit being that stipulated in the figure 24.

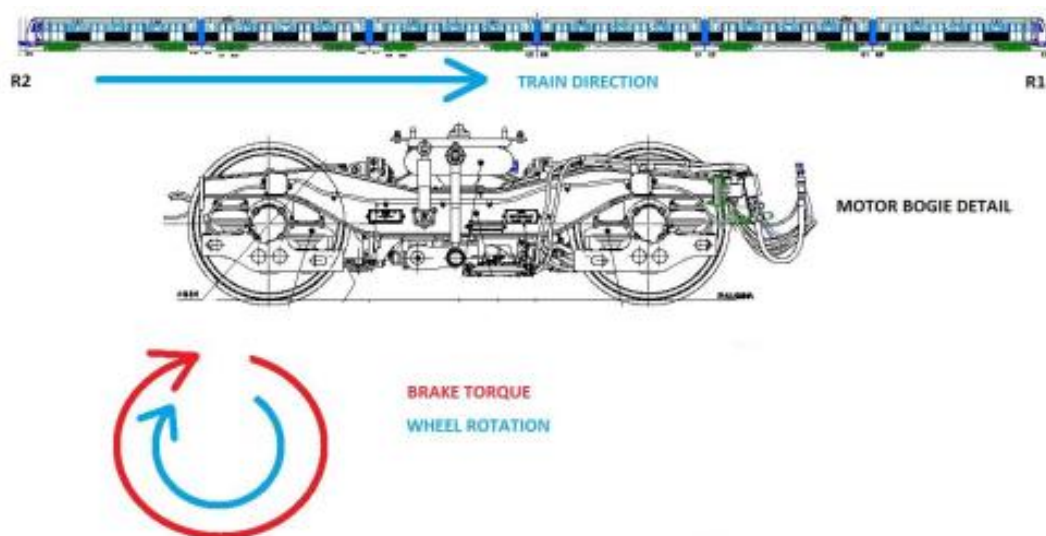
Figure 25 – turning of the wheels, respectively of the stator field of TEM type BM3-CAF put in operation, at the banking movement

After running 95 m, at 09:49:24 o'clock, when the speed of 13,433 km/h was reached, the TEM software calculated the *absolute value* of the couple according to the braking requirement commanded by CCU, but for the couple *sign*, TCU calculated a **false answer**<sup>1</sup> considering the values of the inputs, the active cabin (that was opposite the hauling movement) and the direction (real red), where the magnetic vector of the initial rotor was null (MC on neutral position), the sign being that stipulated in the figure 25. This logic of software through which the reference of the active cabin was priority to the direction red from the sensors of the bogies led to the orientation of the stator field to the direction of the vehicle traction, resulting in the recording of a traction electric effort +395 KN and the acceleration TEM BM3-CAF.

The crew of the locomotive LDH took measures for braking the rake of vehicles, applying the brakes of the locomotive LDH, but the speed continued to increase, reaching the maximum value of 63,129 km/h.
