# Rail Accident Report

**Serious injury to a cyclist at Scate Moor  
bridleway crossing  
8 January 2006**

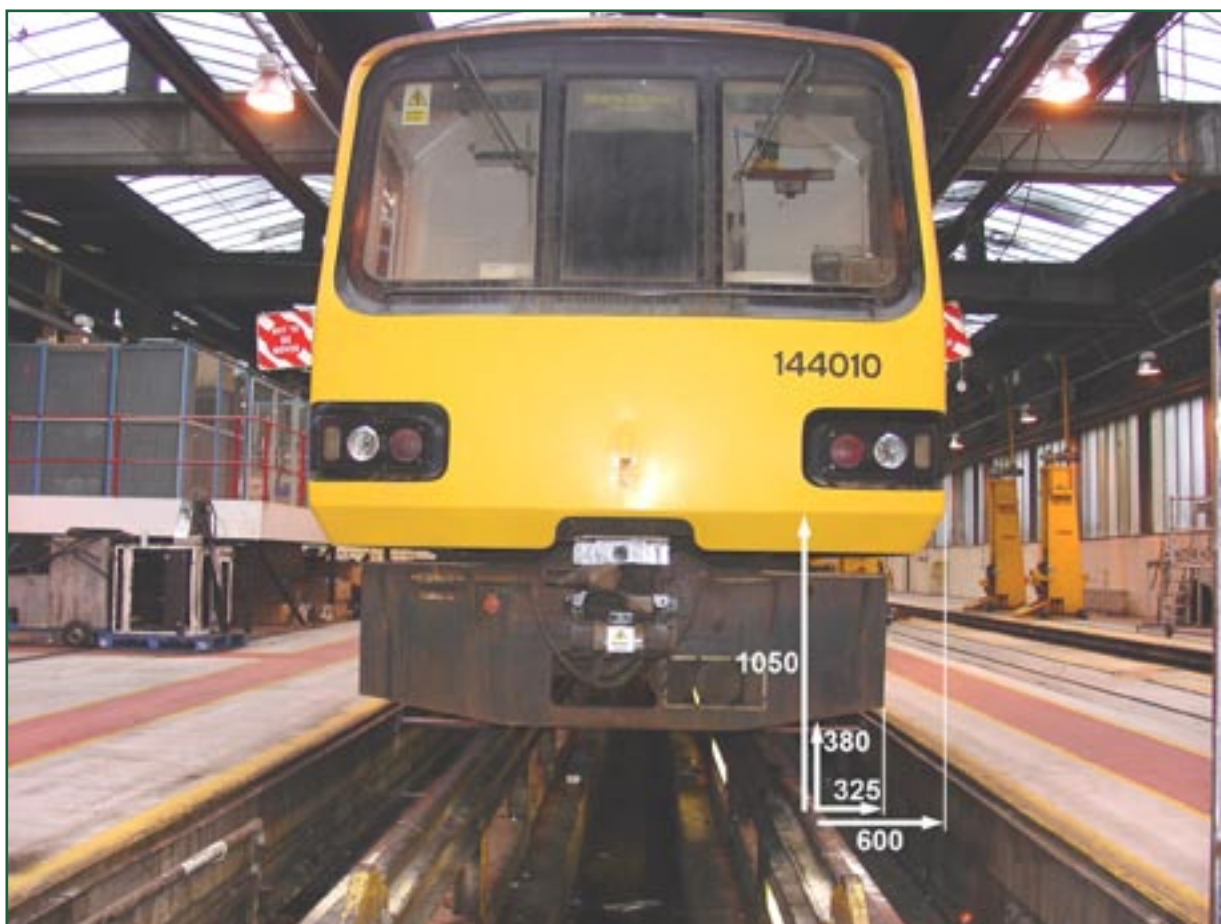
Figure 8: A class 144 DMU showing measured dimensions (mm) from the rail

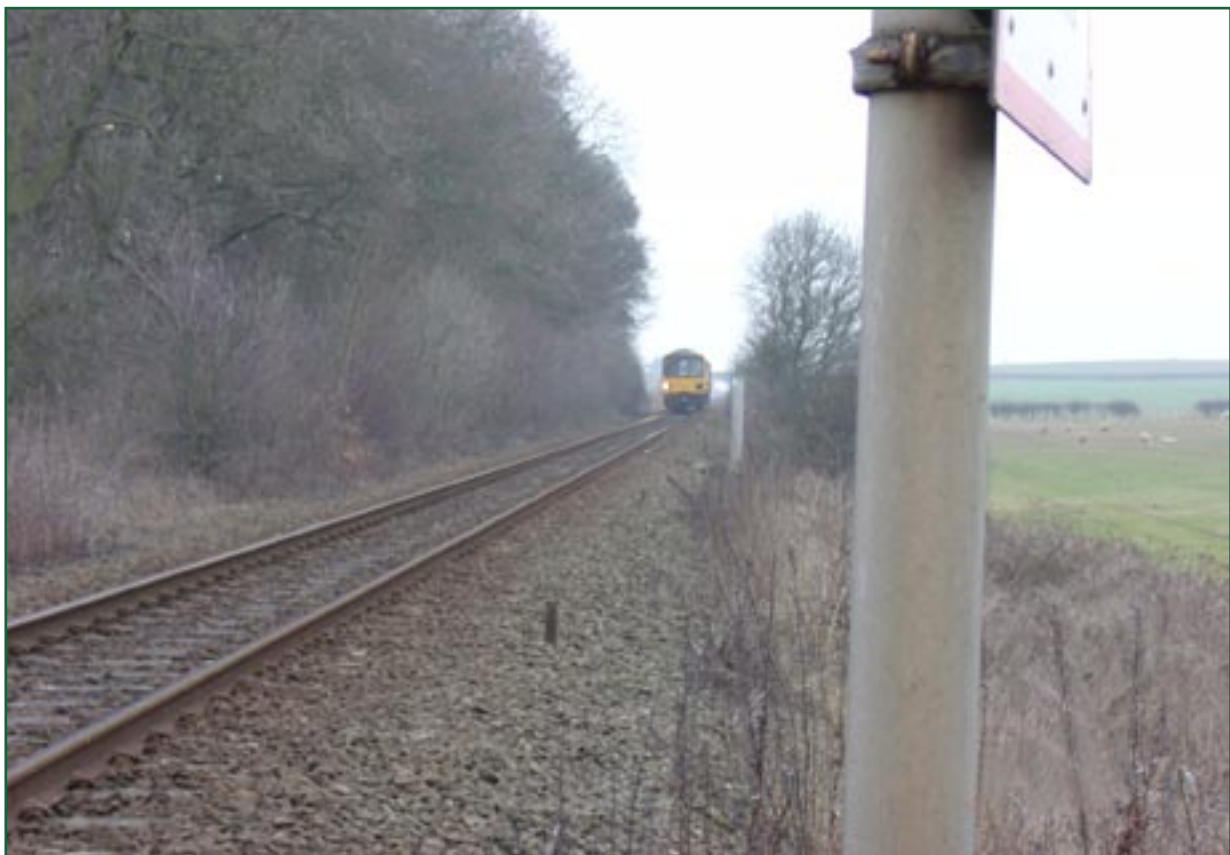
*Figure 10: A class 144 DMU approaching the crossing in daylight – approximately 250 m and 12 seconds from the crossing*
