# Rail Accident Report

## **Penetration and obstruction of a tunnel between Old Street and Essex Road stations, London 8 March 2013**

Report 03/2014  
February 2014

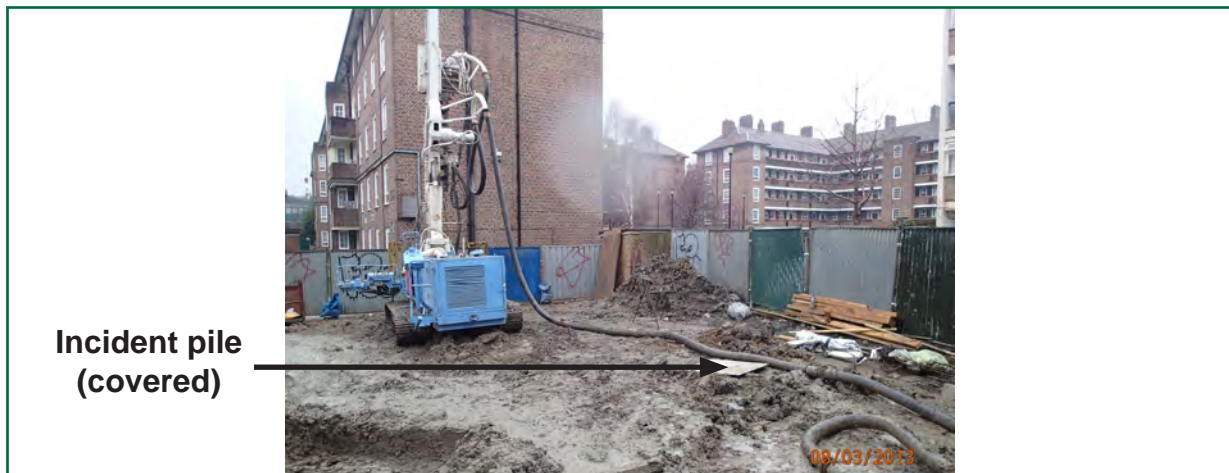
Figure 3: Piling rig on site at East Road

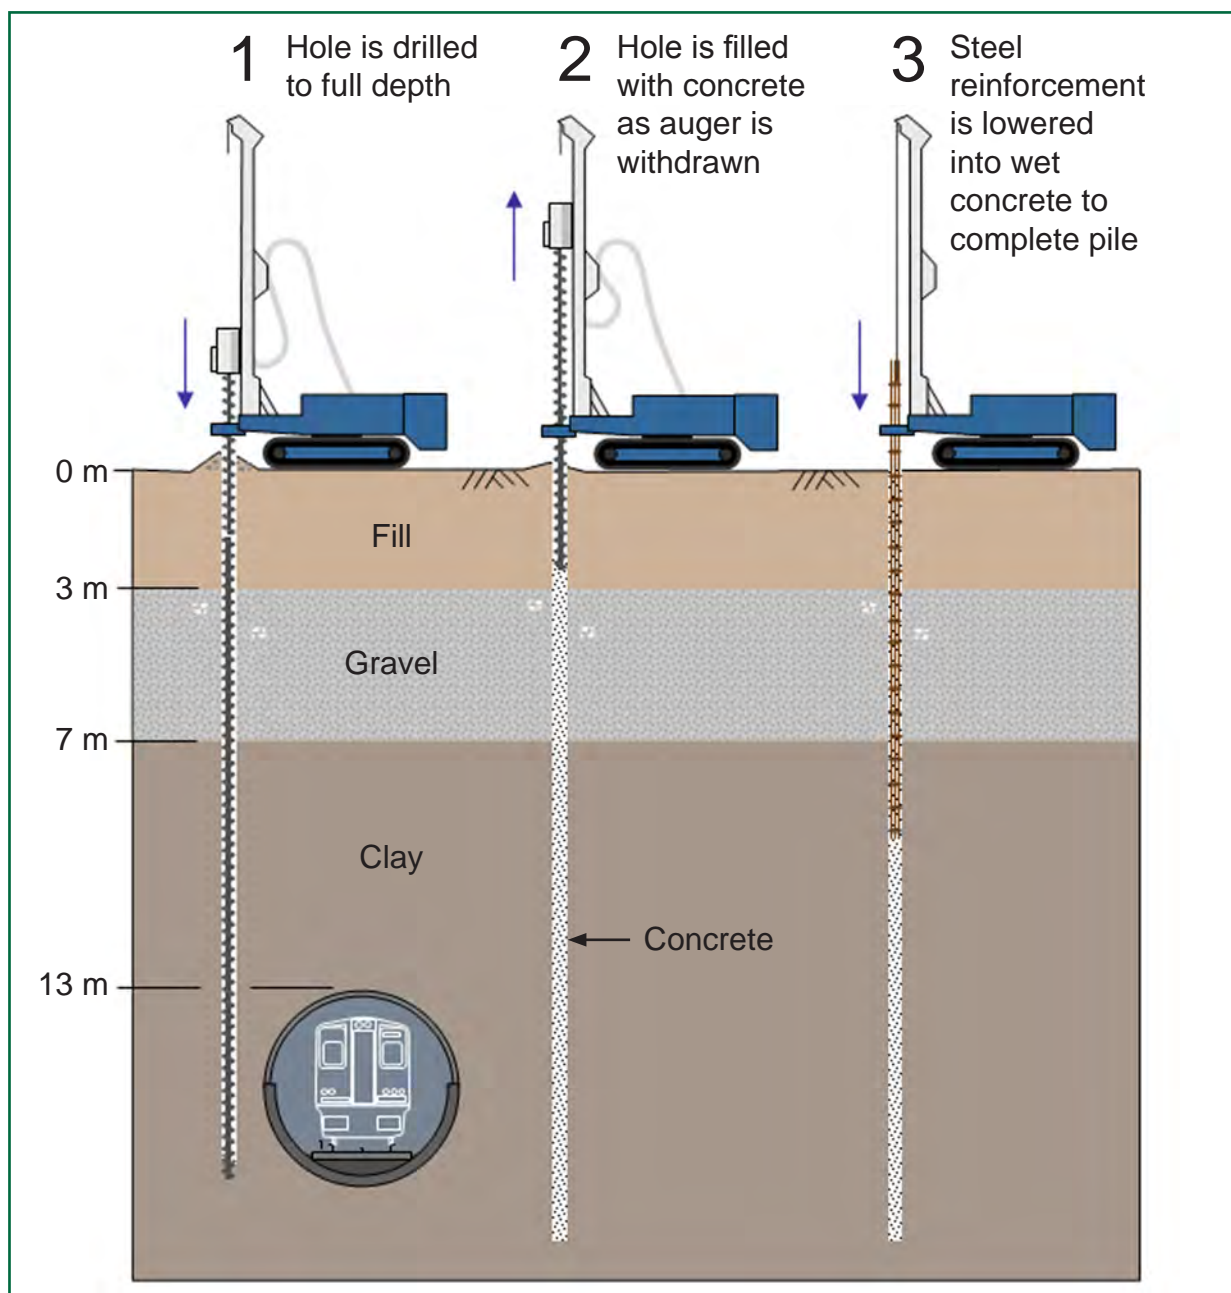
Figure 4: Diagram showing how a bored pile is constructed (tunnel level shown for comparison)

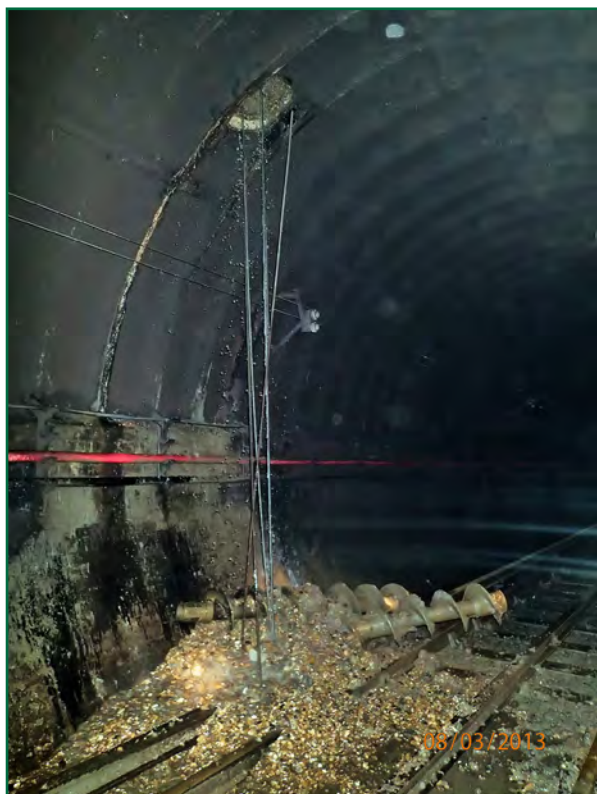
- 9 Water entering through the hole was naturally occurring groundwater from a layer of gravel through which the auger had passed.
- 10 There were no injuries caused to staff or passengers, or damage to trains.

Figure 5: Penetration of tunnel lining and debris on track

- 23 Train services were suspended between Moorgate and Finsbury Park for the remainder of Friday 8 March. There was no scheduled passenger service on the following Saturday or Sunday, so during this period, Network Rail was able to repair the tunnel lining and remove the two sections of auger, the metal bars and 0.75 tonnes of soil which had fallen down the hole.

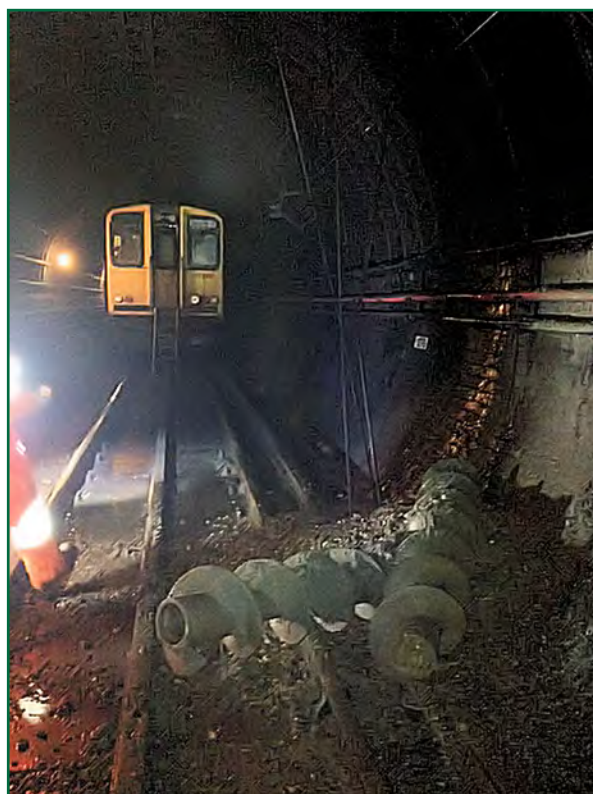
Figure 6: Auger sections and debris on the track (photograph courtesy of Network Rail)

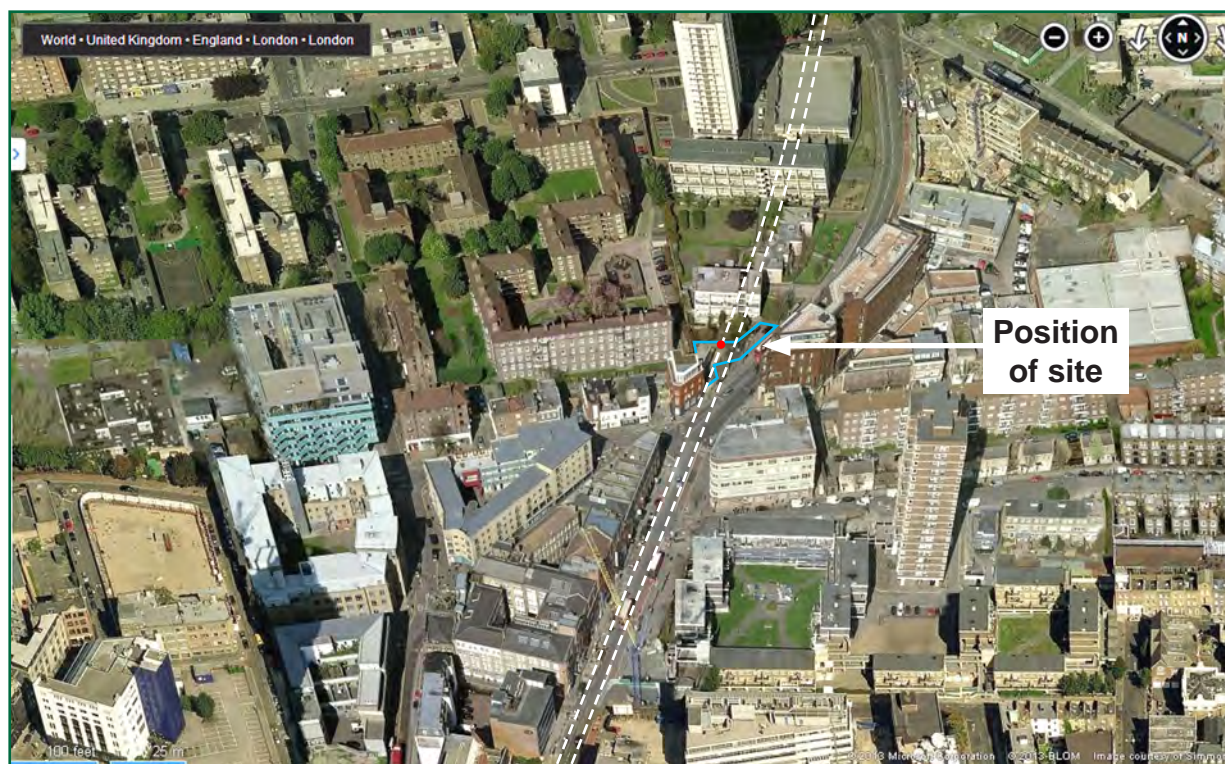
Figure 7: Aerial view of site, enhanced to show alignment of tunnels and site location (copyright Microsoft Corporation 2013)

The site plan shows the proposed new building footprint in blue. The building is L-shaped, with one wing along 105/115 East Road and another wing extending south towards Alberton Street. The plan includes labels for existing structures, streets, and proposed features. A north arrow is located in the top left corner.

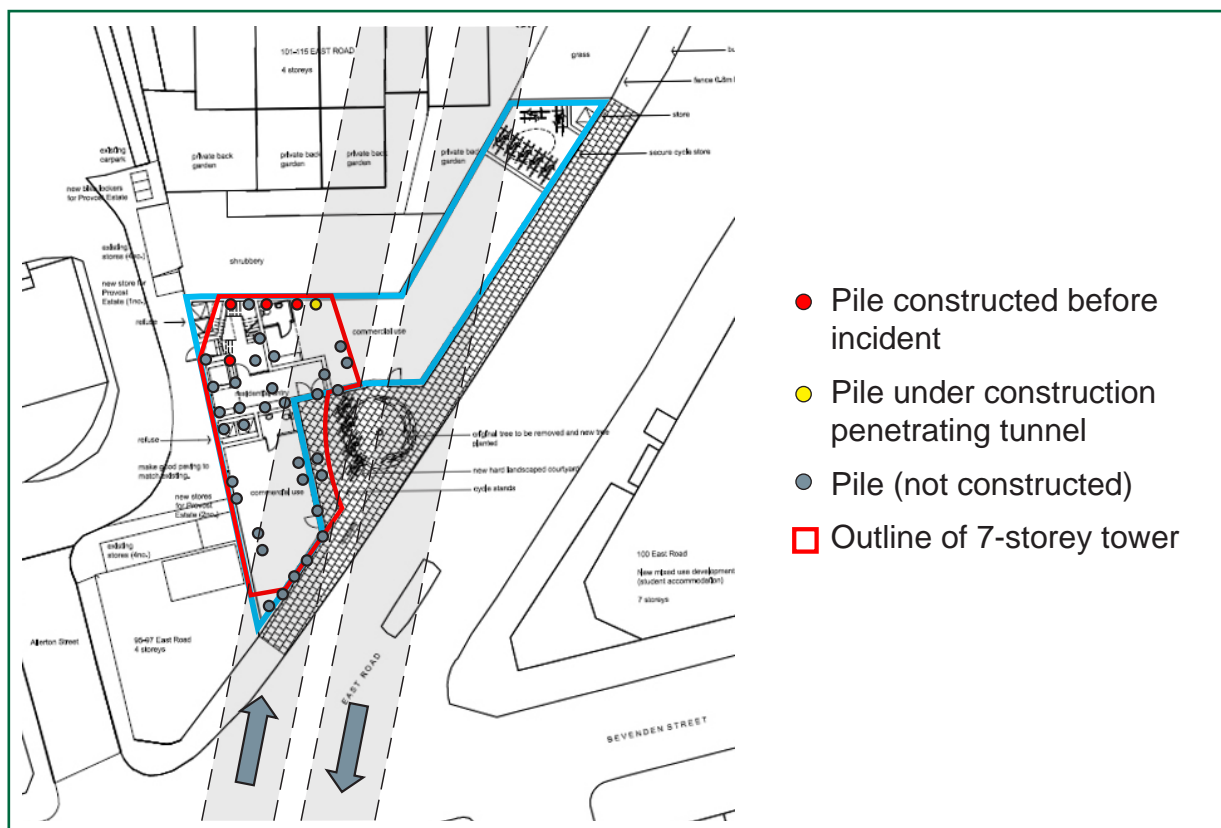
- 28 Unknown to the designers, the planned position of 19 of the 39 piles intersected the Down Moorgate line tunnel (figure 10). The longest piles would have extended over 9 metres below rail level (figure 11).

Figure 10: Extract from 2011 planning application enhanced to show location of piles and tunnels

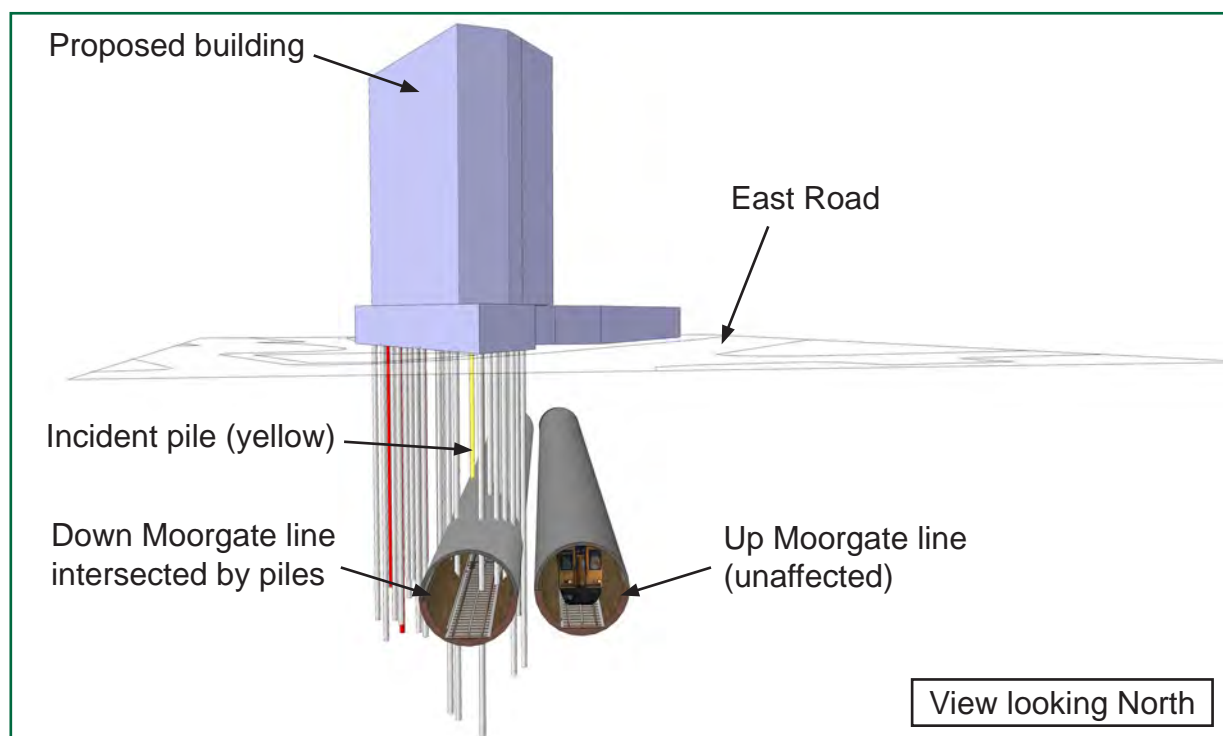
Figure 11: Scale diagram showing proposed foundation layout and extent of interaction with railway tunnel

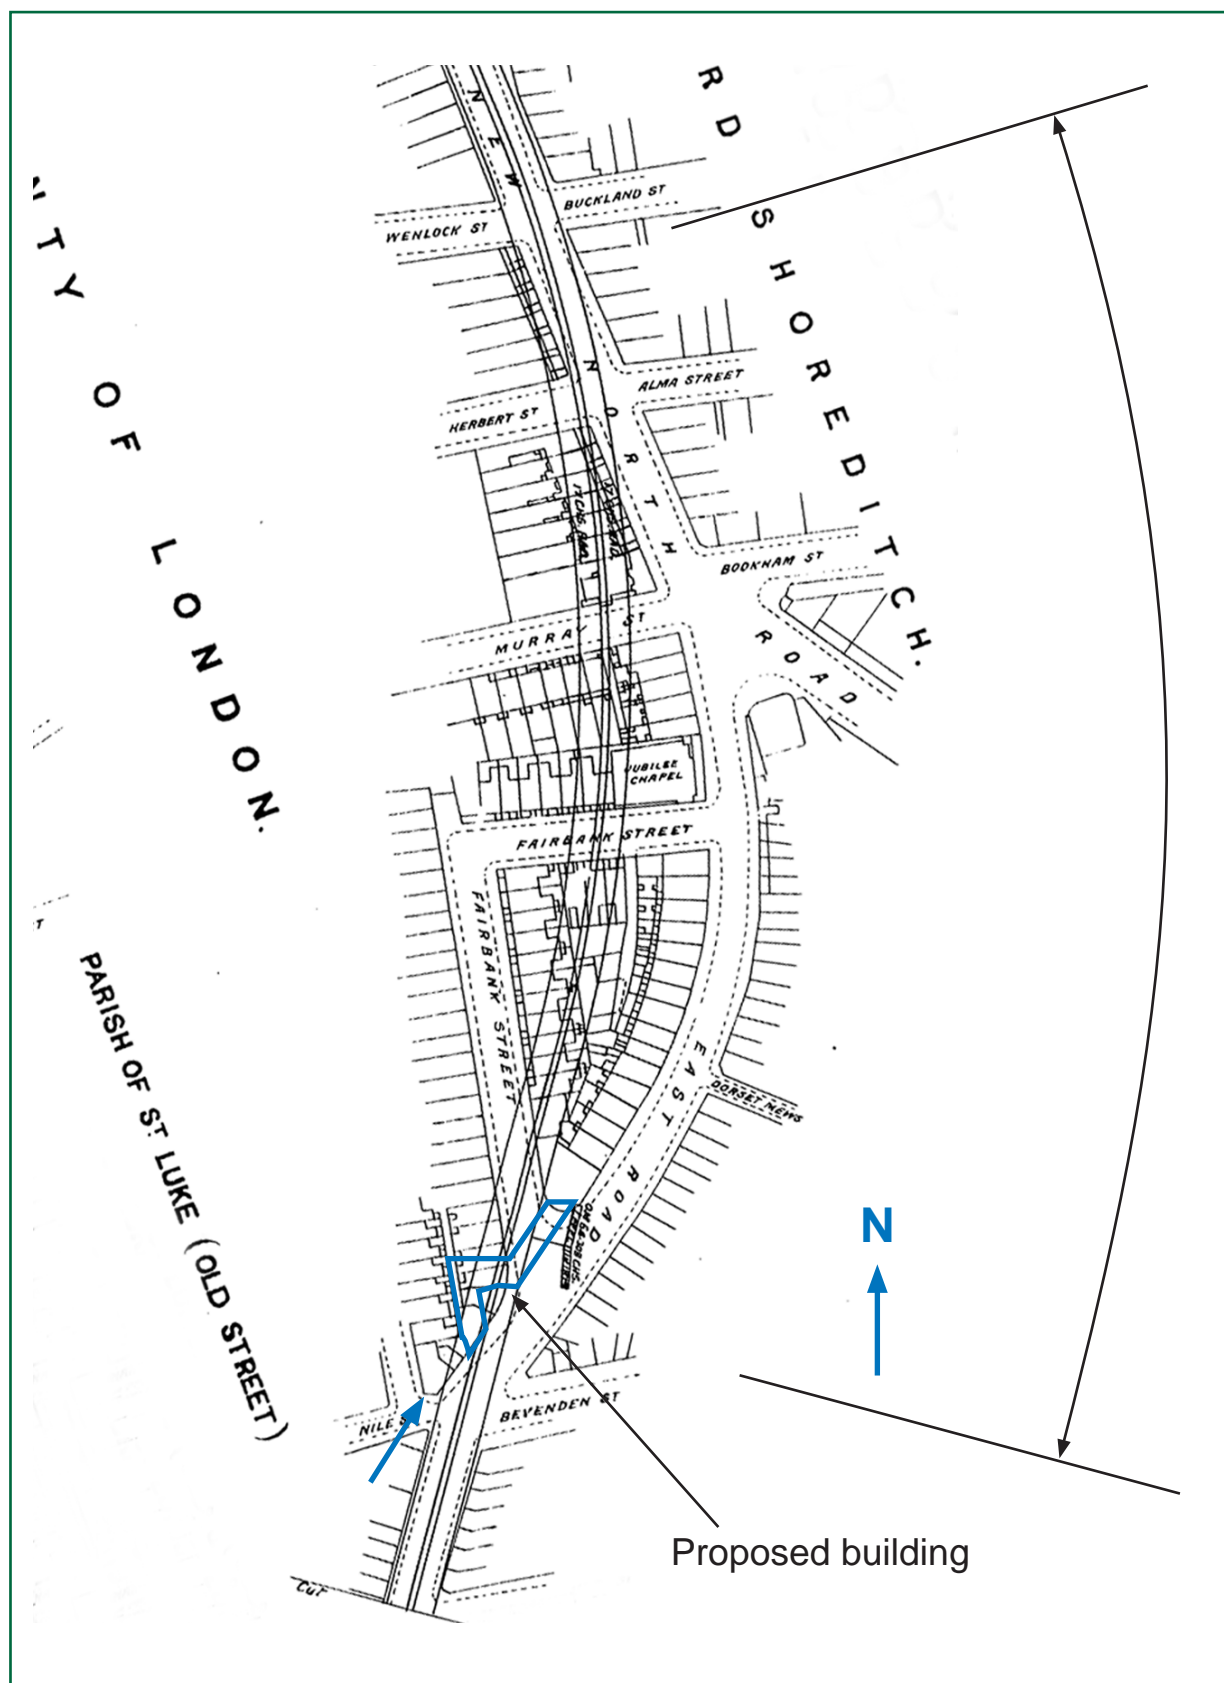
Figure 12: Extract from Great Northern and City Railway map showing route of tunnels beneath residential property, including Fairbank Street, and outline of proposed building (blue)

- 34 The GN&CR tunnels generally followed public highways, but a bend in East Road required a 280 metre length of the tunnels to be constructed in part beneath private property, and in part beneath Fairbank Street (figures 12, 13 and 14). This is one of the few locations on London’s underground railway network where the early tube tunnels (designed and constructed between 1884 and 1907) passed for some substantial distance under private property.

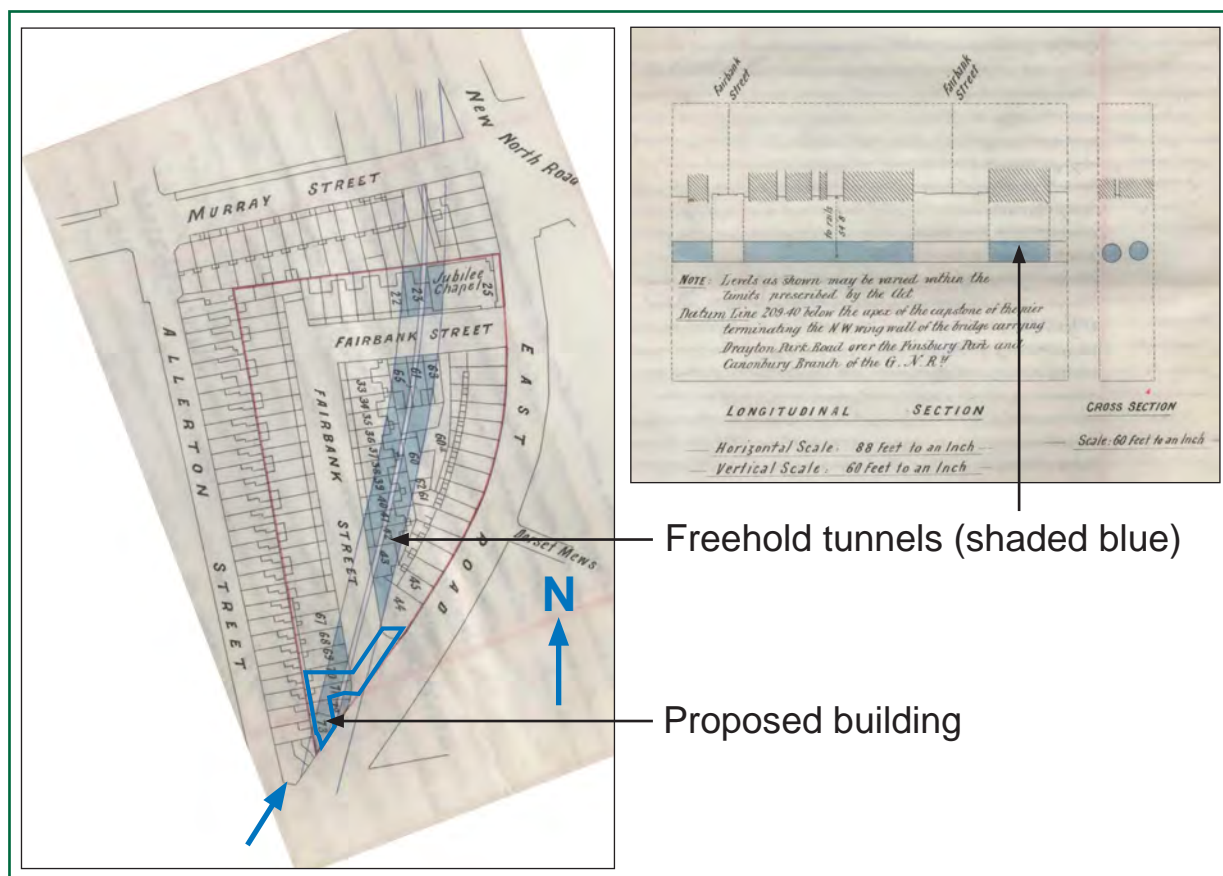
Figures 13 and 14: Extracted plan and sections from 1902 Conveyance of the freehold tunnels showing outline of proposed building (blue)

- protect tunnels under Fairbank Street (not protected by land ownership); and
  - enhance protection of tunnels beneath properties either side of Fairbank Street (figures 13 and 14) where the London Transport Board already owned the subsoil around the tunnels.

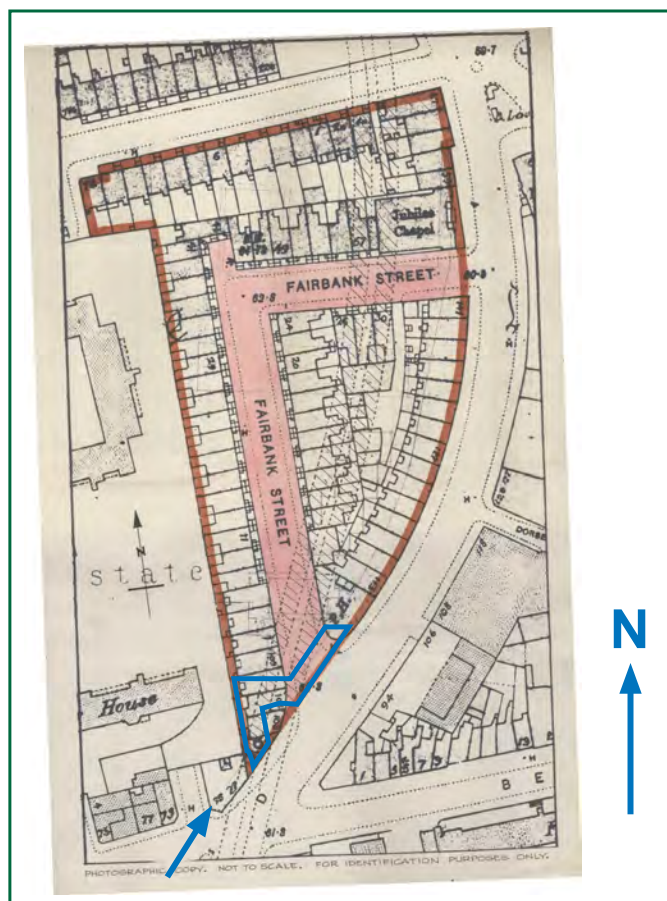
Figure 15: Extracted plan from the 1967 Undertaking showing protected area and outline of proposed building (blue)

- 45 The Moorgate tunnels which run under this land (figure 15), were at that time owned by the London Transport Board (refer to appendix C). As there was only limited legal protection for the tunnels (paragraph 35), the London Transport Board sought an undertaking to protect its asset from the proposed and any future demolition and re-development works which had the potential to adversely affect the safety of the railway. The London Transport Board objected to the stopping up of Fairbank Street until the undertaking was provided.

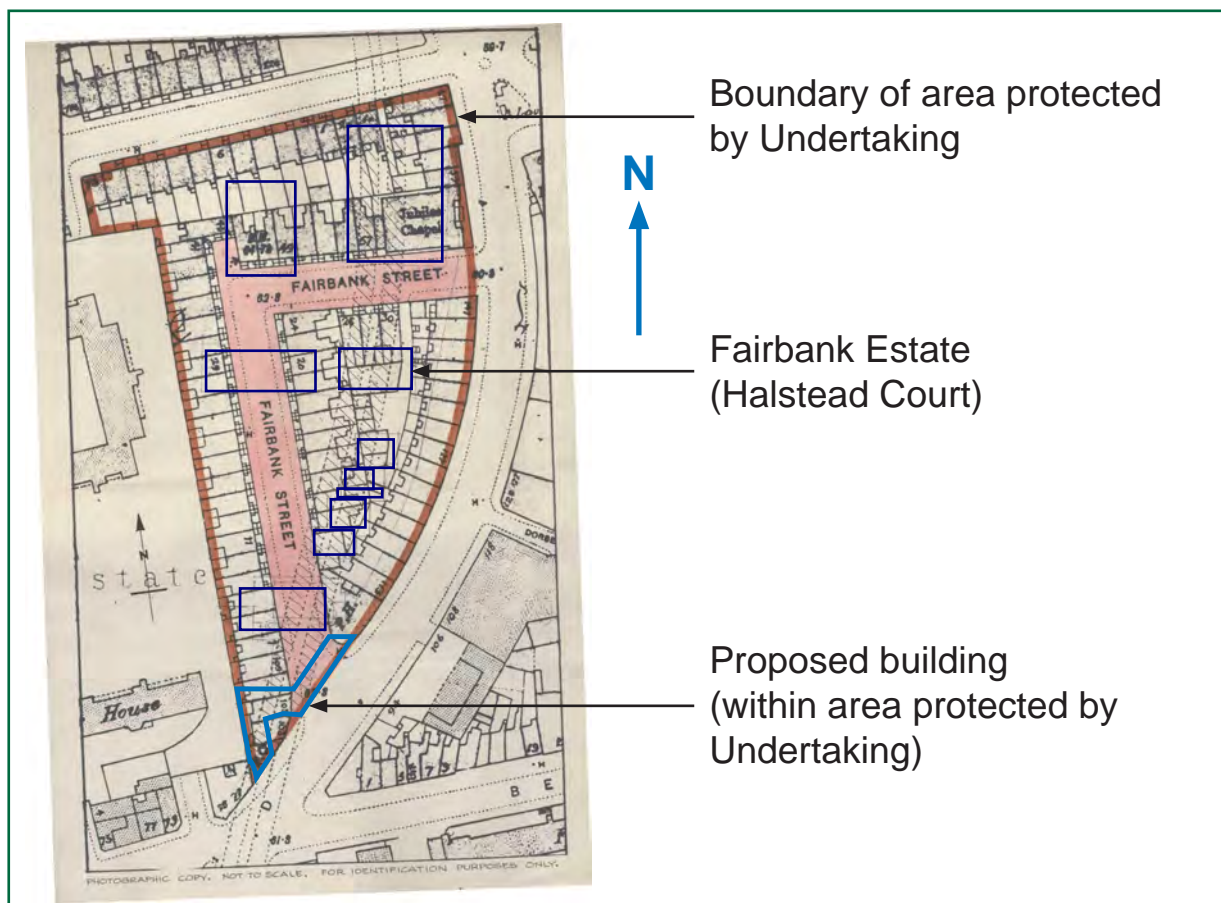
Figure 16: Extracted plan from the 1967 Undertaking, enhanced to show the outline of the post-1967 Fairbank Estate development (dark blue) and proposed building (blue)

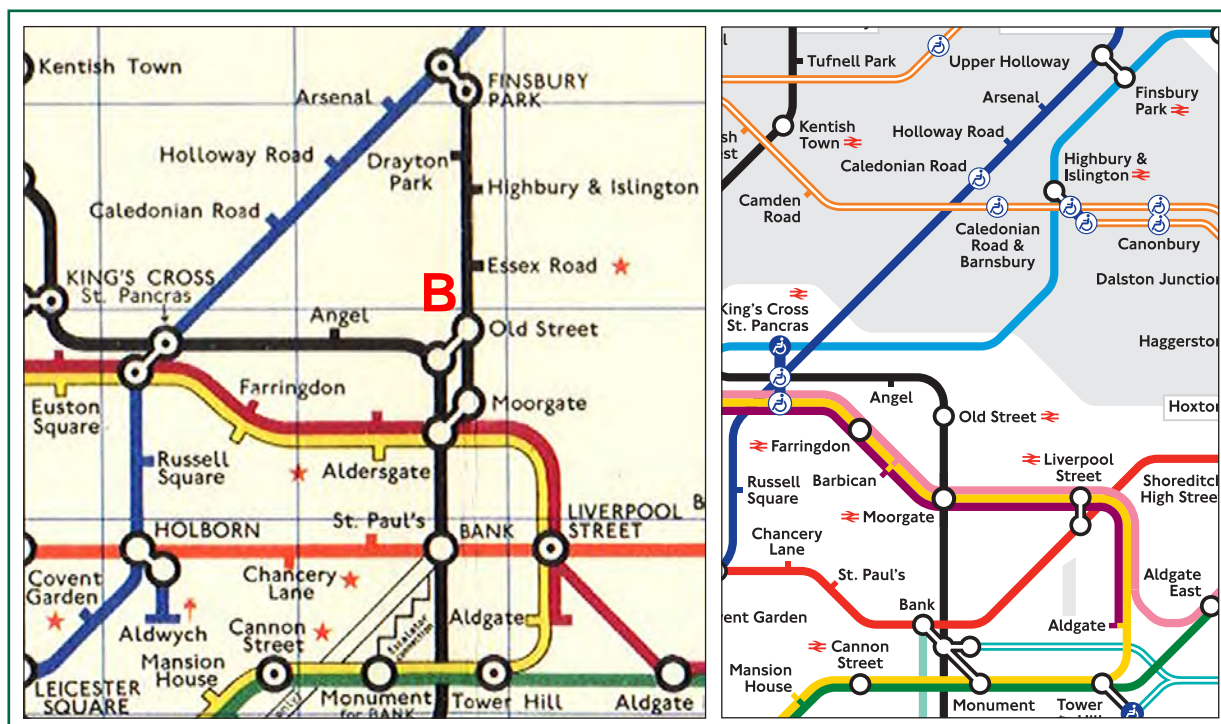
Figures 18 and 19: Extracts from London Underground maps from 1964 and 2013. The Northern City line is shown running between Moorgate and Finsbury Park on the 1964 map (position 'B').

61 The current London Underground map does not show the Northern City line as it is now part of the national rail network (figures 18 and 19). Mapping issues are discussed in paragraph 92 onwards.

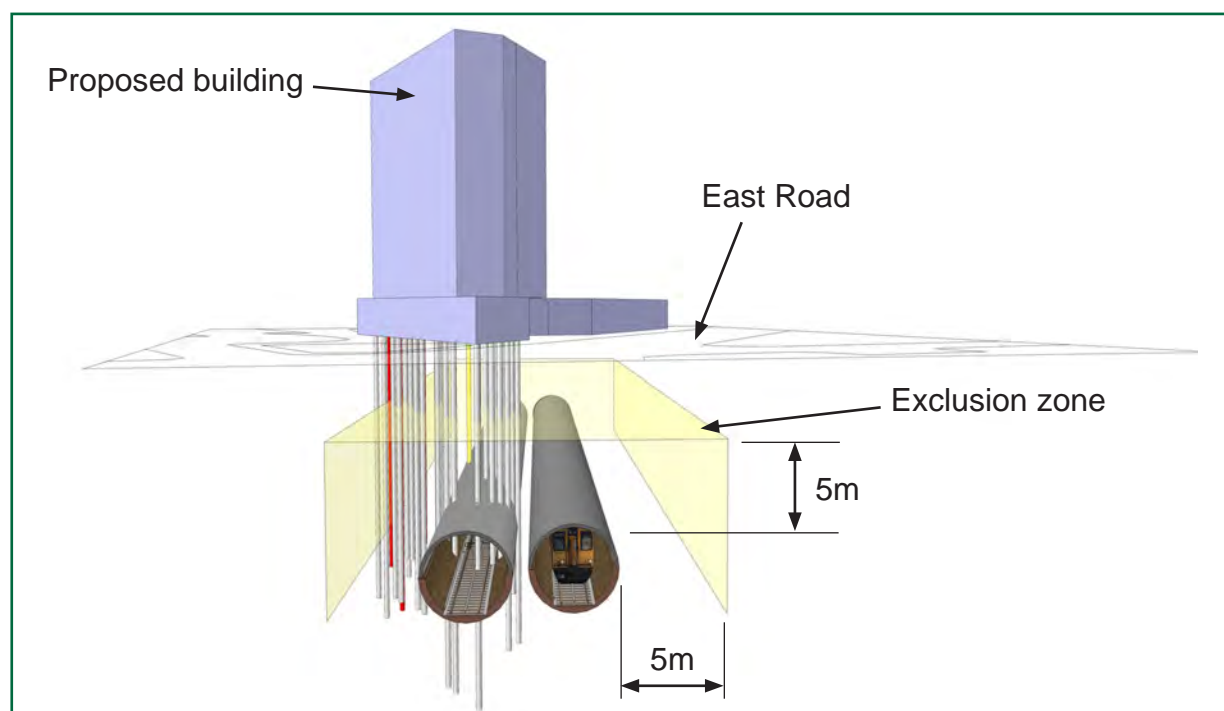
- 85 If Network Rail had been consulted, it would generally seek to prohibit the construction of piles within a five metre zone above and on either side of a tunnel (figure 20). This restriction is given in a Network Rail guidance document titled 'Conditions and requirements for engineering works in the vicinity of Network Rail tunnels', which states that no piles are to be driven or bored within this zone. Network Rail's asset protection department normally issues this document to developers when it receives enquiries about carrying out work adjacent to, or over, Network Rail's structures.

Figure 20: Scale diagram showing Network Rail's generic piling exclusion zone. Most of the proposed piles are located within this zone.

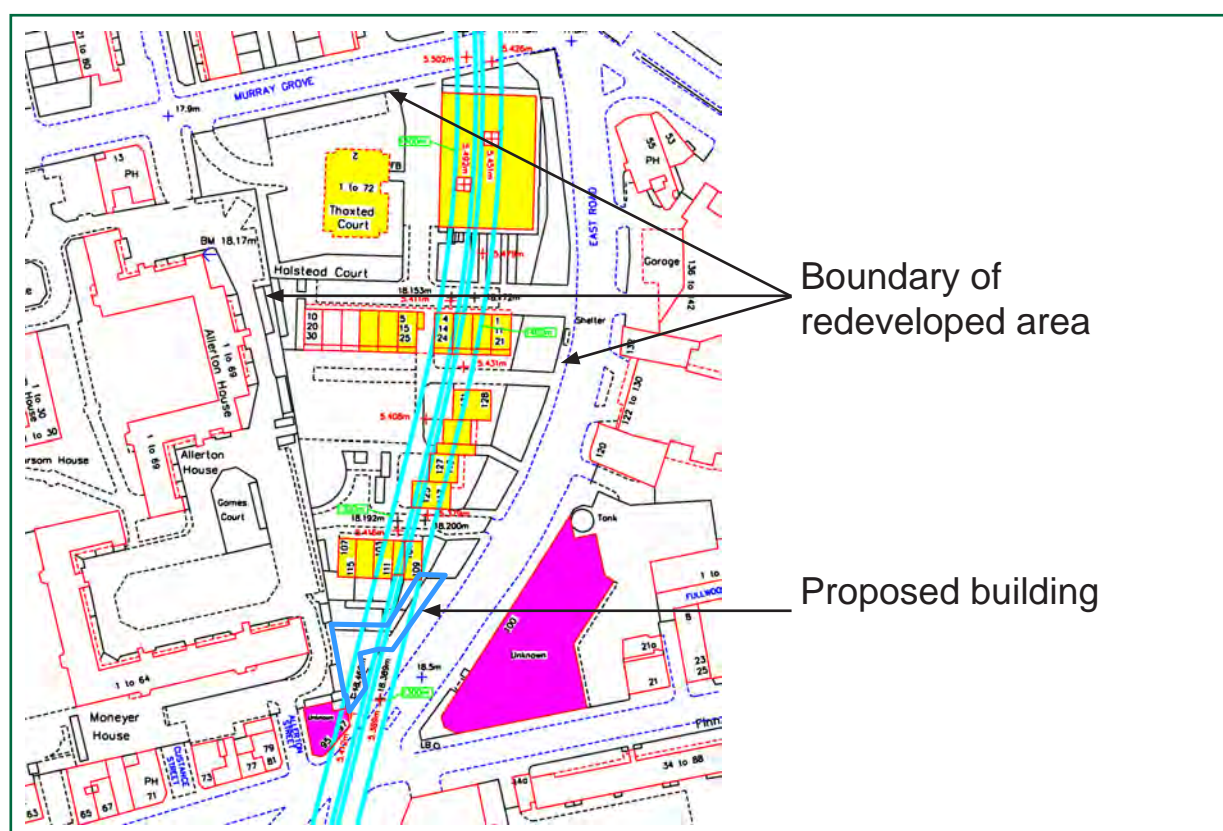
- 87 Network Rail's property department also used a digital mapping system (known as GI Portal). GI Portal uses Ordnance Survey mapping data and shows the line of most, but not all of Network Rail's tunnels. As the Moorgate tunnels were not shown on Ordnance Survey mapping (paragraph 70), they had been added to the GI Portal based on information from a detailed survey commissioned by Network Rail which was completed in 2006. The RAIB has verified that the position of the Down Moorgate tunnel relative to the site is shown in approximately the correct position on Network Rail's mapping by (figure 21) plotting the known position of the incident pile.

Figure 21: Extract from Network Rail's 2006 tunnel survey (post-1967 residential development shown in yellow)

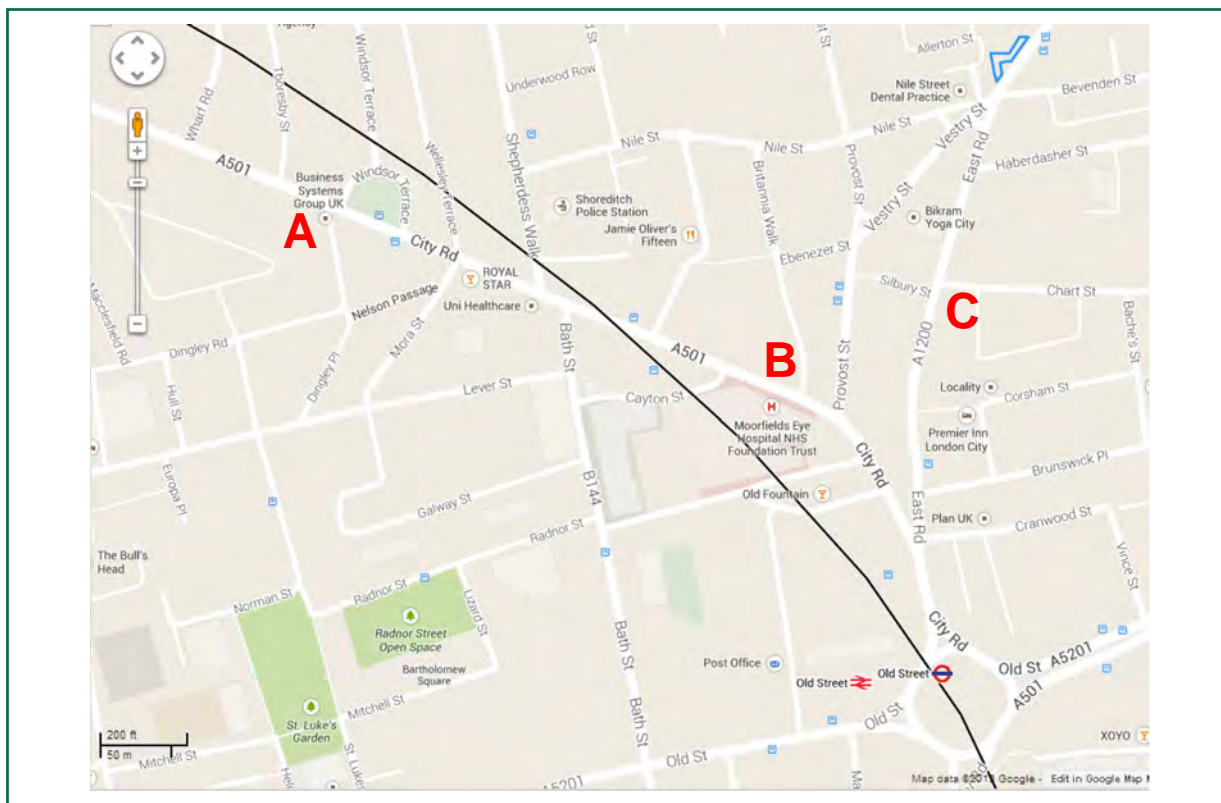
- 93 Accurate alignment information is not publicly available for underground railways in central London. In the absence of this information, some maps show an assumed alignment for the tunnels. For example, Google Maps (figure 22) shows a stylised alignment for the London Underground Northern Line which is significantly different from the actual alignment (figure 23). The lack of accurate information creates a risk of future development affecting existing tunnels due to misinterpretation of where the tunnels are located. For example, properties at locations A, B and C (figures 22 and 23) are much closer to existing tunnels than suggested by Google Maps.

Figure 22: Screen capture of a Google Maps image of the area north-west of Old Street station. The black line represents the London Underground Northern Line. The Moorgate tunnels are not shown. Positions A, B, C and the East Road site refer to both figures 22 and 23.

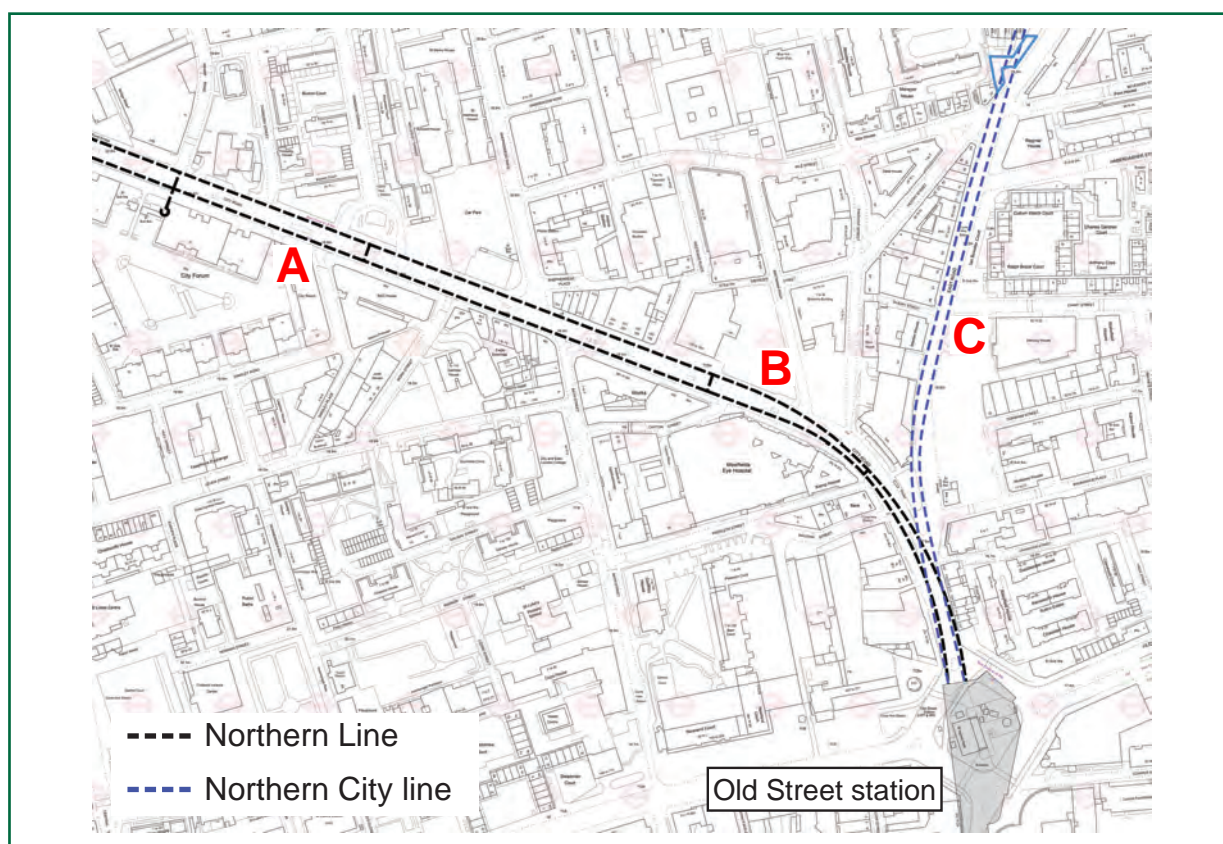
Figure 23: Plan showing the actual alignments of London Underground's Northern Line and Network Rail's Moorgate tunnels overlaid on Ordnance Survey mapping (alignment information courtesy of London Underground and Network Rail)
