REPUBLIC OF SERBIA
CENTER FOR INVESTIGATION OF ACCIDENTS IN TRANSPORT
SECTOR FOR INVESTIGATION OF ACCIDENTS IN RAILWAY TRAFFIC
Nemanjina 11, 11000 Belgrade

FINAL REPORT ON INVESTIGATION OF SERIOUS ACCIDENT

Type of accident:	Death of the railway worker (the train driver) while jumping out of the train in motion
Train No:	432
Place:	Rakovica municipality, settlement Resnik, the area of the train station Resnik
Date:	25.06.2019.
Time:	06:17

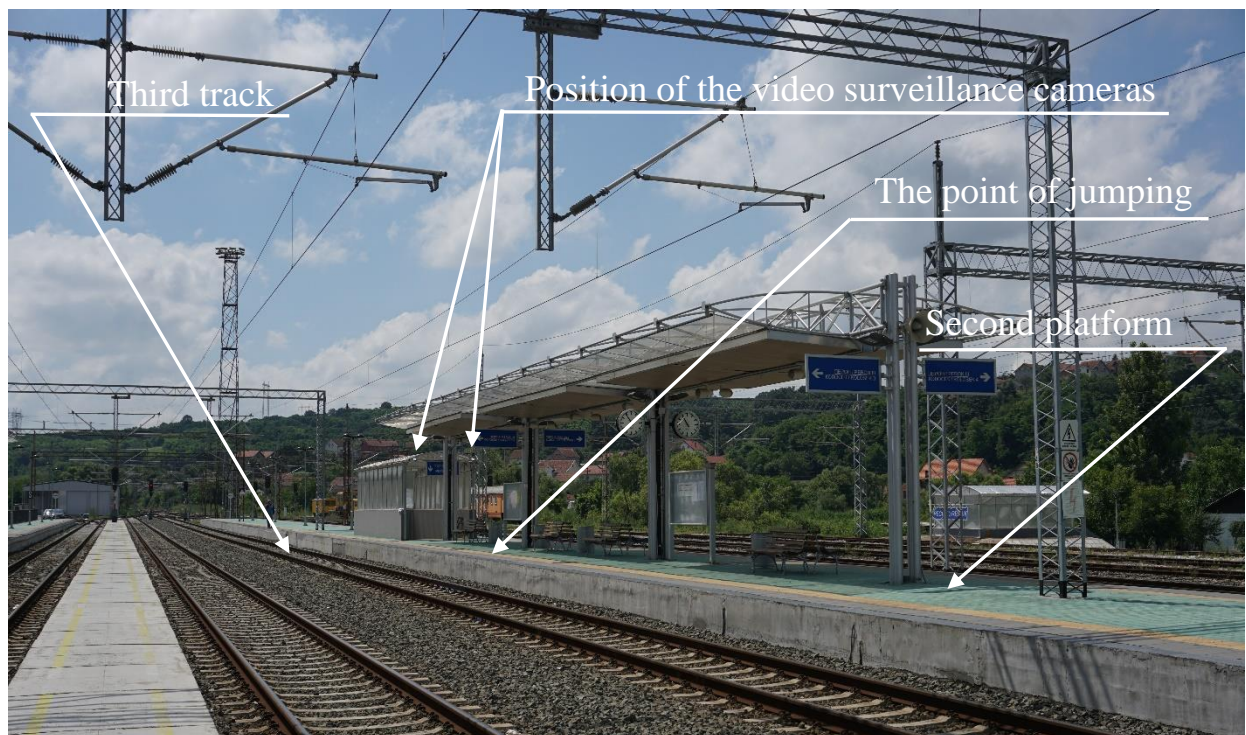
The appearance of the site of the serious accident, jumping of the railway worker out of the train No. 432, is shown in Figure 2.1.2.1.

Figure 2.1.2.1: The appearance of the point of jumping
(view from the direction of the station facility - of the first station track)

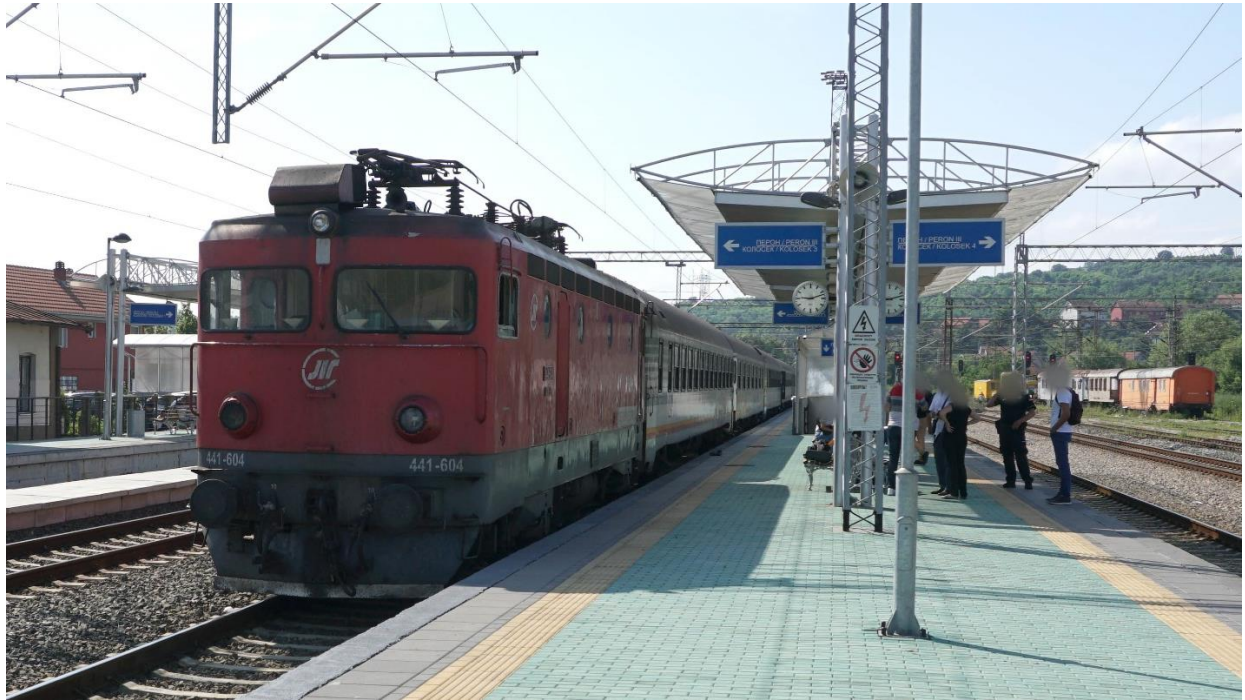
The appearance of the site where the train No. 432 stopped after the serious accident is shown in Figure 2.1.2.2.

Figure 2.1.2.2: The appearance of the site where the train stopped after the serious accident

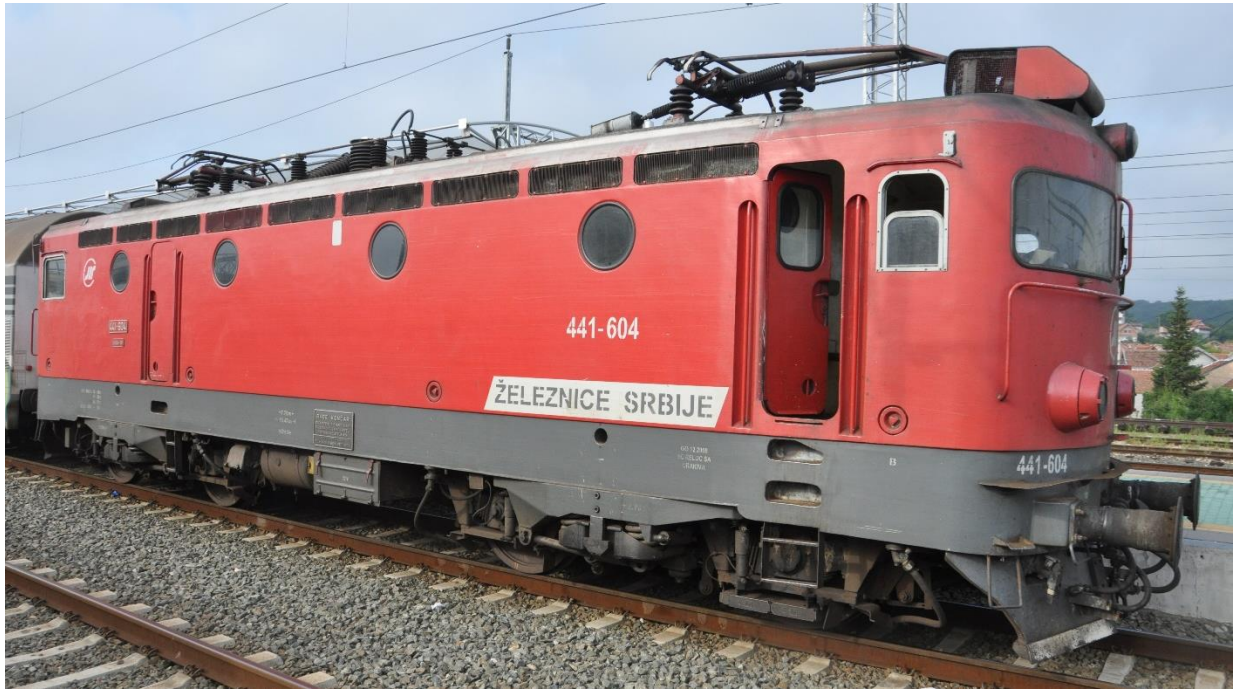
Figure 2.2.2.1: The appearance of the locomotive 441-604 (source: MUP RS)

There are two doors on the sides of the locomotive 441-604 (one door to enter the driver's cab and the other to enter the engine compartment). Doors to entry into the engine compartment do not have a window and are placed between the condenser windows. On all 4 doors there is a handle in the dented part of the door plating. The door lock does not lock, but can be locked from the inside by a movable lever. On each side of each door are handrails located in the dented space of the locomotive body plating. Below the doors for entrance into the driver's cab on the lower base there are two dents and two steps for entrance, and below the doors for entrance into the engine compartment there are one dent and two steps. The appearance of the doors of the side of the locomotive 441-604 is shown in Figure 2.2.2.1.

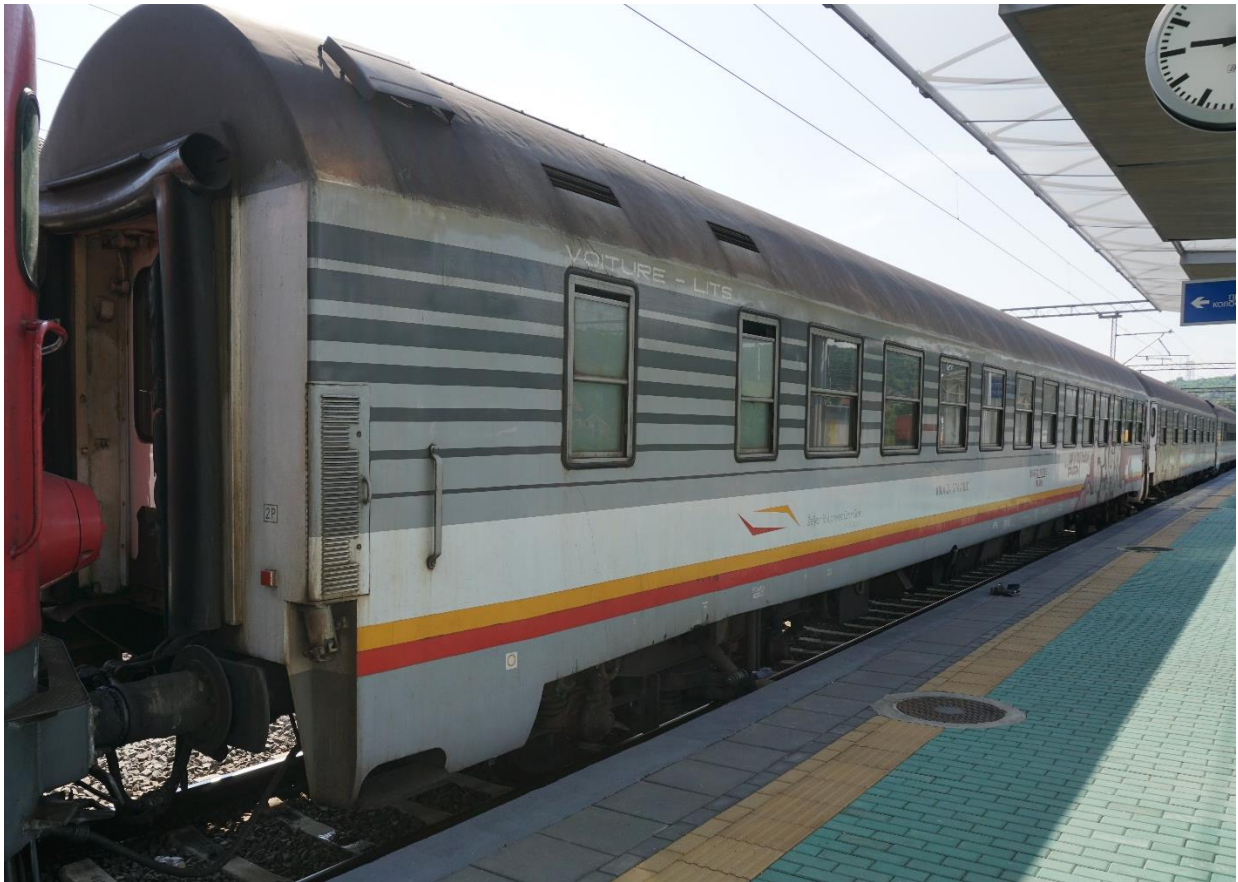
Figure 2.2.2.2: The appearance of wagon *WLABlm* - couchette car No. 50 62 72-10 510-3

Figure 2.2.2.2. shows the appearance of *WLABlm* wagon - sleeping car No. 50 62 72-10 510-3. The dead train driver, employed at the railway undertaking “Srbija Kargo” a.d., was found below the second axle of the first bogie of the given wagon (viewed in direction of train movement).

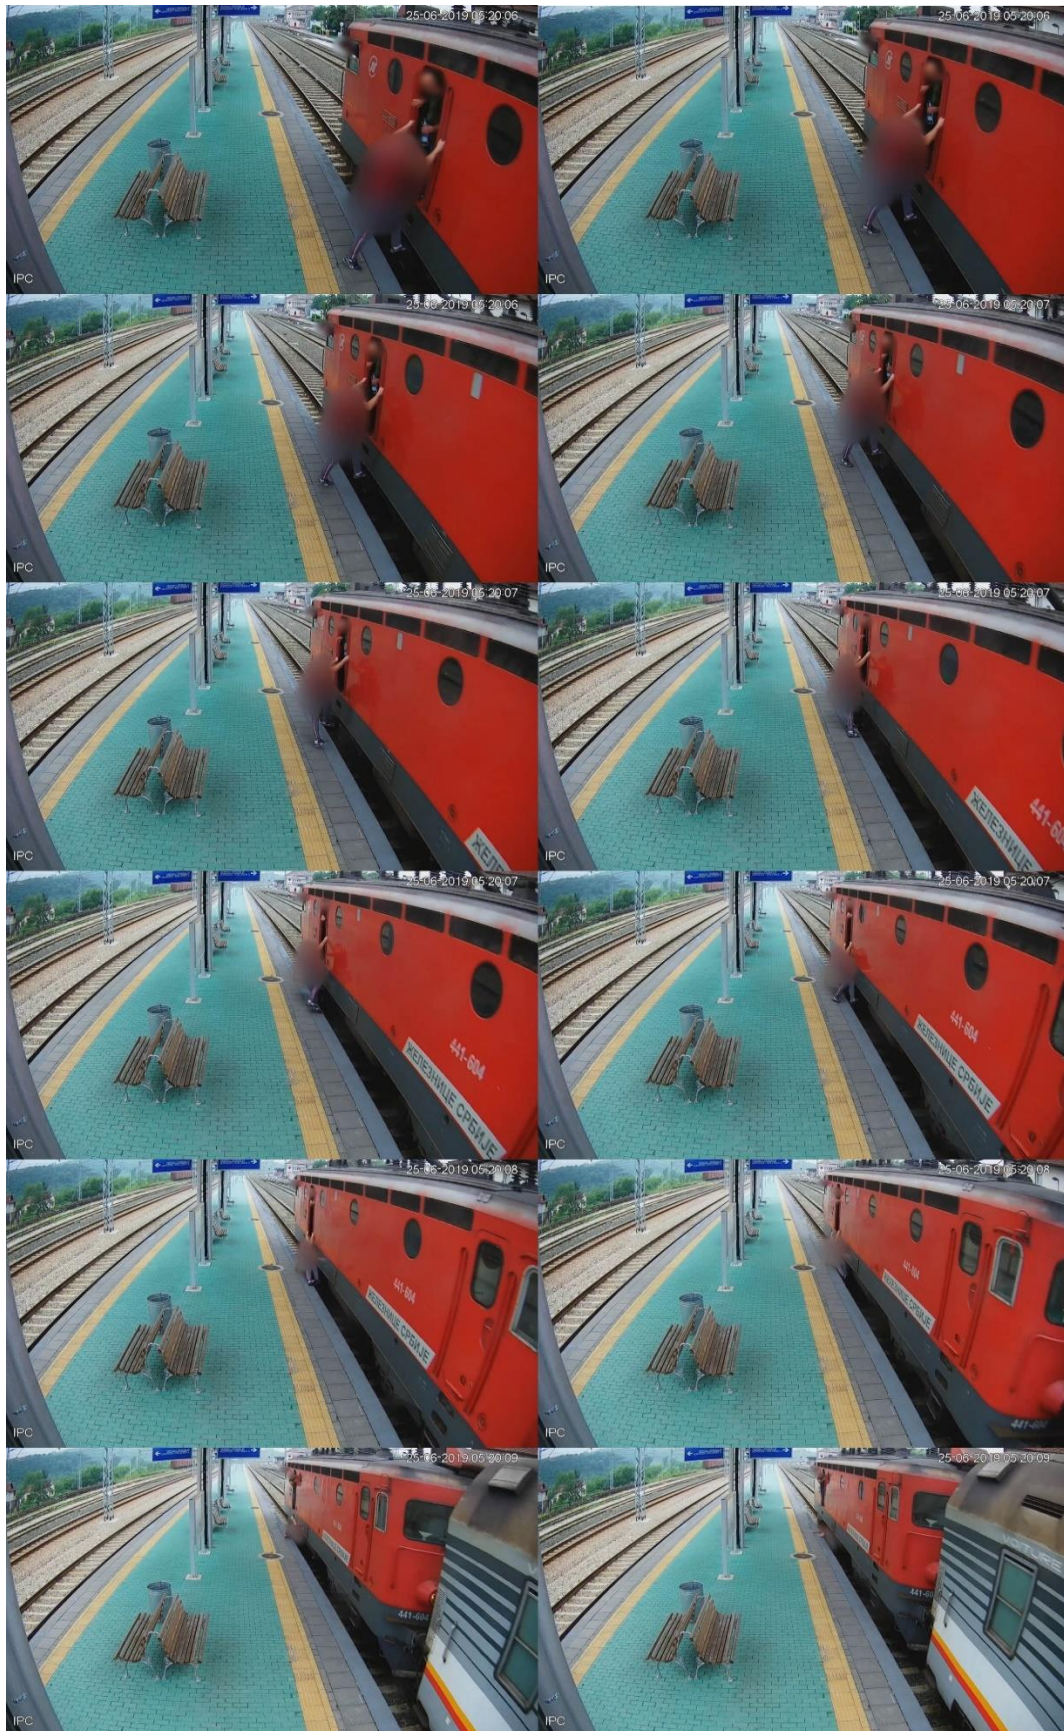
From "IŽS" a.d. a video recording (video) of surveillance cameras installed in the Resnik station on the roof structure of the entrance to the underpass was provided (see Figure 2.1.2.1.). The cameras are positioned so that the video can show the left part of train No. 432 (viewed in the direction of train movement) from the moment of passing of the train past where the cameras were placed. The video shows that at the moment when the train No. 432 (train locomotive 441-604) appears in the frame, the train driver employed by the railway undertaking "Srbija Kargo" a.d. traveling to work stands on the outside of the door of the locomotive engine compartment with his face turned toward the locomotive (back facing the second platform), holding with both hands by the holders placed on each side of the door of engine compartment of the locomotive, with his left foot resting on the step below the locomotive engine compartment, while he protruded his right leg back a short distance from the platform. At one point, with the foot of the right leg he touches the platform, the foot of the left leg falls from the stair to the platform and due to the movement of the train, he falls with all his body first on the platform and then to the space between the platform and the track, that is, between the platform and the train locomotive. The train driver of the locomotive 441-604 of the train No. 432 and the train driver who in the driver's cab of the locomotive 441-604 was travelling into the domicile after the shift were observing this event all the time, and the train driver of the locomotive 441-604 of the train No. 432 from the driver's cab of the locomotive with the protruded head through the side window of the driver's cab, and the train driver who in the driver's cab of the locomotive 441-604 of the train No. 432 was travelling into the domicile after the shift by standing in the locomotive on the side door of the locomotive's engine compartment.

The appearance of the video surveillance sequences immediately before the occurrence of the respective serious accident is given in Figure 4.2.2.1.

Figure 4.2.2.1: Video surveillance sequences immediately before the occurrence of the serious accident
(source: “IŽS“a.d.)
