REPUBLIC OF SERBIA
CENTER FOR INVESTIGATION OF ACCIDENTS IN TRANSPORT
SECTOR FOR INVESTIGATION OF ACCIDENTS IN RAILWAY TRAFFIC
Nemanjina 11, 11000 Belgrade

FINAL REPORT
ON INVESTIGATION OF A SERIOUS ACCIDENT

Accident type:	Serious accident on the level crossing
Train No.:	Shunting composition MS-4
Place:	City of Pančevo, city settlement Stara Misa, area of the industrial track of the Oil Refinery Pančevo ("NIS" a.d. Novi Sad)
Date:	09.01.2020.
Time:	02:35

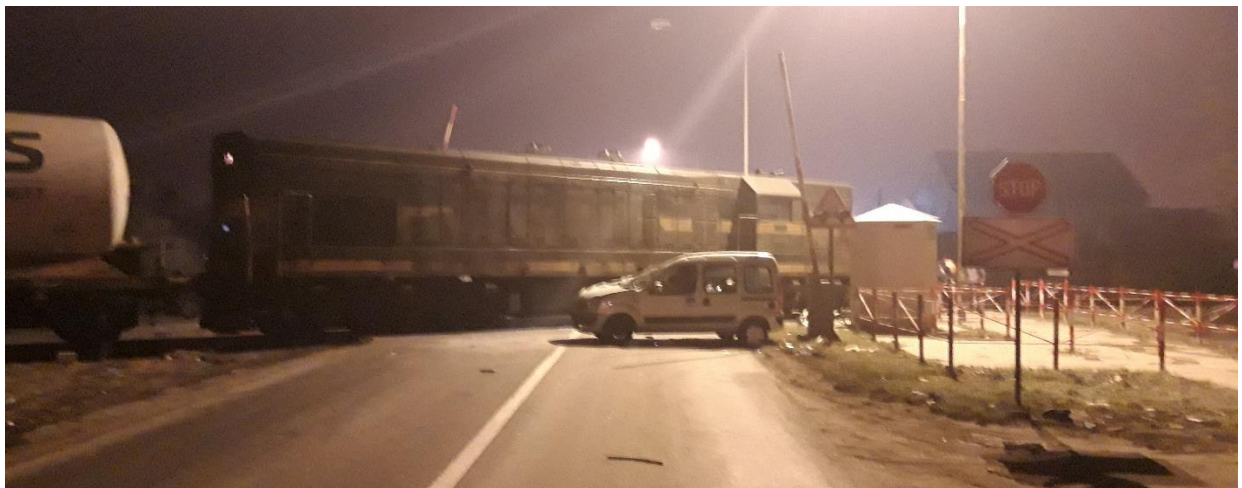
After the overtaking, the shunting composition MS-4 continued its movement further at the length of 12m, after which it stopped (Figure 2.1.2.1.).

Figure 2.1.2.1: Appearance of the shunting locomotive 661-155 and the road passenger vehicle after the serious accident (view from the road, in the direction opposite to the direction of the road passenger vehicle movement, source: "NIS"a.d.)

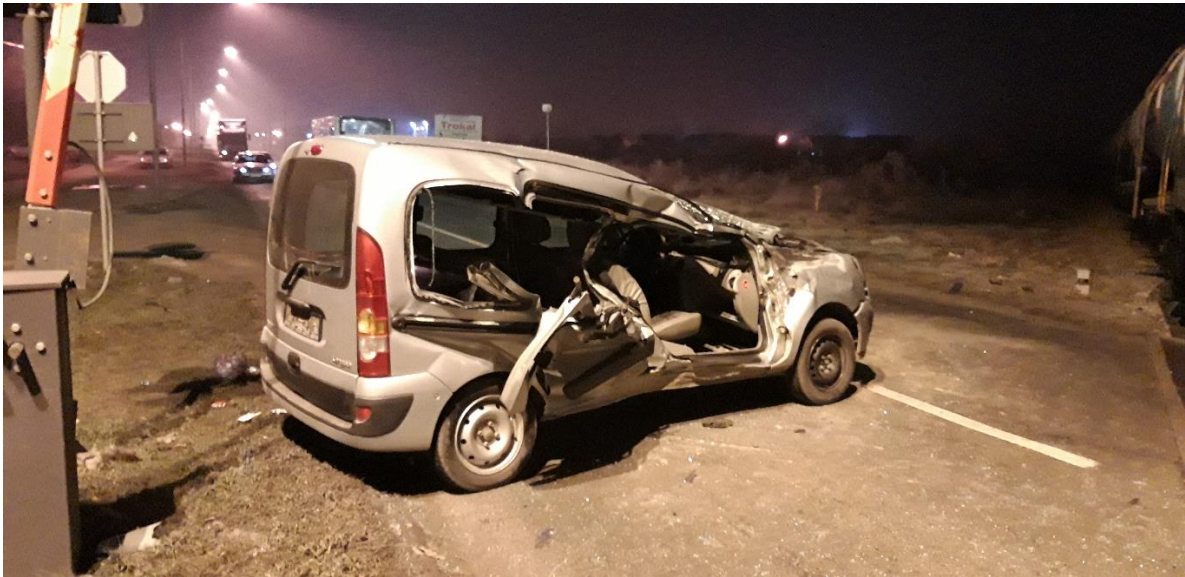
After the collision, the shunting composition MS-4 threw the road passenger vehicle to the right side in relation to the direction of movement of the shunting composition MS-4, i.e., to the left side in relation to the direction of movement of the road passenger vehicle, in the next road lane, upon which the road passenger vehicle rotated 90°. On that occasion, the right side of the road passenger vehicle was significantly damaged (Figure 2.1.2.2).

Figure 2.1.2.2: Appearance of the road passenger vehicle after the serious accident
(view in direction of the road passenger vehicle movement, source: “NIS”a.d.)

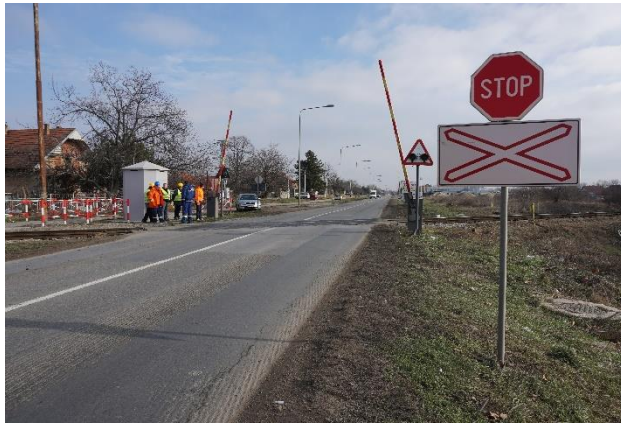
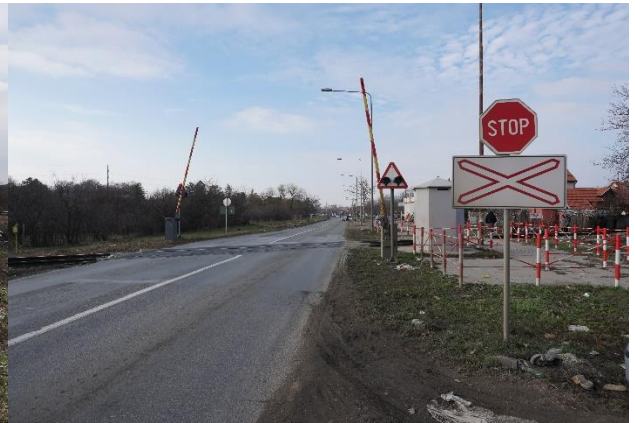
The appearance of the level crossing, viewed from the road, is shown in Figures 2.2.3.1. and 2.2.3.2.

Figure 2.2.3.1: Appearance of the level crossing
(viewed from the direction of the center of Pančevo)

Figure 2.2.3.2: Appearance of the level crossing
(view from the direction of Kovin)

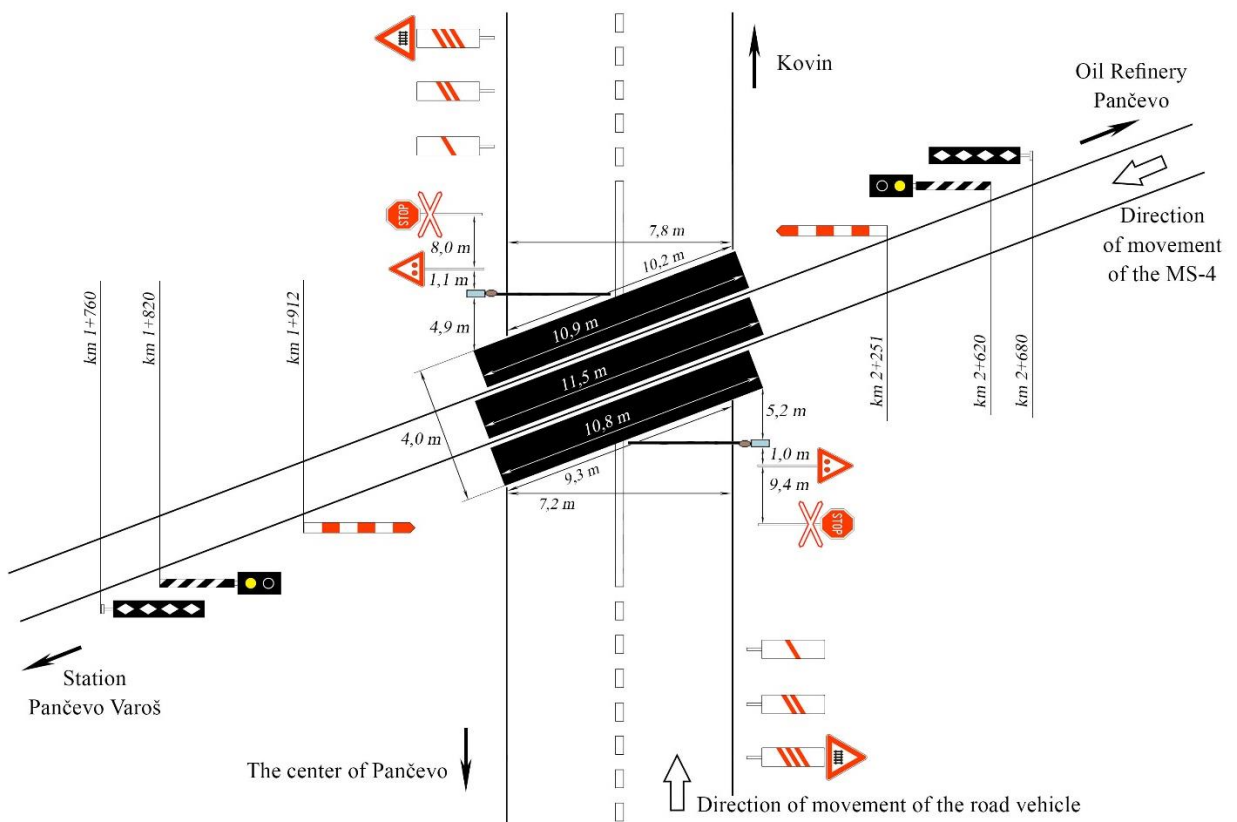
The sketch of the level crossing is shown in Figure 2.2.3.3.

Figure 2.2.3.3: The sketch of the level crossing

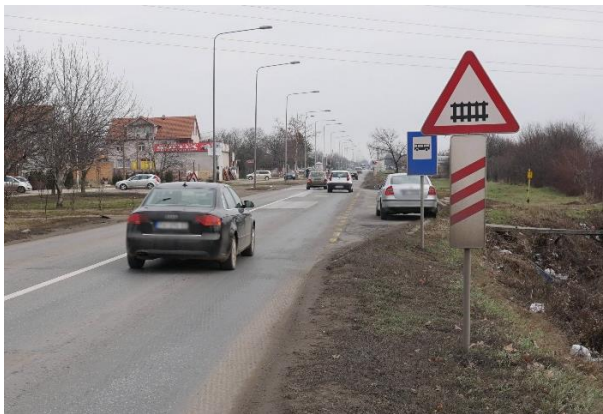
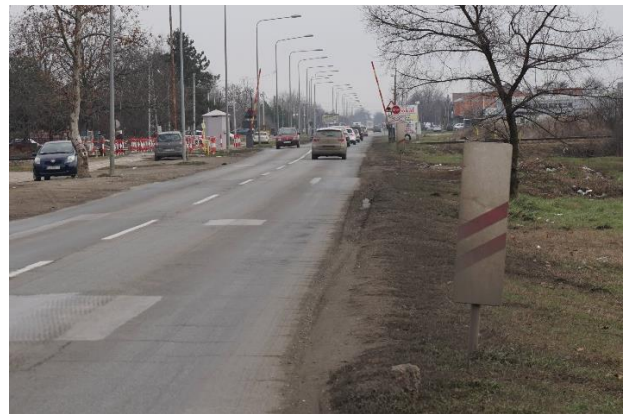
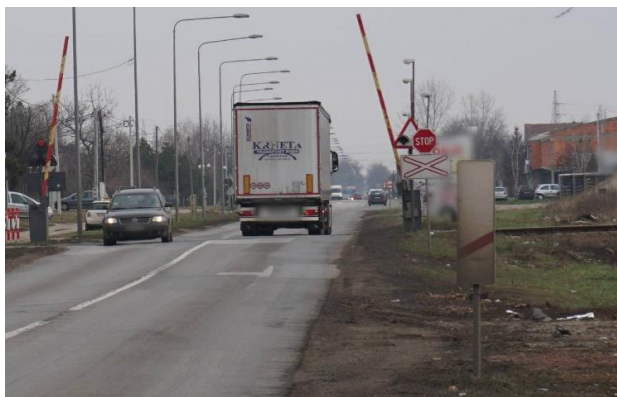
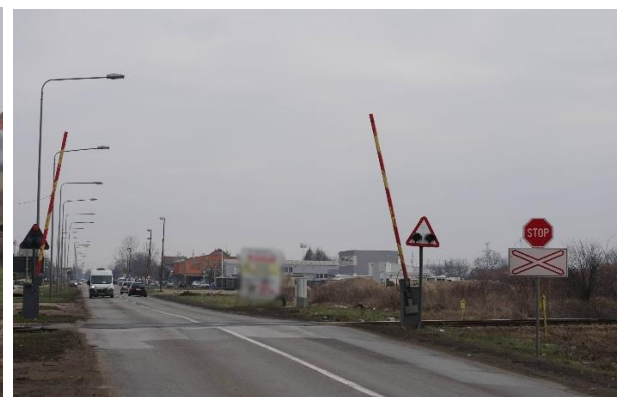
On the respective state road, before encountering the level crossing from the direction of the center of Pančevo to Kovin, on the supporter, which is located on the right side of the road next to the roadway and is approximately 240 m away from the level crossing, traffic signs are set: I-32: “Crossing of a railway line with barriers or semi-barriers” and I-35: “Approaching the point of crossing of the road and the railway line” (Figure 2.2.3.4.). On the supporter, which is located on the right side of the road next to the roadway, and is approximately 160 m away from the level crossing, there is a traffic sign: I-35: “Approaching the point of crossing of the road and the railway line” (Figure 2.2.3.5.). On the supporter, which is located on the right side of the road next to the roadway and is 80 m away from the level crossing, there is a traffic sign: I-35: “Approaching the point of crossing of the road and the railway line” (Figure 2.2.3.6.). On the supporter, which is located on the right side of the road next to the roadway and is 15.6 m away from the level crossing (the beginning of the rubber panel), traffic signs are set: I-34: “Andrejin krst” and II-2: “Obligation of stopping”, on the supporter, which is located on the right side of the road next to the roadway and is 6.2 m away from the level crossing (the beginning of the rubber panel), a traffic light is set: IV-9 which regulates the crossing of the road over the railway at the same level (used for announcement of approaching train and announcing the lowering of the barrier) and on the right side of the road next to the roadway and 5.2 m away from the level crossing (the beginning of the rubber panel) a half-barrier supporter has been set at the level crossing (Figure 2.2.3.7).

Figure 2.2.3.4: Appearance of the traffic signalization
(view from the direction of the center of Pančevo)

Figure 2.2.3.5: Appearance of the traffic signalization
(view from the direction of the center of Pančevo)

Figure 2.2.3.6: Appearance of the traffic signalization
(view from the direction of the center of Pančevo)

Figure 2.2.3.7: Appearance of the traffic signalization
(view from the direction of the center of Pančevo)

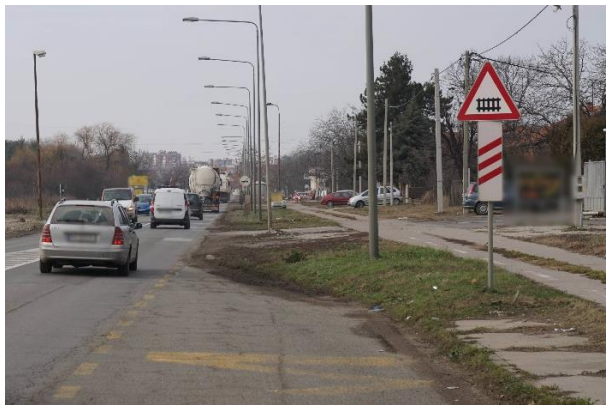
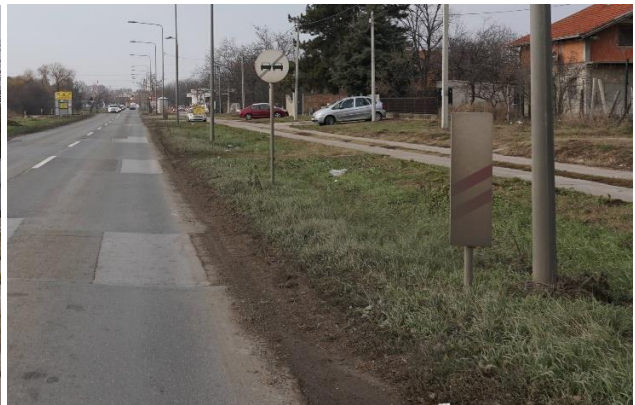
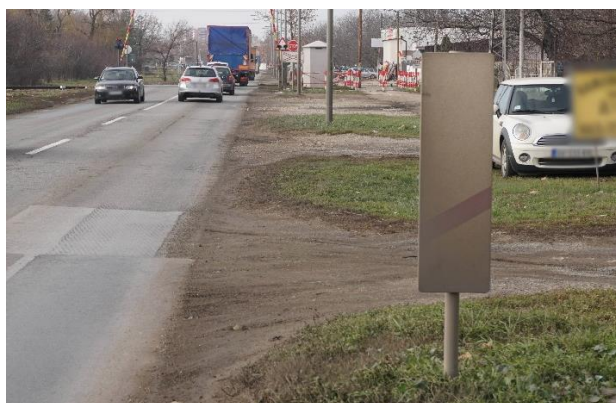
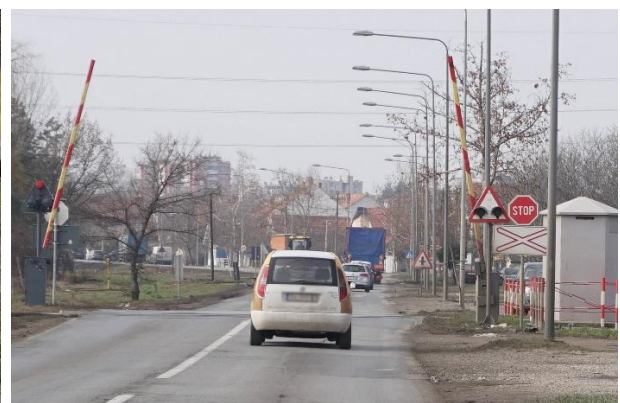
On the respective state road, before encountering the level crossing from the direction of Kovin to the center of Pančevo, on the supporter, which is located on the right side of the road next to the roadway and is approximately 240 m away from the level crossing, traffic signs are set: I-32: “Crossing of a railway line with barriers or semi-barriers” and I-35: “Approaching the point of crossing of the road and the railway” (Figure 2.2.3.8.). On the supporter, which is located on the right side of the road next to the roadway and is approximately 160 m away from the level crossing, there is a traffic sign: I-35: “Approaching the point of crossing of the road and the railway” (Figure 2.2.3.9.). On the supporter, which is located on the right side of the road next to the roadway and is approximately 80 m away from the level crossing, a traffic sign: I-35 is set: “Approaching the point of crossing of the road and the railway” (Figure 2.2.3.10.). On the supporter, which is located on the right side of the road next to the roadway and is 14.0 m away from the level crossing (the beginning of the rubber panel), traffic signs are set: I-34: “Andrejin krst” and II-2: “Obligation of stopping”, on the supporter, located on the right side of the road next to the roadway and is 6.0 m away from the level crossing (the beginning of the rubber panel), the traffic light is set: IV-9 which regulates crossing of the road over the railway line at the same level (it serves for announcement of approaching of the train and lowering the semi-barriers) and on the right side of the road next to the roadway, 4.9m away from the level crossing (the beginning of the rubber panel) the supporter of semi-barrier is set on the level crossing (Fig. 2.2.3.11.).

Figure 2.2.3.8: Appearance of the traffic signalization
(view from the direction of Kovin)

Figure 2.2.3.9: Appearance of the traffic signalization
(view from the direction of Kovin)

Figure 2.2.3.10: Appearance of the traffic signalization
(view from the direction of Kovin)

Figure 2.2.3.11: Appearance of the traffic signalization
(view from the direction of Kovin)

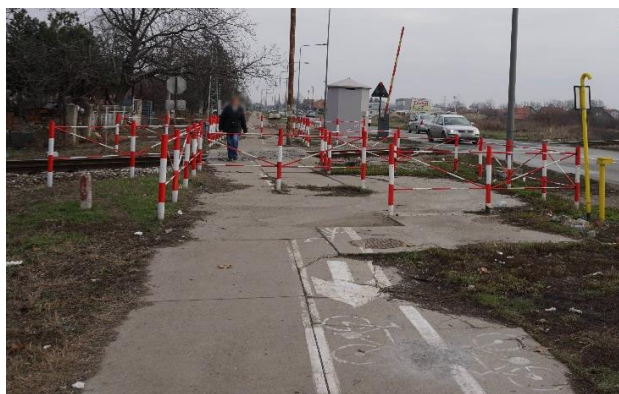
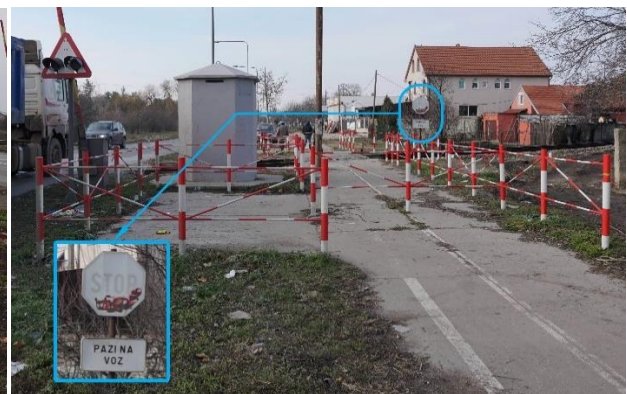
On the left side of the state road, seen in the direction from Pančevo to Kovin, there is a concrete pedestrian and bicycle path. Traffic at the crossing of pedestrian and bicycle path over the industrial track is secured with bypasses and traffic signs at level crossings for pedestrians and cyclists. On the pedestrian and bicycle path, the drive ramps are made of concrete, and at the level crossing itself there are stacked granite cubes (cobblestones). Bypasses exist on both sides of the level crossing and are painted red and white. On the pedestrian and bicycle path, before encountering the level crossing from the direction of Kovin to the center of Pančevo, on the same supporter, which is located on the right side next to the pedestrian and bicycle path, the traffic sign II-2: “Obligation of stopping” is set, as well as supplementary table: “Watch out of the train”. Before encountering the level crossing for pedestrians and cyclists from the direction of the center of Pančevo towards Kovin, there are no traffic signs set in front of the level crossing (Figures 2.2.3.12. and 2.2.3.13.).

Figure 2.2.3.12: Appearance of the pedestrian and bicycle path (view from the direction of Pančevo)

Figure 2.2.3.13: Appearance of the pedestrian and bicycle path (view from the direction of Kovin)

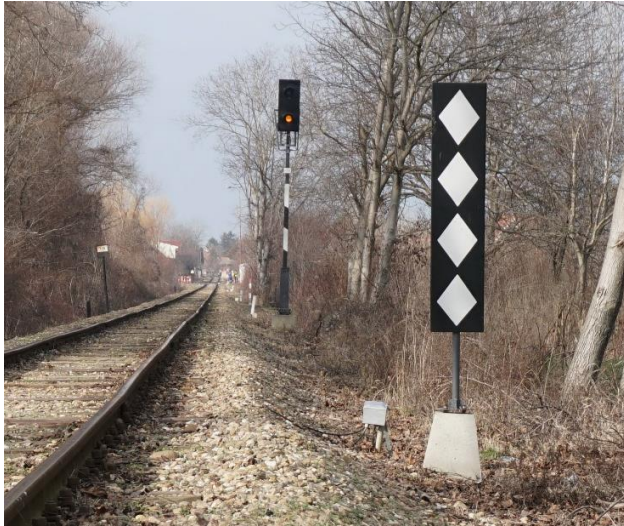
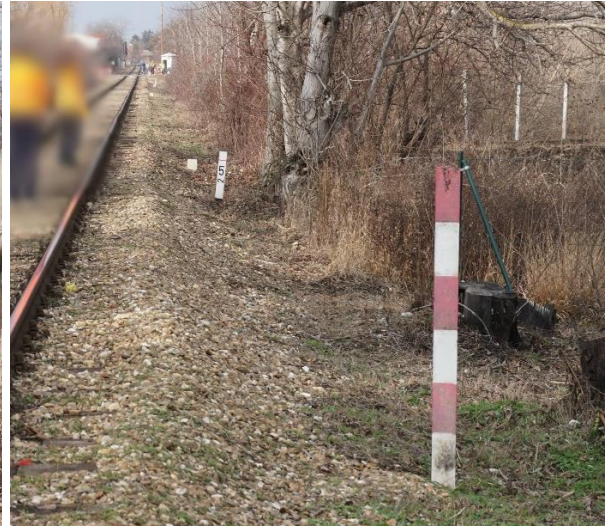
On the industrial track, before encountering the respective level crossing from the direction of the Marshalling Yard of the Pančevo Oil Refinery to the Pančevo Varoš station, at km 2+680, the switch-on point signal was installed, aspect of a signal 57: “Switching point, expect control signal”, and at km 2+620, the control light signal KS 2 was installed (Figure 2.2.3.14) and at km 2+521 the signalling mark 209 was installed: “Watch out, the level crossing” (Figure 2.2.3.15).

The mentioned signals and the signalling mark are installed on the right side of the track, viewed in the direction of the descending stationing, that is, viewed in the direction of movement of the MS-4 shunting composition.

Figure 2.2.3.14: Appearance of the signal on the industrial track (view from the direction of Pančevo Oil Refinery)

Figure 2.2.3.15: Appearance of the signalling mark 209 (view from the direction of Pančevo Oil Refinery)

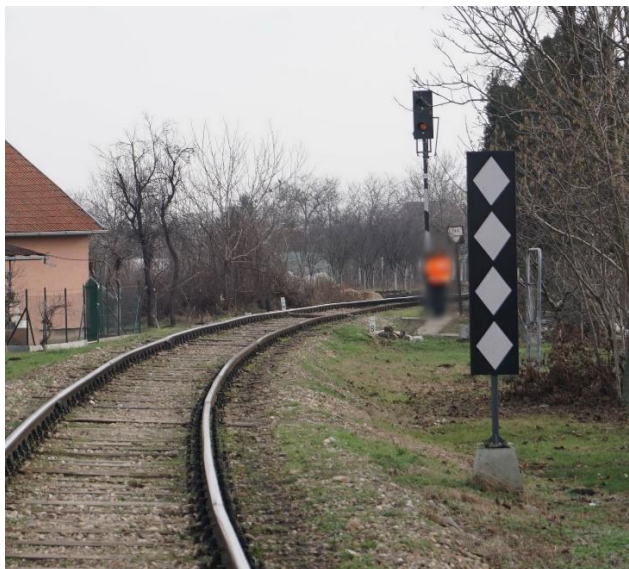
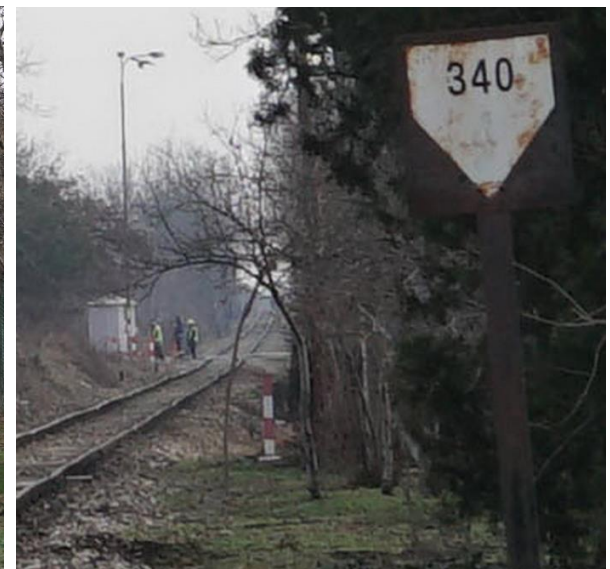
On the industrial track, before encountering the respective level crossing from the direction of the Pančevo Varos station to the Marshalling Yard of the Pančevo Oil Refinery, at km 1+760, the switch-on point signal was installed, aspect of a signal 57: “Switching point, expect control signal”, at km 1+820, the control light signal KS 1 was installed (Figure 2.2.3.16) and at km 1+912 the signalling mark 209 was installed: “Watch out, the level crossing” (Figure 2.2.3.17). These signals and signalling mark are installed on the right side of the track, viewed in the direction of increasing stationing.

Figure 2.2.3.16: Appearance of a signal on the industrial track (view from the direction of the station Pančevo Varoš)

Figure 2.2.3.17: Apparency of the signalling mark 209 (view from the direction of the station Pančevo Varoš)

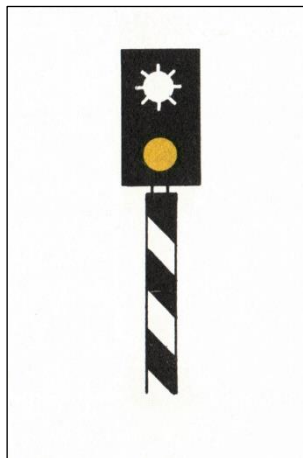
Figure 82

one yellow calm and above it one white flashing light towards the train (see Figure 82).

The white flashing light turns on and off in the rhythm of the road traffic sign in front of the level crossing.

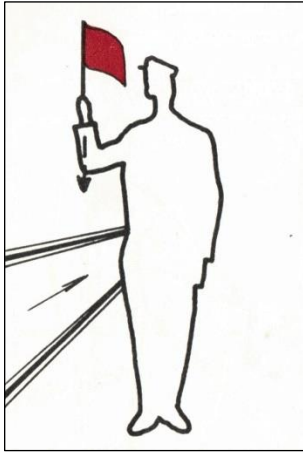
Figure 135.

wave the developed signal flag vertically up and down in short strokes, and in addition one short whistle with a mouth whistle: ● (see Fig. 135);
