# **Beyond Human Error**

A HOF Approach to understanding incidents and controlling major risks

European Rail Safety Days, November 2021

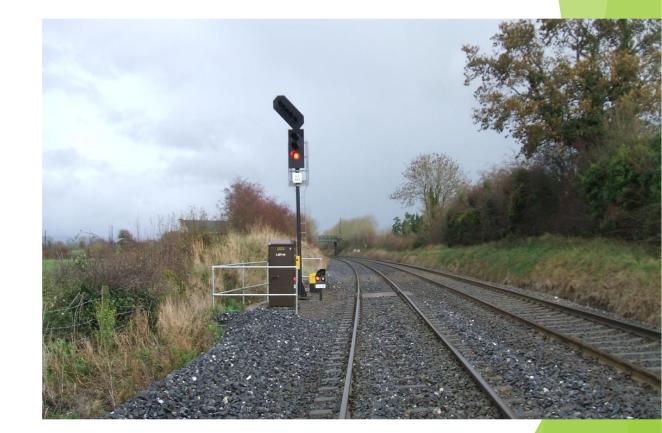
- Three SPADs at this signal in 8 years
  - 2011, 2017, 2019
- Signal is on the approach to a loop platform
  - Signal at the end of the loop is approach controlled
  - Therefore, signal is usually encountered at yellow
  - Approximately once a day, a train crosses in front of a train scheduled to approach, so the signal is red

- Approach control on the signal in the platform sets a strong expectation for the signal before the one SPADed to be a double yellow
- The isolated 4 aspect signal introduces the possibility to confuse which signal is red
- CAWS uses the same tone for yellow and double yellow aspects
- Restricted view of the SPADed signal limits the opportunity to recover from the error
