STATE COMMISSION ON RAILWAY ACCIDENT INVESTIGATION
Ministry of the Interior and Administration

REPORT No. PKBWK 3/2025

**on the investigation of a serious railway accident
that occurred on 3 December 2023 at 10:06 hrs at Jaszczów station
at turnout no. 1 on track 1, at km 201.000 of railway line no. 7
Warszawa Wschodnia Osobowa - Dorohusk,
the area of infrastructure manager PKP PLK S.A. Railway Line Plant in Lublin**

WARSAW, 15 April 2025

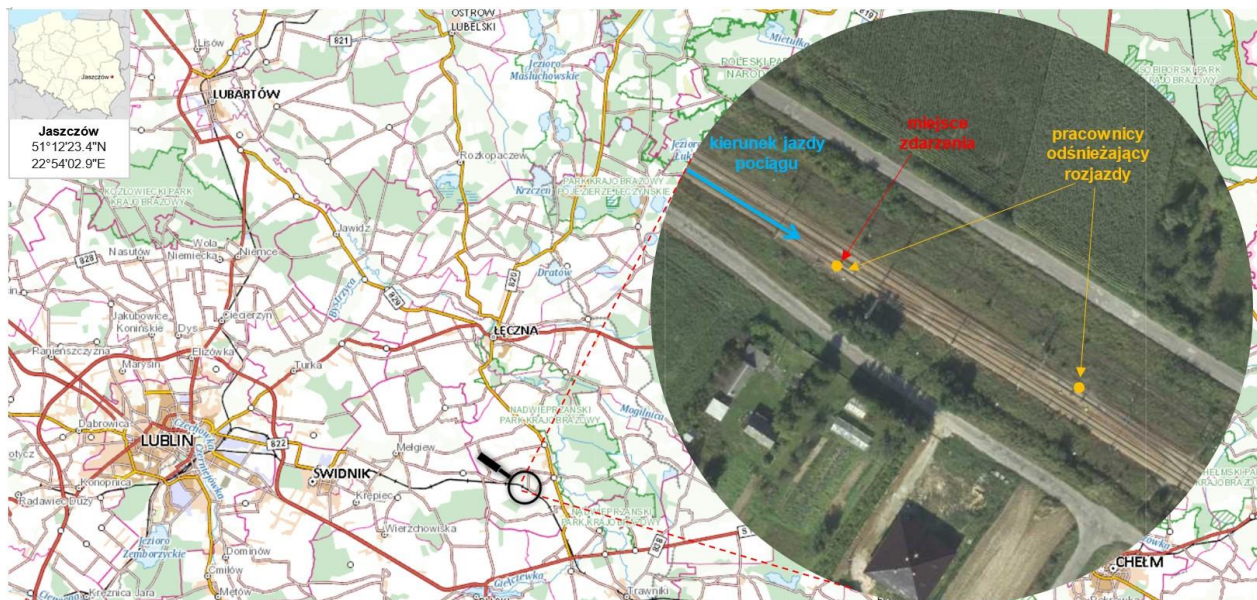
Photograph 1– A general view of the occurrence site (source: Geoportal)

Before the station entry, track 1 is situated on a slope gradient of 8.6 % and in a right-hand curve with a radius of $R=903$ m.

Meteorological conditions: overcast sky, sparse snowfall, good visibility and audibility, air temperature minus 3°C, moderate gusts of wind, 22 cm snow cover.
