STATE COMMISSION ON RAILWAY ACCIDENT INVESTIGATION
Ministry of the Interior and Administration

REPORT No. PKBWK 05/2025

**on the investigation of a serious railway accident that occurred on 1 July 2024 at 09:19 hrs
on the Ożarów Mazowiecki - Błonie route, track no. 2, category B level crossing at km
17.211 of railway line no. 3 Warszawa Zachodnia - Kunowice,
area of infrastructure operator PKP PLK S.A. Railway Line Plant
in Warsaw**

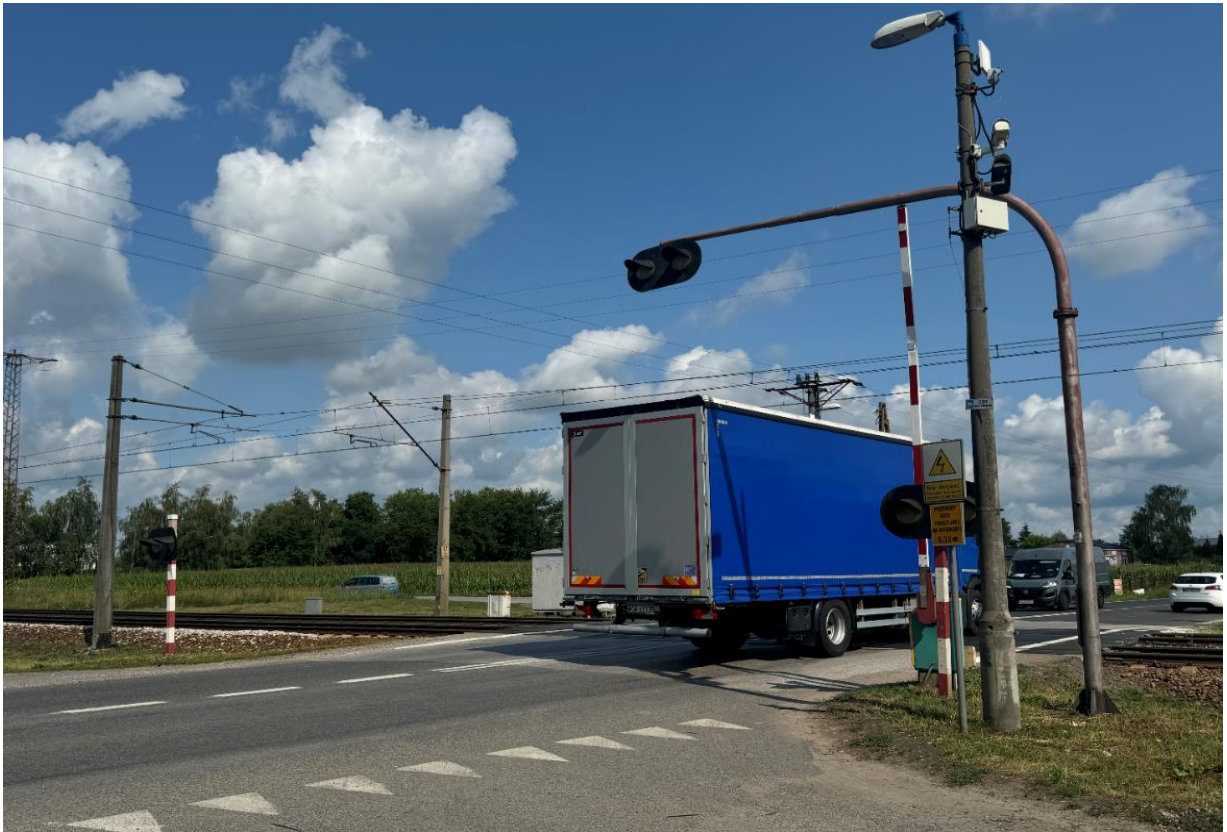
Photograph 4– A general view of the occurrence site (source: PKBWK)

The Category B crossing, identification number 003 017 211, where the serious accident occurred is located on Class G voivodeship road no. 718 Borzęcin - Pruszków, road kilometre 6.080, Ceramiczna Street, in the vicinity of the town of Ołtarzew, Municipality of Ożarów Mazowiecki. The road is made of an asphalt surface with a dirt shoulder. The width of the roadway on the crossing is 9.0 m. As at the day of the occurrence, the permitted speed of road vehicles on the road in the area of the crossing was 90 km/h, the angle of intersection of the road with the railway tracks was 90°. The area of the intersection of the railway line and the road is located outside a built-up area in the vicinity of the town of Ołtarzew in the Warsaw West County, Mazowieckie Voivodeship. Along voivodeship road DW718, on both sides of the crossing, there are road signs A-9, G-1a, G-1b, G-1c, G-2, and boards informing on the height of the suspension of the catenary line.

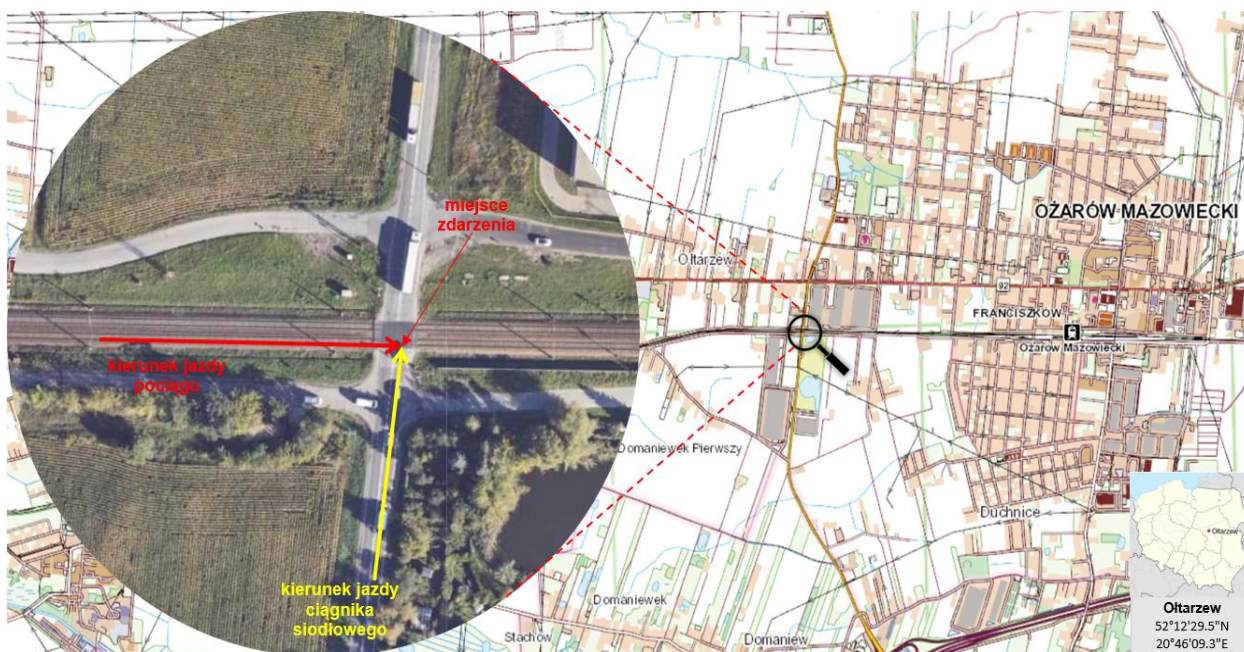
Figure 1– General view of the occurrence site (source: Geoportal)
