REPUBLIC OF SERBIA  
CENTER FOR INVESTIGATION OF ACCIDENTS IN TRANSPORT  
SECTOR FOR INVESTIGATION OF ACCIDENTS IN RAILWAY TRAFFIC  
Nemanjina 11, 11000 Belgrade

## FINAL REPORT ON ACCIDENT INVESTIGATION

Accident type: Train collision

Location: Belgrade, Vračar tunnel, between the station Vukov Spomenik and Pančevački Most junction and halt.

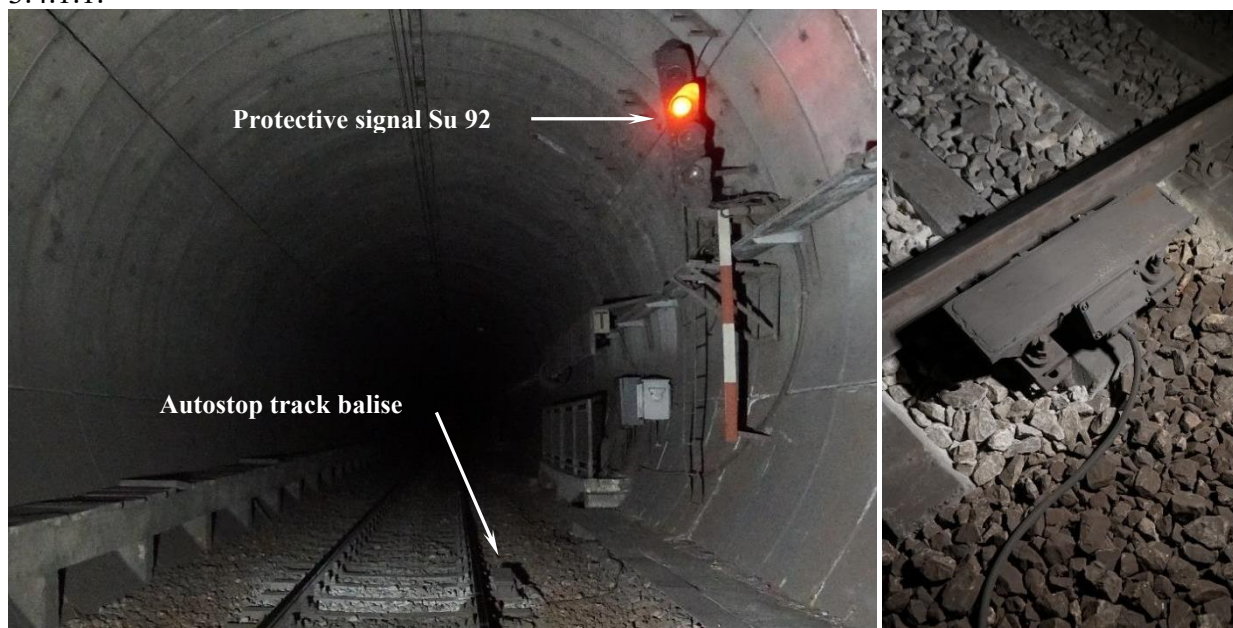
**Figure 3.4.1.1:** The appearance of the autostop track balise installed at the Su92 protective signal

An on-site inspection, the CINS working group found that in the tunnel near the Su92 protective signal there was installed an autostop track balise. It was undamaged.

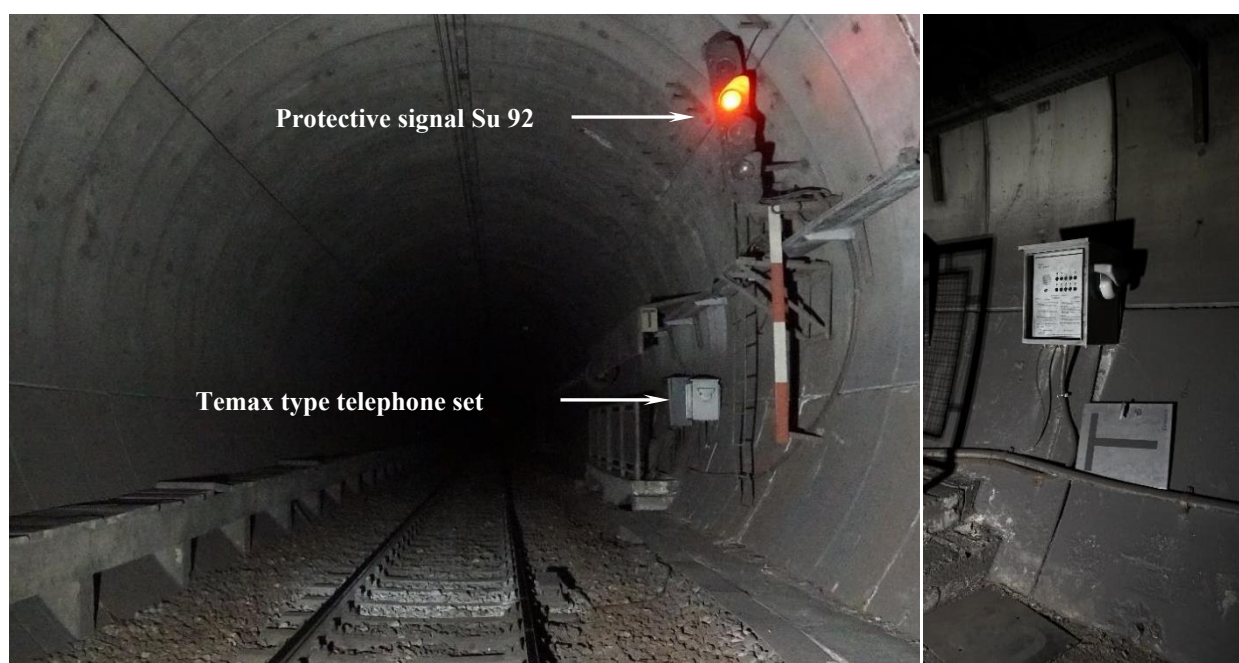
**Figure 3.4.3.1:** Appearance of a Temax type telephone set built into the Su92 protective signal

During an on-site inspection by the CINS working group, it was determined that a Temax telephone was installed in the tunnel near the Su92 protective signal, from which it was possible to establish contact with train dispatchers at the Vukov Spomenik and Pančevački Most junction and halt. It was in good condition and in operation.

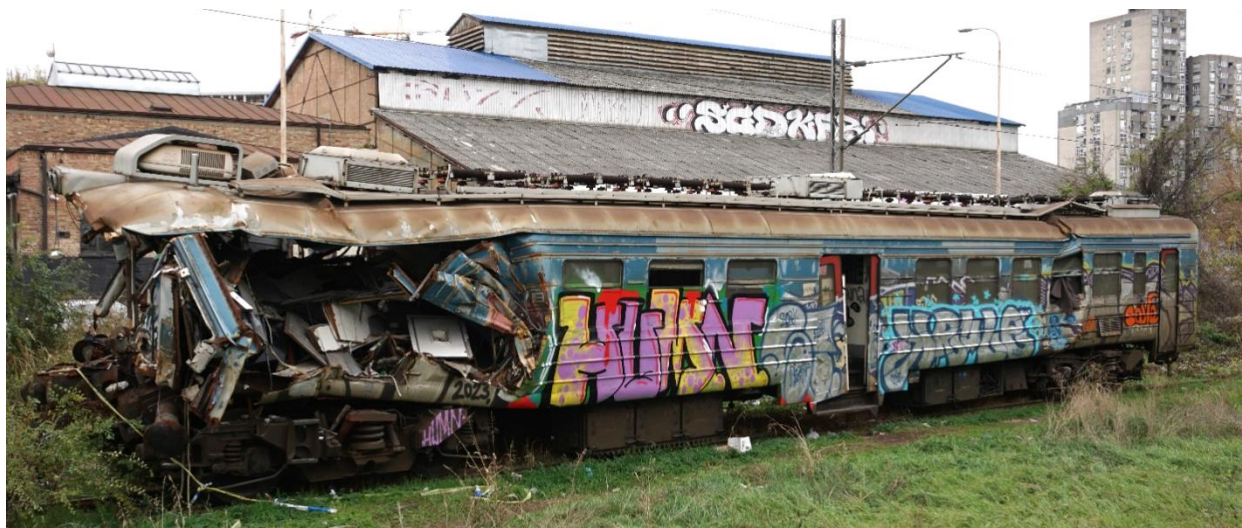
**Figure 4.2.5.1:** Appearance of the motor coach 412-005

The motor coach 412-005 was inspected on 20.11.2024 at the Pančevački Most station, on the Danube track. The appearance of the motor coach 412-005 as found on site is shown in Figures 4.2.5.1, 4.2.5.2, 4.2.5.3. and 4.2.5.4.

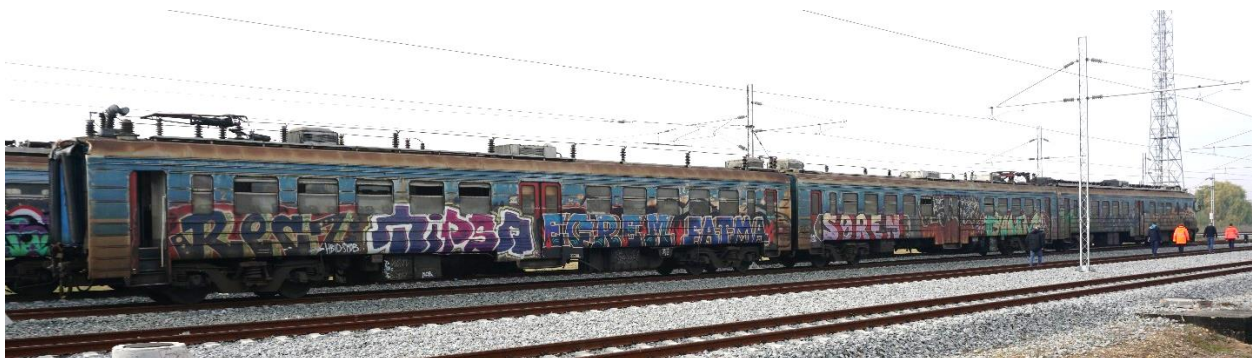
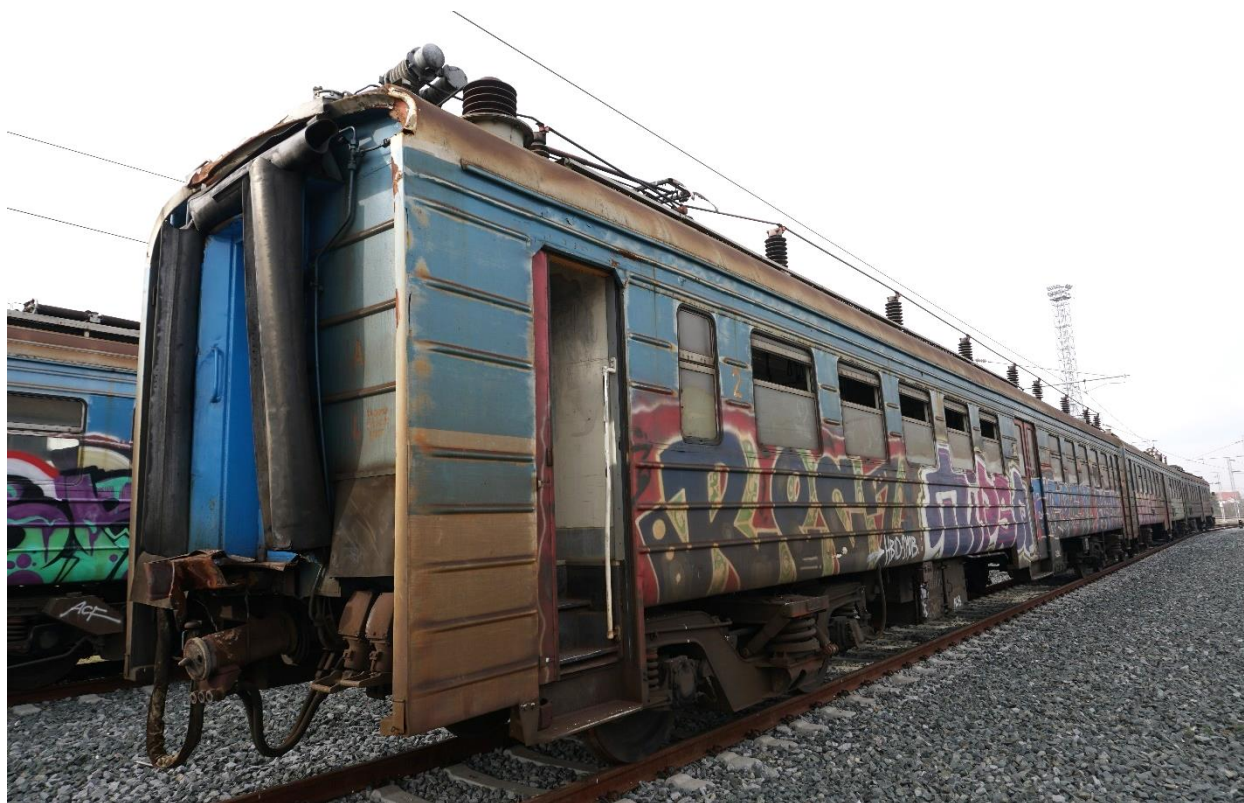
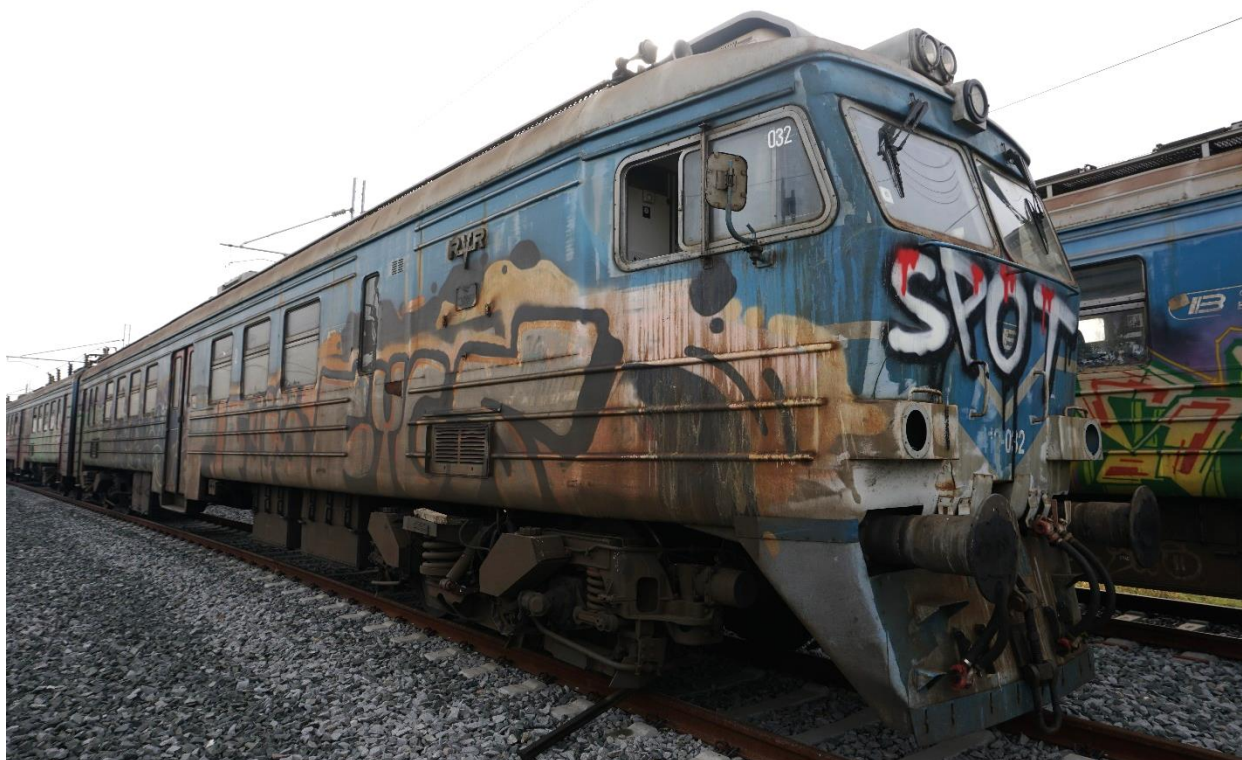
**Figure 4.2.5.8:** Appearance of the trailer vehicles 416-013 and 416-095 and the motor coach 412-032

**Figure 4.2.5.9:** Appearance of the trailer vehicle 416-013

**Figure 4.2.5.10:** Appearance of the motor coach 412-032

A visual inspection of the trailer vehicles 416-013 and 416-095 and motor coach 412-032 found that the two trailer vehicles and the motor coach are complete. All parts of the subassemblies are present in their places. The bogies are in good condition with the presence of deformations resulting from the accident (on the motor coach 412-032, the shunter's poles are bent and damage was observed on the body of the trailer vehicles 416-013, see pictures 4.2.5.11, 4.2.5.12. and 4.2.5.13.).

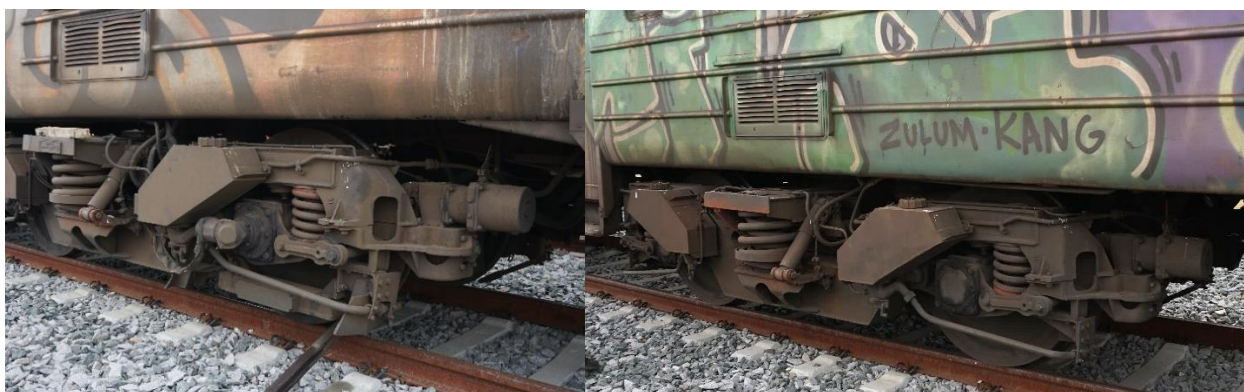
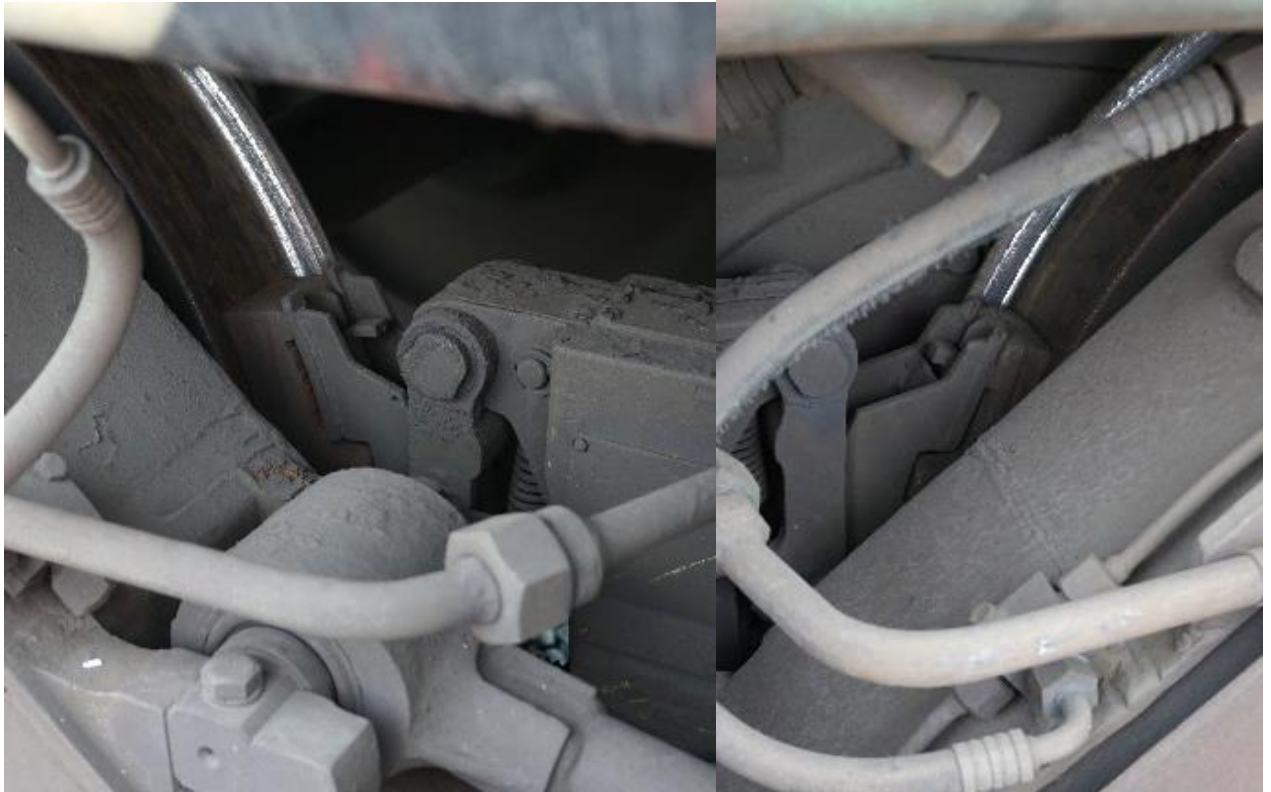
**Figure 4.2.5.11:** Appearance of the bogies of the motor coach 412-032

**Figure 4.2.5.12:** Appearance of the brake blocks at the bogies of the motor coach 412-032

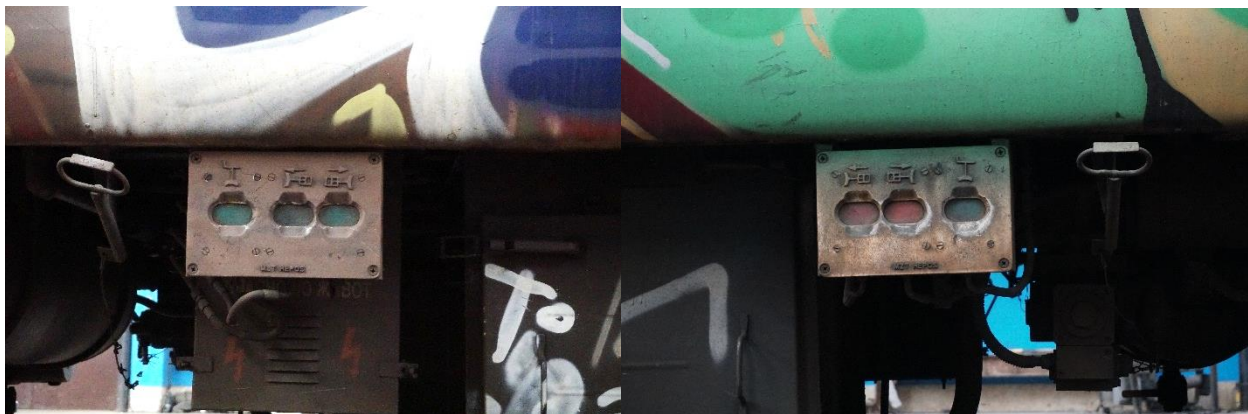
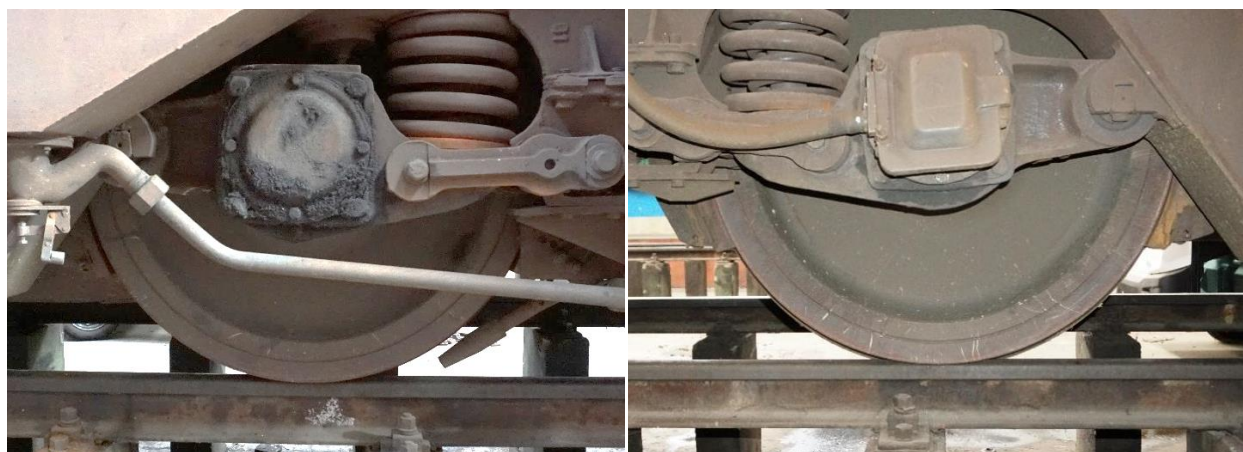
During the brake test in place, it was found that all vital brake devices (main and auxiliary compressed-air reservoir, main air conductor, brake cylinders, brake blocks, ...) were in good condition and functioning (see Figures 4.2.5.17. and 4.2.5.18.).

**Figure 4.2.5.17:** Appearance of the brake indicator on the trailer vehicle 416-013 (in the released position) and trailer vehicle 416-095 (in the locked position)

**Figure 4.2.5.18:** Appearance of brake blocks in the released position (left) and locked position (right)

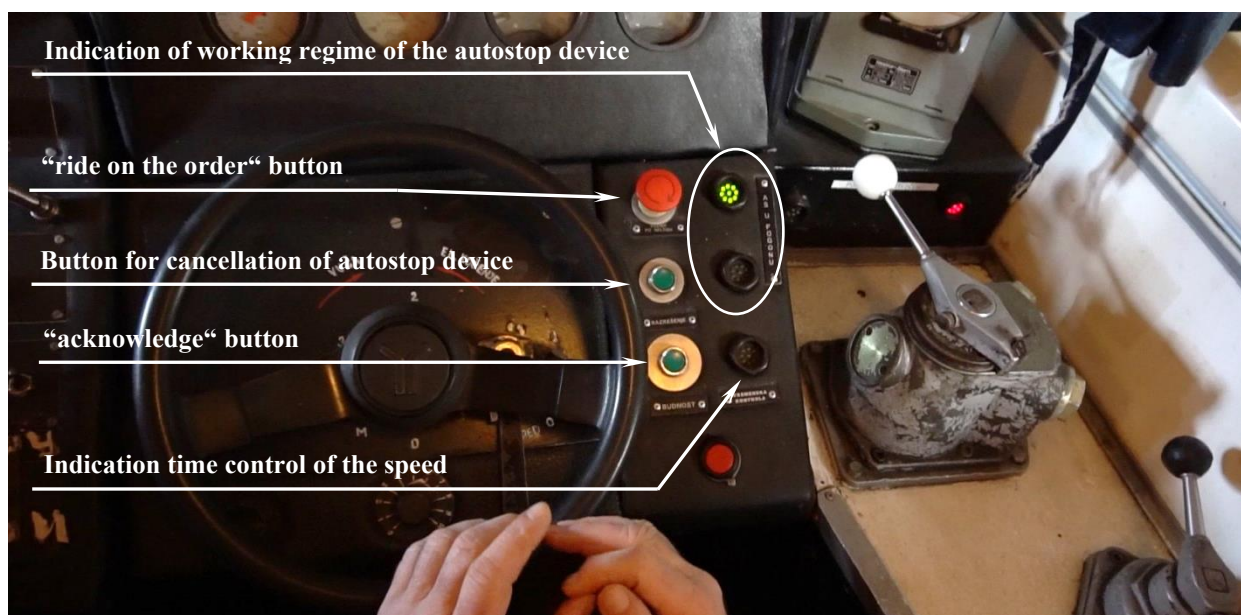
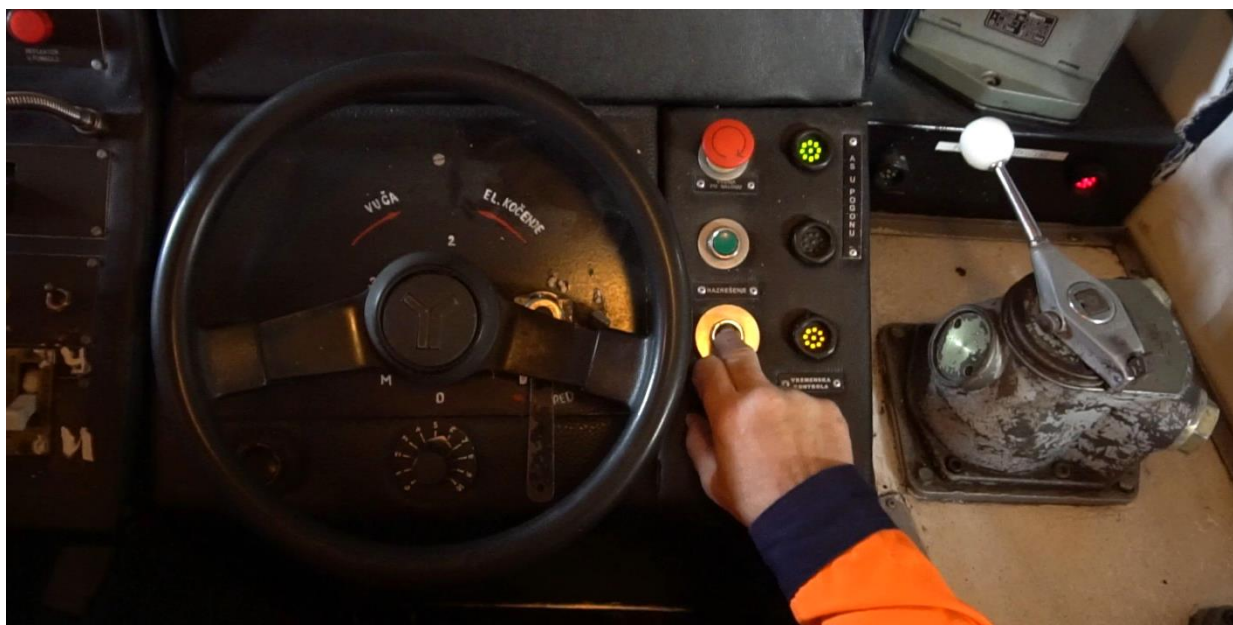
The autostop device was tested by simulating the impact of the track autostop balise on the locomotive receiver head of the autostop device and by monitoring the indications in the driver's cab of the 412-032 motor coach. It was found that the autostop device responded correctly to frequencies of 1000 Hz (passing through a yellow signal) and 2000 Hz (passing through a red signal) and initiated forced braking if the "acknowledge" or "ride on the order" buttons were not operated, respectively.

**Figure 4.2.5.19:** Appearance of the block of switches and signal lamps of the autostop device

**Figure 4.2.5.20:** Appearance of the use of the "acknowledge" button and the indication of the time speed control

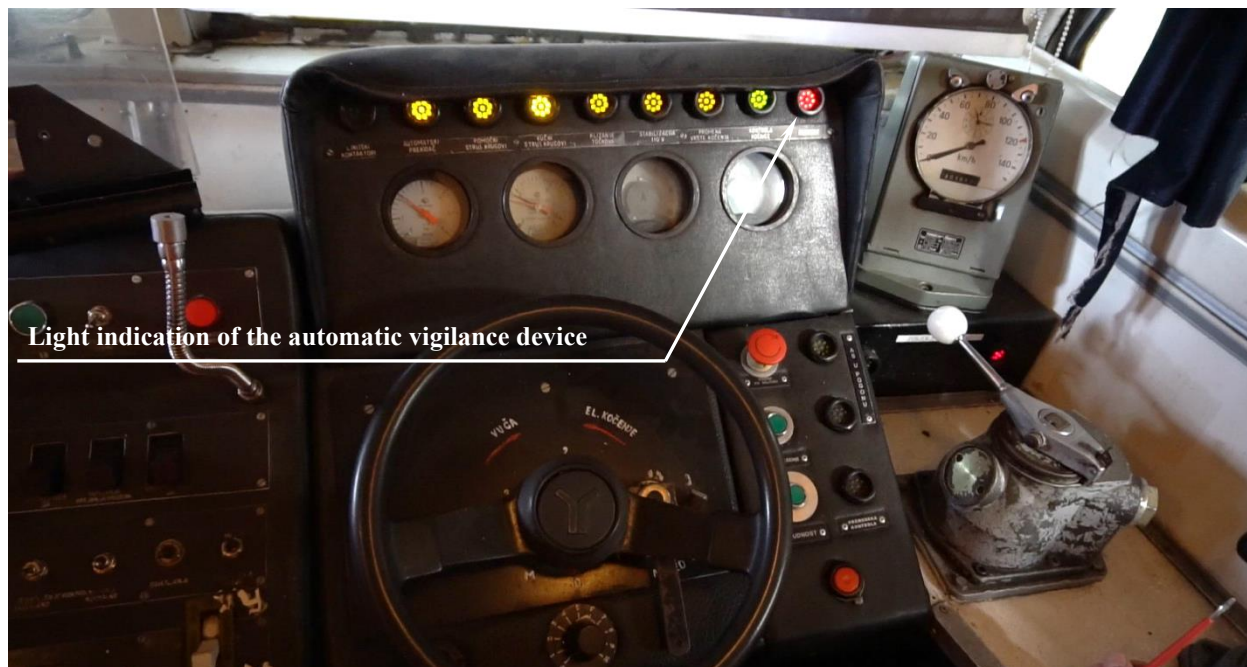
**Figure 4.2.5.21:** Appearance of the light indication of the automatic vigilance device

Also, in the driver's cab of the motor coach 412-032, the operation of the vigilance control device (automatic vigilance device) was checked by simulating operating an EMV at a speed of 25 km/h. The automatic vigilance device reacted correctly even after the light and sound indication, initiating the forced braking mode in the event of possible irregularities (continuously holding the foot or hand control for more than 25 s or lack of pressure on the control after 2.5 s). It was found that the automatic vigilance device functioned properly during the test.

Figure 4.2.5.21 shows the appearance of the light indication of the automatic vigilance device warning of irregular operation by the train driver in the driver's cab of the motor coach 412-032.

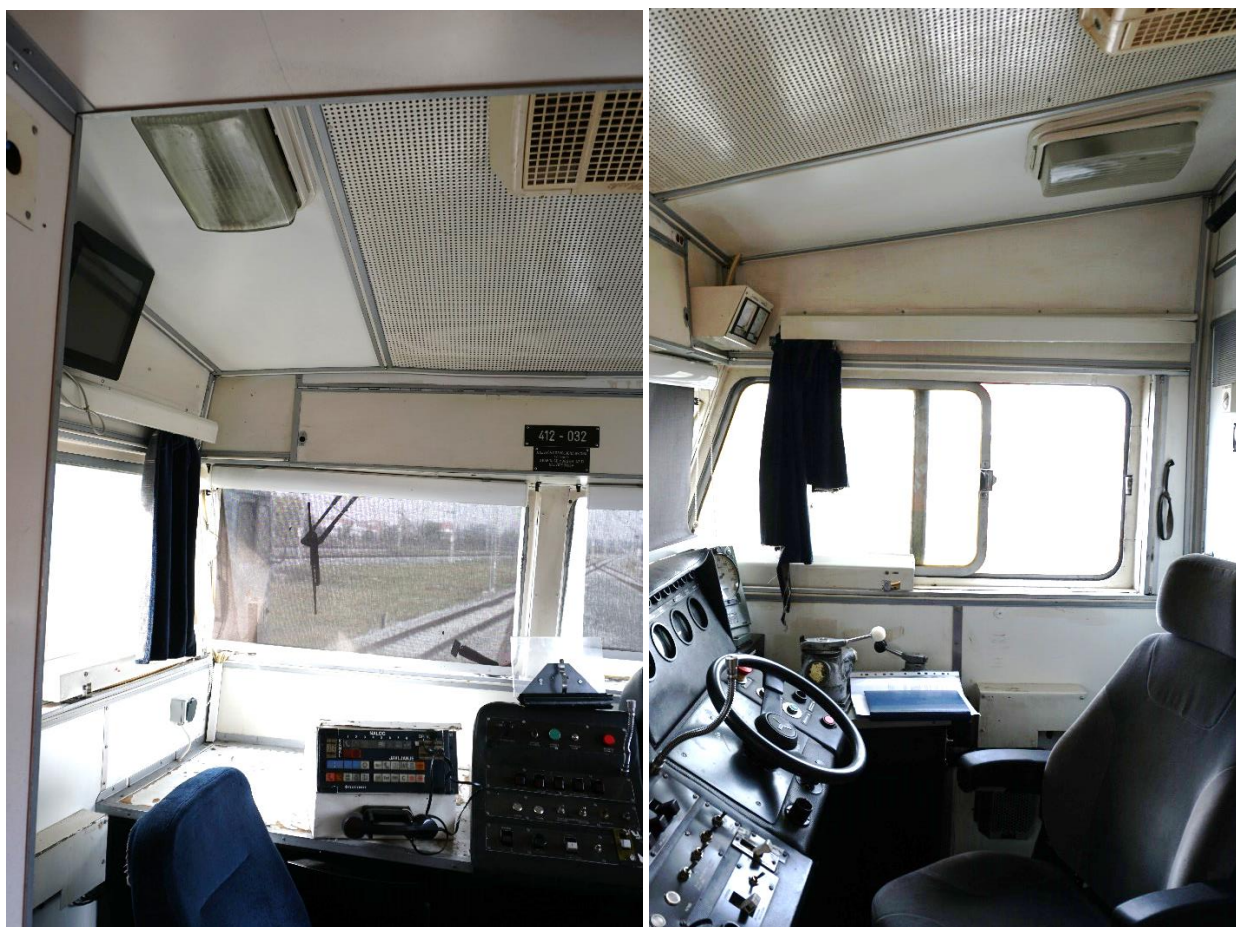
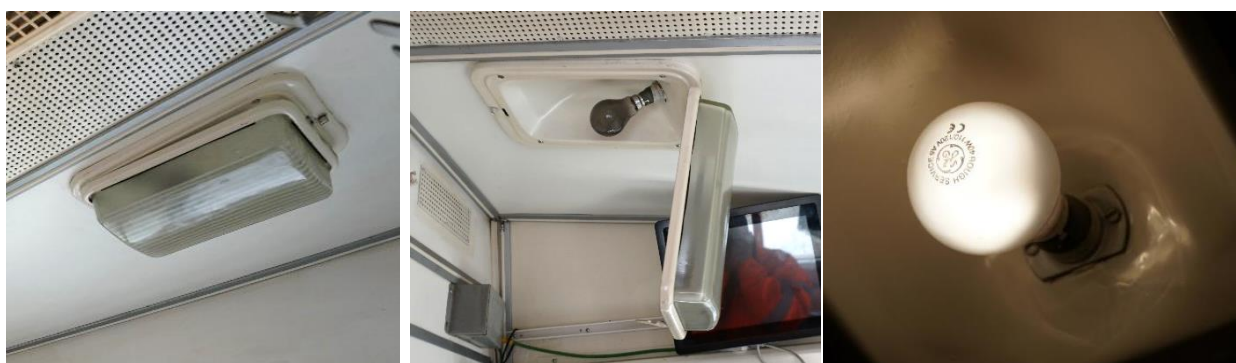
During the inspection, it was found that in the driver's cab of the motor coach 412-032, two identical lamps were installed on the ceiling to illuminate the driver's cab area, one lamp next to the window on each side, closer to the rear wall of the driver's cab. Each lamp is equipped with one incandescent bulb with a nominal voltage of 110 V and a power of 40 W.

**Figure 4.2.5.22:** Position of lights in the driver's cab of the motor coach 412-032

**Figure 4.2.5.23:** Appearance of the lamp in the driver's cab of the motor coach 412-032
