**REPUBLIC OF BULGARIA**  
**NATIONAL AIR, MARITIME AND RAILWAY TRANSPORT,**  
**ACCIDENTS INVESTIGATION BOARD**  
**(NAMRTAIB)**

**FINAL REPORT**

**investigation of significant accident – front collision of shunting train № 30802 with direct freight train № 30595 along Kremikovtsi- Svetovrachane interstation on 15.01.2025**

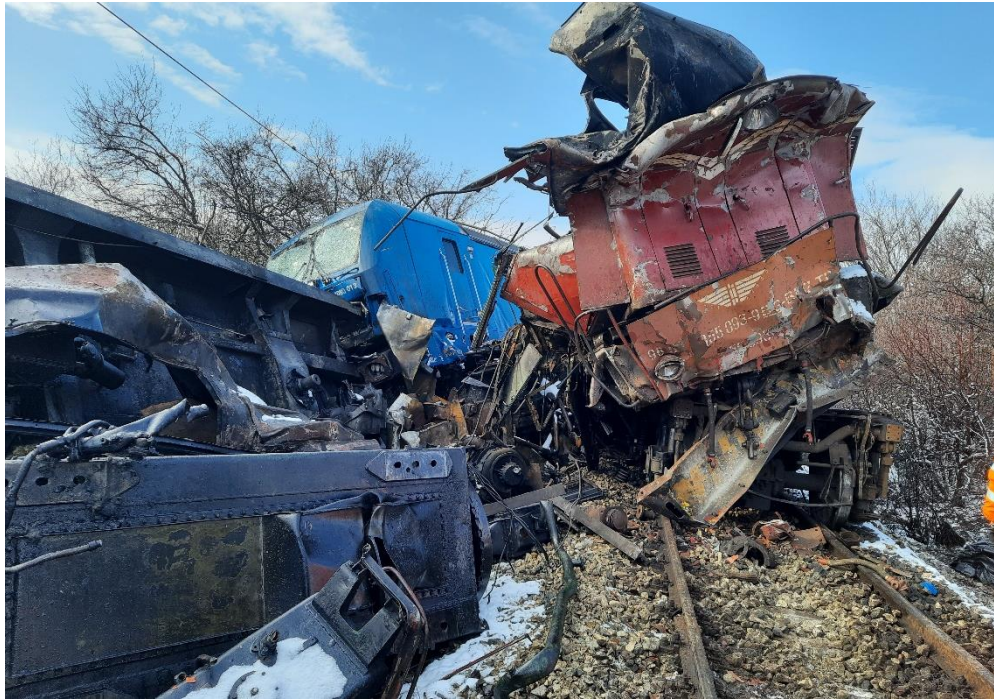
**Fig. 1.1. Place of the accident.**

At 15:57 p.m. at km 11+949 in the Svetovrachene - Kremikovtsi interstation, a collision occurred between DFT No. 30595 of Pimk Rail EAD and ST No. 30802 of BDZ-Cargo EOOD.

Damage was caused to the railway track, the signalling equipment, the catenary and, the rolling stock-locomotives and wagons.

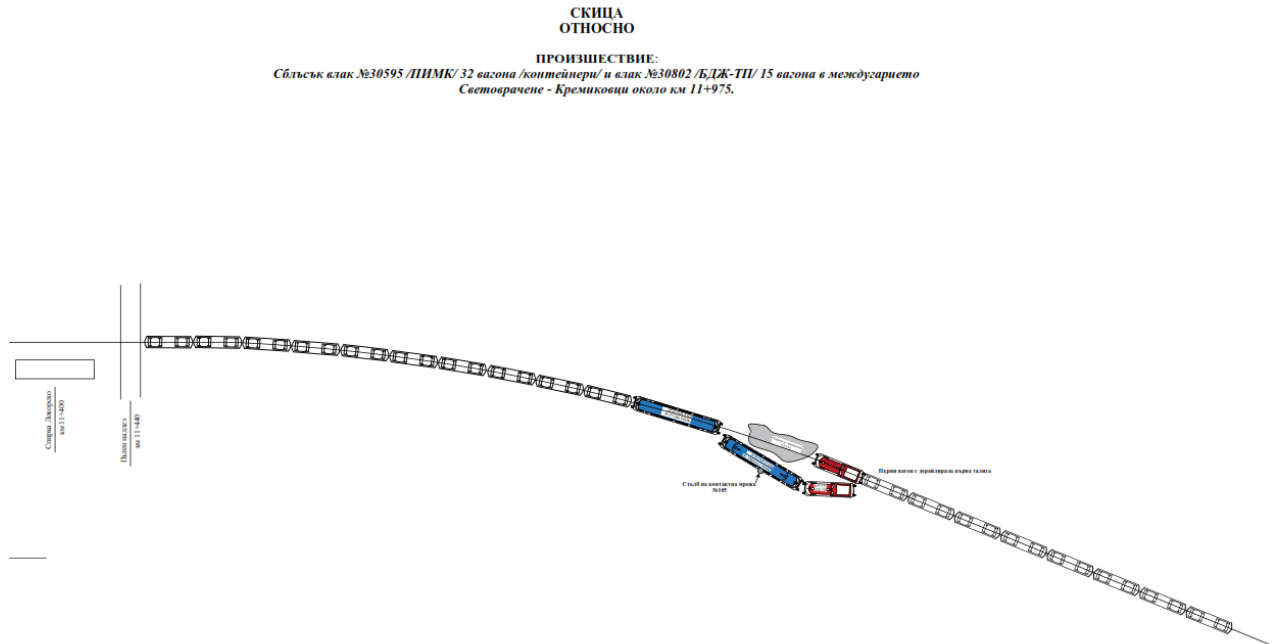
**Fig. 1.2. Scheme of the place of the accident.**

The event occurred at km 11+949 in the Svetovrachene - Kremikovtsi interstation on 15.01.2025 at 15:57 p.m. The railway track in the area of the accident is straight with a slope of 4 ‰ in the direction of the kilometre mileage (Fig. 1.2)

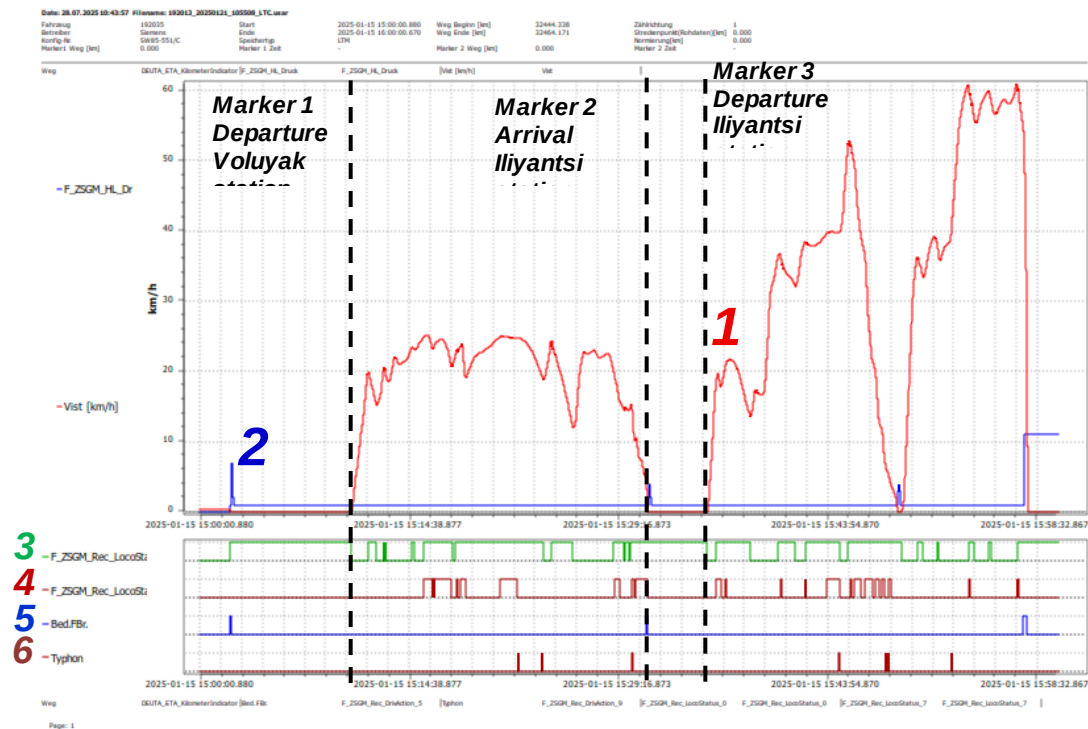
Fig. 4.1.

DFT No. 30595 departed from Voluyak station at 15:10:39 p.m. (Fig. 4.1, marker 1). During the movement, the speed varied between 12 and 25 km/h and at 15:31:20 p.m. it arrived at Iliyantsi station after traveling 6.933 km in 20 minutes and 41 seconds (Fig. 4.1, marker 2). The locomotive driver used the electrodynamic brake to reduce the speed from 20 km/h to 1 km/h, when the automatic pneumatic train brake was also activated, which reduced the pressure in the main air duct to 4.4 bar, with which the train settled on the station track. It stopped for 4 minutes and 9 seconds (Fig. 4.1, the distance between marker 2 and marker 3).

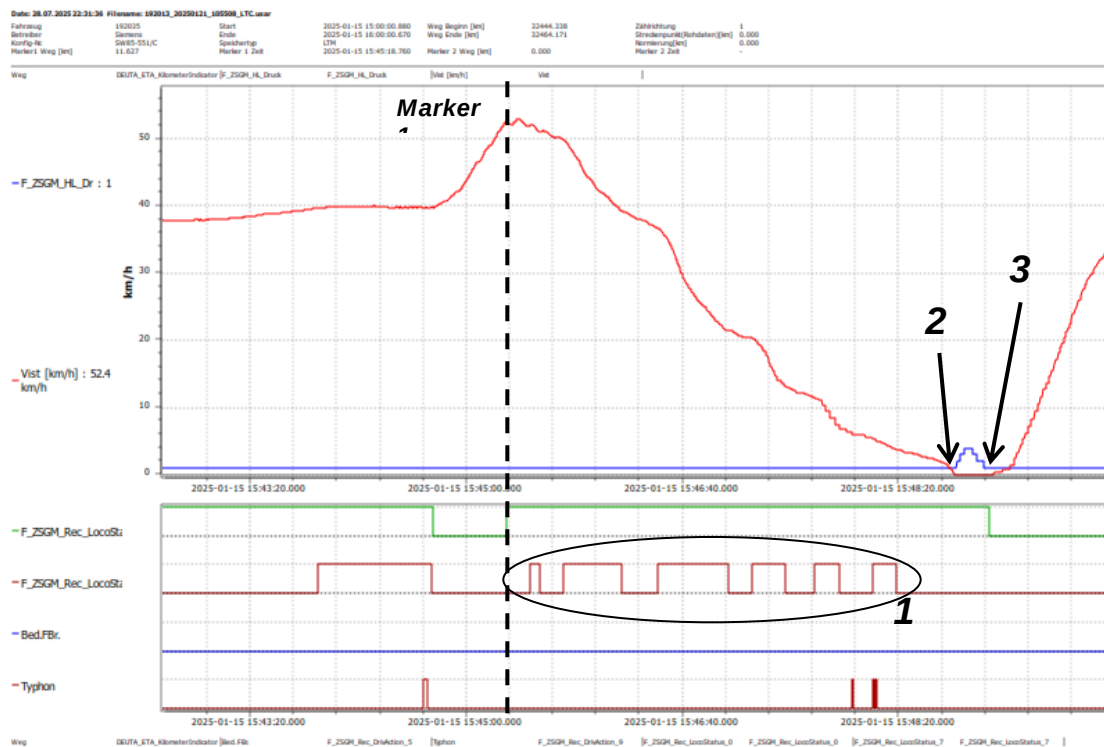
Fig. 4.2.

The train departed at 15:35:30 p.m. from Iliyantsi station to Svetovrachene station (Fig. 4.1, marker 3). The speed of movement in the Iliyantsi – Svetovrachene interstation section changed from 13.6 to 52.9 km/h. At 15:45:18 p.m. at a speed of 52.4 km/h, the traction force of the locomotive was turned off and it switched to free-running (inertia) mode (Fig. 4.2, marker 1). The speed increased to 52.9 km/h at 15:45:23 p.m. and began to decrease to 0 km/h by successive application of electrodynamic braking (Fig. 4.2, pos. 1). At 15:48:46 p.m., the train stopped in front of the entrance signal of

Svetovrachene station, having traveled 6.103 km since its departure from Iliyantsi station in 13:16 minutes (Fig. 4.2, pos. 2).

After a 16.5 second stopped at the entrance signal of Svetovrachene station, DFT No. 30595 departed at 15:49:02 p.m. (Fig. 4.2, pos. 3). It passed Svetovrachene station without stopping. The speed increased to about 36 km/h, decreased slightly to about 33 km/h, increased again to about 40 km/h, then increased to about 60 km/h and for 3.298 km fluctuated between 56.5 and 60.9 km/h for 3:23 minutes (Fig. 4.1).

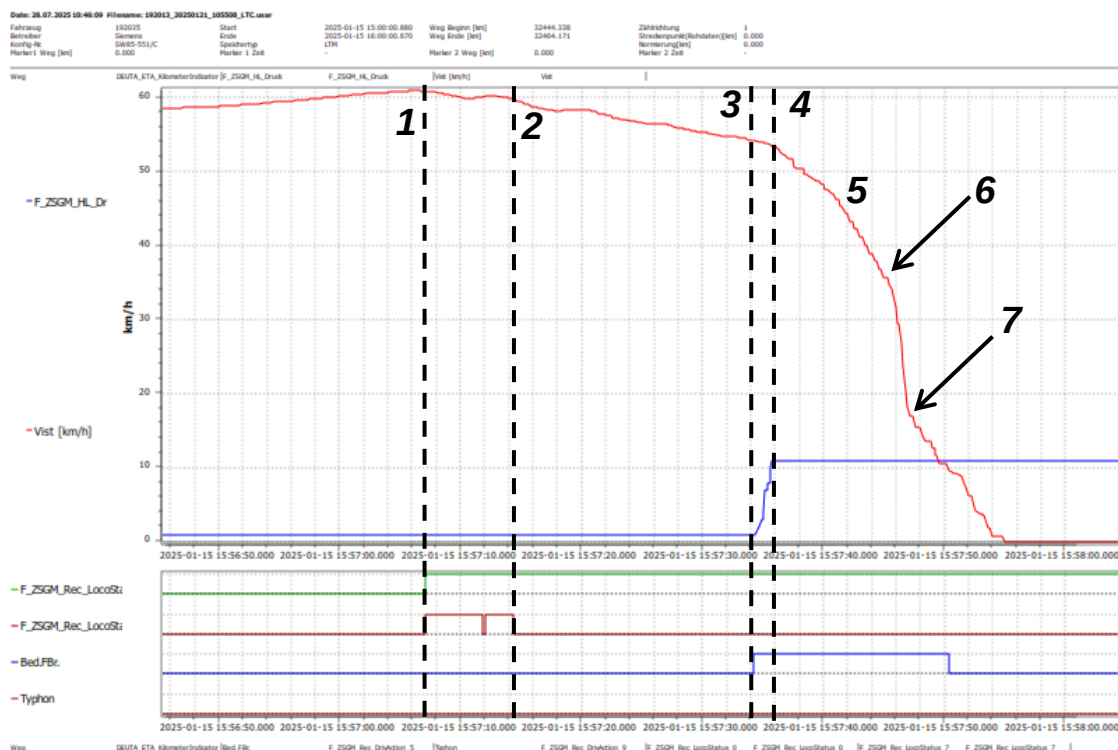
Fig. 4.3.

At 15:57:07 p.m. at a speed of 60.8 km/h, the locomotive driver switched off the traction force of the locomotive and activated the electrodynamic brake (Fig. 4.3, item 1). After 7 seconds, at 15:57:14 p.m., after the train traveled 123 meters, the locomotive driver switched off the electrodynamic brake (Fig. 4.3, item 2) and the speed decreased due to the natural resistance of movement (Fig. 4.3, speed graph between positions 2 and 3). At 15:57:34 p.m., the locomotive driver activated the automatic pneumatic train brake to the quick hold position (Fig. 4.3, item 3). At 15:57:35 p.m. the braking effect of the automatic pneumatic train brake was present (Fig. 4.3, item 4) and the speed started to decrease at a faster rate (Fig. 4.3, item 5). The rate of decrease was maintained until 15:57:46 p.m. at a speed of 29.4 km/h (Fig. 4.3, item 6). At that point, the rate of decrease in speed increased further and after 0.99 seconds for 7 meters the speed decreased to 17 km/h, i.e. the decrease was 12.4 km/h (Fig. 4.3, item 7). From 15:57:47 p.m., the rate of decrease in speed returned to its previous value until 15:57:54 p.m. when the speed value was 0 km/h (Fig. 4.3, item 8).

- The engine driver activated the pneumatic train brake at 15:57:34 p.m., 19,656 km after its departure from Voluyak station, within 54,1 km/h speed. The train permissible speed along the interstation is 60 km/h;

- The braking effect of the automatic pneumatic train brake occurred at 15:57:35 p.m., 19.680 km after departure from Voluyak station, 24 meters and one second from the moment of its activation, at a speed of 53.4 km/h;

The duration of the collision is a difficult to measure quantity. In this case, it is assumed that the duration of the collision is 1 second, based on the data of the recording device of locomotive No. 91521080013-1. The cause for this is the registration of a change in speed (Fig. 4.3, the distance on the graph from pos. 6 to pos. 7), the rate of change of which is greater and is caused by the collision between the two trains. The duration of the process is 0.99 seconds.

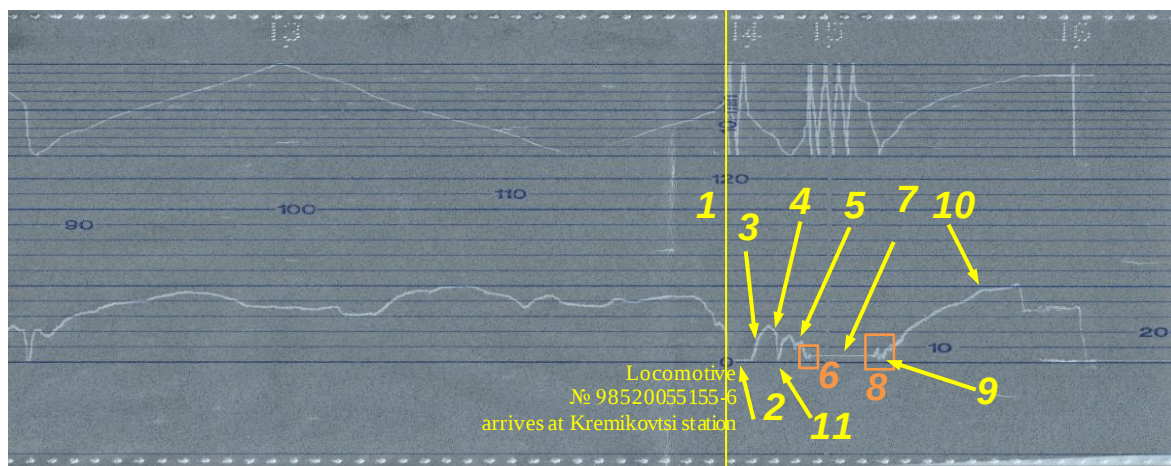
**Fig. 4.7.**

Locomotive No. 98520055155-6 arrived at Kremikovtsi station at 13:16:00 p.m. and settled on the station track (Fig. 4.7, pos. 1). It stayed there from 13:16:00 p.m. to 14:05:35 p.m. for 49:35 minutes (Fig. 4.7, pos. 2). At 14:05:35 p.m. it started, accelerated to 24 km/h, covering 400 meters in 1:55 minutes until 14:07:30 p.m. (Fig. 4.7, pos. 3), after which the speed decreased to 0 km/h, covering another about 220 meters in 40 seconds until 14:08:10 p.m. (Fig. 4.7, pos. 4). There was a 30-second stop (Fig. 4.7, pos. 11) and the locomotive started again at 14:08:40 p.m., accelerated to 18 km/h, decreased to 9 km/h, accelerated again to 12 km/h, then the speed decreased to 0 km/h at 14:13:10 p.m., after having traveled 680 meters in 4:30 minutes (Fig. 4.7, pos. 5). After the locomotive stopped, a single movement at a speed between 1 and 2 km/h was registered, which was due to the coupling of locomotive No. 98520055155-6 to locomotive No. 98520055093-9, which was currently coupled to the train set on the track in the industrial branch (Fig. 4.7, pos. 6). Locomotive No. 98520055155-6, already attached to the head of ST No. 30802, stayed on the track of the industrial branch from 14:13:10 p.m. to 15:43:30 p.m. for 1:30:20 hours (Fig. 4.7, pos. 7).

At 15:43:30 p.m. are registered several movements with speed up to 6 km/h (fig. 4.7, pos. 8).

on the industrial branch at Kremikovtsi station (Fig. 4.7, pos. 9). The speed increased to 10 km/h, at which a fluctuation between 8 and 12 km/h was observed due to a slight pull in the train, after which it began to increase to 48 km/h, with ST No. 30802 covering 4,280 km in 8 minutes (Fig. 4.7, pos. 10). The speed was maintained at that value for 300 meters in 30 seconds and then increased to 52 km/h after covering 420 meters in 35 seconds (Fig. 4.8, pos. 1). At 15:58:30 p.m. the speed began to decrease sharply and from 52 km/h it reached 34 km/h in less than 10 seconds, covering 200 meters (Fig. 4.8, pos. 2).

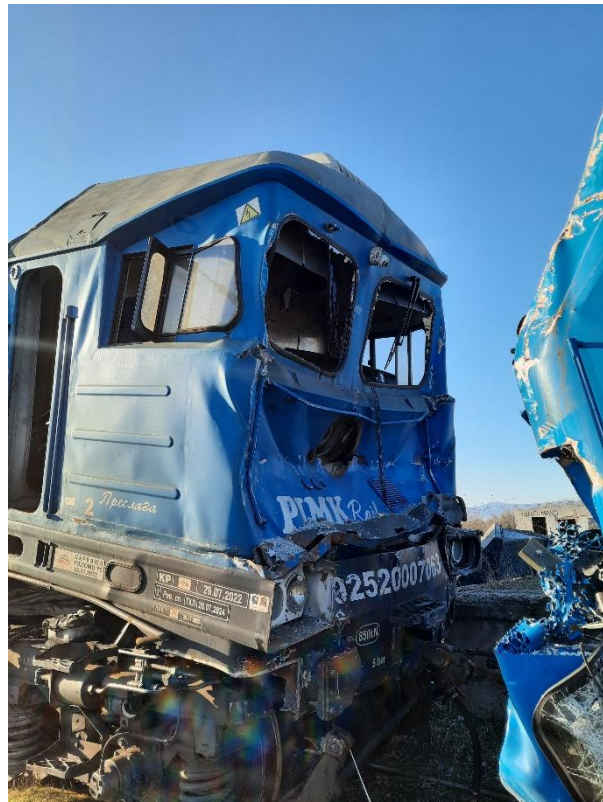
**Fig. 4.14.**

- Locomotive № 92520007063-7 is with one deformed cabin № 2 (front on the movement direction), smashed front wall, with broken missing glasses of the front windows and destroyed buffers (fig. 4.14). The leading frame of locomotive is thorn and deformed in the area of the colling block after the second cabin (fig. 4.15). There are observed deformations on the frame and the lever brake system of the second bogie.

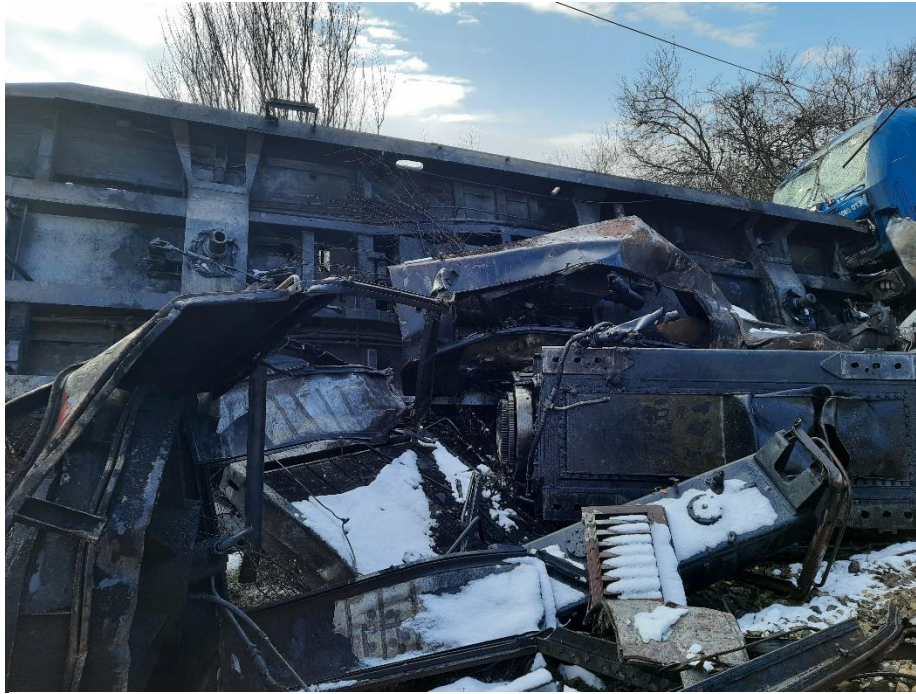
**Fig. 4.17.**

- Locomotive № 98520055155-6 fell on its left side in the movement direction after the clearance of the rail track with totally deformed bodyshell (fig. 4.16). The bodyshell is totally separated from the bogies and together with the locomotive № 91521080013-1 fell aside from the rail track (fig. 4.17), while the bogies, nevertheless the damages remained on the track (fig. 4.18). The bogies are with deformed frames, wheelset together with wheelset reducers, and the cardan shafts are separated from them, as the corpuses of the reducers are broken. Elements of the spring hanging and the lever brake system are missing and deformed (fig. 4.19).

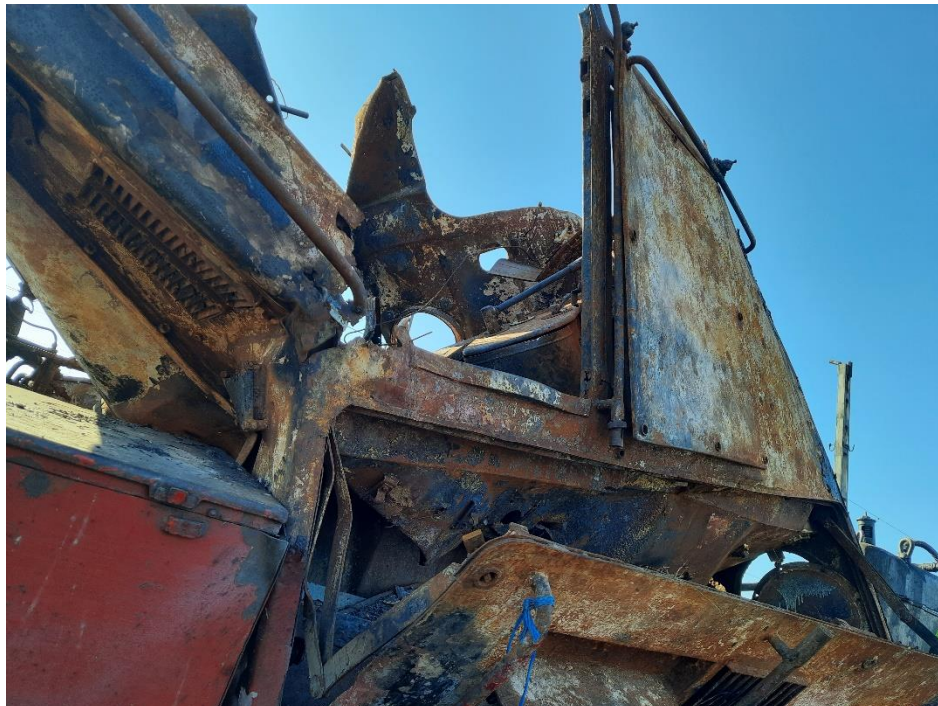
**Fig. 4.27.**

The ignition of diesel locomotive № 98520055093-9 is not a result from leaked and burnt fuel. The burn marks do not indicate the presence of petroleum products. Furthermore, there are no tanks or pipelines containing fuel or lubricants located in the control cabin.

The inspection did not find any traces of metal or plastic containers used to transport flammable or easily flammable substances.

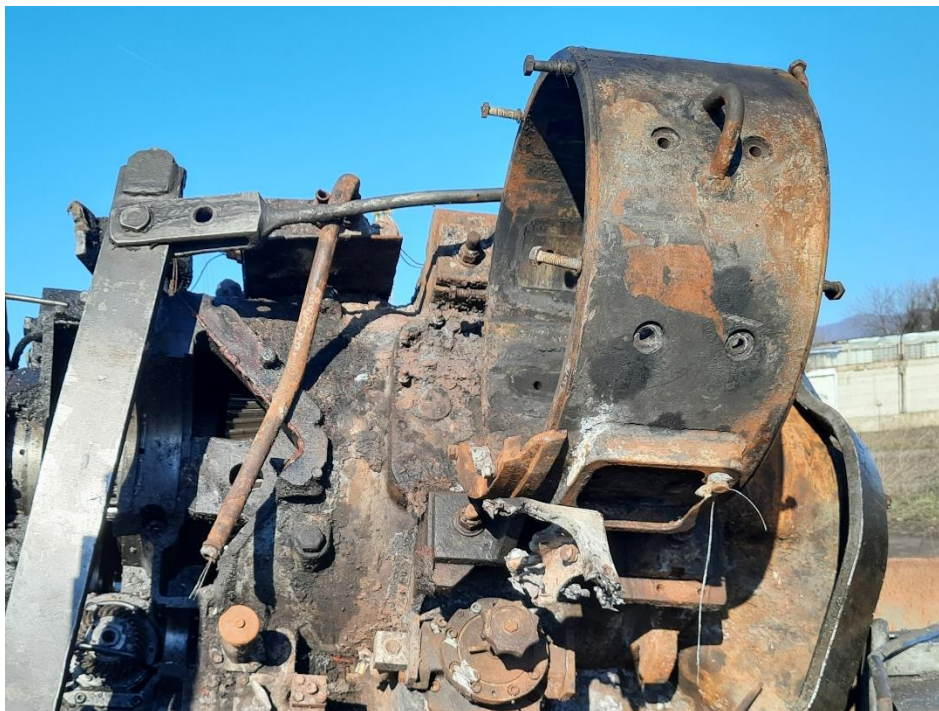
**Fig. 4.28.**

Initially, attention was focused on the starter-generator, which had a completely burned and destroyed rotor, as well as a burned stator and a charred stator housing (Fig. 4.28). The traces left on the starter-generator housing indicate subsequent combustion rather than a source of fire.

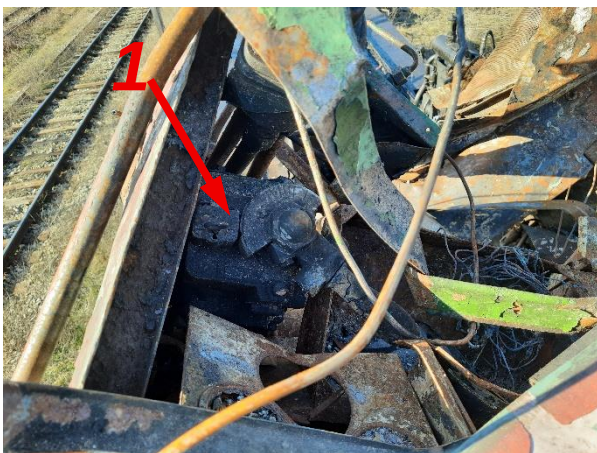
**Fig. 4.30.**

Within the inspections of the diesel locomotives, it was found that during movement, the brake valve at console No. 2 of locomotive No. 98520055093-9 (rear in the direction of movement) was set to the third insulated position, but the key was in the lock, which indicated that the brake valve was not locked in this position (Fig. 4.30, pos. 1). The locomotive driver controlled the locomotive from console
