STATE COMMISSION ON RAILWAY ACCIDENT INVESTIGATION
Ministry of Interior and Administration

REPORT No. PKBWK 7/2025

**on the investigation of a serious railway accident
that occurred on 26 November 2024 at 12:30 hrs
on the Sochaczew - Bednary route,
track no. 1, km 61.941 of railway line no. 3 Warszawa Zachodnia - Kunowice,
a Category B level crossing
the area of the infrastructure operator PKP PLK S.A., Railway Line Plant in Warsaw**

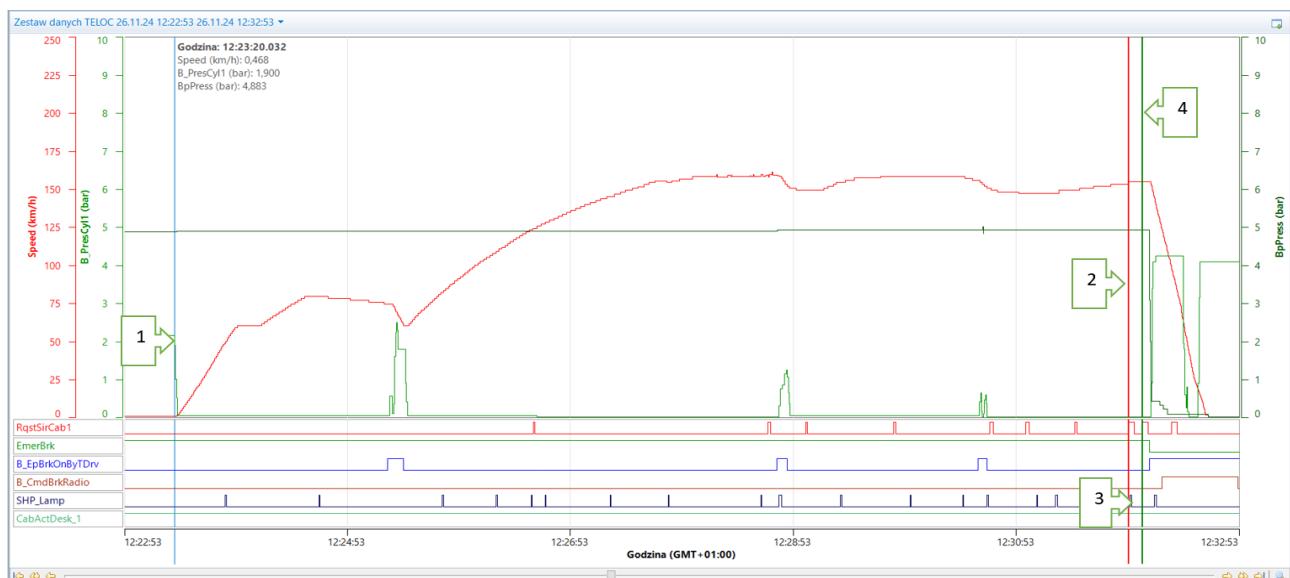
Figure 2 – A chart of the event data for EIJ 5220 train from Łowicz Główny station until the moment of the collision (prepared by PKBWK)

Train EIJ 5220 departed from Łowicz Główny station according to the timetable at 12:23:20 hrs (Fig. 2, point 1). After covering 17.447 km at 12:31:53 hrs, travelling at 153.3 km/h, the train passes the W6b indicator located at kilometre 63.020. At the indicator, the train driver gives the Rp1 "Attention" signal for 3 seconds (Fig. 2, point 2). When giving the Rp1 "Attention" acoustic signal, the train driver acknowledges vigilance and deletes the activated SHP system (Fig. 2, point 3). After travelling for 201 m, at 12:31:56 hrs, after getting out of the curve, despite not being required to give any acoustic signals, the train driver starts giving the Rp1 "Attention" acoustic signal for 3 seconds (Fig. 2, point 4).

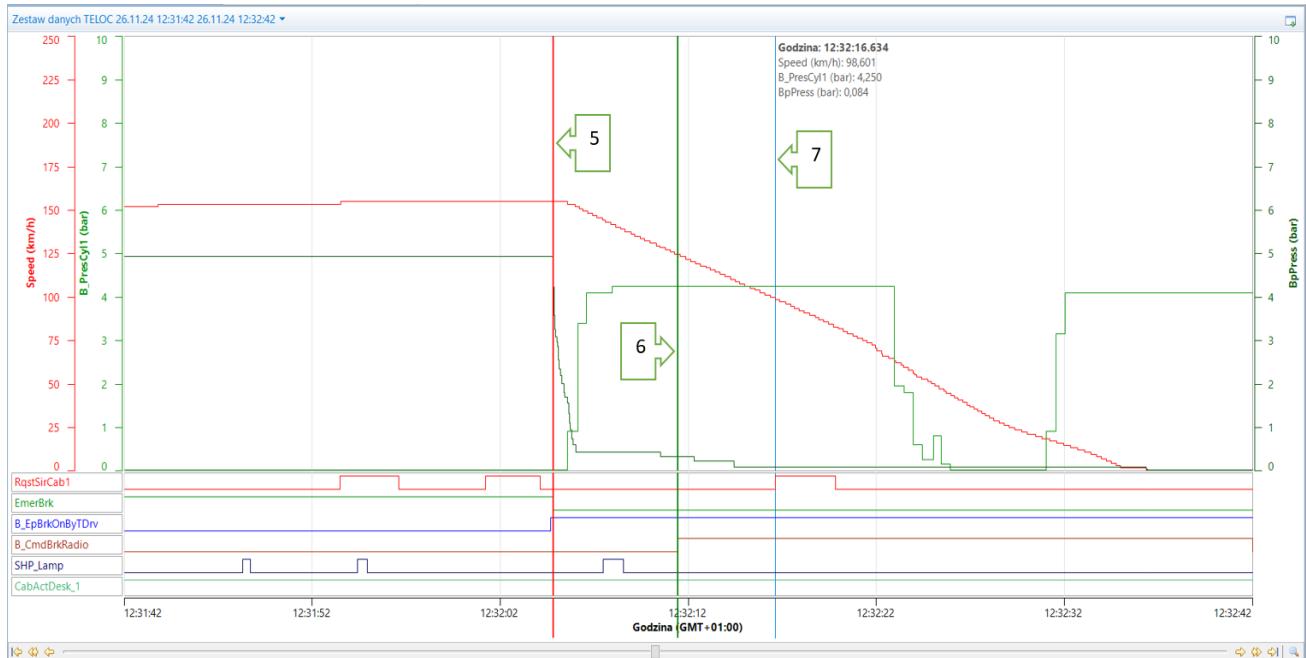
Figure 3 – A chart of the event data for train EIJ 5220 one minute before the impact (prepared by PKBWK)

After travelling for 37 m from the point where the Rp1 "Attention" signal is terminated, at 12:32:04.8 hrs, there is air discharge from the braking system after the train driver implements emergency braking (Fig. 3 and 4, point 5). When emergency braking is implemented, the train is 543 m from the axis of the crossing and is travelling at 155.4 km/h. At 12:32:11 hrs, at the speed of 124.6 km/h, the train driver activates the "Radio-stop" system and gives the A 1r "Alarm" signal. This takes place 285 m from the axis of the crossing (Fig. 3, point 6). Having

travelled 418 m since the emergency brake was implemented (125 m from the axis of the crossing), at 12:32:16 hrs, at the speed of 98.6 km/h, the train driver repeats the Rp1 "Attention" signal (Fig.3, point 7) which lasts for 3 seconds. At 12:32:22 hrs, the train hits the lorry at the speed of 70.7 km/h (Fig. 4, point 8). The head of the train stopped 112 m from the axis of the crossing at kilometre 61.830 at 12:32:36 hrs (Fig.4, point 9).
