**REPUBLIC OF BULGARIA**  
**NATIONAL AIR, MARITIME AND RAILWAY TRANSPORT, ACCIDENTS**  
**INVESTIGATION BOARD (NAMRTAIB)**

**FINAL REPORT**

**Investigation of significant railway accident – derailment of DFT № 80694 between the stations  
Lyubenovo distributing station – Simeonovgrad on 15.08.2025**

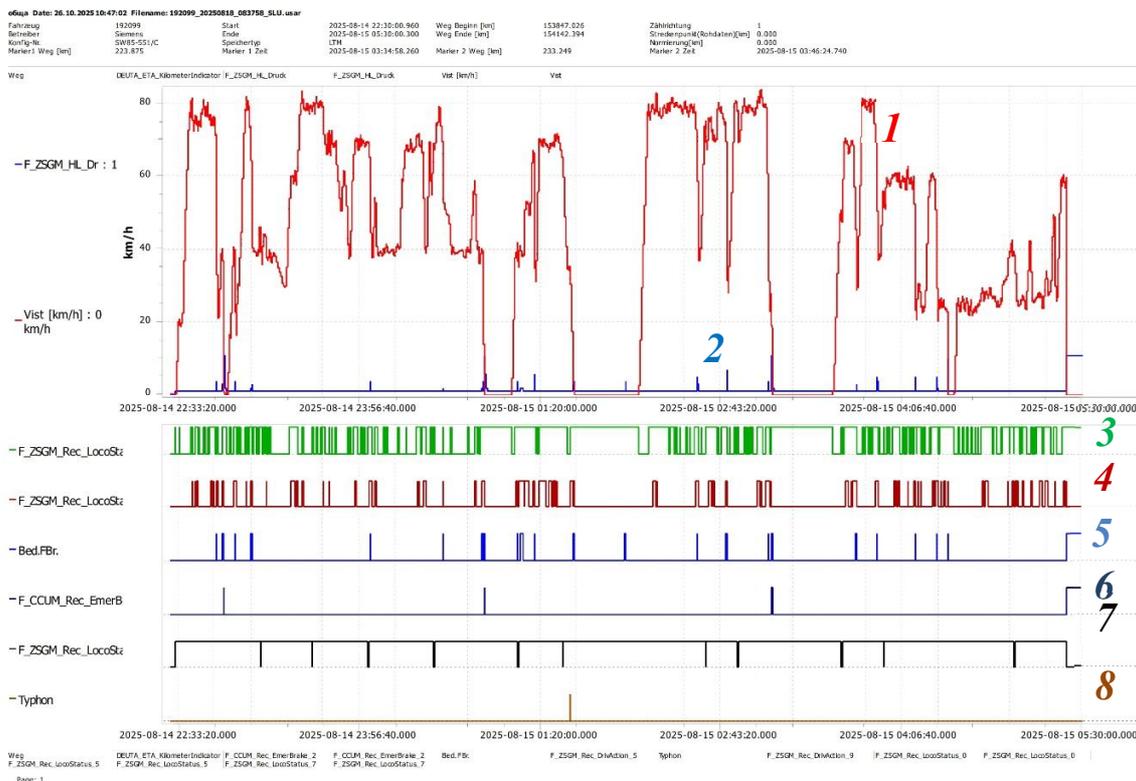
**Fig. 4.2 Chart with the registered and recorded movement data of DFT № 80694 from the registering device of the leading locomotive № 91521080032-1**

The registered data are split into two packages: analogue and digital. The following parameters are used within the data reading (fig. 4.2):

- Analogue data (upper part of the chart):
  - Movement speed (km/h): pos. 1, marked in red color;
  - Pressure in the main air duct: pos. 2, marked in the blue color (the values in the pressure are reflected in Table 4.2):

- Digital data (lower part of the chart):
  - Information on the applied drag force: position 3, green color, (F\_ZSGM\_Rec\_LocoStatus\_0); indications: 0 – traction regime; 1 – lack of traction regime (movement on inertia);
  - Information on the applied electro-dynamic stop: position 4, dark red color, (F\_ZSGM\_Rec\_LocoStatus\_7); indications: 1 – presence of electro-dynamic stop; 0 – lack of electro-dynamic stop;
  - Information on the activation of automatic pneumatic brake by the brake valve

- (F\_ZSGM\_Rec\_DrivAction\_5): position 5, blue colour; indications: 1 – presence of pneumatic stop; 0 – lack of pneumatic stop;
  - Information on activation of the automatic pneumatic brake from valve for immediate stop or from split of the main air duct (F\_CCUM\_Rec\_EmerBrake\_2): position 6, dark blue colour; indications: 0 – lack of activation; 1 – activation;
  - Information on the condition of the main air switch of the locomotive (F\_ZSGM\_Rec\_LocoStatus\_5): position 7, black colour; indications: 1 – presence of voltage in the locomotive; 0 – lack of voltage in the locomotive;
  - Information on activated air sound signal (F\_ZSGM\_Rec\_DrivAction\_9): position 8, brown colour; indications: 1 – submission of a sound signal; 0 – lack of a sound signal;

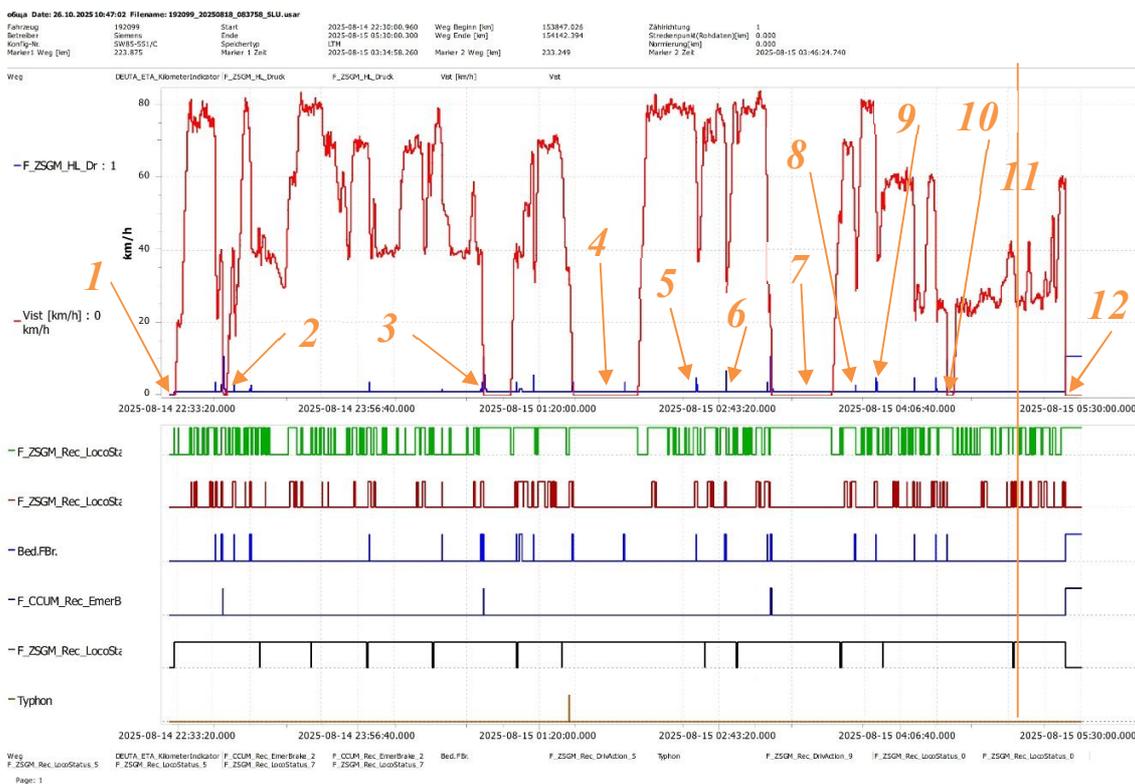
**Fig. 4.3 The schedule of the total travelling time of DFT № 80694 from the origin station to the place of the accident**

DFT № 80694 departed from Varna station at 22:32:05 p.m. (fig. 4.3, pos. 1). During the movement, it respected the sectional speeds and reductions along the rail track. Due to different reasons, it stopped at a few places along the route:

- In Poveyanovo station: from 22:54:42 p.m. until 22:55:35 p.m. for 0:00:53 hours (fig. 4.3, pos. 2);
- In Podvis station: from 0:54:45 a.m. to 1:07:04 a.m. for 0:12:19 hours (fig. 4.3, pos. 3);
- In Karnobat station: from 1:35:45 a.m. until 2:05:33 a.m. for 0:29:48 hours, where it performed a test B (fig. 4.3, pos. 4);
- Along Zimnitsa station it passed without stopping at 2:33:32 a.m. with speed 36,8 km/h (fig. 4.3, pos. 5);
- Along Yambol station it passed without stopping at 2:46:52 a.m. with speed 28,0 km/h (fig. 4.3, pos. 6);
- In Kermen station: from 3:07:13 a.m. until 3:35:01 a.m. for 0:27:48 hours, without performing tests B (fig. 4.3, pos. 7);
- Through Konyovo station it passed without stopping at 3:46:22 a.m. with speed 29,0 km/h (fig. 4.3, pos. 8);

- Through Nova Zagora station it passed without stopping at 3:56:09 a.m. with speed 36,9 km/h (fig. 4.3, pos. 9);
- In Radnevo station: from 4:28:13 a.m. to 4:31:08 a.m. for 0:02:55 hours (fig. 4.3, pos. 10);
- Through Lyubenovo distributing station passed without stopping at 5:01:03 a.m. with speed 24,0 km/h (fig. 4.3, pos. 11);
- At km 11+460 along Simeonovgrad – Lyubenovo distributing station at 5:23:07 a.m. (fig. 4.3, pos. 12).

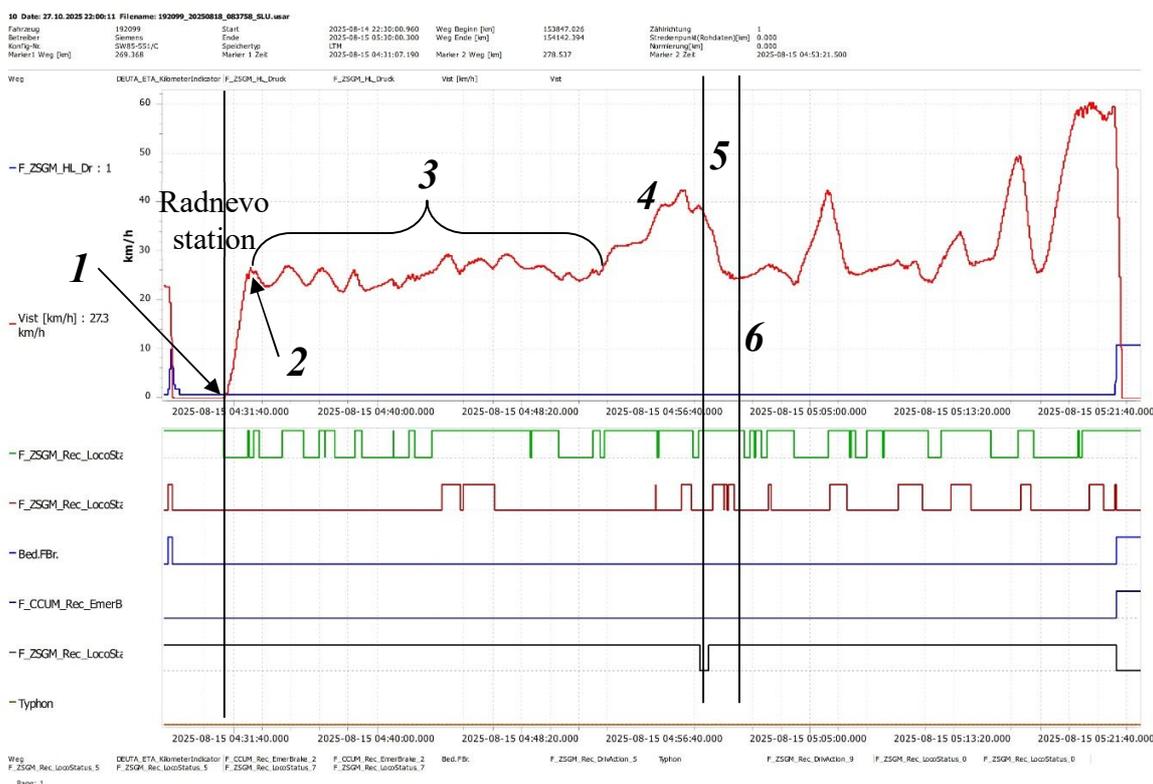
**Fig. 4.5 Chart of movement of DFT № 80694 from Radnevo station to Lyubenovo distributing**

DFT No. 80694 stayed at Radnevo station from 04:28:14 a.m. to 04:31:07 a.m. for 00:02:53 hours (Fig. 4.5, pos. 1). At 04:31:07 a.m. it set off, with the speed increasing to 25.4 km/h for 00:01:21 for 0.252 km (Fig. 4.5, pos. 2). From this moment until 04:53:21 for 8.917 km for 00:20:52 hours, the speed varied in the narrow interval between 21.9 and 29.4 km/h (Fig. 4.5, pos. 3). From 04:53:21 a.m. the speed

started to increase, reaching 31-32 km/h for 00:01:30 hours for 0.790 km, increased again to 40 km/h and then to 42.5 km/h at 04:57:44 a.m., 11.734 km after departure from Radnevo station (Fig. 4.5, pos. 4). From that moment, the speed started to decrease due to the natural resistance of the train movement, because the locomotive pantograph was removed from 04:58:40 a.m. to 04:59:10 a.m. for 00:00:30 hours, during which time the train travelled 0.317 km and the speed reached 35 km/h, i.e. decreased by 4 km/h (Fig. 4.5, pos. 5). At 04:59:23 a.m. the driver activated the EDB, which caused the speed to decrease more rapidly to reach a value of 24-25 km/h when passing through the Lyubenovo distributing station at 05:01:03 a.m. (Fig. 4.5, pos. 6).

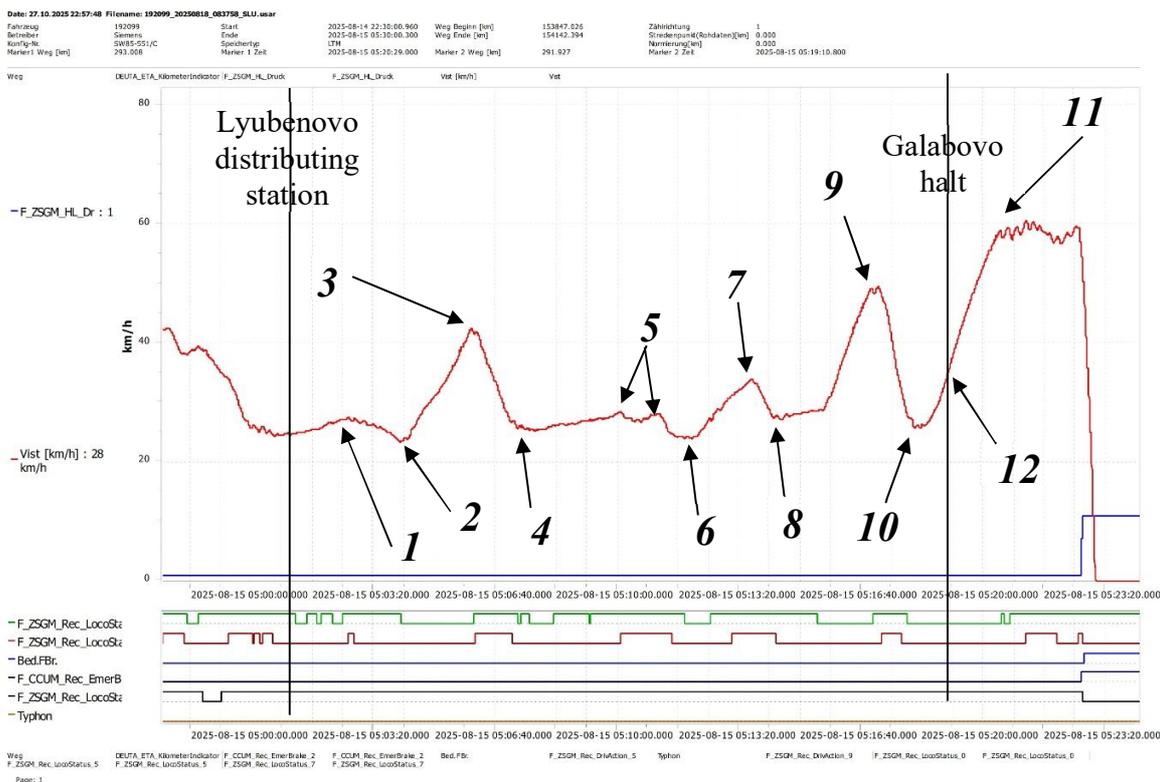
**Fig. 4.6 Chart of the travelling time of DFT № 80694 from Lyubenovo distributing to the place of the accident**

After leaving the Lyubenovo distributing station the speed increased and at 05:02:44 a.m. it reached a value of 26.9 km/h (Fig. 4.6, pos. 1), 0.728 km after the station, after which it decreased by applying the EDB, to 23.4 km/h at 05:04:46 a.m., after another 0.591 km (Fig. 4.6, pos. 2). The speed then increased to 42.4 km/h at 05:06:01 a.m. after passing 1.025 km (Fig. 4.6, pos. 3). Again, the speed decreased by applying EDB to 25.2 km/h (Fig. 4.6, pos. 4), increased to 28 km/h at 00:03:21 a.m. over 1,500 km (Fig. 4.6, pos. 5) and decreased again to 24.1 km/h (Fig. 4.6, pos. 6). The speed reached a value of 33.6 km/h at 05:13:43 a.m. Then 5.969 km after passing the Lyubenovo distributing station (Fig. 4.6, pos. 7), decreased to 27.7 km/h (Fig. 4.6, pos. 8), increased again to 48.8 km/h (Fig. 4.6, pos. 9) and decreased again to 26.1 km/h at 05:18:12 a.m., 8.549 km from the Lyubenovo distributing station (Fig. 4.6, pos. 10).

From that moment the speed started to increase sharply and after 2,246 km and 00:02:58 hours, at 05:21:10 a.m. reached value of 60,4 km/h (fig. 4.6, pos. 11). Thus, at 05:19:10 a.m. DFT № 80694 passed Galabovo halt in a traction regime and accelerating movement, with speed 37,8 km/h (fig. 4.6, pas. 12).

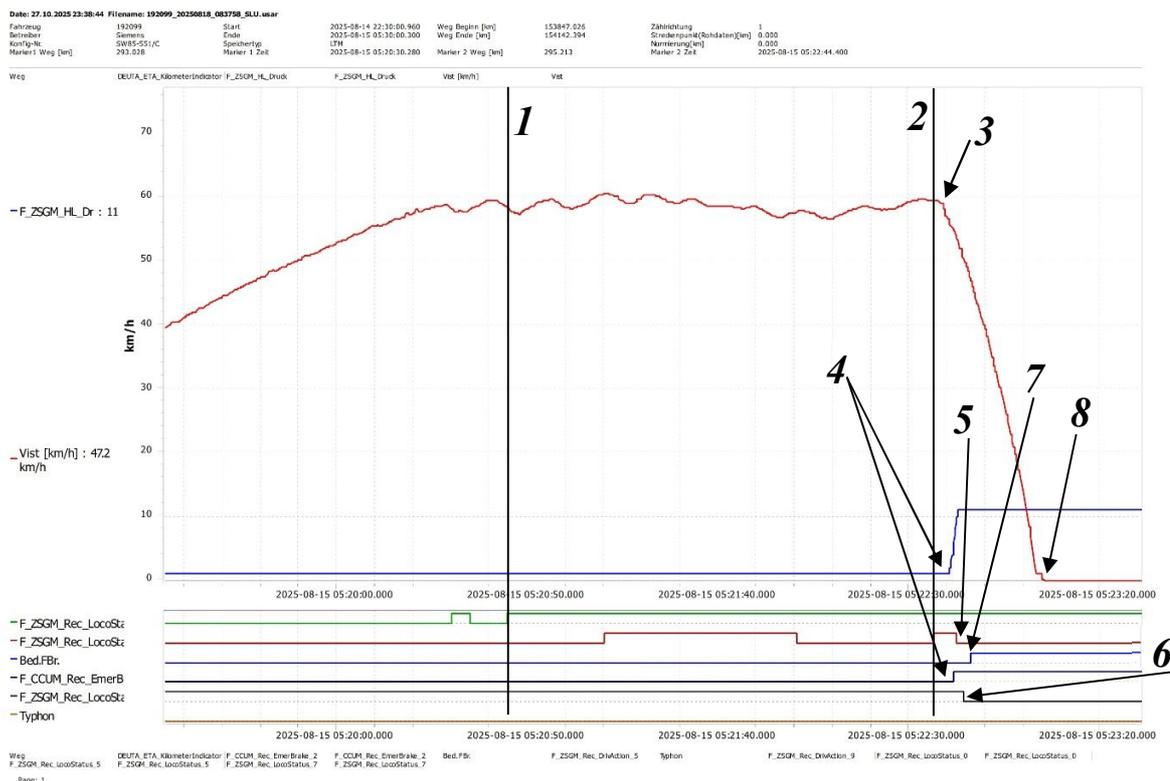
**Fig. 4.7 Chart of the total travelling time of DFT № 80694 from Galabovo halt to the place of the accident**

At 05:20:30 a.m., 293.028 km from the start of the movement of DFT No. 80694, 00:02:37 and 2.339 km before the accident, at a speed of 58 km/h, the driver switched off the traction mode. He controlled the movement using the EDB, because of which the speed of movement changed between 57.2 and 60.4 km/h (Fig. 4.7, pos. 1).

At 05:22:36 a.m., 2.064 km before the final stop, the driver once again activated the EDB, because of which the speed began to decrease smoothly from 59.4 to 56.8 km/h (Fig. 4.7, pos. 2). At 05:22:39 a.m., i.e. 00:00:02 hours and 0.039 km after the action, the speed began to decrease sharply (Fig. 4.7, pos. 3). The train being separated caused the sharp decrease in speed. At 05:22:40 a.m., 0.023 km and 00:00:01 hours after that, at a speed of 56.4 km/h, the pressure in the main air duct began to decrease due to a break due to the splitting of the train (Fig. 4.7, pos. 4). At 05:22:42 a.m. after 0.012 km 00:00:00.7 hours at a speed of 53.5 km/h, the EDB was switched off (Fig. 4.7, pos. 5). At 05:22:44 a.m. after 00:00:01 hours and 0.026 km at a speed of 50.3 km/h the main air duct of the locomotive (MAD) was automatically switched off and the pantograph was removed (Fig. 4.7, pos. 6). At 05:22:46 a.m., 00:00:01 hours and 0.025 km after the automatic removal of the pantograph, at a speed of 47.2 km/h the driver activated the ATB in fast braking mode (Fig. 4.7, pos. 7).

B 05:23:07 a.m., 295,367 km from its departure of the origin station the speed decreased up to 0,0 km/h, and the locomotive of DFT № 80694 established at km 11+460 along the interstation Lyubenovo distributing – Simeonovgrad (fig. 4.7, pos. 8).

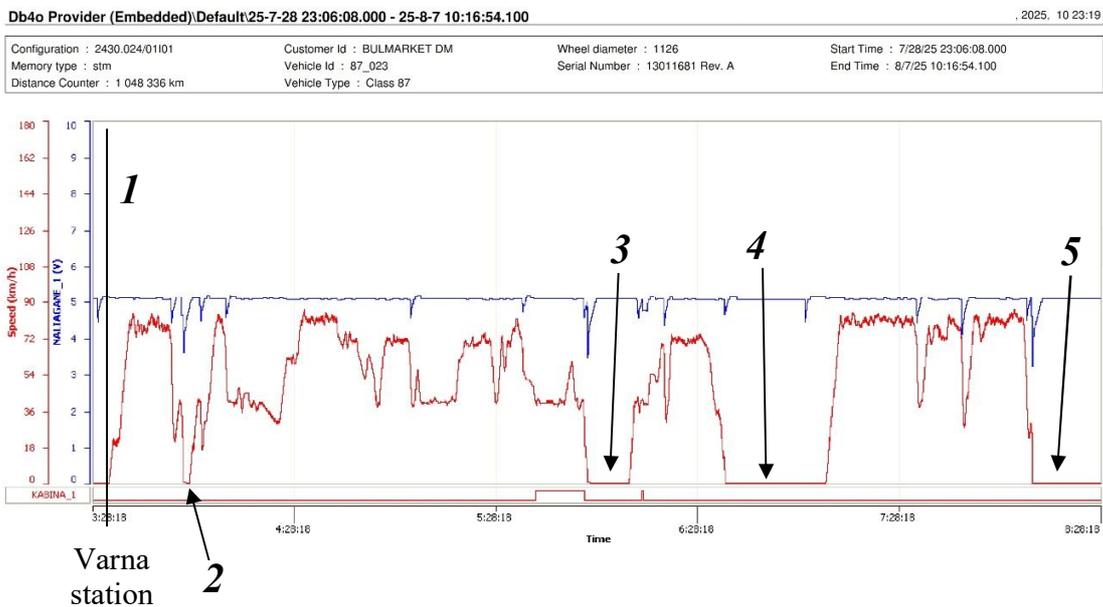
**Fig. 4.9 Chart of the travelling time of DFT № 80694 from origin station to Kermen station**

The registering on the speedometer installation of locomotive № 91520087023-5 do not differ from those of the leading locomotive № 91521080032-1 (fig. 4.9). From its departure from Varna freight park station (fig. 4.9, pos. 1) to Kermen station DFT № 80694 stayed in Poveľyanovo station (fig. 4.9, pos. 2), in Podvis station (fig. 4.9, pos. 3), in Karnobat station (fig. 4.9, pos. 4) and in Kermen station (fig. 4.9, pos. 5).

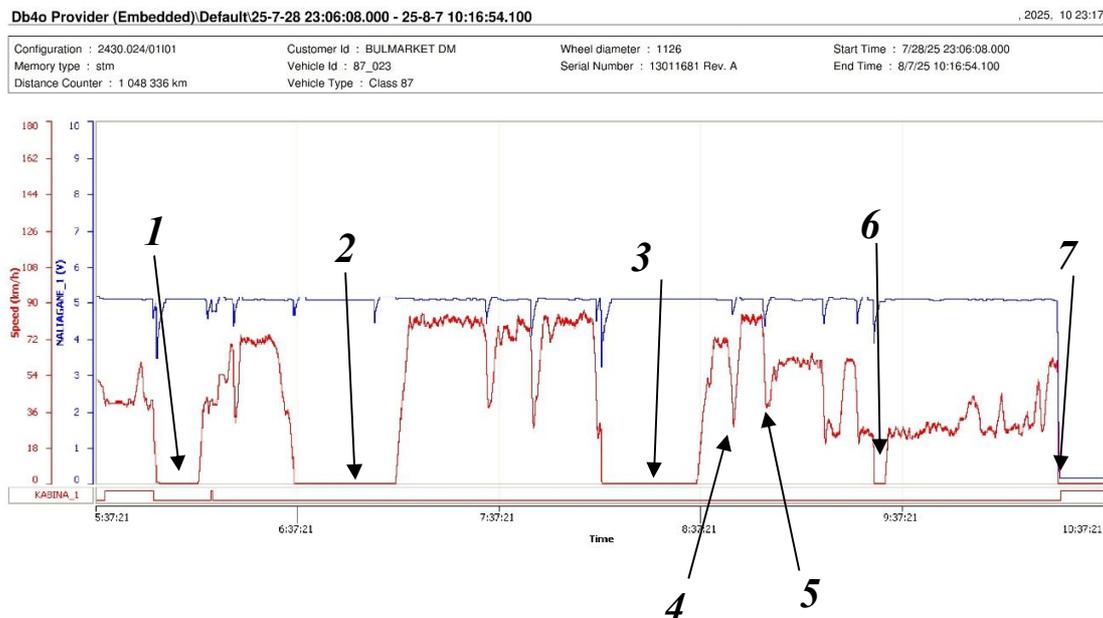
**Fig. 4.10. Chart of the travelling time of DFT № 80694 from Podvis station to the place of the accident**

Fig. 4.10 shows the schedule of movement of DFT No. 80694 from Podvis station to the location of locomotive No. 91520087023-5 at km 12+000 after the accident. The stops at Podvis station (Fig. 4.10, pos. 1), at Karnobat station (Fig. 4.10, pos. 2) and at Kermen station (Fig. 4.10, pos. 3) are again

marked. This was done in order to overlap the two schedules and not to lose the connection between them. Further, the train passed without stopping through Konyovo station (Fig. 4.10, pos. 4), Nova Zagora station (Fig. 4.10, pos. 5) and stopped at Radnevo station (Fig. 4.10, pos. 6). The train's movement is described in detail in the analysis of the movement of locomotive No 91521080032-1.

Locomotive № 91520087023-5 established at km 12+000 after the derailment of 13 wagons of the train composition (fig. 4.10, pos. 7).

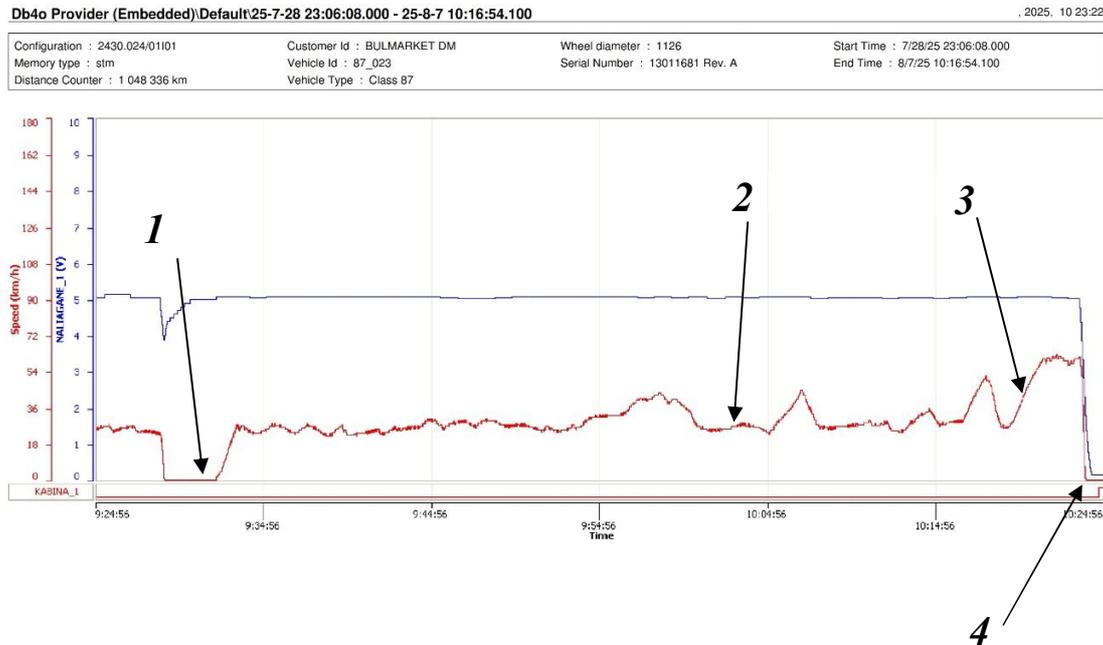
**Fig. 4.11 Chart of the travelling time of DFT № 80694 from Radnevo station to the place of the accident**

Fig. 4.11 shows the last stop of DFT No. 80694 at Radnevo station, the change in speed in the Radnevo – Lyubenovo distributing station and Lyubenovo distributing station – Simeonovgrad section to the accident site at km 11+460, with locomotive No. 91520087023-5 located at km 12+000. The

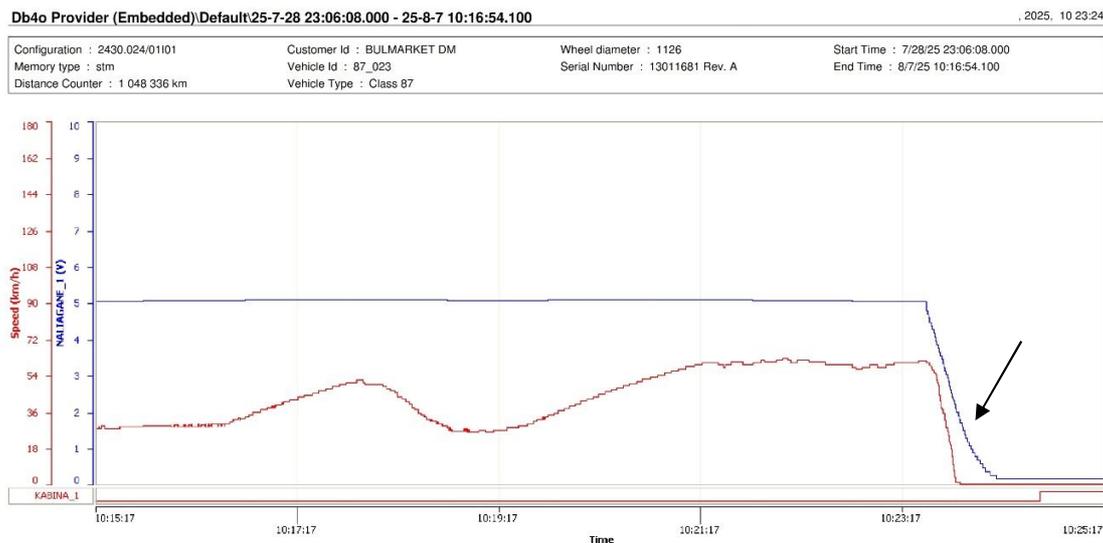
**Fig. 4.12. Chart of the travelling time of DFT № 80694 from the origin station to the place of the accident**

On fig. 4.12 is evident that the pressure in the main air duct in locomotive No. 91520087023-5 decreased slower than the decrease in speed, which is clear evidence that the locomotive did not activate the automatic brake.

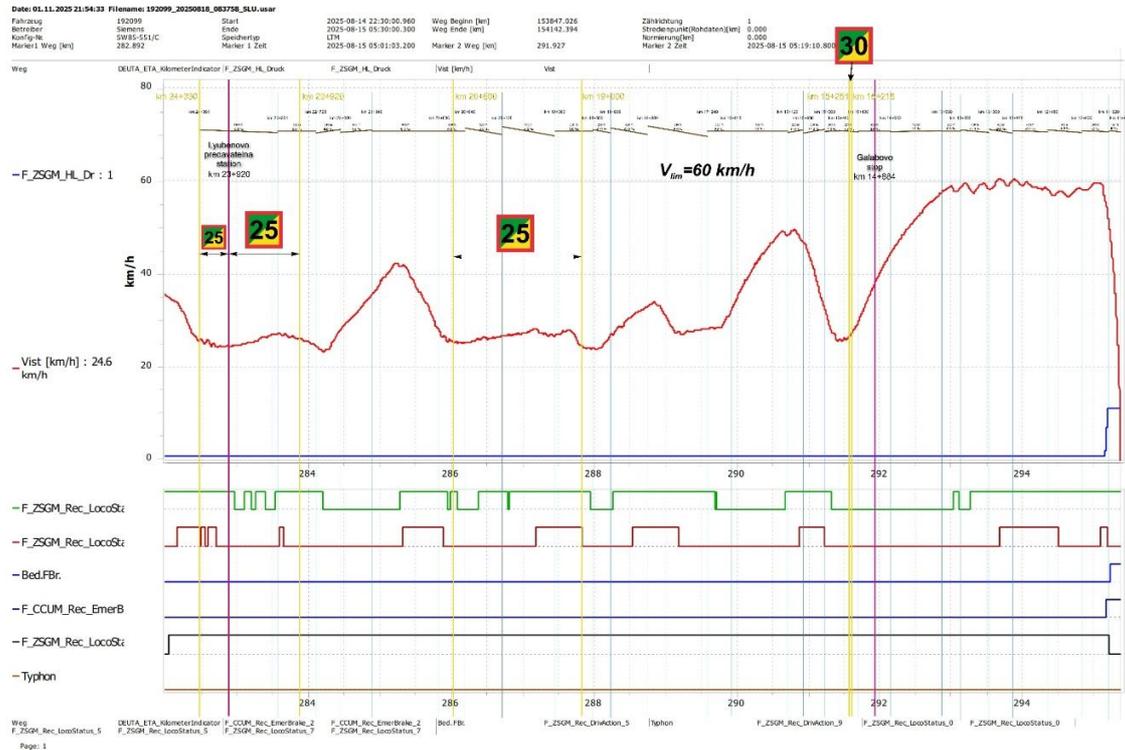
Fig. 4.13.

The movement speed along the interstation Lyubenovo distributing – Simeonovgrad is with low values due to the presence of many reductions up to 25 and 30 km/h, evident from fig. 4.13.
