MINISTRY OF
CONSTRUCTION AND TRANSPORT
TRANSPORTATION SAFETY BUREAU

FINAL REPORT

2023-0661-5
(HU-10426)

Railway Accident / Derailment
Tiszatenyő - Mezőtúr, 9th July 2023

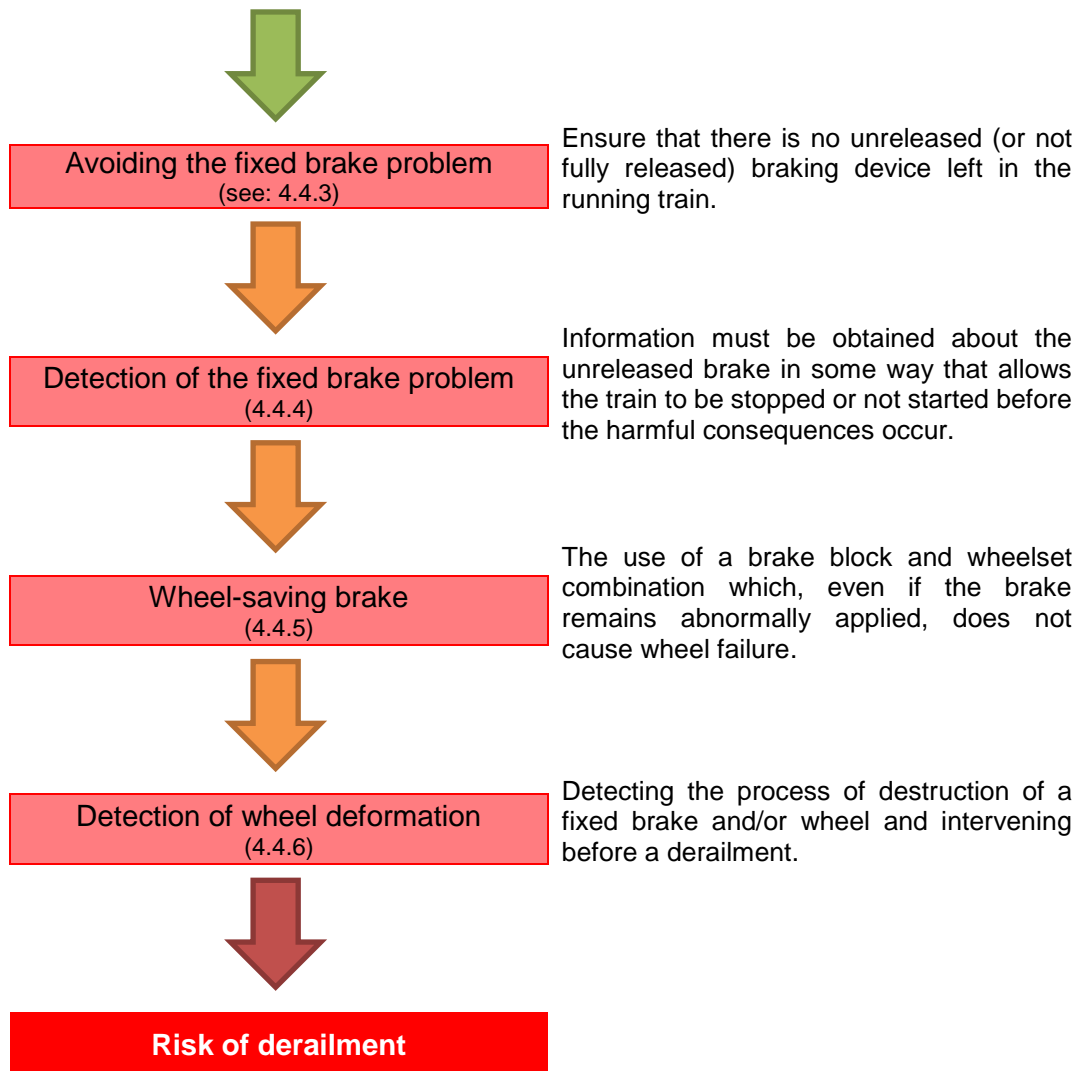
The occurrence is the consequence of a process from a fault to an emergency to an accident, a process that can be stopped at several points by appropriate interventions and safety measures. The points of intervention identified in this occurrence (each option is discussed in more detail in the referenced chapters):
