REPUBLIC OF SERBIA
CENTER FOR INVESTIGATION OF ACCIDENTS IN TRANSPORT
SECTOR FOR INVESTIGATION OF ACCIDENTS IN RAILWAY TRAFFIC
Nemanjina 11, 11000 Belgrade

FINAL REPORT ON ACCIDENT INVESTIGATION

Accident type: Train derailment

Train No.: 51202

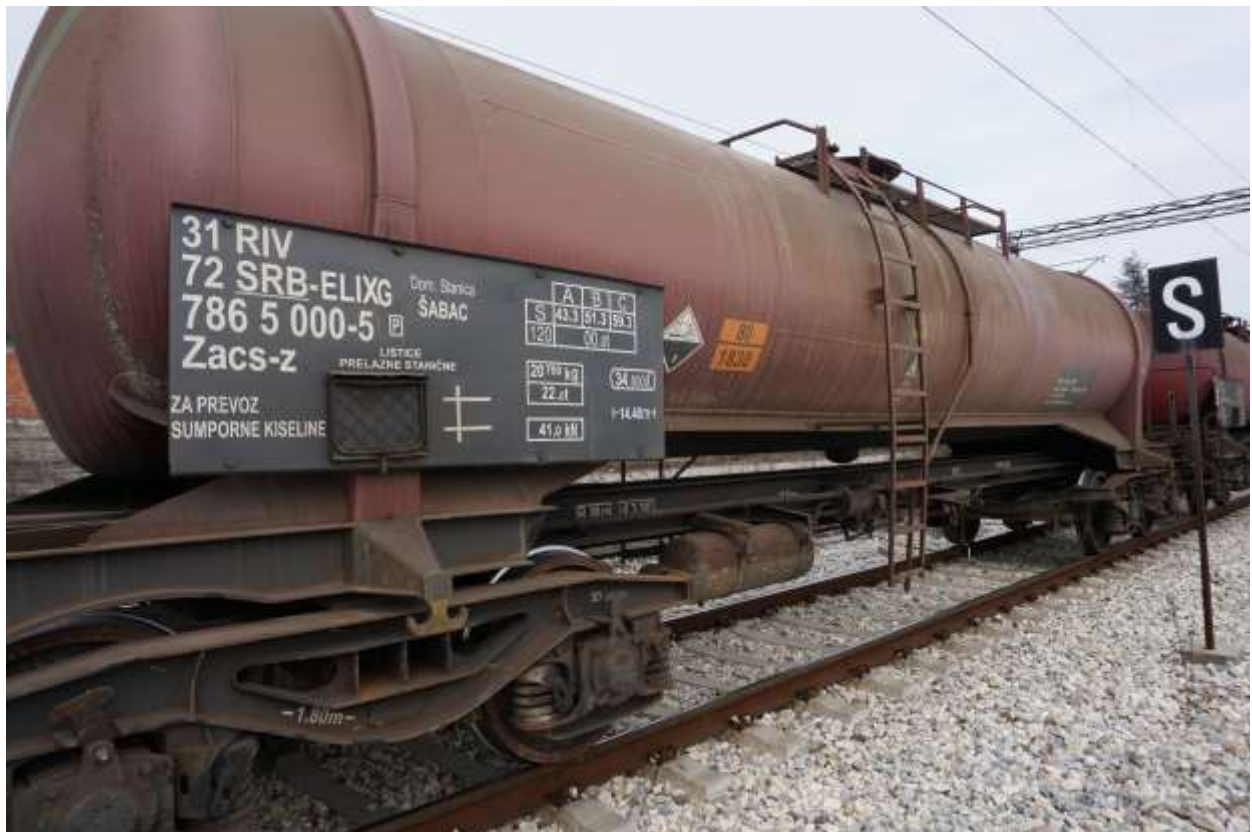
Figure 2.2.2.1: Appearance of the Z-series tank wagon for sulphuric acid transport

The wagons of the series Z that participated in the accident in question are four-axle special closed wagons for the transport of sulfuric acid with appropriate filling and dispensing systems.

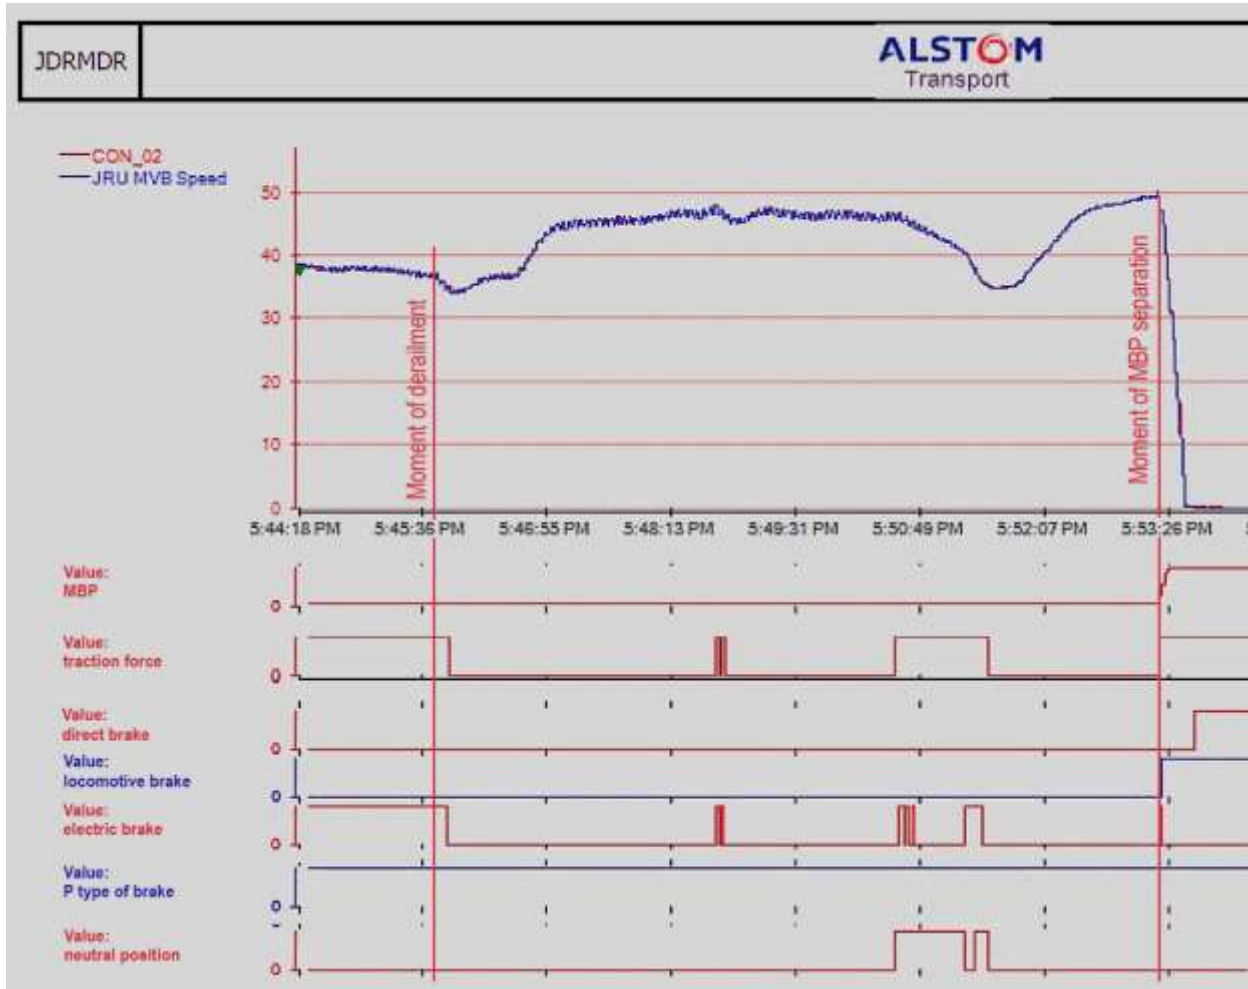
Figure 4.2.14.1: Extract from the graphical record of the train movement recording device, locomotive 193-910

“Srbija Kargo” a.d. provided graphical and tabular representations, as well as an analysis of the data from the train movement recording device on locomotive 193-910. Figure 4.2.14.1. shows the train speed, main air pipe pressure, and activation indicators of individual brake components.

CINS representatives determined on site that the head of the locomotive stopped at km 24+753 (88 sleepers from the km 27+700 hectometer mark and 246 sleepers from the km 27+900 hectometer mark). From the graphical record and the provided tables, the locomotive stopped at 17:53:59 according to the locomotive time.
