# ANNUAL REPORT

of the Investigation Body for  
Railway Accidents and Incidents

# 2018

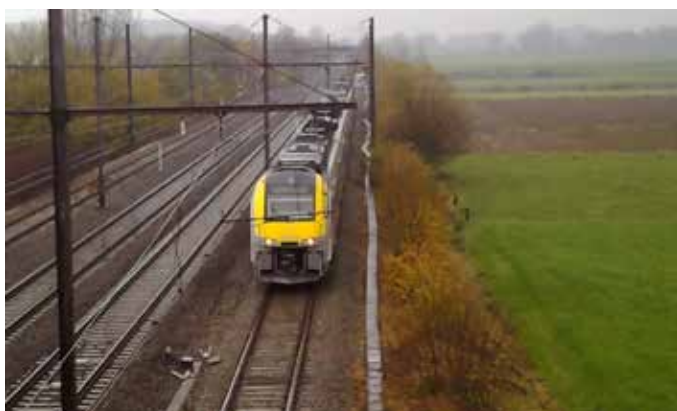
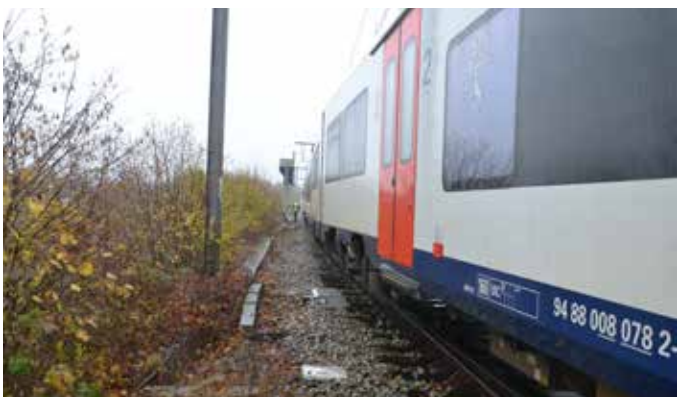
Neufvilles: 20 November 2017

The inspection of the train by the driver reveals that the two last wagons of the train have derailed. The infrastructure is severely damaged over a distance of 14 kilometres.

The initial inspections of the rolling stock, of the tracks and of the area surrounding the tracks reveal that one of the wheels of the penultimate wagon n° 3368 4952 072-9 broke some 17 kilometres from the train's stopping point, causing the derailment of the wagon. The wagon remained attached to the train, causing damage to the infrastructure. Four pieces of the broken wheel were found in the tracks.
