KÖZLEKEDÉSBIZTONSÁGI  
SZERVEZET

# **ANNUAL REPORT 2010**

## **Transportation Safety Bureau**

### **Hungary**

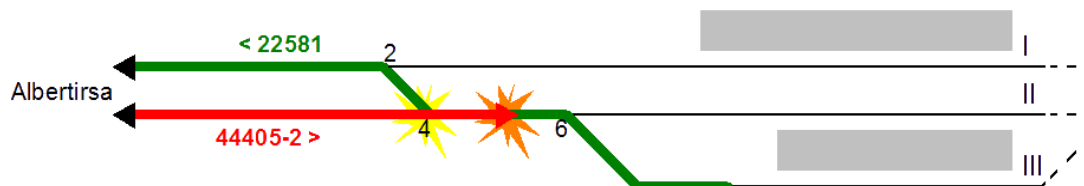
On 30 August 2008 at 11:25, having passed entry signal 'A' indicating 'Stop', freight train no. 44405-2 split switch no.4 open and then collided with wagon no. FMK-002 of work train no. 22581 departing from platform III of Ceglédbercel-Cserő station. No one was injured.

The accident was attributed primarily to human factors (SPAD). However, the IC believes that another contributing factor was the too frequent duty service of the engine-driver who, besides, spends approximately 6 hours commuting to work.

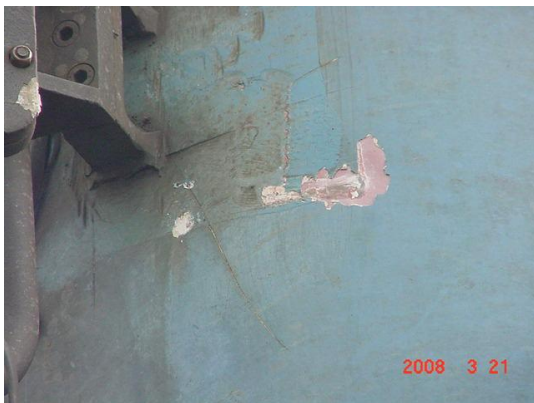
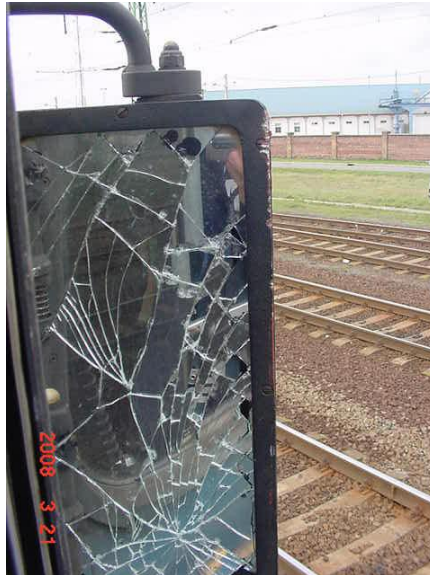
On 21 March 2008 at 9:17 hrs, having departed from track IV and passed exit signal indicating 'Stop', train no. 65540-1 collided with train no. 65411 passing track III at Szerencs station. The two vehicles collided with a little force, therefore only the first right rear-view mirror of the locomotive (reg. no. V43-1060) of train 65540-1 broke.

The engine driver of train no. 65540-1 did not pay sufficient attention to the exit signal indicating Stop, it collided with passing train no. 65411.

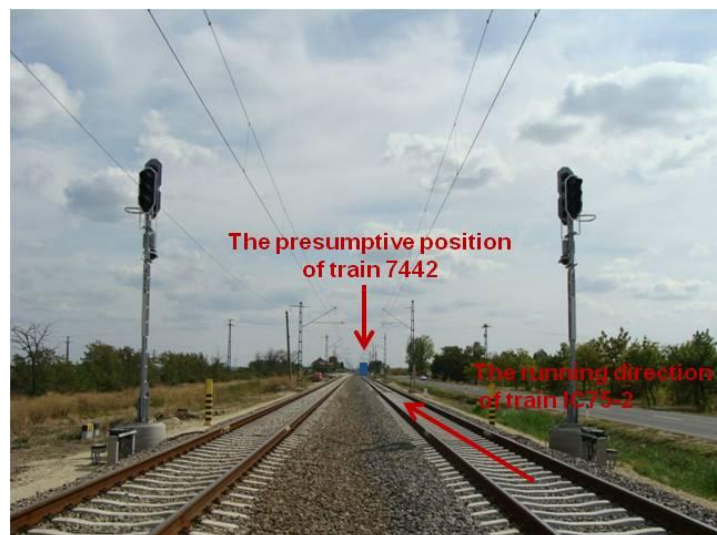
The block system between the two stations developed a fault due to the previous day's storm. As a consequence, block signal no. AT376 became inoperative (red light was on the signal) and it was impossible to send clear signal onto entry signal 'B' of Nagylapos crossover. At the same time, traffic control was also impossible between Nagylapos and Gyoma.

- The staff did not comply with the regulations of the written order given at Mezőtúr station when travelling with train no. IC75-2.
- The Unified Vigilance Warning and Train Control Device (EÉVB) was not switched off at the right place.
- The 'look-out service' i.e. a second person on board the locomotive ordered at Mezőtúr station could not prevent the accident.
- Having passed the entry signal, they followed behind the train standing in the occupied block section.
- This was the first occasion the engine driver of train no. IC 75-2 had driven a train after the section had been reconstructed and he had not been informed about the changes.

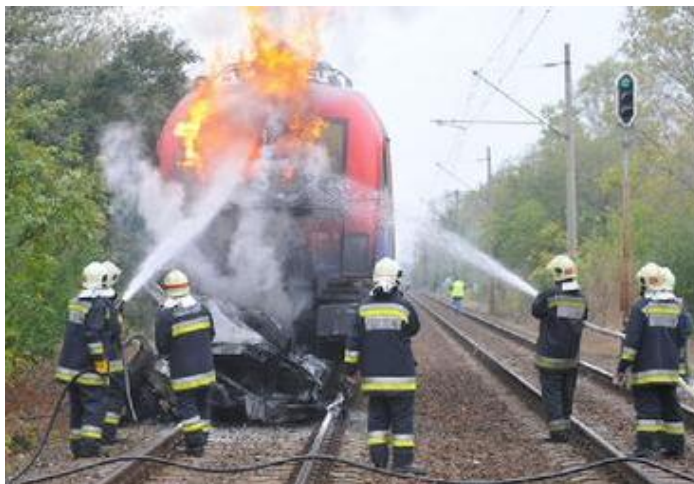
On 17 October 2009 at 12:10 hrs, passenger train no. 6588 collided with a car at LC AS2179 - protected with warning lights and half barriers - between Ebes and Debrecen stations. The car was torn in two and part of it was crushed underneath the locomotive. After stopping, the part of the car under the locomotive caught fire which spread onto the driver's cab of the locomotive. The driver of the car died at the site of the accident.

- The half barrier of the LC was in vertical (open) position at the time of the accident.
- Train no. 6588 had closed LC no. AS2132 between Ebes and Debrecen stations, however, it remained closed for a longer time than usual (it did not open automatically) and therefore after the timing it went into failure mode (the warning lights turned dark and the half barriers opened).

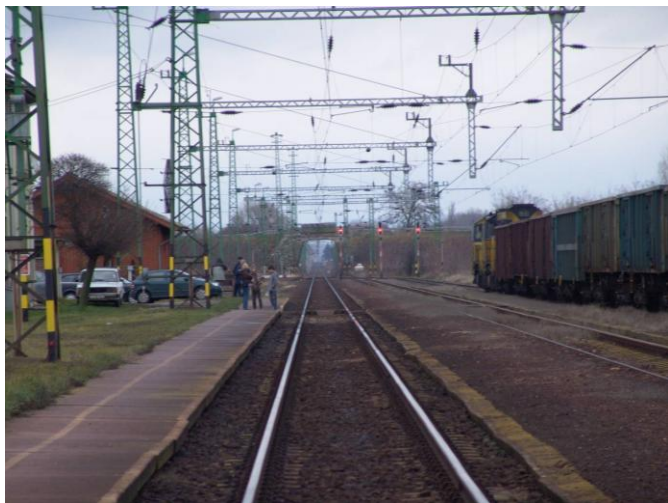
On 9 December 2009 freight train with two Czech locomotives (series 740) running from Ostrava to Ajka-Bauxitrakodó - carrying coal - was separated at Devecser station as the rest of its route was going to be on a hilly area.

While the train was waiting for departure, its crew left it - without stopping the locomotive and locking the wagons - and went to the traffic office. As a consequence, the train broke loose (as the station is on a slight incline), split points no. 1 open and rolled towards Tüskevár station.

The crew was unable to stop the train either at the area of Devecser station or on the open track. It was eventually stopped by the movements inspector of Tüskevár station - who had been notified about the incident - with two double scotch blocks. Beforehand he arranged for train no. 905 (which was to arrive at Tüskevár) to be stopped at the neighbouring station.

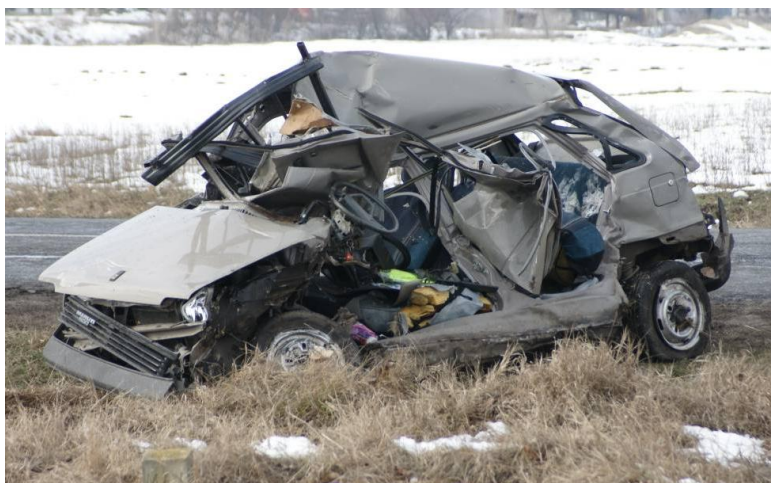
As a consequence of the accident, two passengers of the car lost their lives. The motor coach sustained minor damage but remained operable. The car was written off.

The IC established in the course of the investigation that the warning lights were indicating flashing red light signal towards the road at the time of the accident. The construction and design of the IC complies with the relevant regulations in force. The train did not exceed the speed limit.

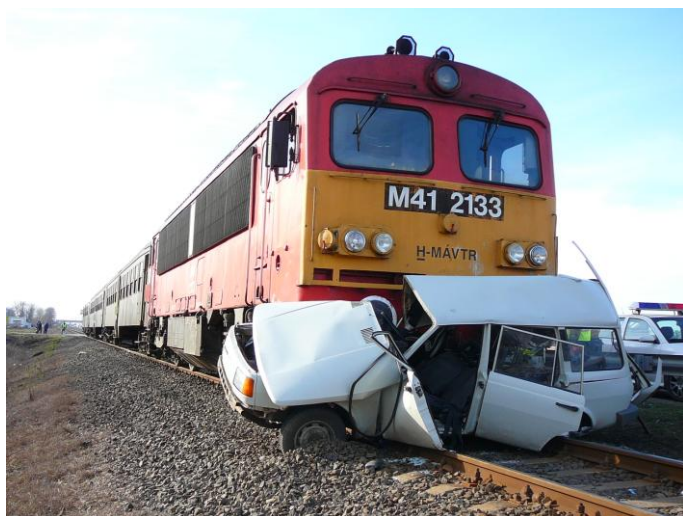
The passenger of the car died at the site and the driver was taken to hospital with serious injuries. As a consequence of the collision, the locomotive (M41-2133) sustained minor, and the car sustained substantial damage.

The warning lights of LC AS41 operated normally at the time of the accident; they indicated 'Stop' towards the road. The car drove onto the LC disregarding the Stop signal, where it collided with the passenger train. Train no. 6615 did not exceed the speed limit.

The IC conducted a site survey immediately after the accident and examined the site on a number of occasions afterwards as well. In the course of the investigation, the IC examined the construction and design of LC assuming that it might have had an indirect effect on the occurrence of the accident. The IC considered the accidents previously occurred at this LC as well as the effects of the measures taken by the relevant authorities. It also emphasised the deficiencies of the construction and design of the junctions at the LC causing recurring accidents.
