# **NIB ANNUAL REPORT 2013**

Safety Investigation Authority

This is the annual report of railway sector of the Safety Investigation Authority, Finland for calendar year 2013.

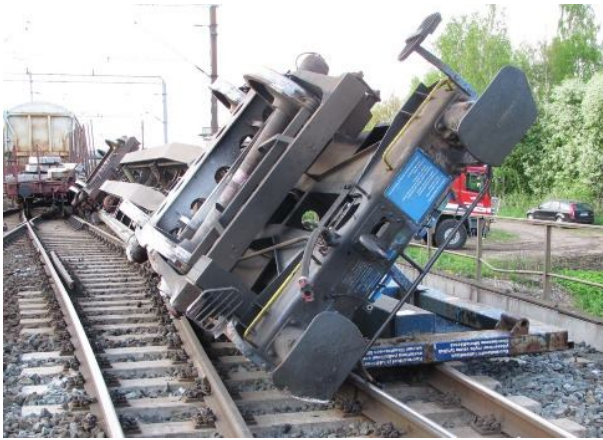
R2012-02

**Derailement of turnout transport wagons in the Riihimäki railway yard on 22 May 2012 and Kouvola railway yard on 28 June 2012**

At 3:09 a.m. on Tuesday 22 May 2012, a turnout transport wagon, positioned as the 16th wagon of a freight train and carrying two turnout elements with concrete sleepers, was derailed at the southern end of the Riihimäki railway yard. When the derailing occurred, the train was running through the yard's turnouts at a speed of 26 kmph. The derailed wagon and its load finally fell onto the adjacent track. The accident inflicted damage to the track and track equipment and significantly hindered railway traffic until the following evening.

About a month later, at 1:20 p.m. on 28 June 2012, a similarly loaded turnout transport wagon was derailed in the Kouvola railway yard. This wagon was the last car in a 20-car train. It was derailed when travelling through the turnout and finally toppled onto the adjacent track. The speed of the train at the moment of derailment was 14 kmph. Some changes were required to the hump yard arrangements, due to the track and track equipment being damaged. The accident did not significantly hinder train traffic.

Imbalanced loading caused the sideways load balance distribution of the turnout transport wagon to be very uneven. The wheel-weight ratio was 1:1.96, meaning that wheels on one side were carrying almost double the load compared to wheels on the other side. This caused the frame of the wagon to lean heavily on the side bearer blocks placed on top of the bogies. Due to the remarkable imbalance, significant friction was generated between the frame and side bearer block. This friction made it difficult for the bogies to turn when travelling on curves and through turnouts.

The wagon's bogie pivot centres were also rather dry and somewhat rusty. This required the use of more force for turning the bogie.

In the Riihimäki accident, the head of the rail was cracked at the spot where the derailment occurred. In Kouvola, the turnout at the derailment spot was in poor condition, featuring wear exceeding the allowed measurement values. Moreover, the track featured dents of varying depth around the turnout. These flaws and wear contributed to the wheel flange rising on top of the rails. Similar turnout transports with imbalanced loads have been previously carried out without any problems. This fact supports the notion that wear and flaws in the track played a key role in the accidents.

- The risk assessment element of the safety management system should also extend assessment to existing standardised activities.
- In the turnout condition monitoring system, turnouts that have been found to be in poor condition should be repaired or replaced to ensure that they fulfil the measurement values and other requirements set for turnouts.

- Unambiguous operational instructions regarding maintenance and traffic limitations should exist for cases in which the measurement values and acute limits determined for turnouts are exceeded.
