# ANNUAL REPORT

of the Rail  
Accident and Incident  
Investigation Unit

## 2020

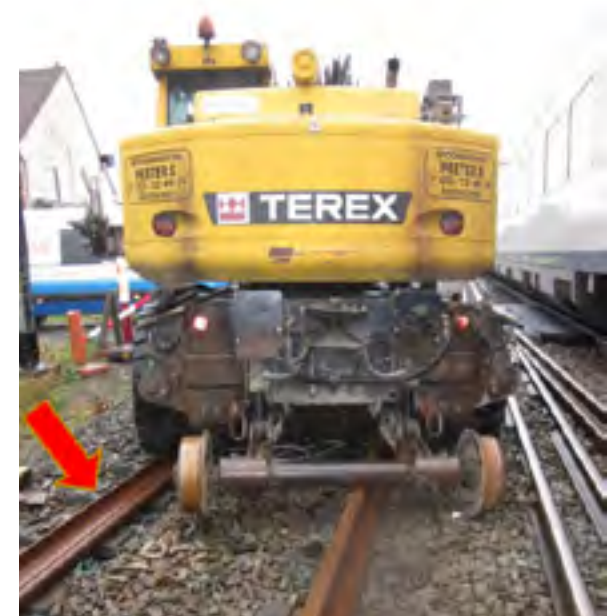
The **direct cause** of the accident was the intrusion of the crane jib into the adjacent track's loading gauge and the train's ability to enter this zone without an effective safety method being activated.

The **first underlying factor** is the lack of fully developed procedures on the part of the infrastructure manager for the choice, dissemination and application of the specific safety methods, which should take account of dynamic working conditions such as the transition from one safety method to another, among other things.

A **fourth underlying factor** is the limited consideration given in the infrastructure manager and the contractor's training sessions to dangers and risks related to a change in operational circumstances.
