Joint Network Secretariat Urgent Procedure Task Force “Extreme effects of thermal overload in special cases of freight operation

**Final report –**

**Part 3: Detailed information on the work of the  
JNS task force**

02. February 2022

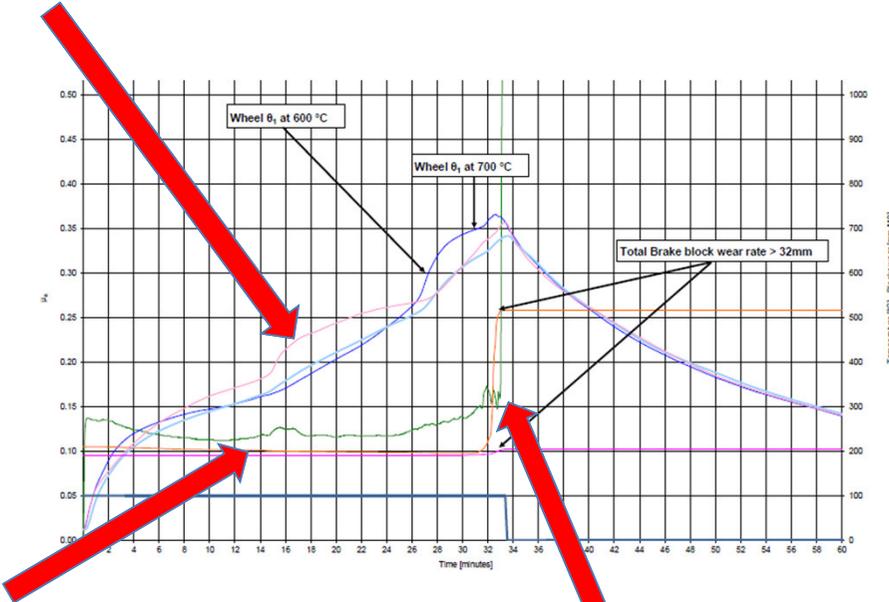
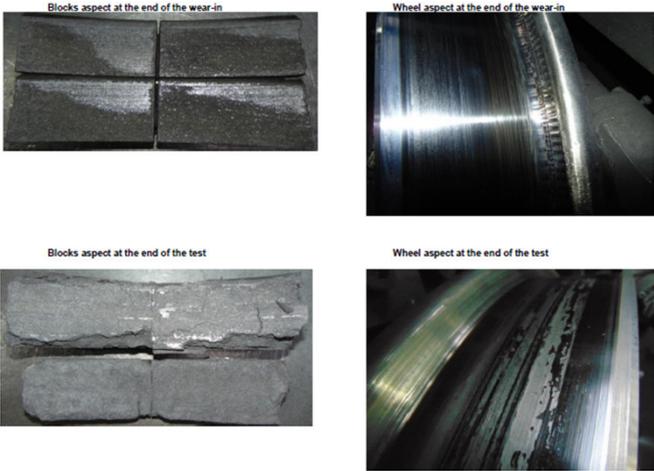
### test program A6 of UIC leaflet 541-4 – example test result LL-block - type A

At temperature of approximately 700°C, significant increasing wear (self destroying) and in parallel decreasing temperature of the wheel

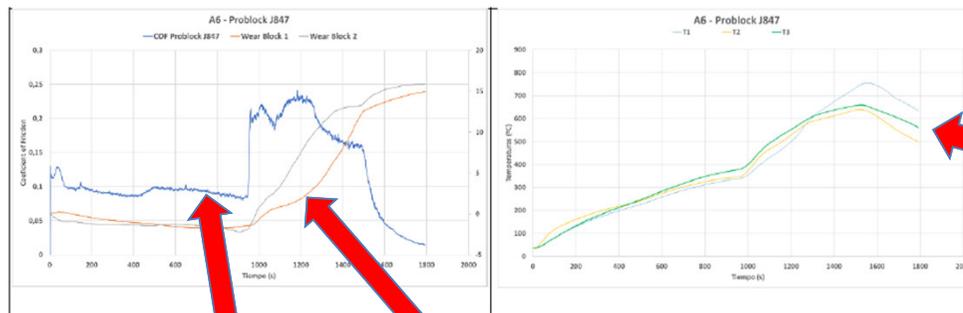
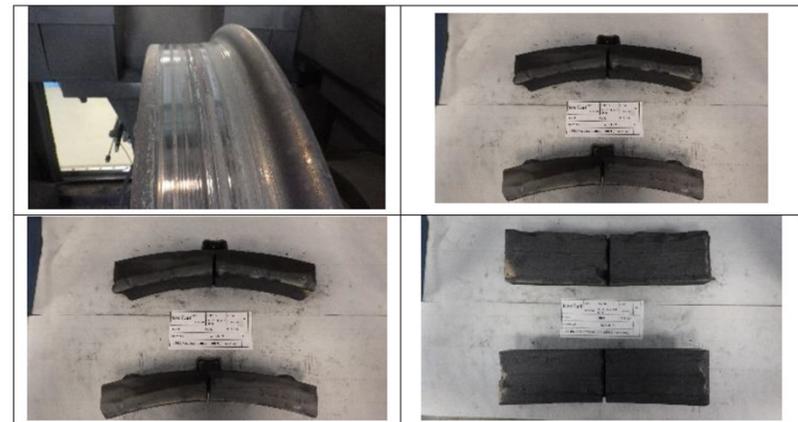
### Locked brake testing test program A6 of UIC leaflet 541-4 – example test result LL-block - type B

At temperature of appr 400°C, significant increasing wear up to max value of 16 mm, at that time the average wheel temperature is approximately 700°C

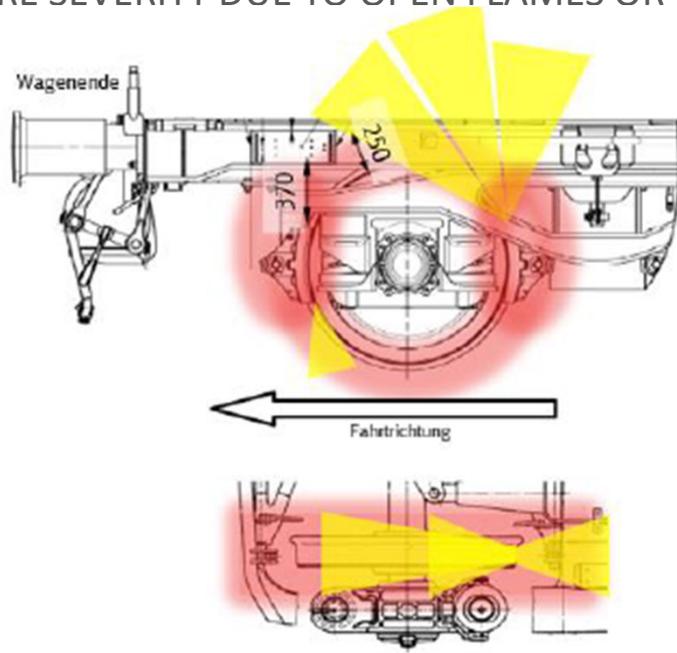
Two heat affected Zones

- One is created by the brake blocks through radiant heat and open flames (yellow)
- Second due to the heating of the wheel tread (red)

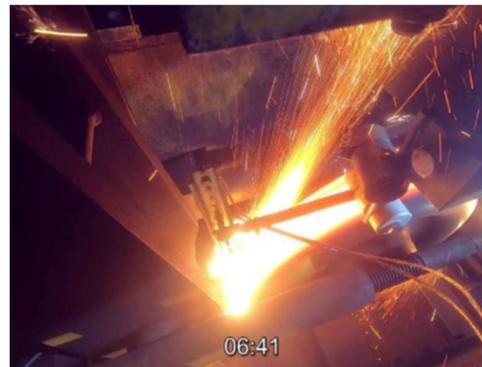
LL-Block

- The sparking of the rear brake direction of travel represents the main source for sparks. The sparks produced can occur at a distance of < 1 m from the point of spark formation in direct contact with the brake block.
- Possible burning materials may act as an ignition initiator. It is estimated that, in addition, the ignition effect of the sparks decreases considerably.

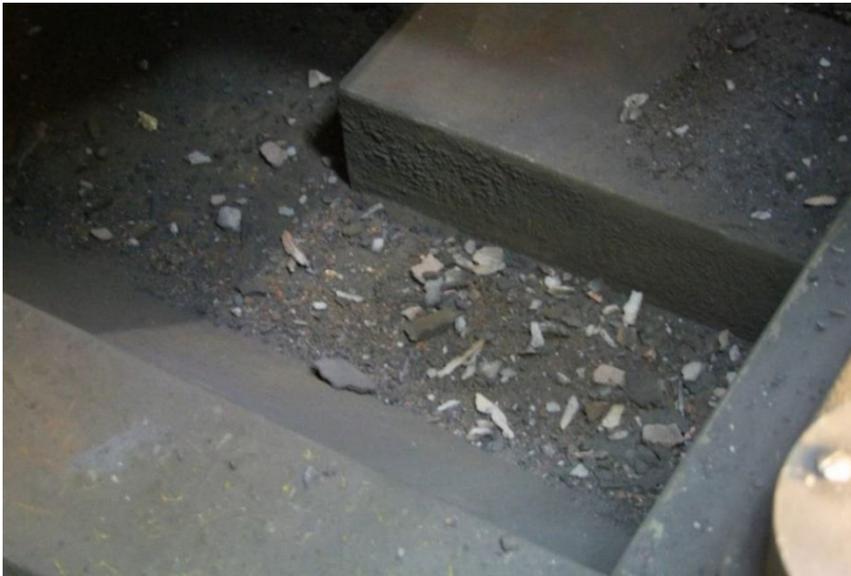
- The largely flaky material spalling from the burning brake blocks was examined. The fragments of the blocks had a maximum volume of 1 cm<sup>3</sup>. The fragments of CBB that were produced during the test were collected by the collection tray under the test stand.
- A spreading of the fragments beyond this was not detected. The ejection distance is therefore limited to the immediate vicinity of the braked wheel.

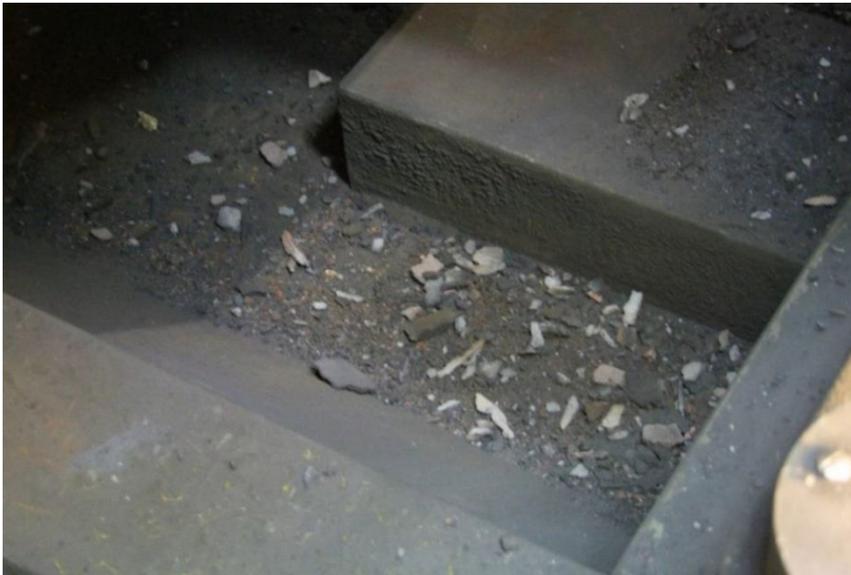
- The influence on the load is strongly dependent on the respective constructive vehicle solution.
- A fire protection severity exists here in the case of existing installation spaces on the vehicle or load that offer suitable storage areas for material accumulations.

- The briefly glowing broken block material can then act as an ignition initiator.
- The use of flame-retardant materials that meet the fire protection requirements for freight wagons according to Regulation (EU) No 321/2013 effectively limits the spread of fire to the vehicle.

- Infrastructure: in tests carried out, safe ignition of the dry tufts of grass was observed in a temperature range of over 600 °C. In the temperature range between 400 °C - 600 °C, an increased severity of ignition must be expected. It must therefore be assumed that the erupted block material reaches areas adjacent to the ballast bed and can act as an ignition initiator there. (comparison with CI )

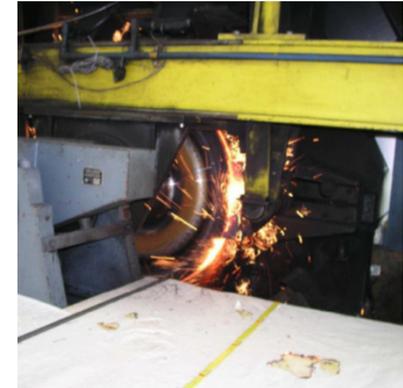
CI-block

- Broken out block material of composite brake blocks has a significant ignition potential for slope fires and cargo.
- But comparing the technological and physical properties of CBB and CI material, it becomes clear that the heat capacity of fused beads made of cast iron material is far higher than that of the CBB material.
- **Due to the difference in heat capacity, the ignition potential of broken-out CBB is lower than that of beads from molten cast iron blocks.**
