# SUMMARY OF SAFETY REPORT

## COLLISION OF TWO FREIGHT TRAINS AT TINTIGNY ON 4 MAY 2012

**Investigation Body for Railway Accidents and Incidents**

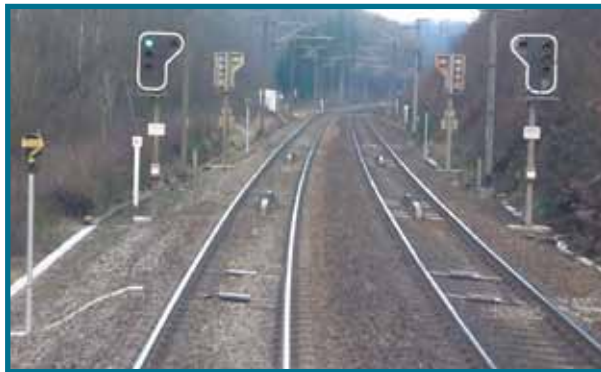
The analysis of the dynamics of the accident allowed us to identify the pivotal event as the passing of the permissive signal at danger by the second train.

This is a failure of the command principle that provides for signals ensuring the spacing of trains. The risks of collision in human terms as well as material, environmental and financial need to be avoided as a priority. Signalling is mainly responsible for foreseeing this. The signals should ensure spacing between trains and should therefore guarantee that catching up is avoided.

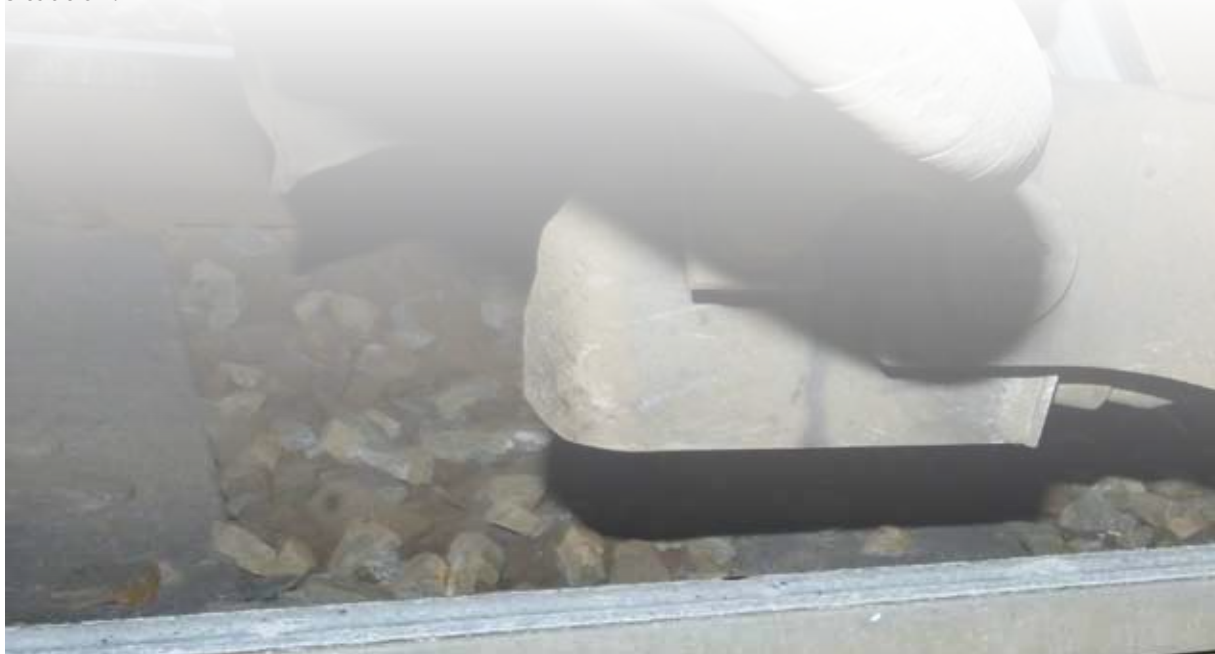
Passed this critical point, there should be recovery measures which can still prevent an accident. Once the last signal separating the two trains had been crossed, there was no longer a technological element allowing the train to be automatically stopped before the obstacle, or to aide the driver in achieving this. There is no technological means on a train that can help the driver in a similar way to that found, for example, on road vehicles. It is more and more common to encounter road vehicles equipped with devices that brake the vehicle automatically if an obstacle appears suddenly ahead of the vehicle when travelling at a low speed. The driver of the train (EE44883) did not have help from this type of technology.

Our analysis showed that the operator had contacted the first train with GSM-R and not the driver of the second train: there is no obligation for communication in this type of situation. A simple communication would have allowed the driver to have a correct mental image of the situation.

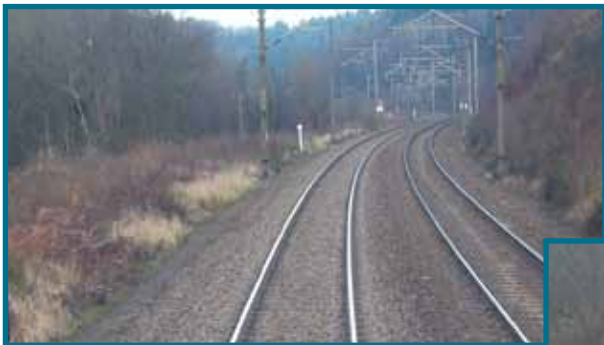
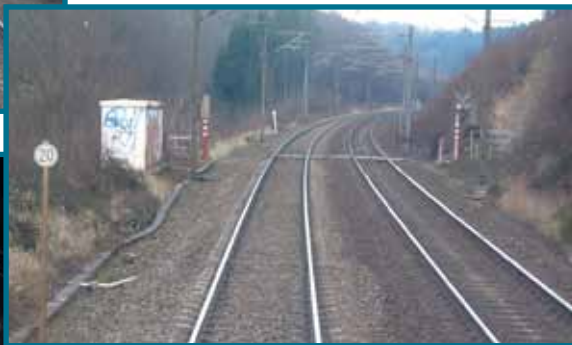
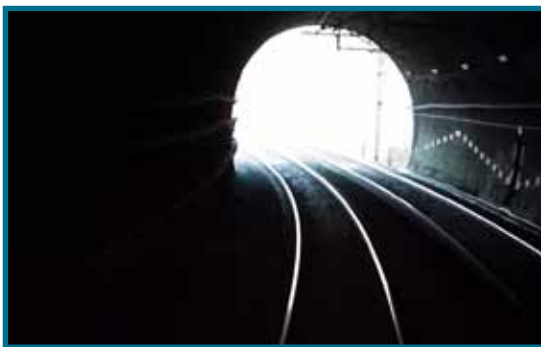
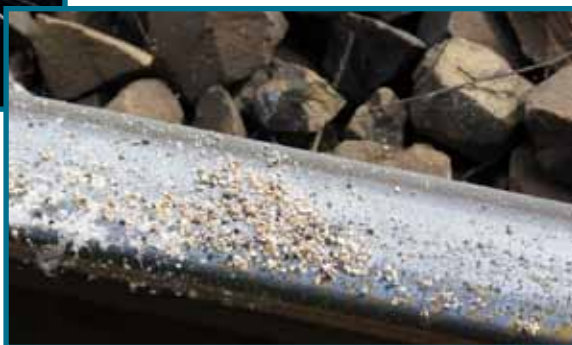
The risk linked to the situation had been poorly evaluated: the curve of the Lahage tunnel and the visibility conditions did not allow the driver of the second train to see the first train sufficiently early to be able to bring their train to a halt. The length of the track that they could see clearly ahead of them was not long enough at this section of the line to be able to safely stop their train.
