**FINAL REPORT**

**technical investigation of a railway accident - derailment of nine freight  
wagons of the composition of freight train No. 50601 when entering  
Dupnitsa r.w. station i.w.o. switch No. 10 on 23.01.2016**

Ministry of Transport, Information Technology and Communications,  
REPUBLIC OF BULGARIA  
Railway Accidents Investigation Unit - RAIU

April 2016

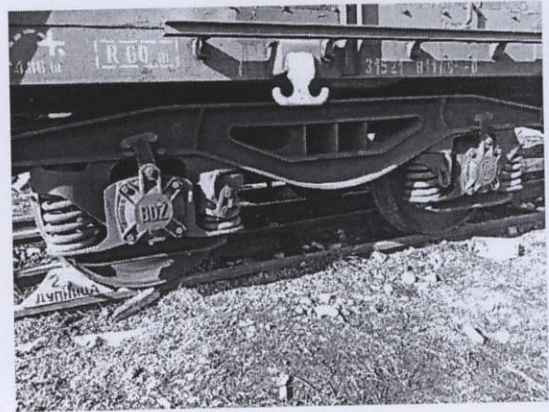
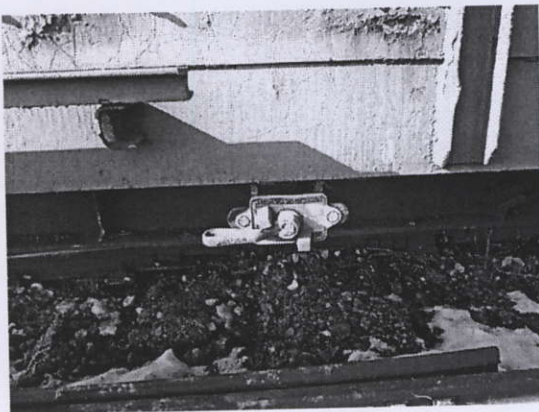
table with activated braking systems. The brake of freight wagon No. 31529326281-4 - sixth after the locomotives acted (Fig. 9, 10, 11) and that of freight wagon No. 31521811065-0 - eighth after the locomotive was isolated at the station Iliyantsi origin station (Fig. 12, 13). Wagons 9, 10 and 11 after the locomotive were not available at the inspection at Dupnitsa station and the state of their brakes was unable to be assessed. From the examples and calculations made, it became clear that the train was not provided with brake mass in its departure from Delyan station to Dupnitsa station, even assuming that the missing freight wagons were running with brake systems.
