**SPECIALIZED UNIT FOR INVESTIGATIONS OF ACCIDENTS AND INCIDENTS IN
RAILWAY TRANSPORT AT MTITC**

FINAL REPORT

**investigation of a railway accident – fire occurred
in electric locomotive № 46221.8 while in motion, during servicing fast train № 8602
between Svoboda station and Chirpan station on April 09, 2019**

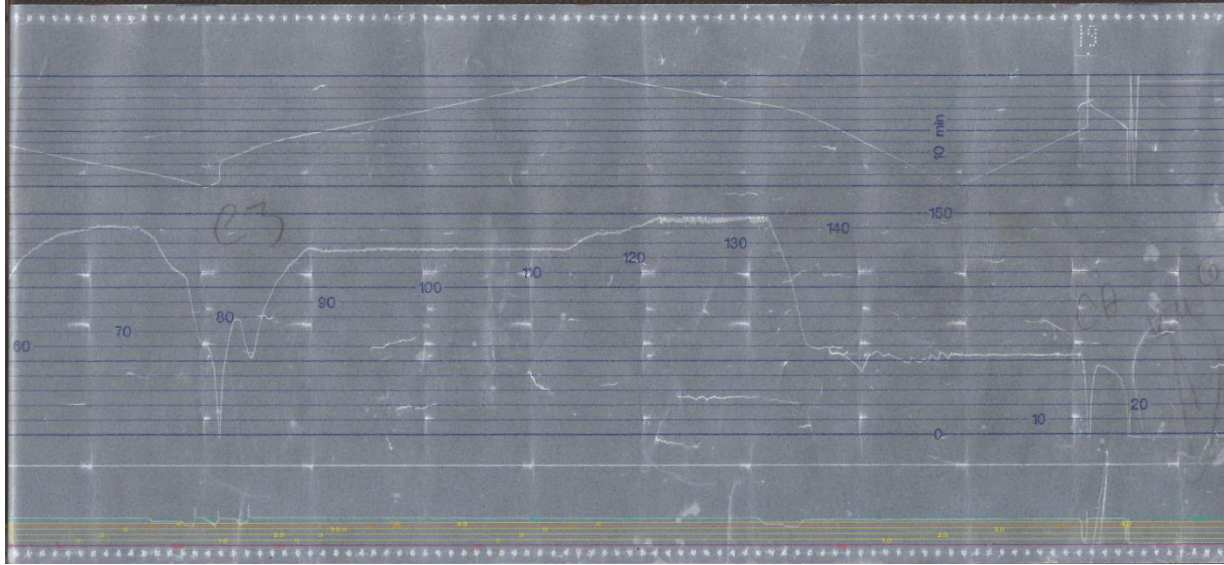
Fig. 5

The train moves at a speed of 140 km/h when 3100 m before Stara Zagora at 18:28 hours begins to decrease without using ABC, i.e. due to the natural resistance in movement (Fig. 5). Speed decreases to 135 km/h. In this way, it traverses 500 meters and in less than a minute the motorman triggers the brake by dropping 0.7 bar from the main air duct. The speed decreases to 110 km/h, as in this time the train travels 1300 m for about a minute. In this moment the motorman performs a second hold and releases another 1 bar and the pressure in MAC is set at 3.7 bars. The speed starts to decrease at a faster pace, and it is just 80 km/h 450 meters farther.

Apparently by motorman's discretion this has been more than necessary, and after a very short extra hold of down to 3.4 bars, he makes a partial loosening of up to 4.0 bars, and about another 70m farther he makes a full loosening using an impact filling. The brakes loosen for about 250 meters and the rate of deceleration decreases again. Subsequent new partial holdings up to 4.6, to 4.15, to 3.7, followed by complete retention to 3.4 bars in the main air duct and immediately afterwards partial loosening to 4.3 bar, followed by full loosening with an impact filling at setting the train at the station. These actions of the motorman show that either the motorman felt insecure in the braking performance of the train, or the train showed unsustainable behavior in braking mode.

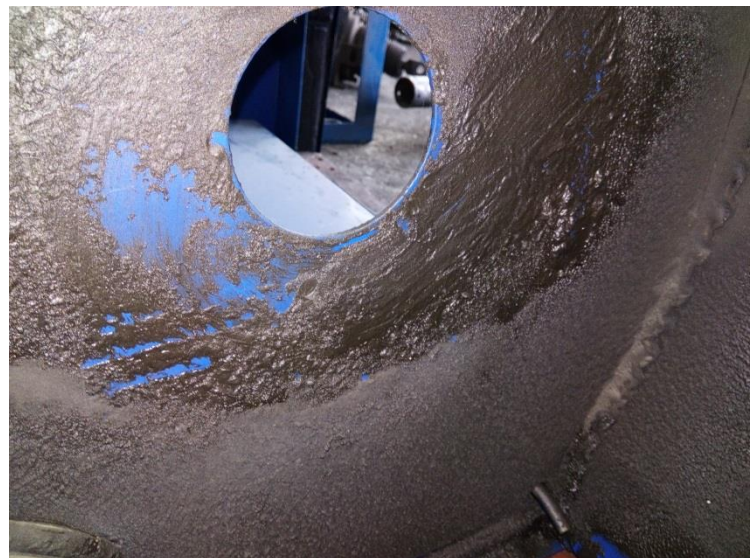
Fig. 7

The Investigation Commission took note of the factual situation and the consequences of the ignition, and after several inspections at Plovdiv Locomotive Depot and at Sofia Locomotive Depot, it was found that the main cause of the ignition has been the incoherence of the cooling turbine towards the main compressor's shaft as a result of which a front impact rotation has occurred during, which has led to its rear part being rubbed into the wall of the air outlet camera (Fig. 6). The friction between the two surfaces (steel in steel) has created sparks which have ignited the greased dust layered on the noise insulation of the inside walls of the compressor's cameras (Fig. 7). As a result, a flame has occurred and the temperature in the camera has risen. As a consequence of the flames and the high temperature, the sound insulation mounted on the inner side of the compressor unit cameras' covers (Fig. 8) is ignited. The ignited insulation has further increased the temperature which has led to the ignition of the power cable insulation supplying the compressor unit which passes through the same cameras (Fig. 9).

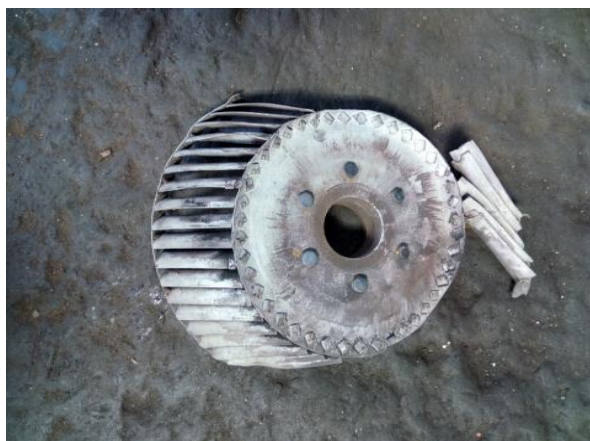
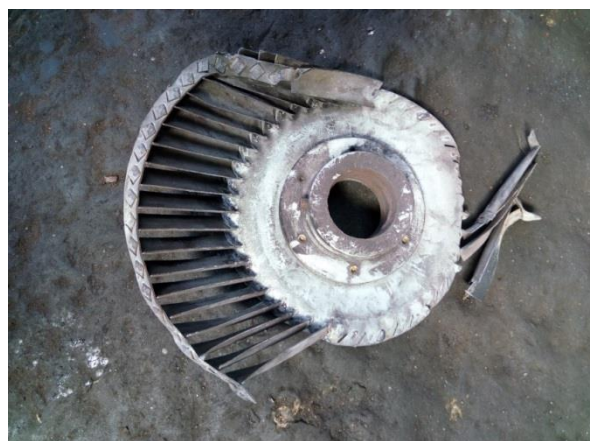
The Investigation Commission took a comprehensive view of the compressor unit cooling turbine and found out blockage trace marks on the holdfast hub on the drive shaft of the compressor electrical motor. There were no missing blades, or such as dislodged by the turbine casing due to centrifugal forces (Figures 11 and 12). Deformations of the turbine blades have occurred due to the contact with the walls of the camera and there are no traces of malfunctions occurring before the accident. The fastening screw on the turbine bush is in working condition, showing signs of deformation and contact with the shaft of the electric motor (Fig. 16). Two traces were found on the locking screw of the engine shaft, one of which is a tapered depression and is assumed to be done during a previous mounting (Fig. 13). The second trace is a recess in the form of a path along the shaft. At the same time, the inside of the turbine hub shows a double trace of blockage in the form of a screw obtained from the cooling turbine falling off from the motor shaft as
