RAILWAY ACCIDENT INVESTIGATION UNIT
AT THE MINISTRY OF TRANSPORT, INFORMATION TECHNOLOGY AND
COMMUNICATIONS

FINAL REPORT

technical investigation of railway accident –
derailing of freight train Nr. 90570 on point Nr. 5 upon entrance in
Hitrino station on 10.12.2016

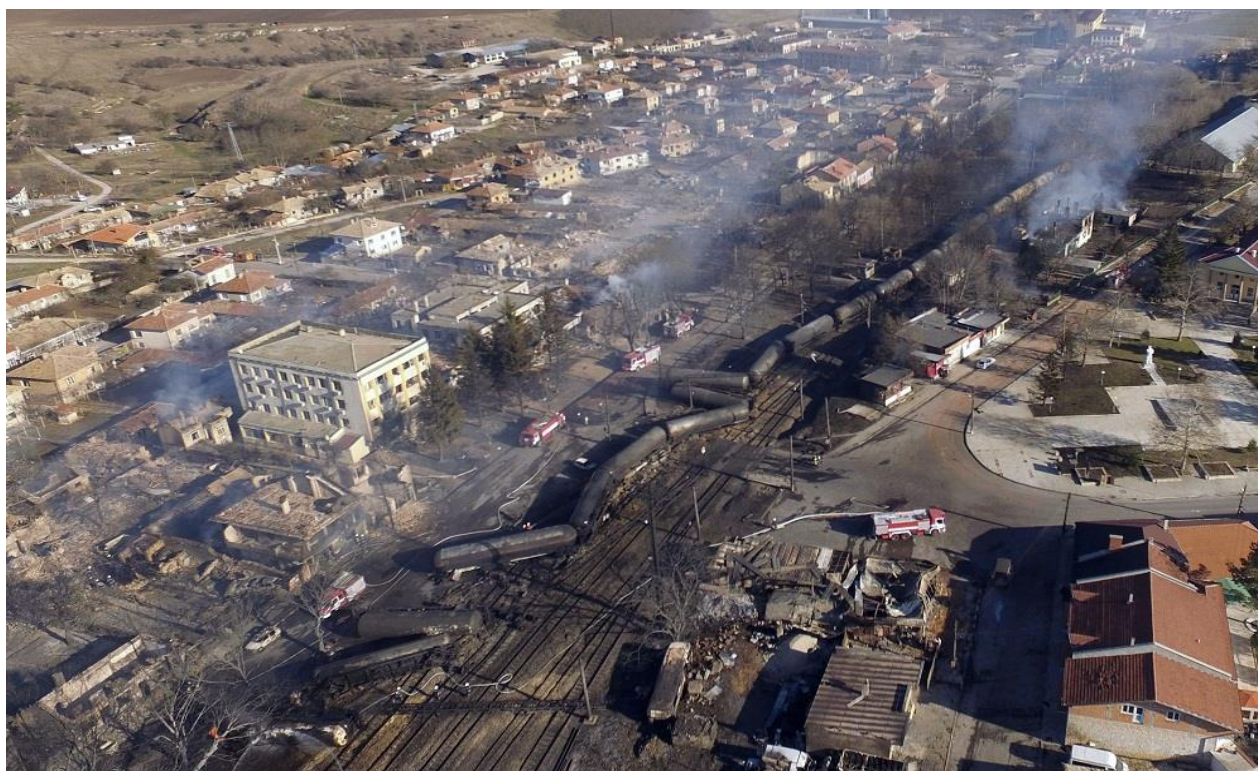
Figure 1

The two electric locomotives and the first five wagons arrived at the station. One part of the train had derailed, and the other part had settled in the throttle place accommodating the points at Post Nr.2. The post switchman at Post Nr. 2 called the traffic controller on duty via the station telephone connection line to inform him that freight train Nr. 90570 had derailed. During the conversation the post switchman felt strong suffocating smell which was followed in a while by a powerful explosion, as a result of which an extensive fire burst out, covering a significant area of the station and the village of Hitrino (Figure 1).

As a result from derailing of the train, the reservoir of one wagon-cistern – the 10th one in line, Nr. 33 87 791 5652-4, was punctured, from where the transported load (propylene) leaked off, exploding afterwards.

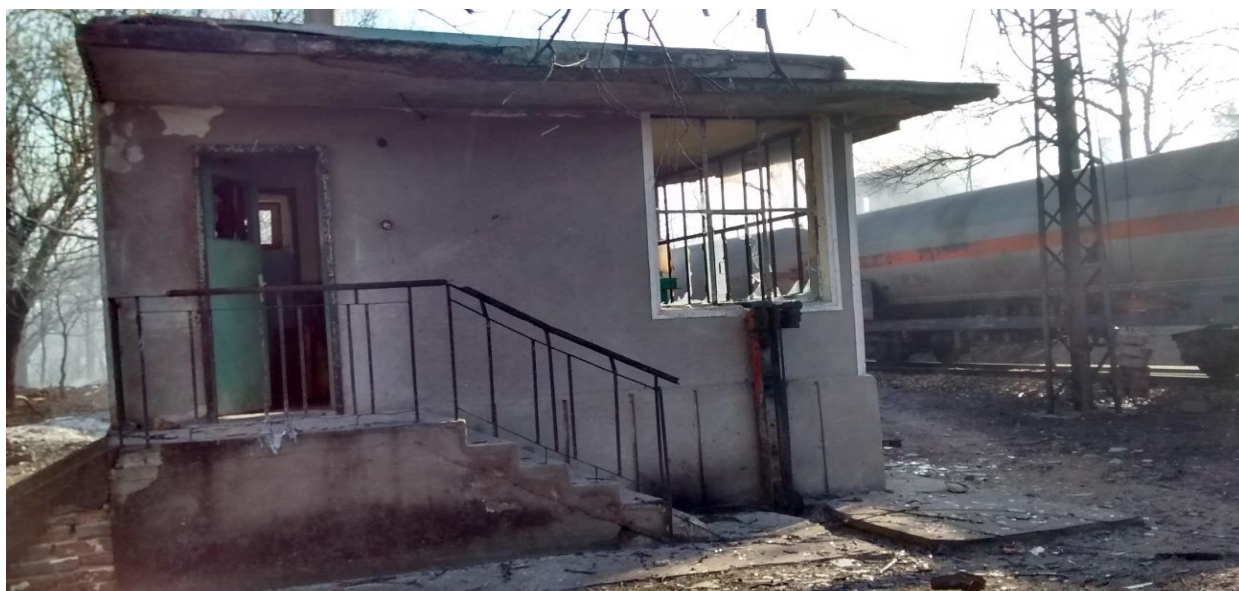
Figure 3

At 05:35 h. the traffic controller on duty went in front of the reception building of the station to meet the arriving train. After the train had entered the station and passed through the railway level crossing, found in the throttle place accommodating the points at km 110⁺⁴⁶⁰, the traffic controller on duty saw sparkles emitted from the wheels of the train. A few seconds later the lighting at the level crossing switched off, the catenary swung, and only a part of the train continued trafficking towards the reception building. The wagons, from the 6th to the 17th one, derailed, the remaining 9 wagons from the train did not derail and stopped in front of point Nr.1 at Post Nr.2 (Figure 3).

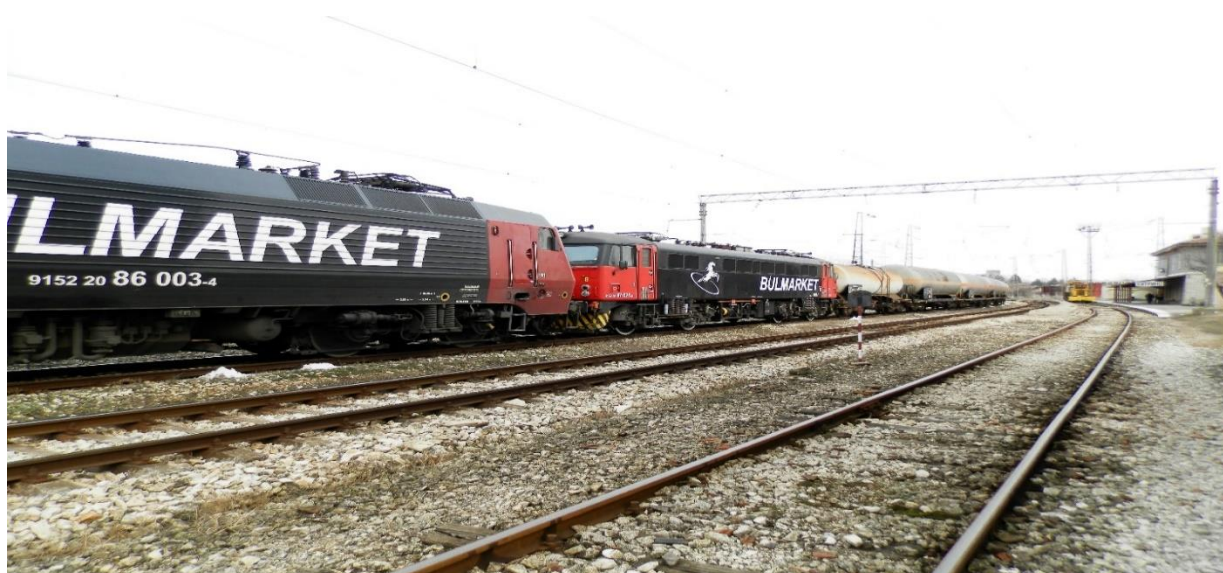
Figure 6

wagon and laid aside on the Fourth platform (Figure 5). The other 5 wagons with the two locomotives continued their trafficking and stopped 340 m after the reception building of the

station (Figure 6).

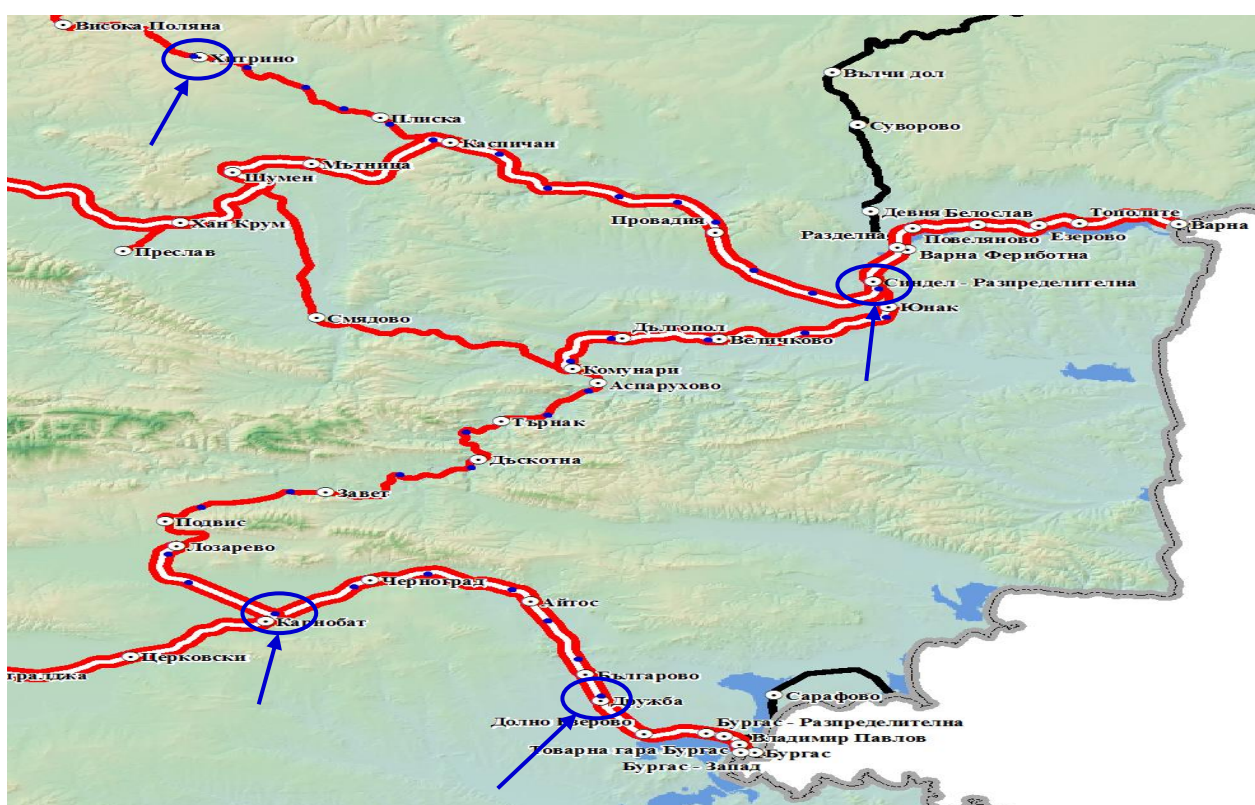
Figure 9

From Druzhba station to Hitrino station freight train Nr. 90570 travelled, being composed of two electric locomotives – supportive one ahead of the train – Nr. 86003.4, and train one – Nr. 87025.0, and 26 wagon-cisterns, including 20 ones full of propylene, 3 ones full of propane-butane, 2 empty ones as front guard and 1 empty cistern transported for repair, 104 wheel axes

and gross mass weight of 1756 tons (Figure 9).

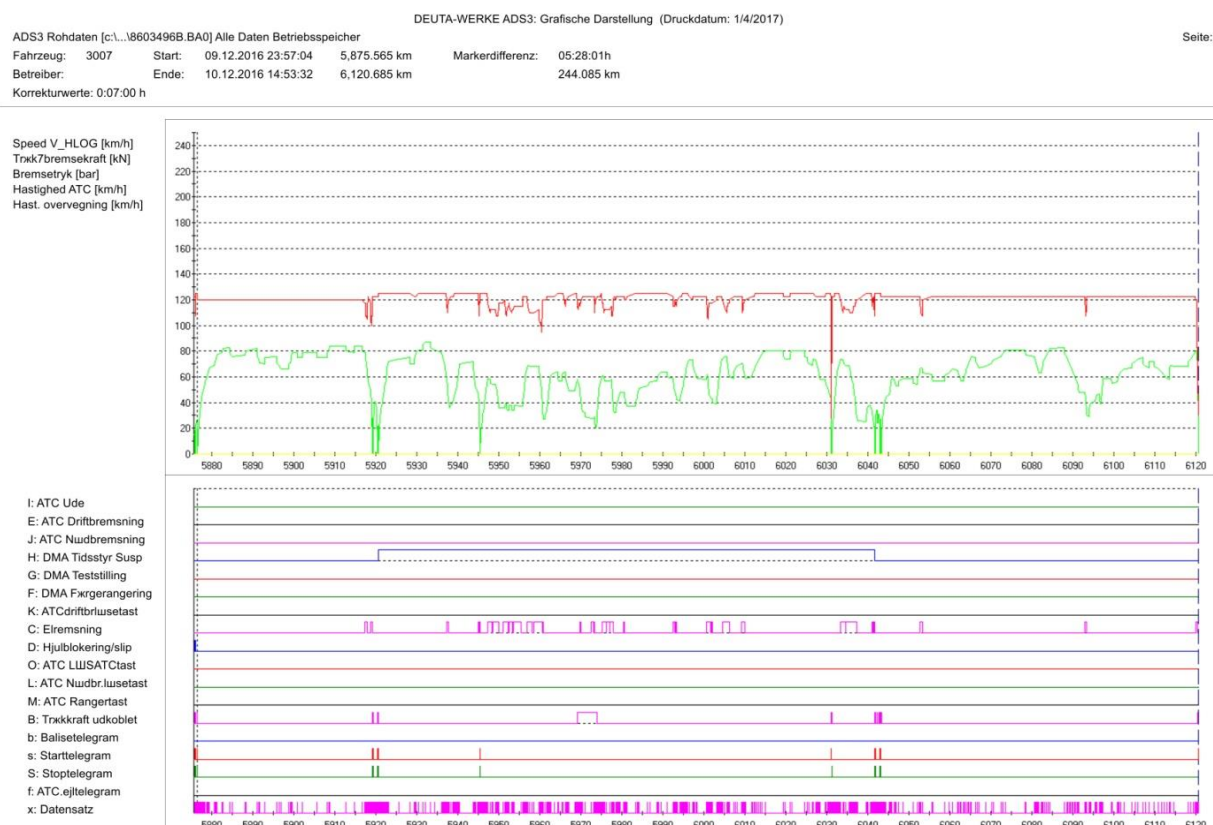
Figure 10, upper part, exhibits the diagrams of changing of the speed (in green color) and the pressure in the main air duct (in red color) as function from the travelled road.

The lower part of Figure 10 exhibits the digital parameters of the movement of the

It was established that the alertness maintenance device of the locomotive was switched off from Karnobat station to Sindel-razpredelitelna station (in this section locomotive Nr. 86003.4 travelled as a second locomotive in the composition of the train, and at that time locomotive Nr. 87025.0 was positioned ahead of the train). The digital parameter with designation „H:DMA Tidsstyr Susp” (designated with blue color at the lower part of Figure 10) has “zero” value from Druzhba station to Karnobat station, thereafter an increase is registered (rectangular impulse) to Sindel-razpredelitelna station, and after that the parameter again drops down to “zero” value up to Hitrino station.

The recorded parameters of the train’s trafficking were surveyed and analyzed in detail in the last 3000 meters before entering of the train at Hitrino station (point Nr. 1). Figure 10 exhibits in graphics the recorded parameters from km **200,320** to km **203,320** (provisional kilometers, the last 3000 meters before the occurrence of the derailing accident). According to the trafficking schedule of train Nr. 90570, the permitted maximum speed at the section between Pliska and Hitrino stations is 70 km/h.

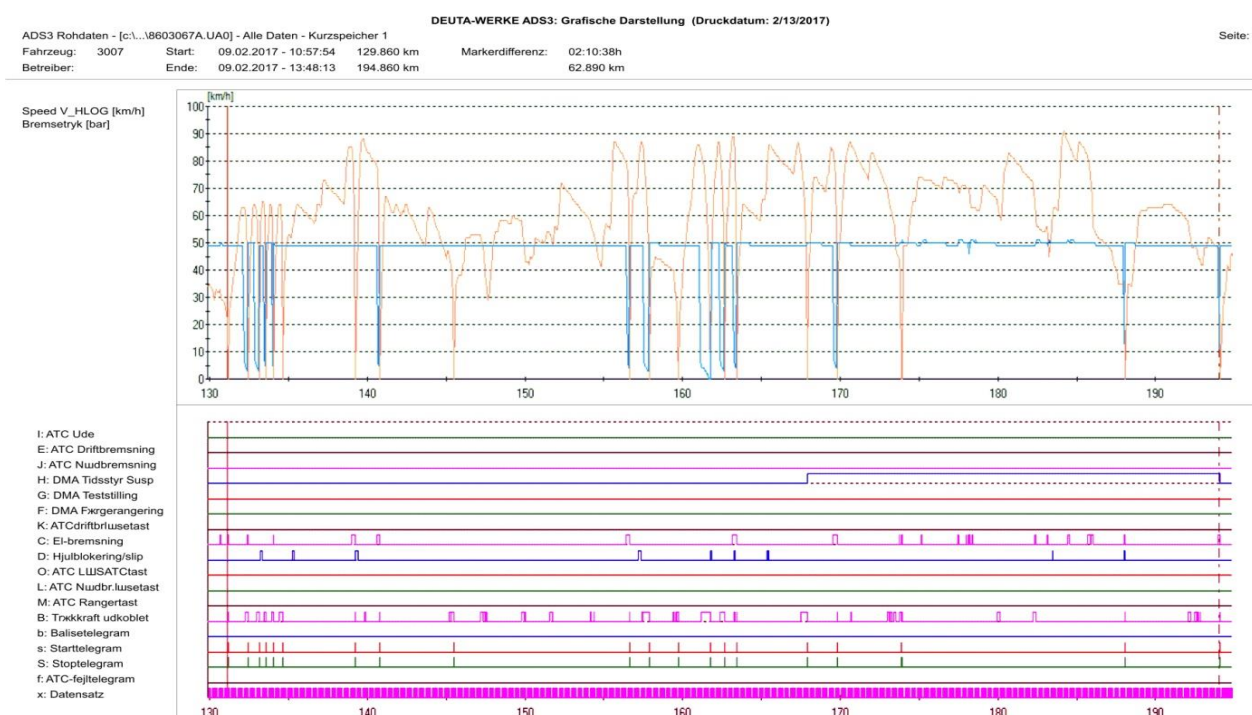
Figure 12

Figure 12, upper part, exhibits the schedules of changing of the speed (in red color) and

the pressure in the main air duct of the train (in light blue color) as a function from the travelled road.

Figure 12, lower part, exhibits the registered digital parameters of the locomotive's movement.

The digital parameter, designated with „H:DMA Tidsstyr Susp” (depicted in blue color in the lower part of Figure 12) is of “zero” value up to km 167,900, after which an increase is registered (rectangular impulse) to Poduyane-passenger station (km 194,065), where the alertness maintenance device is switched on again.

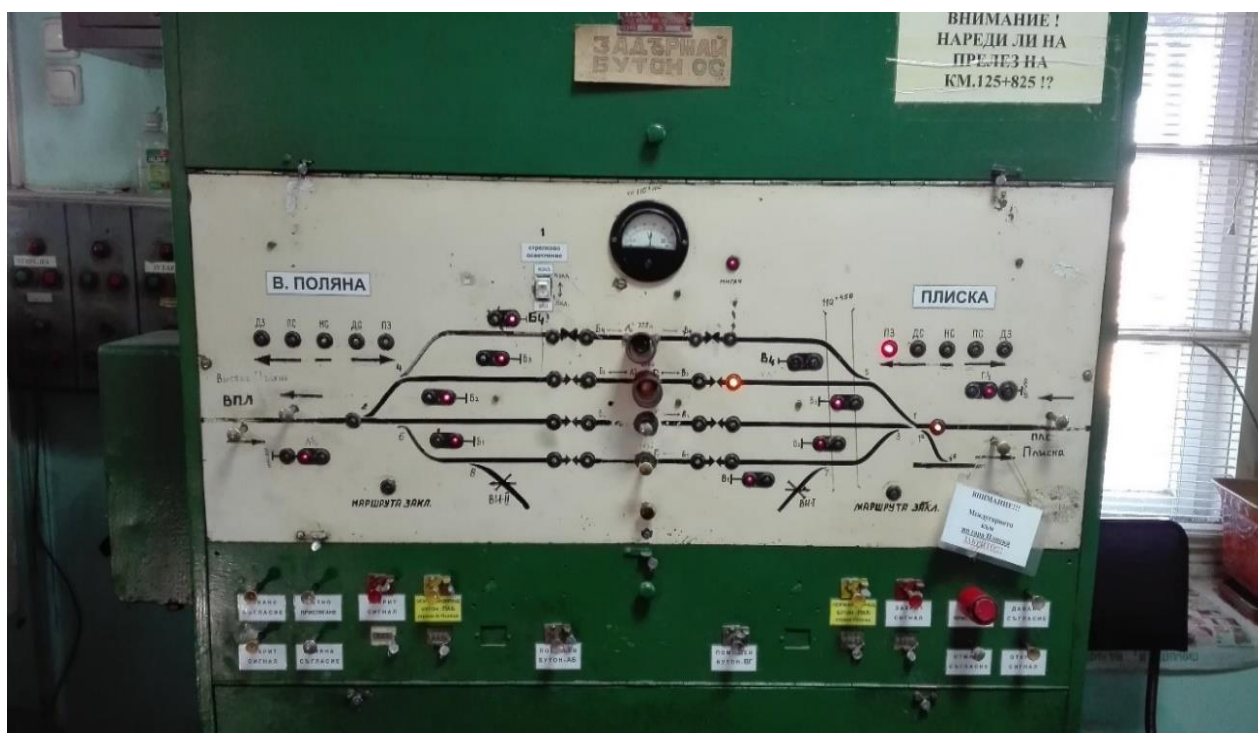
Figure 17

Hitrino station is provided with Relay Key Dependence System with Control unit found in the premises of the traffic controller at the reception building of the station, and Executive units found at the points' Posts Nr.1 and Nr. 2 in the two throttle places of Hitrino station. On 14.12.2016 the Investigation Commission at the MTITC performed survey of the external and

internal equipment in the presence of a mechanic - “safety provision equipment”, to register the condition of the prepared route with the installation in the station and at Post Nr. 2, of the partaking in the route entrance points Nr. 1 and Nr. 5, and the position of the switch rails locked with locks of “Kolben-Danek” type. As evidenced by the control panel of the Control unit in the station (Figure 17) and the position of the keys inserted in the sockets of the Executive unit at Post Nr. 2 (Figure 18) and the dropped barriers of the railway level crossing, the Commission found that the route was properly aligned and the installation was in a faultless state at the moment of the accident.

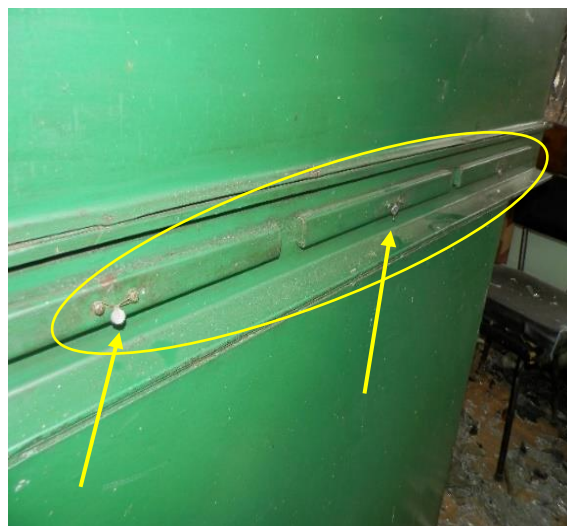
Figure 19

The seals of the Control unit and the Executive units were of a regular state (Figure 19).

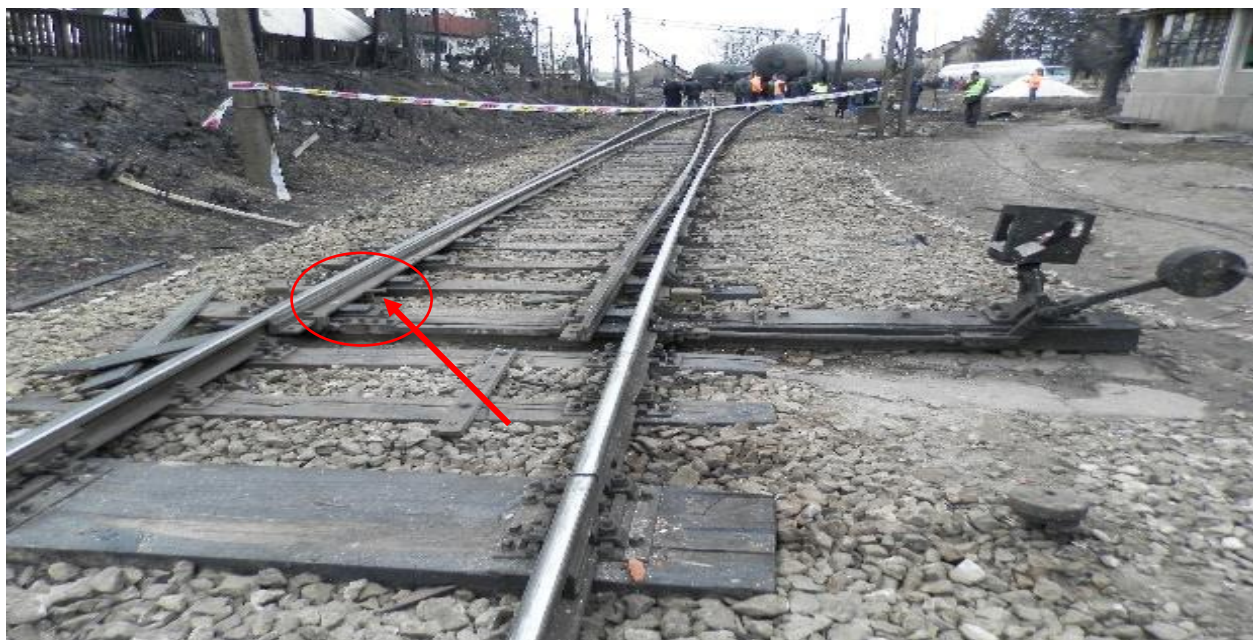
Figure 20

The manual point locks, “Kolben-Danek” type, have locked correctly the switch rails at point Nr. 1 in (+) position (on Figure 20) and point Nr. 5 in (+) position

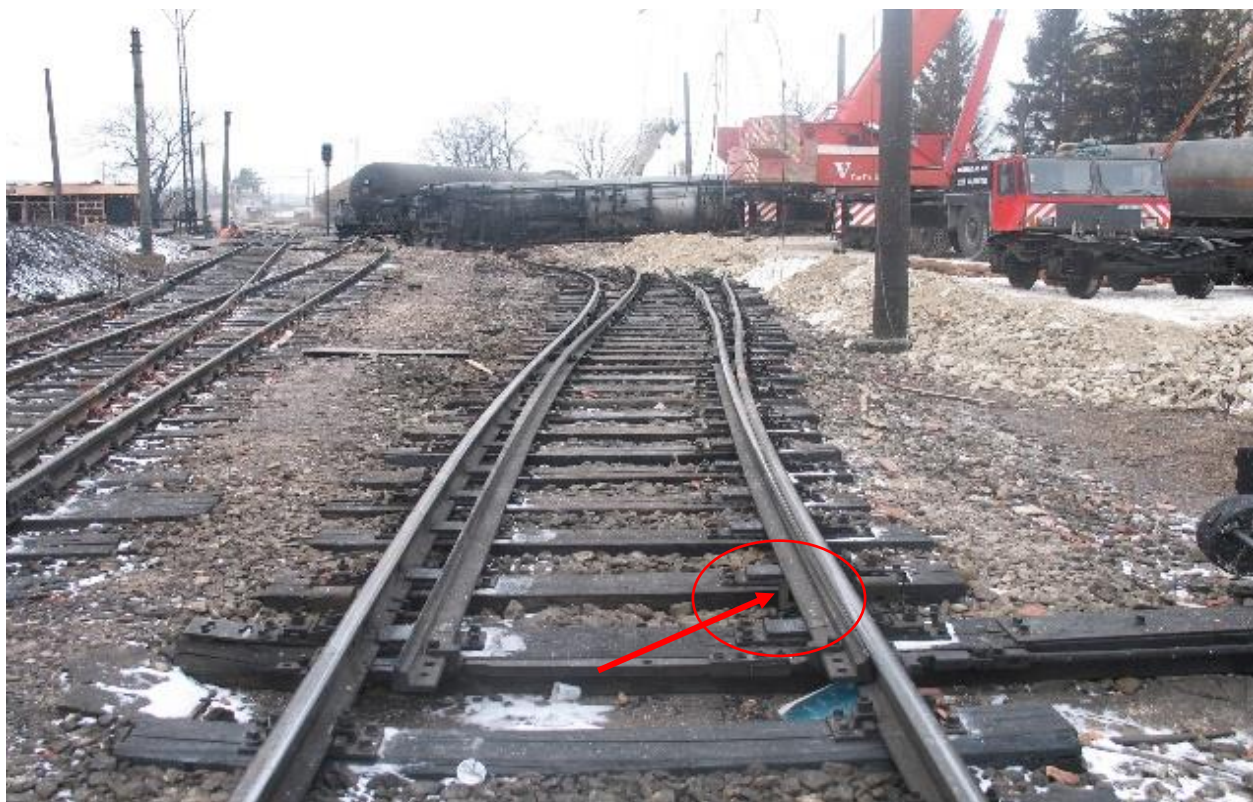
Figure. 21

(on Figure 21) for acceptance of the train on the Third platform. The keys from the manual point locks are placed in the sockets of the Executive unit at Post Nr. 2 for the prepared route, and the platform's lever is turned on correctly for entrance of the train on the Third platform.

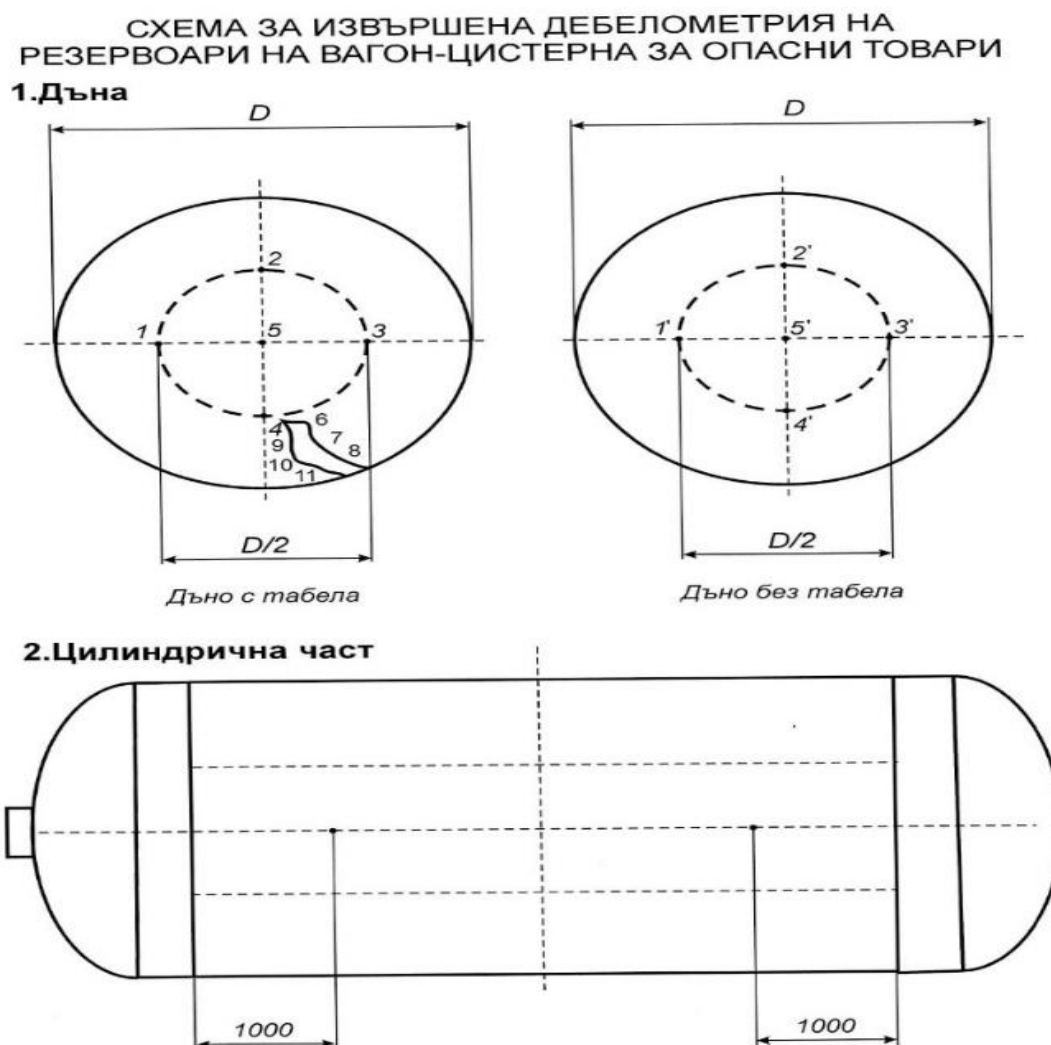
Figure 24

14.7. Measuring the thickness of reservoir Nr. 4418, volume 112440 l, mounted on wagon-cistern Nr. 33 87 791 5652-4 (Figure 24).

- measured values of the bottom thickness with a board – measurements are carried out at eleven points in total, from which the lowest measured value is at p. 8 of 7,8 mm, and the highest measured value is at p. 4 of 9,2 mm;
