FINAL REPORT

**investigation of railway accident – fire outburst in electric locomotive Nr. 44134.2, having
serviced fast train Nr. 8693 at Dimitrovgrad station on 12.10.2017**

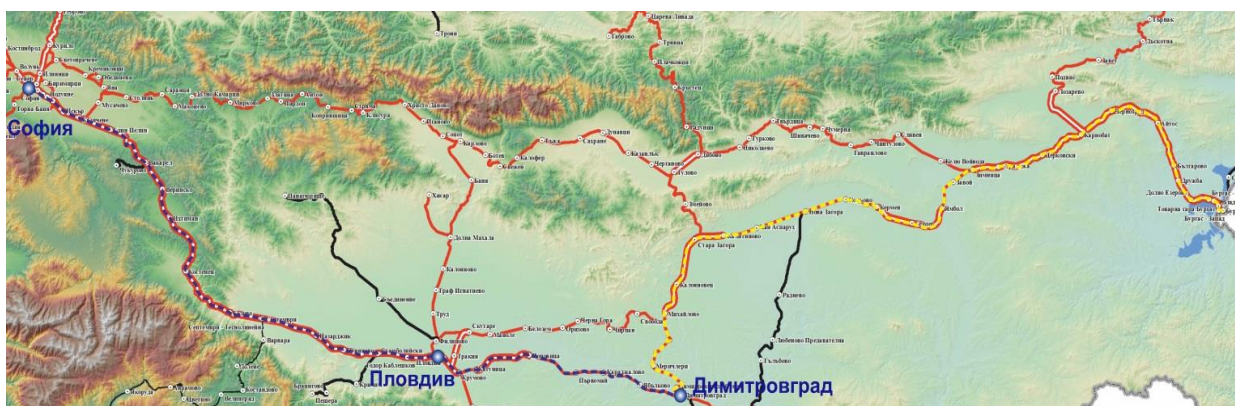
Figure 2

3.3. Fast train Nr. 8693 is on everyday trafficking schedule per the Trains' Trafficking Schedule on the direction of Sofia – Plovdiv – Stara Zagora – Burgas. Because of the performance of planned repairing works on the railway infrastructure and suspension of the traffic in Plovdiv - Mihaylovo section since 04.09.2017, the route of trains from all categories was changed through Dimitrovgrad – Mihaylovo – Stara Zagora section, continuing on the existing route to Burgas, as exhibited on Figure 2.

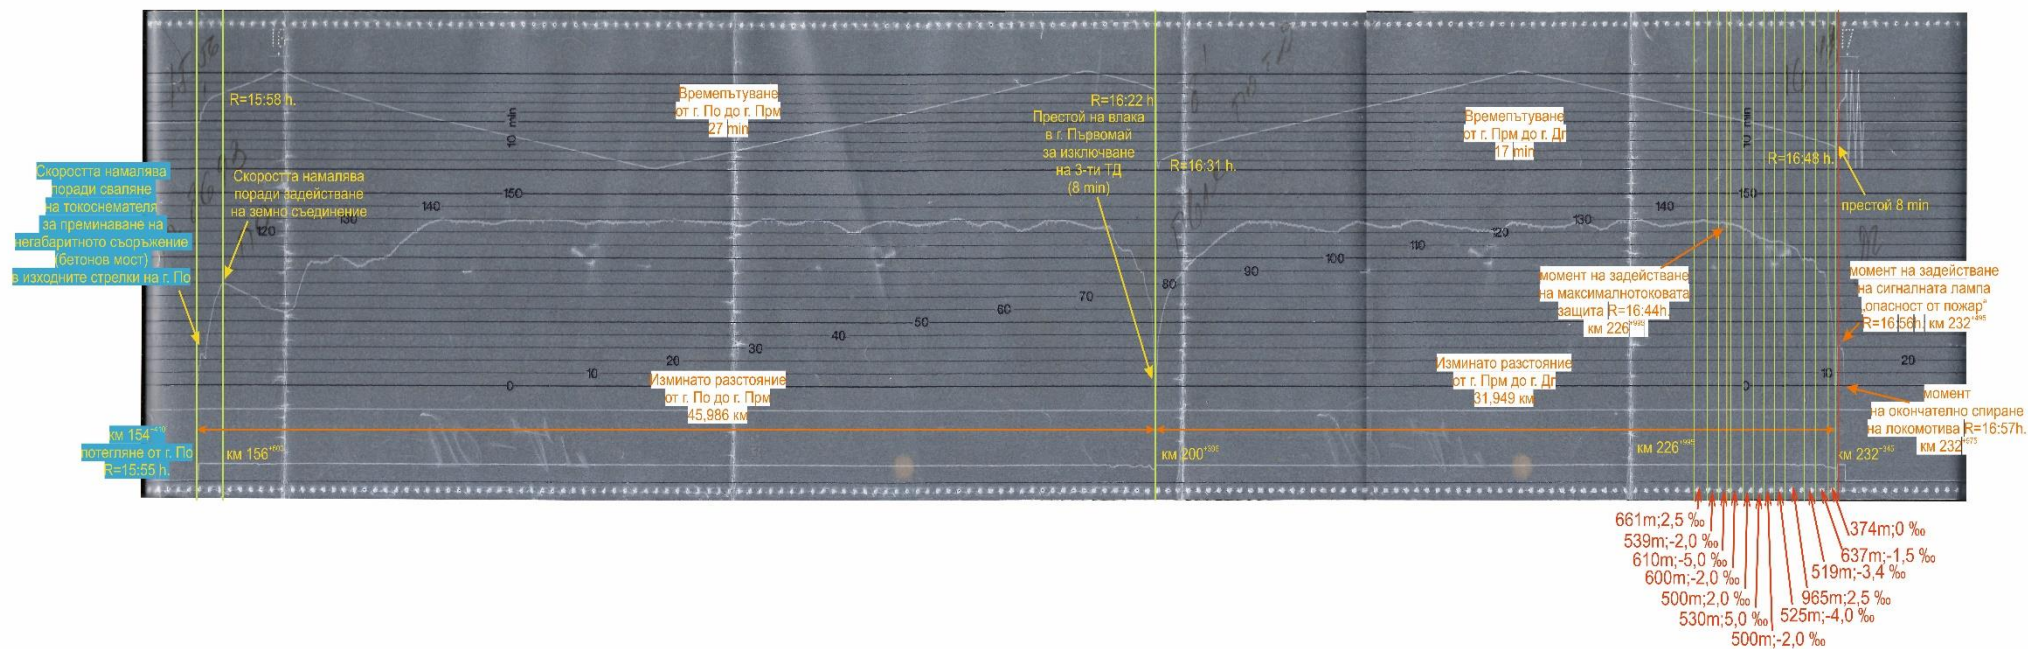
Figure 3

10.6. Deciphering of the speed of locomotive Nr. 44134.2, executed at Plovdiv Locomotive depot of BDZ Passenger Transport EOOD at Sofia – Plovdiv - Dimitrovgrad section on 12.10.2017:

Fast train Nr. 8693 departed from Sofia station at 13:20 h. At the section between Sofia – Poduyane stations the train travelled with speed of up to 55 km/h. The train stayed at Poduyane station for 1 minute and departed therefrom at 15:26 h. At Iskar station the train stayed for 1 minute and departed at 13:35 h. At the section between Poduyane and Iskar stations the train travelled with the speed of 90 km/h. At the section between Iskar and Elin Pelin stations the train travelled with the speed of 80 km/h. At the section between Elin Pelin and Pobit Kamak stations – with the speed of 120 km/h, and at the section between Pobit Kamak and Vakarel stations – with the speed of 65 km/h. At Ihtiman station the train stayed for 4 minutes, departing at 14:23 h. In the section between Vakarel and Verinsko stations the train travelled with 100 km/h, and Verinsko – Ihtiman – with 110 km/h.

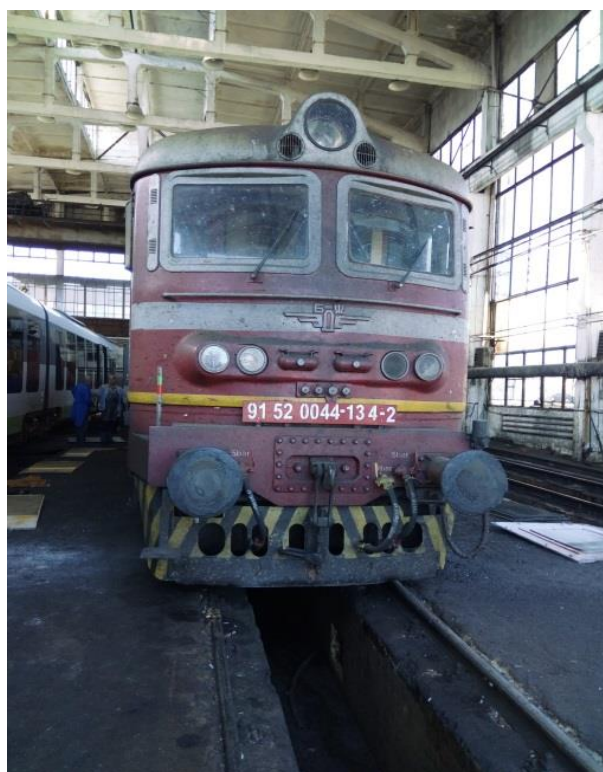
Figure 4

The Investigation Commission carried out detailed surveys of locomotive Nr. 44134.2 at Plovdiv Locomotive depot (Figure 4), getting acquainted with the factual status of the locomotive. The Commission heard by interviewing the locomotive brigades having serviced train Nr. 8693 in the sections between Sofia – Plovdiv and Plovdiv – Dimitrovgrad stations. The investigation studied the positioning of the command units and the indications of the measurement units, left in the locomotive after the accident, which could provide information on the sequence of the consequences having lead to the occurrence of the accident.
