AIR, MARITIME AND RAILWAY ACCIDENTS INVESTIGATION NATIONAL BOARD

FINAL REPORT

**Investigation of a serious railway accident - derailment of a freight train № 80561 in the
entrance switches of Nova Zagora station on 15.05.2020**

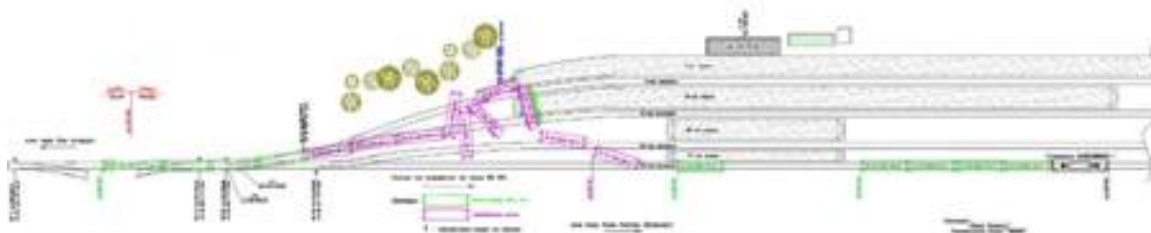
Fig. 4. Scheme of the derailed train

the load scattered between the 1st and 4th tracks, and the locomotive with the first five wagons stops on the 4th track in front of the station (Fig. 4).

suspension of the two bogies have borne off the forces of the resistances in the movement of the wagon obliquely along the ballast prism for 140.58 meters between the 4th and 3rd track (Fig. 4).

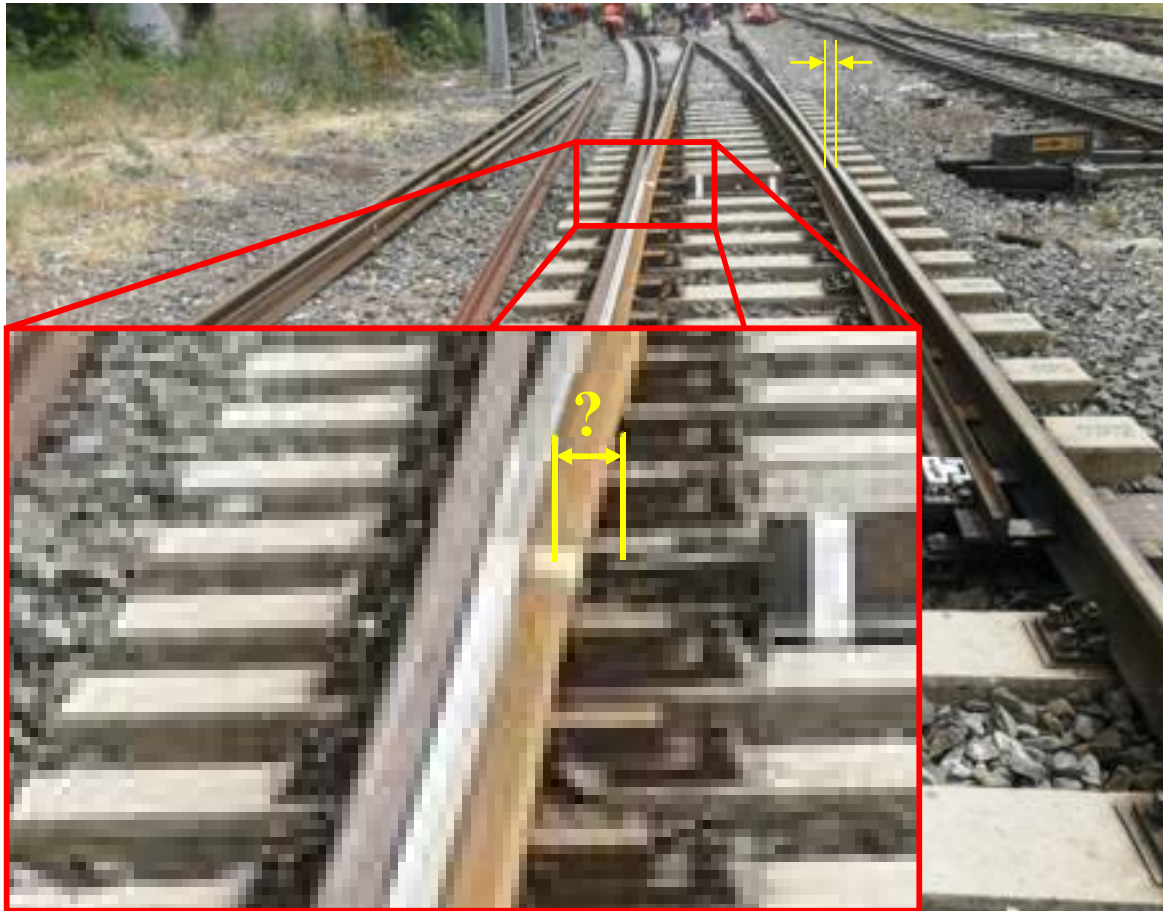
Fig. 6

On 22.05.2020 NRIC changes the left tongue and left shoulder rail of switch № 20 at Nova Zagora station (Fig. 6).

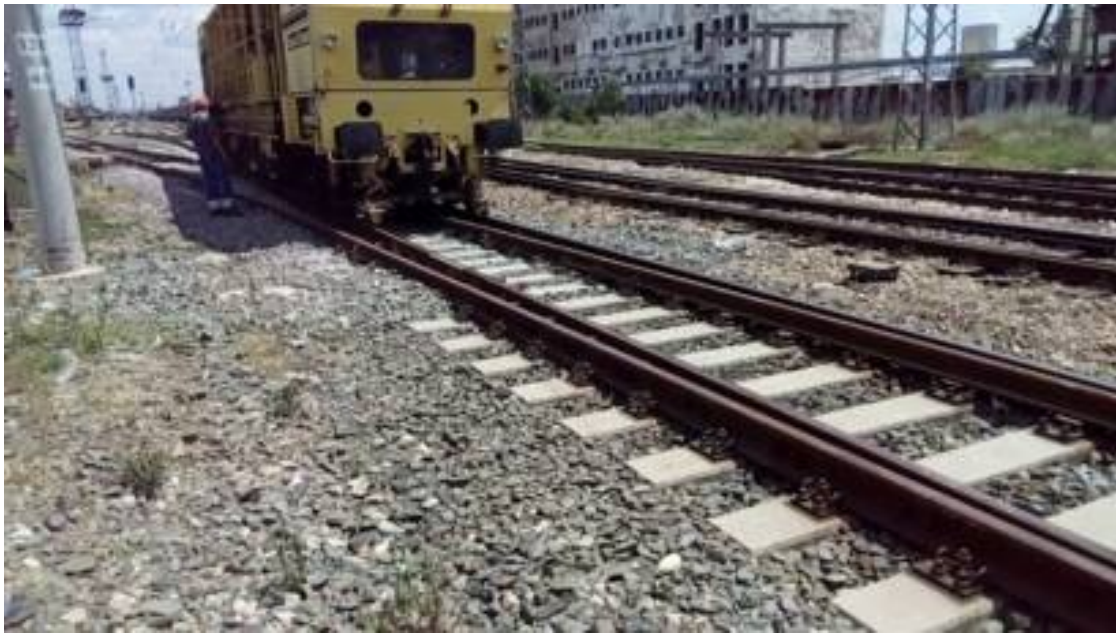
Fig. 7

On 22.07.2020, **after additional adjustments of the spring rocker arm and its normalization**, some experiments are performed with dynamic stabilizer DGS 62-2, for the main and diversion track with maximum load 100 kN and frequency 33 Hz (Fig. 7) to switch № 20 at Nova Zagora station. Three test measurements are performed in both directions, and no changes in

the technical condition of the switch are found. No switch cuts are caused in these tests. The tests are performed along the tongue of the switch.

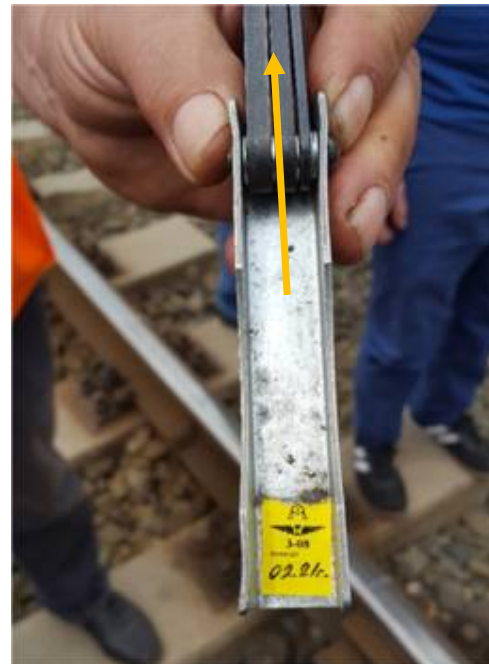
Fig. 42

- Samples were made with a calibrated template 2 mm and a template 4 mm for adhesion to the shoulder rail (Fig. 42).

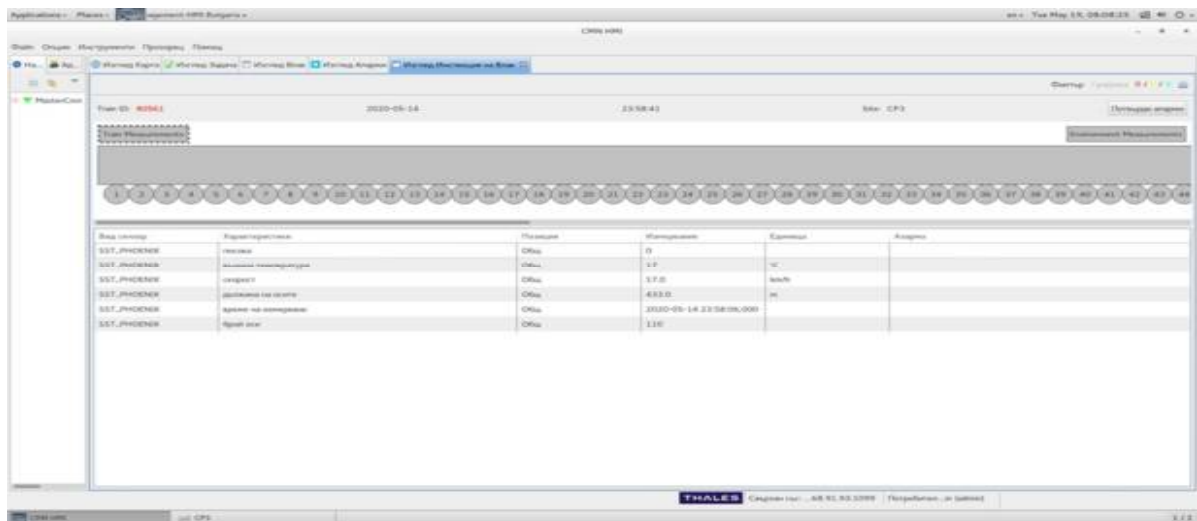
Fig. 45.1

The first axle has passed through post 2 at a speed of 18.5 km / h, and the last 110th axis - at a speed of 13.6 km / h (Fig. 45.1).

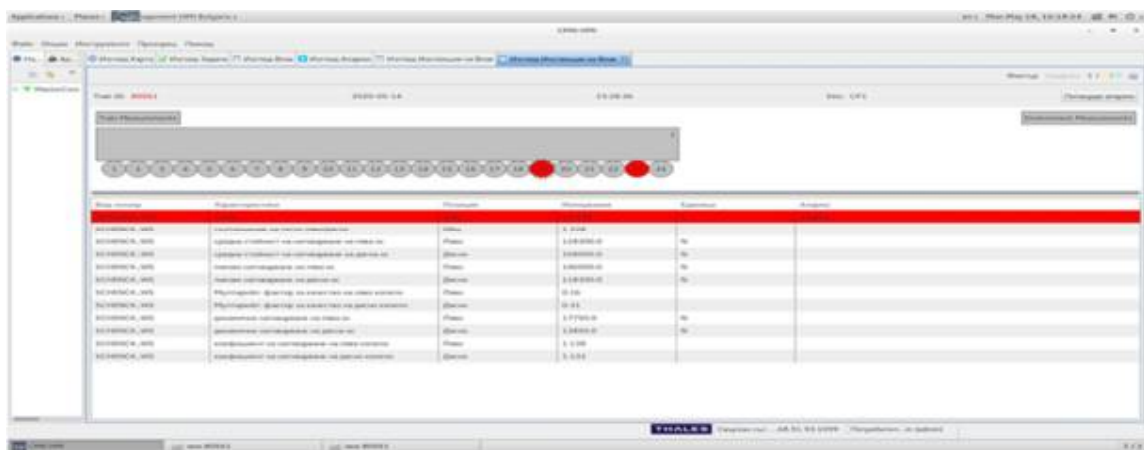
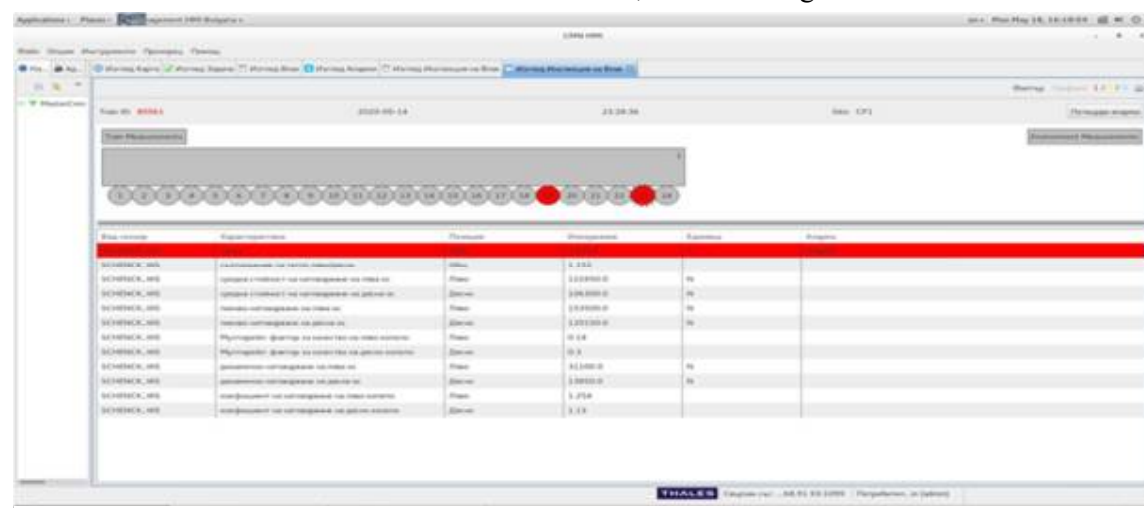
Fig. 47

The train has consisted of 110 axles, but the system has registered only its first 24 axles. The first axle has passed through post 1 at a speed of 34.2 km / h, the 24th axle has passed at a speed of 9.5 km / h. Subsequent axles from 25 to 110 have not been measured and registered, because the speed drops below 9.5 km/h after the 24th axis, nevertheless no measurements have been registered.

The system sets alarms on the 19th and 23rd axles, i.e. 9th and 13th axles of the wagon stock, and 1st axle of the 3rd car and the 1st axle of the 4th car, shown on Figures 47 and 48:

6. Recommendation 6 proposes NRIC to update the Instruction for work with the rolling stock control system in the section Sofia - Plovdiv, in the part minimum speed for measuring and registering the parameters of passing rolling stock, in order to accurately and completely data registering.

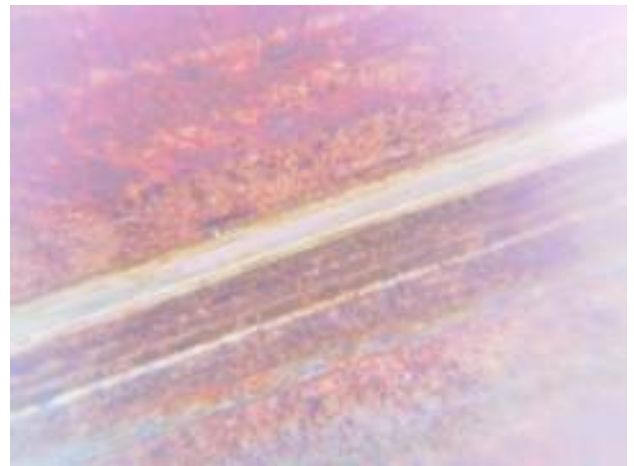
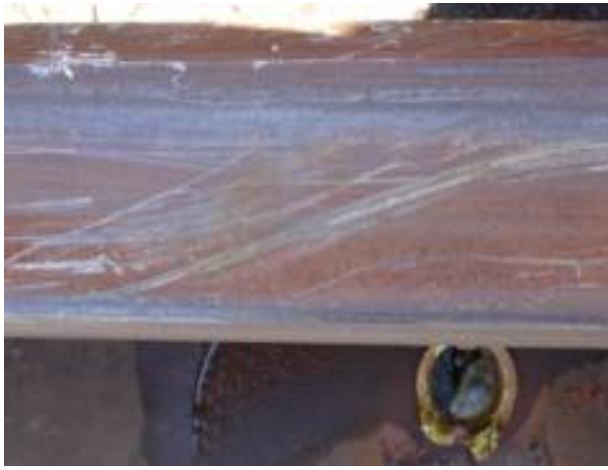
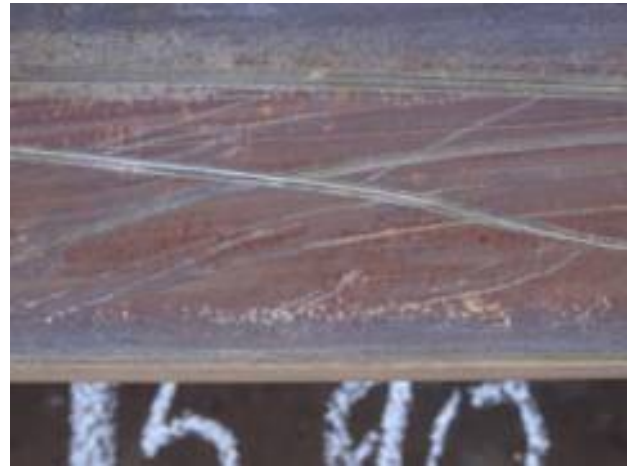
Fig. 50. Surface of the head of the left tongue of switch № 20 between the 4th and 6th meter

At a distance of 4.50 m from the beginning and about 50 cm after the place marked with chalk 4 m along the rail there were lighter coloured traces (Fig. 50 b, 51 a) with corrosion products precipitated on them.

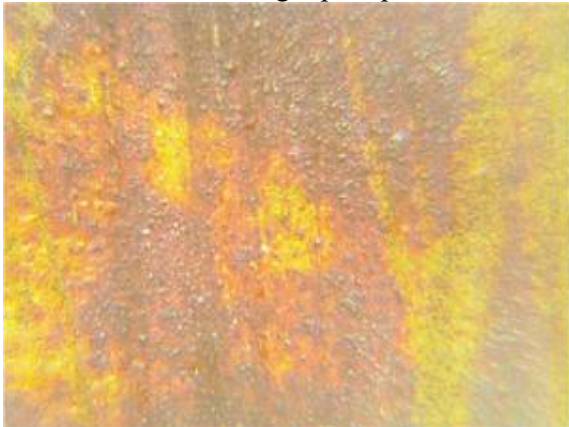
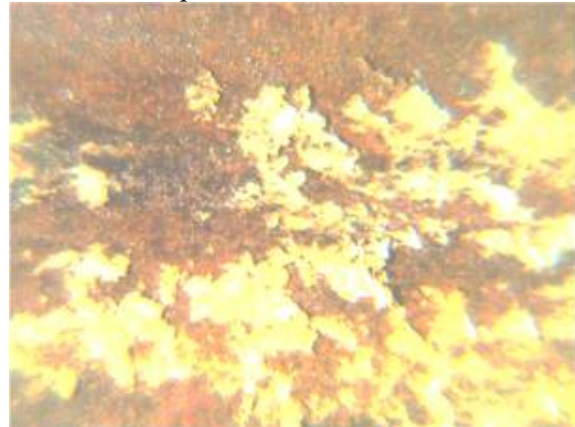
For the purposes of technical expertise, the tongue's head was cleaned of superficial, brown-colored corrosive products by chemical treatment, and microscopic observation was performed (Fig. 51). Precipitations of light yellowish and white color (Fig. 51 b) were found, which are not characteristic of iron oxide products in open atmospheric conditions.

Dark brown and black dense corrosion products were clearly visible beneath the light precipitations - magnetite and lepidocrit, which are result of prolonged atmospheric corrosion of iron.

No traces of scratching or other mechanical impact on the surface of the tongue head were observed between the light precipitations and the dark corrosion products.

Fig. 51. Microscopic image of the scratch marks before (a) and after (b) removal of the surface corrosion products.

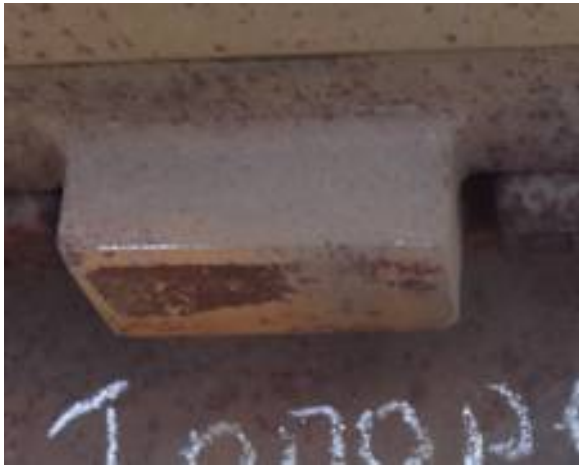
a. Support wedge I

- On support wedge I - trace of abrasion on the side of the wedge (Fig. 52 a);
- On support wedge II - traces of beating on the upper plane of the wedge (Fig. 52 b);
- On support wedge III - traces of beating of two ledges and one rim on the upper plane of the wedge (Fig. 52 c)
- On support wedge IV - traces of beating of two ledges and one rim on the upper plane of the wedge (Fig. 52 d);

Fig. 52. Traces of abrasion on the support wedges of the rail

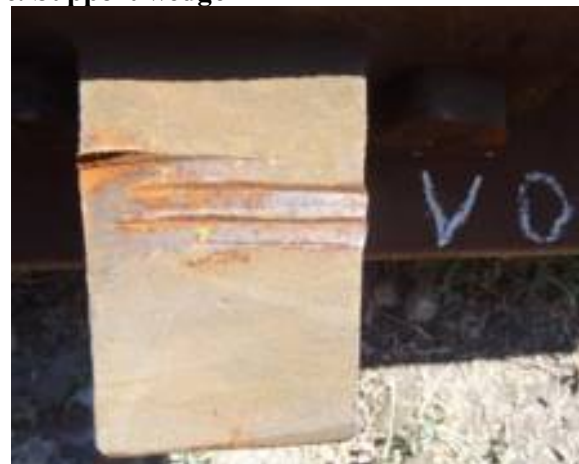
e. Support wedge V

- On support wedge V - traces of beating of two ledges and one rim on the upper plane of the wedge (Fig. 52 e);
- On support wedge VI - traces of beating of two ledges and one rim on the upper plane of the wedge (Fig. 52 f);
- On support wedge VII - traces of beating of two ledges and one rim on the upper plane of the wedge (Fig. 52 g);
- On support wedge VIII - traces of beating of two ledges and one rim on the upper plane of the wedge (Fig. 52 h);
- On support wedge IX - traces of beating of two ledges on the upper plane of the wedge (Fig. 52 i).

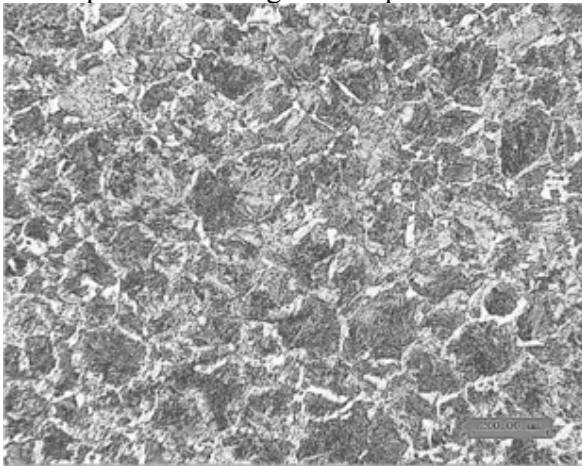
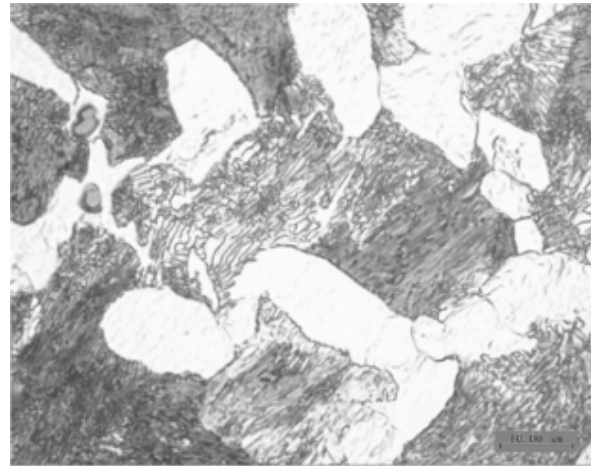
Fig. 53 Steel microstructure, OM.

It was found that the microstructure of the metal is pearlitic-ferritic (Fig. 53). The percentage of the amount of perlite to the amount of ferrite is % P, % F = 65/35. The dispersion of lamellar perlite corresponds to grade 6 - medium-lamellar perlite with a distance between the plates of 1 μm. The grain size is grade 2. An assessment of the non-metallic inclusions in the steel has been performed and the presence of single oxide points has been established.

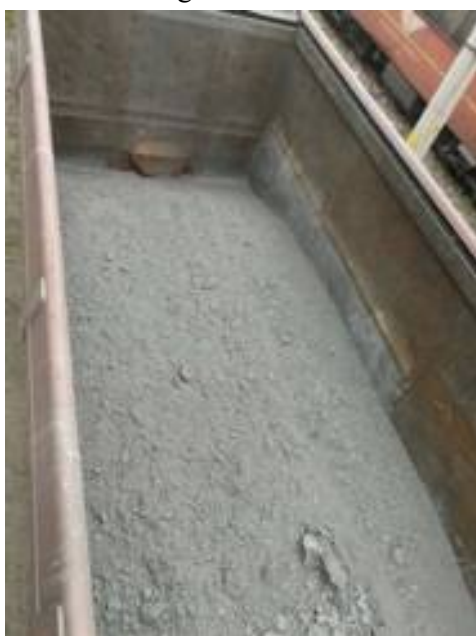
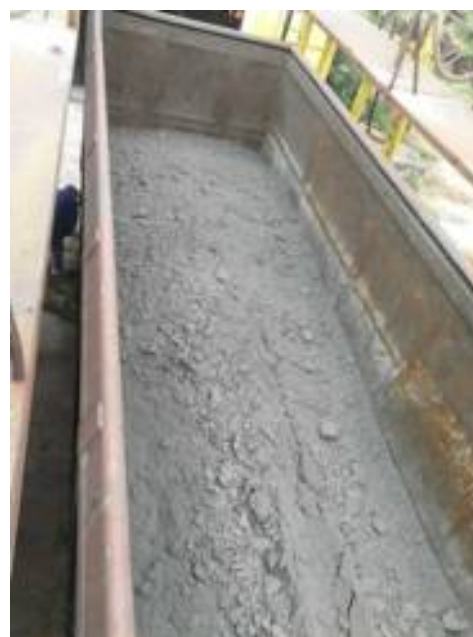
These results are only for control, given the following main circumstances (Figs. 65.1 and 65.2):

- ✓ After the derailment the bogies of the wagon are replaced;
- ✓ Undercutting is found on the wagon basket in the area above the buffer, which confirms the conclusion that the 7th wagon with one of its buffers has hit the 6th wagon;
- ✓ It has been established that there is a so-called "Slope" in the rear of the floor of the wagon, which is at a certain slope, i.e. the floor area of the wagon is not tightly filled. It is obvious that as a result of the impact the bulk cargo has moved forward and to the right in the direction of travel;
