**REPUBLIC OF BULGARIA**  
**NATIONAL AIR, MARITIME AND RAILWAY ACCIDENTS**  
**INVESTIGATION BOARD**

**FINAL REPORT**

**Investigation of railway accident – derailment of locomotive № 46041  
from direct freight train № 30602 while entering in Stolnik station on  
15.01.2021**

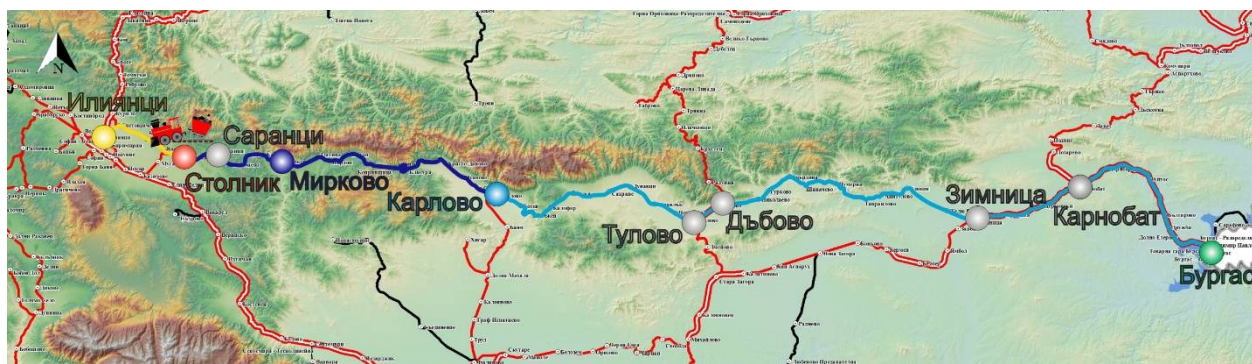
**Fig. 1.1.** Movement route of DFT № 30602

departure track in Stolnik station of switch № 11 in the tongue device (blade) part, where followed derailment of the first wheelset of locomotive № 46041 to the right of the switch at 09:00 a.m. (fig. 1.1, fig. 1.2).

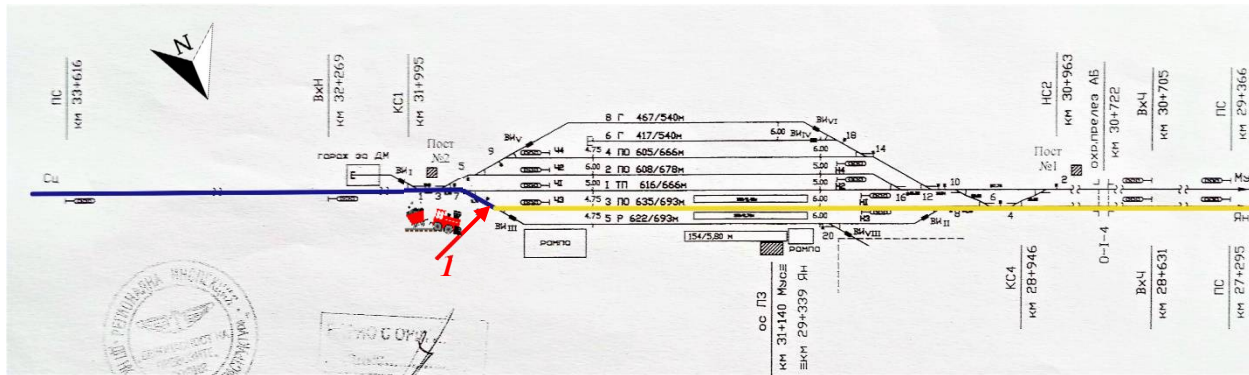
**Fig. 1.2.** Scheme of Stolnik station with the route of movement of DFT № 30602.

- - Route, which the train passed;
- - Part of the route, which the train did not pass;
- 1 - Place of derailment (switch № 11).

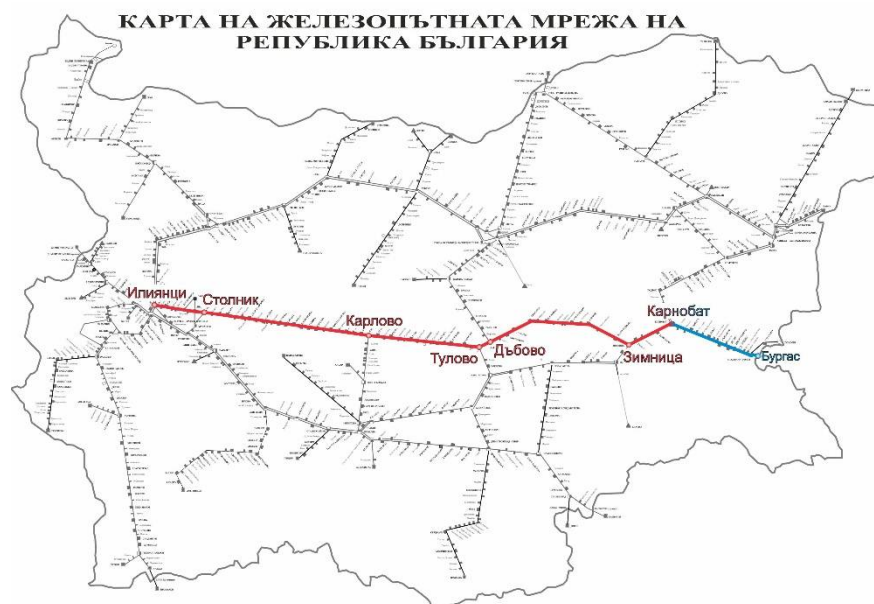
**Fig. 3.1.** Route of DFT № 30602.

The railway accident occurred when the locomotive of DFT № 30602 on switch № 11 (left) entered in the area of the blade at 22 km/h (the right blade was notched above the thresholds), where the first wheelset of the locomotive rose on the right blade and the stock rail, and after 7 meters derailed to the right of the track. The switch led to the third track of Stolnik station with a profile of 3.53 ‰ uphill. Stolnik station is located on the third main railway line in the direction Iliyantsi - Karlovo - Dabovo - Zimnitsa - Karnobat - Burgas. A third main railway line is conventional with speeds of up to 130 km/h (Fig. 3.1).

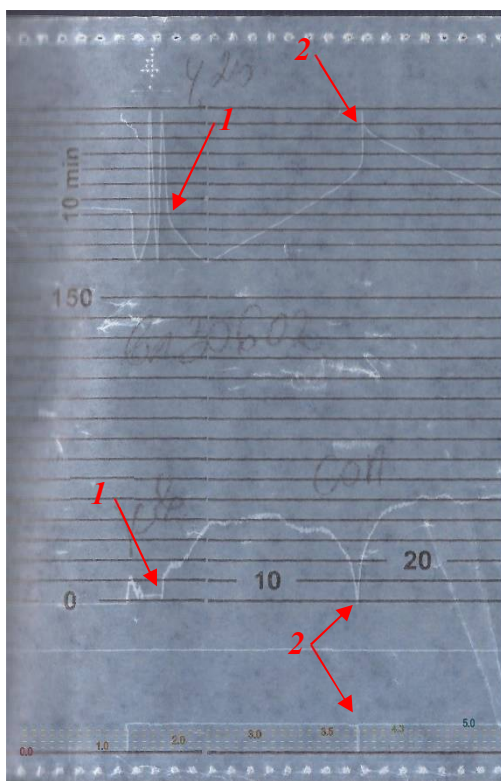
**Fig. 4.1.** Registered operation of DFT № 30602 from Karlovo station to Sopot station

The train departed from Karlovo station at 4:10 a.m. (Fig. 4.1, pos. 1). In the interstation Karlovo - Sopot it developed up to 42 km/h and at 4:56 a.m. it stopped at Sopot station, holding the train brake in an emergency. The train stayed at the station for 5 minutes and at 5:01 a.m. left again (Fig. 4.1, pos. 2).

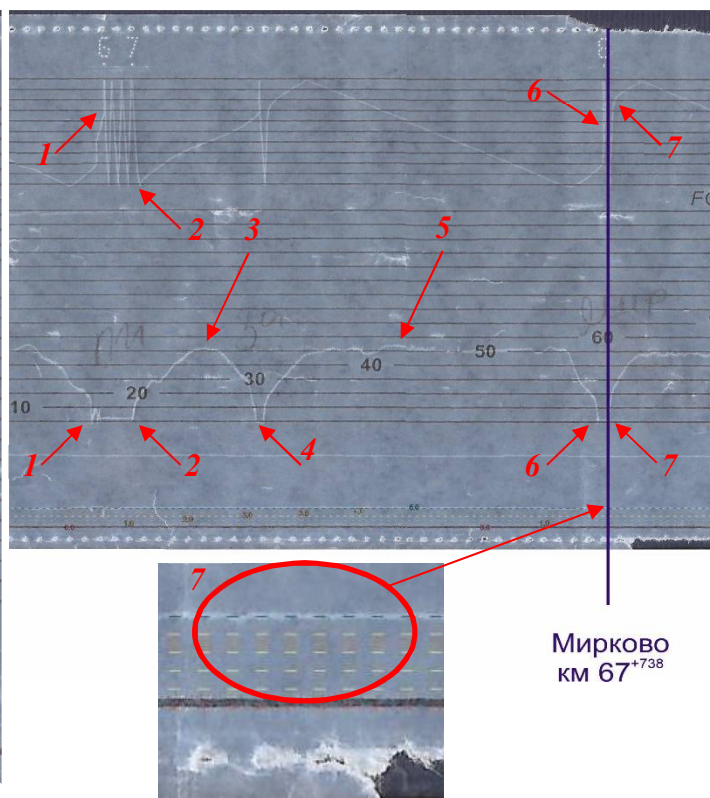
**Fig. 4.2.** Registered operation of DFT № 30602 from Pirdop to Mirkovo station

The train departs from Pirdop station at 7:10 a.m., develops a speed of up to 52 km/h (Fig. 4.2, pos. 3), after which the speed gradually decreases and at 7:17 a.m. settles at Zlatitsa station (Fig. 4.2, pos. 4). The stay at Zlatitsa station is from 7:17 a.m. to 7:37 a.m. (20 minutes) and departs at 7:37 a.m.

In the section from Zlatitsa station to Mirkovo station DFT № 30602 runs, developing a speed of up to 52 km/h (Fig. 4.2, pos. 5). At 7:50 a.m. a gradual reduction of speed began and at 7:52 a.m. it was established at Mirkovo station (Fig. 4.2, pos. 6). It stays at the station for 25 minutes until 8:17 a.m. After its stay the train does not perform test D in violation of art. 245, para. 1, item 5 of Ordinance № 58 and Art. 301, item 5 of the TOSARRT (Fig. 4.2, pos. 7).

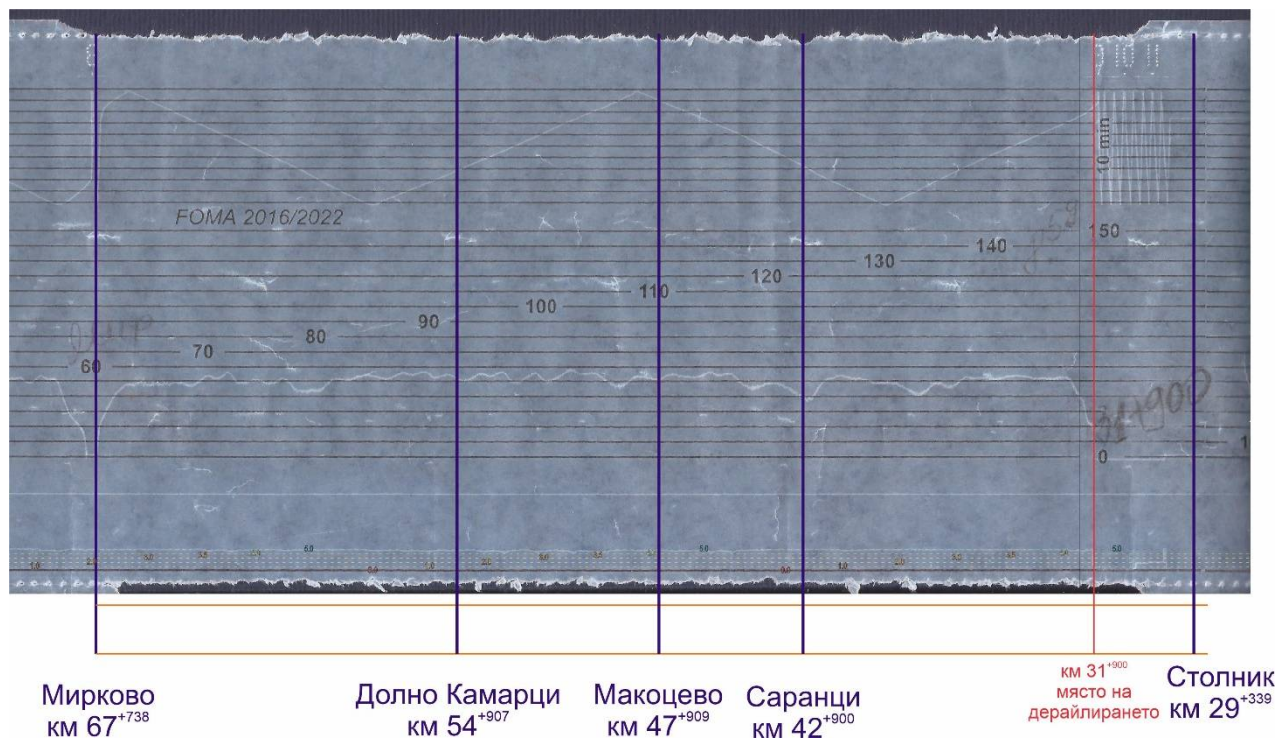
**Fig. 4.3.** Parameters of the movement of DFT № 30602 from Mirkovo to Stolnik station

DFT № 30602 departs from Mirkovo station at 8:17 a.m. and until the moment of the accident at Stolnik station passes without stopping at the stations Dolno Kamartsi, Makotsevo and Sarantsi, developing up to 58 km/h (Fig. 4.3).
