FINAL REPORT

Investigation of significant railway accident – derailment of full tank cars from the composition of direct freight train № 90593 between the stations Vetovo – Senovo on 23.04.2021

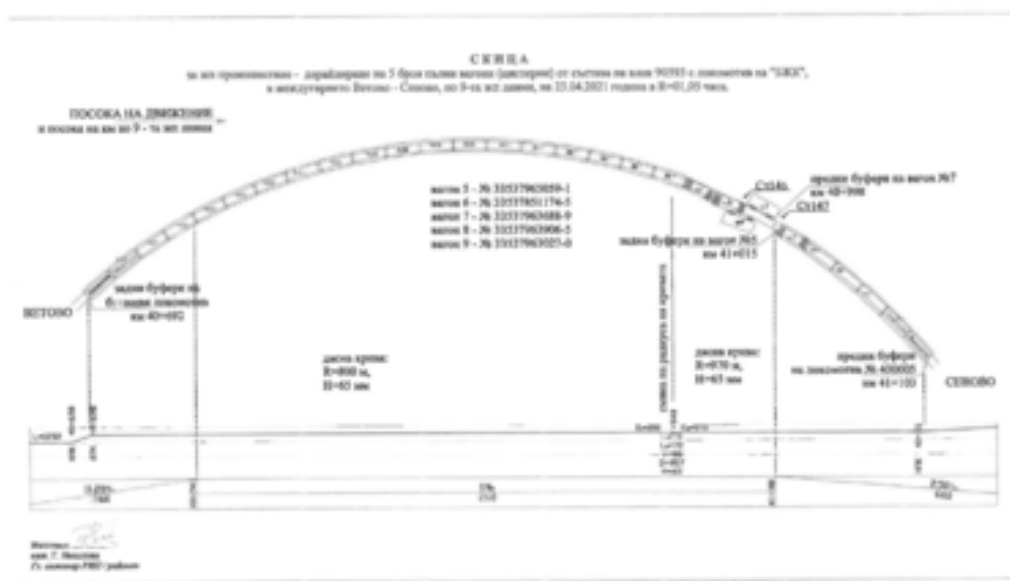
Fig. 1.5. Scheme – place of detection of DFT № 90593

Plan of the rail track: left curve with radius 482 m, superelevation 105 mm (fig. 1.5).

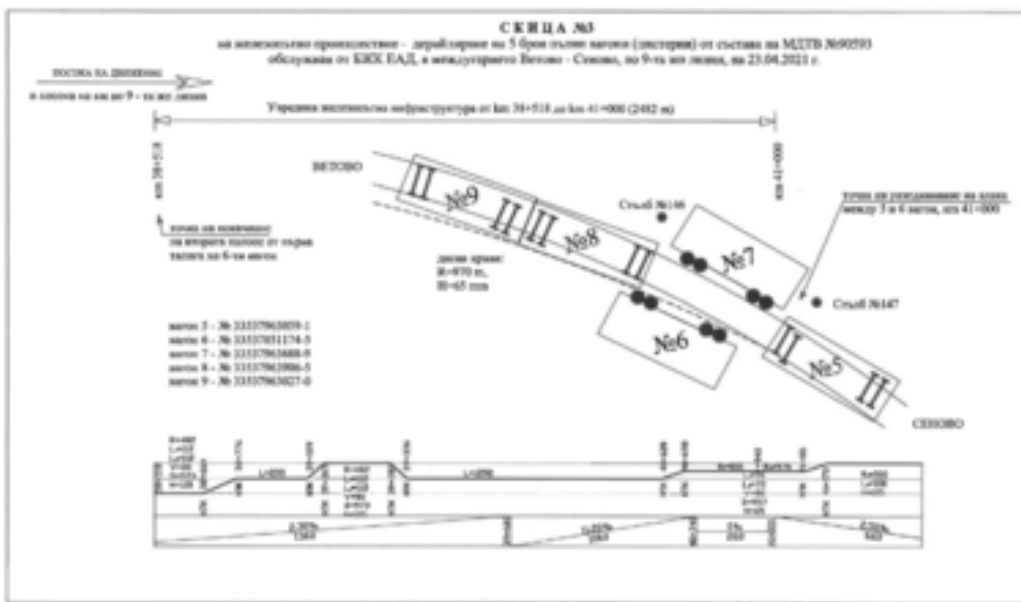
Fig. 1.6. Scheme № 3 – place of derailment of five wagons from the composition of DFT № 90593

Rail track profile: uphill 2,3‰ (fig. 1.6).

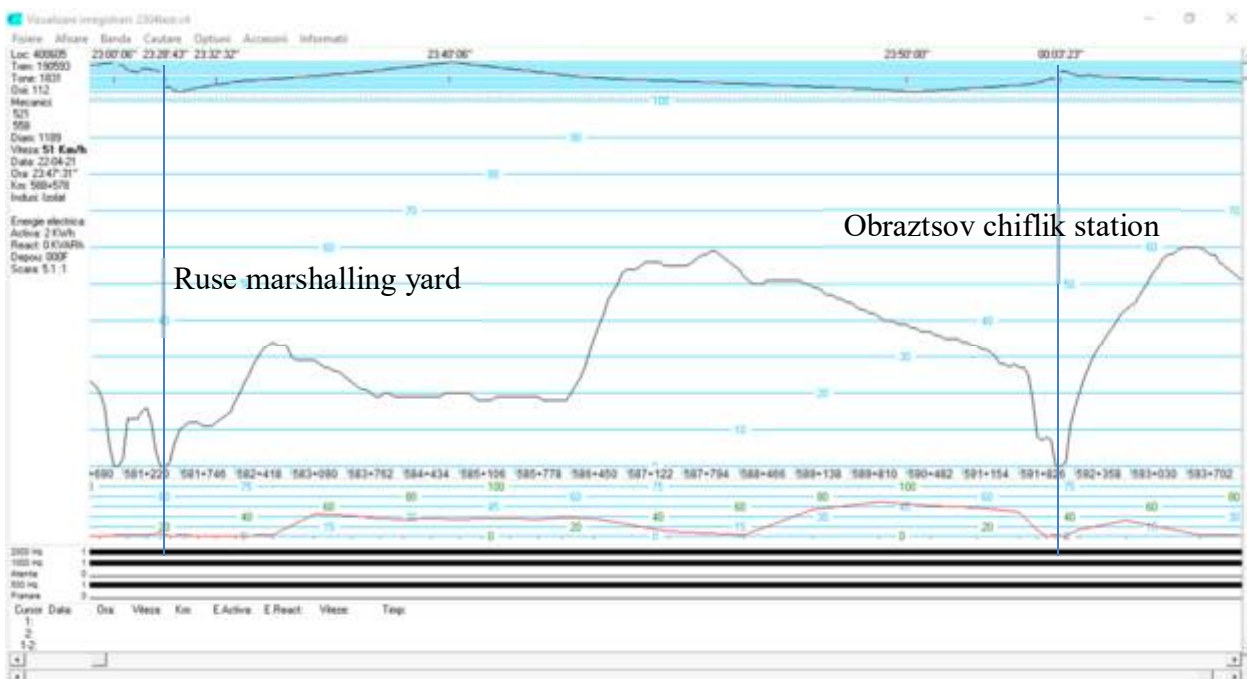
Fig. 4.1. Chart of the movement of train № 90593 from Ruse marshalling yard to Obratsov chiflik station

According to the data from the recording device of locomotive № 91530400605-8 of DFT №90593 departed from Ruse marshalling yard at 23:28:43 p.m. The readings of the locomotive odometer are 581,634. The train accelerated to 59 km/h between the stations and at 23:54:54 p.m. stopped at Obraztsov Chiflik station, which according to the locomotive odometer is at km 592,246. It stayed at the station for 8 minutes and 23 seconds and at 0:03:23 a.m. departed again (Fig. 4.1).

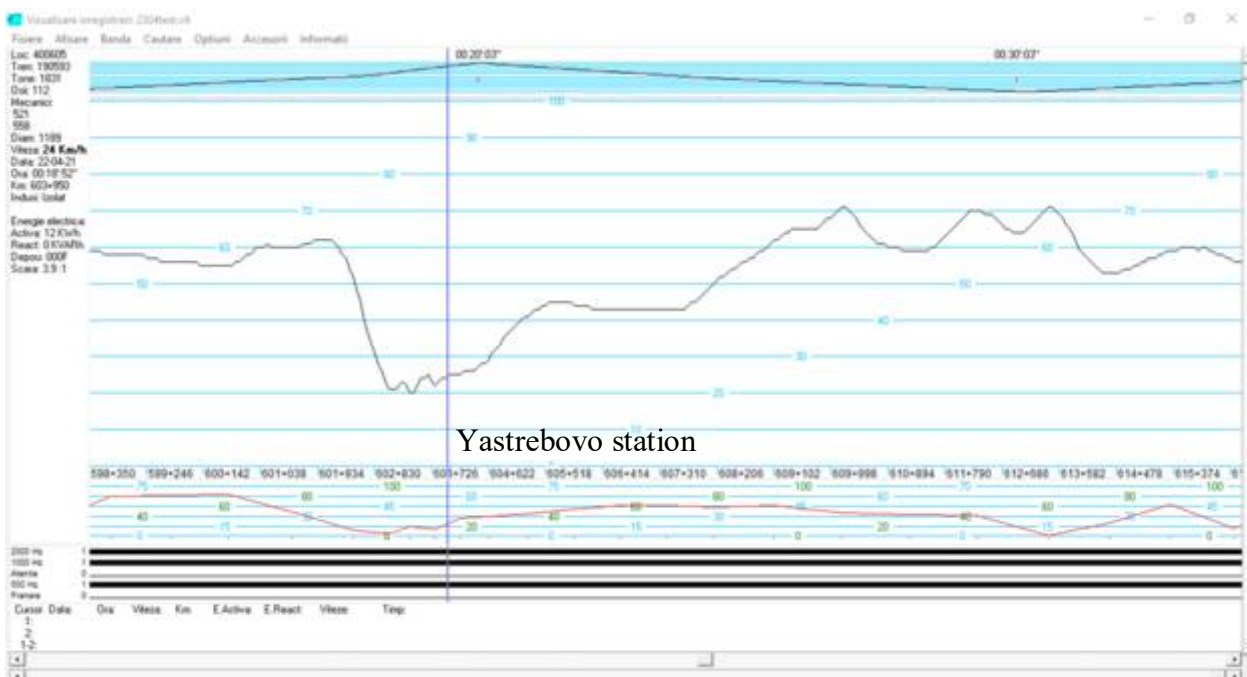
Fig. 4.2. Chart of the movement of train № 90593 while passing through Yastrebovo station

In the section from Obraztsov Chiflik station to the place of derailment the train moved without stopping, reaching a maximum speed of 71 km/h in the interstation Yastrebovo - Vetovo (Fig. 4.2 and Fig. 4.3).

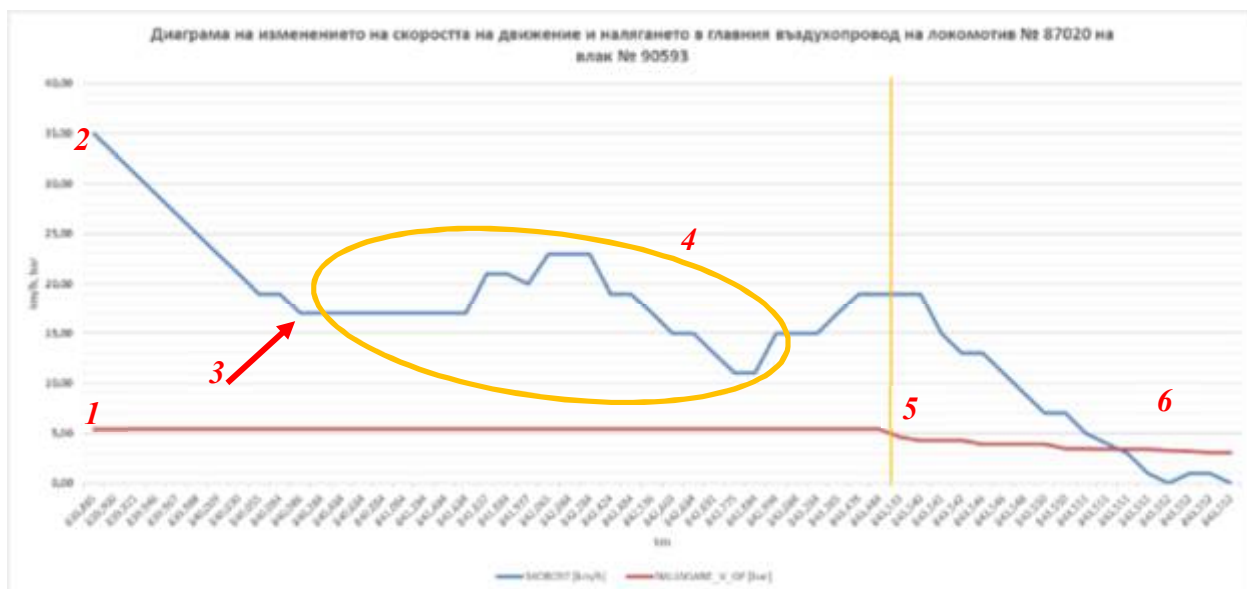
Fig. 4.5. Chart of the movement of DFT № 90593 of the registering device of locomotive № 91520087020-1 latest data before the derailment

When analyzing the data from the registration device of locomotive № 91520087020-1 it makes an impression that the pressure in the main air duct was higher than the normal - 5.41 bar (Fig. 4.5, pos. 1). At the beginning of the recording, from which the movement of the locomotive is analyzed, the speed is 35 km/h (Fig. 4.5, pos. 2). That happened at km 839,885 on the locomotive's odometer at 00:36:34 a.m. on the locomotive clock. The speed gradually decreases and at km 840,055 at 00:36:56 a.m. the time is 19 km/h (Fig. 4.5, pos. 3). At this point, the master locomotive № 91530400605-8 entered the area of the first reduction. Locomotive № 91520087020-1 was located at km 37⁺³⁴⁵. The train moved at a speed between 17 and 23 km/h to km 843,533 on the locomotive odometer at 00:49:02 a.m. (Fig. 4.5, pos. 4). Then, at a speed of 19 km/h, the pressure in the main air duct began to decrease and for 18 meters from km 843,533 to km 843,552 in 14 seconds reached a value of 3.06 bar (Fig. 4.5, pos. 5), which corresponds to emergency stop with the automatic train brake and at 00:49:16 a.m. the speed reached 0 km/h, as locomotive № 91520087020-1 was established at km 843,552, which corresponded to km 40⁺⁶⁹² of the railway line (Fig. 4.5, pos. 6). The stopping time and the distance travelled corresponded to that recorded by the registration device of locomotive № 91530400605-8.

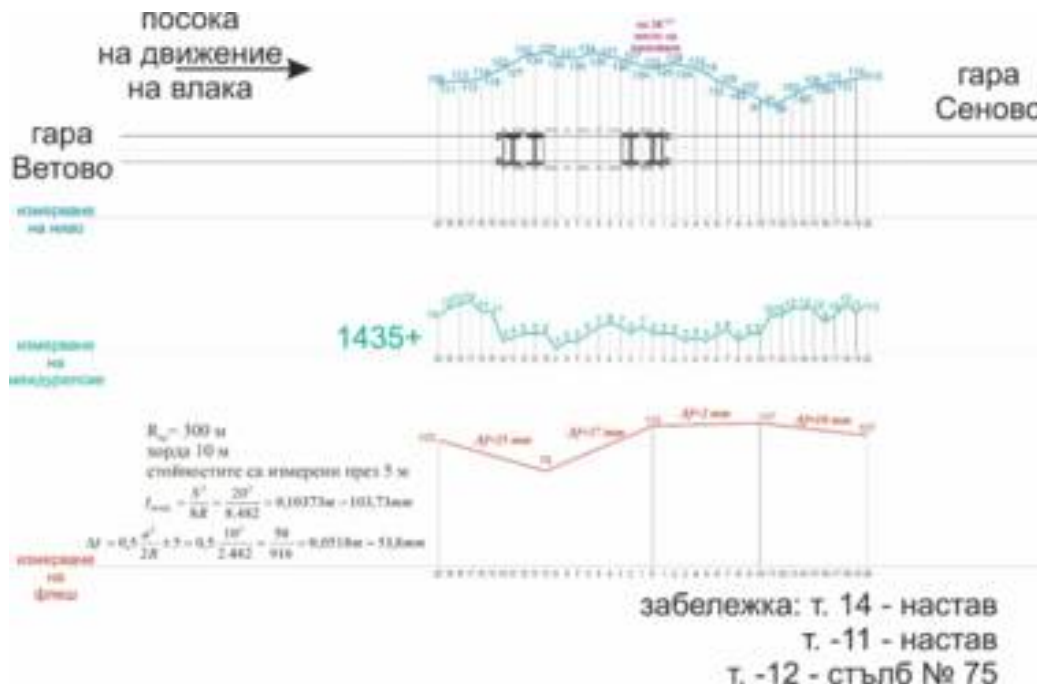
Fig. 4.18. Charts on the rail track condition in the accident area

The data are registered in fig. 4.18, Chart № 1.

The data are registered in fig. 4.18, Chart № 2;

The data are reflected in fig. 4.18, Chart № 3.

The data from the track measuring laboratory EM-120 are from 25.06.2020 and show that the rail track is within the norms.
