R E P U B L I C O F B U L G A R I A
NATIONAL AIR, MARITIME AND RAILWAY ACCIDENTS
INVESTIGATION BOARD

FINAL REPORT

**Investigation of railway accident – derailment of direct freight train
№ 30610 between the stations Shivatchevo – Tvarditsa on 12.03.2021**

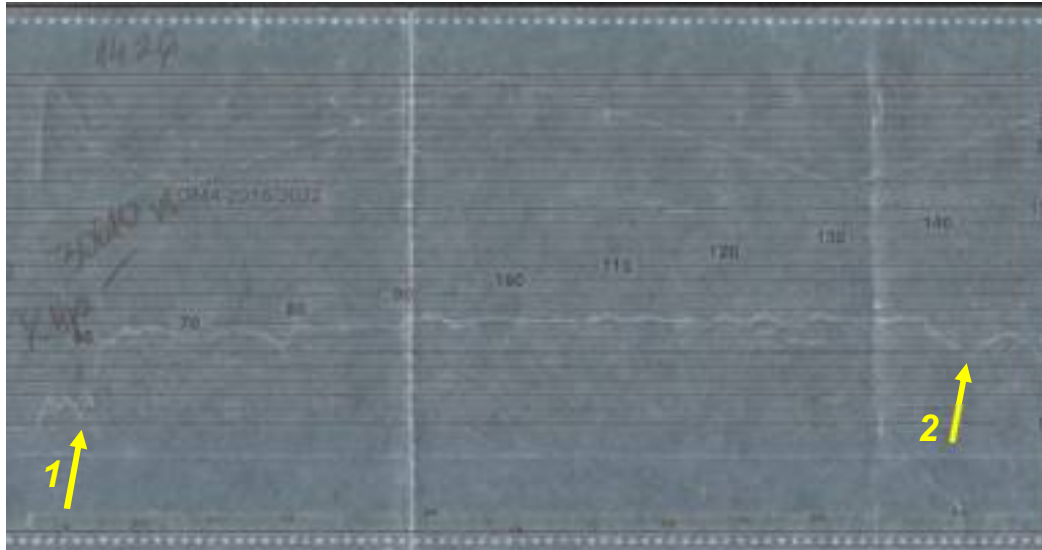
Fig. 4.1. Registration of movement of locomotive № 46032 (as DFT № 30610) from Karnobat to Zimnitsa station.

Locomotive № 46032 performs its first movements in Karnobat locomotive depot at 14:11 p. m. with speed to 10 km/h, and then it increased to 20 km/h, and after another several shunting movements to 20 km/h and at 14:25 p.m. it is placed on station track in Karnobat Western District station (fig. 4.1, pos. 1). After stopping for one minute, it departed at 14:26 p.m. from Karnobat Western District station, and develops 22 km/h, then decreases to 12 km/h, passes through the exit

switches of Karnobat station, and then increases to 70 km/h. So, moving at a speed of up to 77-78 km/h, the locomotive passes 31,7 km, where at 14:52 p.m. the speed of 73 km/h starts to decrease

smoothly and after 1800 meters at 14:54 p.m. reaches 47 km/h (fig. 4.1, pos. 2). The place corresponds to Zimmitsa station.

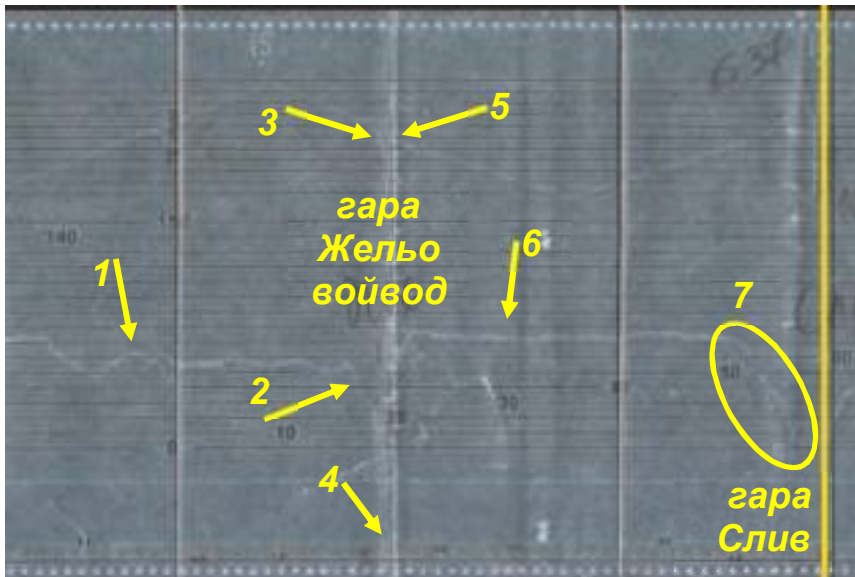
Fig. 4.2. Registration of movement of locomotive № 46032 (as DFT 30610) from Zimnitsa to Sliven station.

Then the speed starts to increase again to 64 km/h (Fig. 4.2, pos. 1). It changes smoothly between 64 km/h and 50 km/h, and thus the locomotive moves to Zhelyo Voyvoda station. After passing 8900 meters at 15:03 p.m., the speed is 56 km/h and begins to decrease - initially at a faster pace to reach a value of 40 km/h, after which the rate of descent becomes slower and reaches 28 km/h it intensifies again until the complete stop of the locomotive at Zhelyo Voyvoda station at 15:04p. m. (Fig. 4.2, pos. 2). Apparently, the locomotive driver initially held the locomotive with the direct brake of the locomotive until it reaches a speed of 40 km/h, then he loosens it, the reduction continues due to the natural resistance in its movement and when it reaches 28 km/h, it holds it again until it reaches 0 km/h. After the locomotive stopping at 15:05 p.m., there is a stop for about 30 seconds (Fig. 4.2, pos. 3). A departure follows, in which the locomotive develops 11-12 km/h, travels about 300 meters and stops again at 15:06 p.m., this time it stays until 15:25 p.m. for 21 minutes (Fig. 4.3, items 1 and 2). During the second stop at Zhelyo Voyvoda station, a pressure drop of up to 0 bar is noted in the area of pressure registration in the main air duct, which means that most likely the locomotive driver checked the registration of the speedometer by opening its cover (fig. 4.2, item 4).

At 15:26 p. m. locomotive № 46032 departs from Zhelyo Voivoda station and develops a speed between 78 and 70 km/h (Fig. 4.2, items 5 and 6). At this speed, the locomotive travels 12.2 km. At 15:34 p. m. the speed of 71 km/h began to decrease gradually, after 1250 meters it reaches 25 km/h, then briefly increases to 31 km/h, it decreases again to 0 km/h after 700 meters and at 15:37 p.m. it is established at Sliven station (Fig. 4.2, pos. 7). During its movement from Karnobat station to Sliven station the locomotive driver observes the section speeds and the reductions on the track.

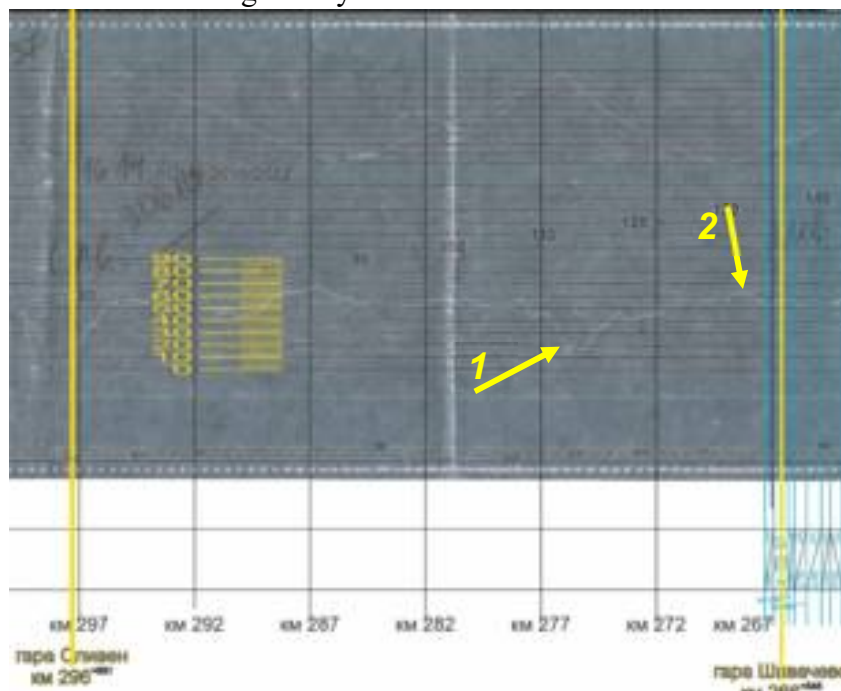
Fig. 4.4. Registering the movement of DFT 30610 from Sliven station to Shivatchevo station.

DFT № 30610 led by locomotive № 46032 departs from Sliven station at 16:14 p.m. (speedometer time). The speed varies between 42 and 78 km/h and thus the train travels 21.4 km (Fig. 4.4). At this point (Fig. 4.4, pos. 1) at 16:40 p.m. the speed decreases to 16 km/h and for 1000 meters in 2.5 minutes it changes between 16 and 22 km/h. After passing this section, the speed increases, and its maximum value reaches 63 km/h (Fig. 4.4, pos. 2).

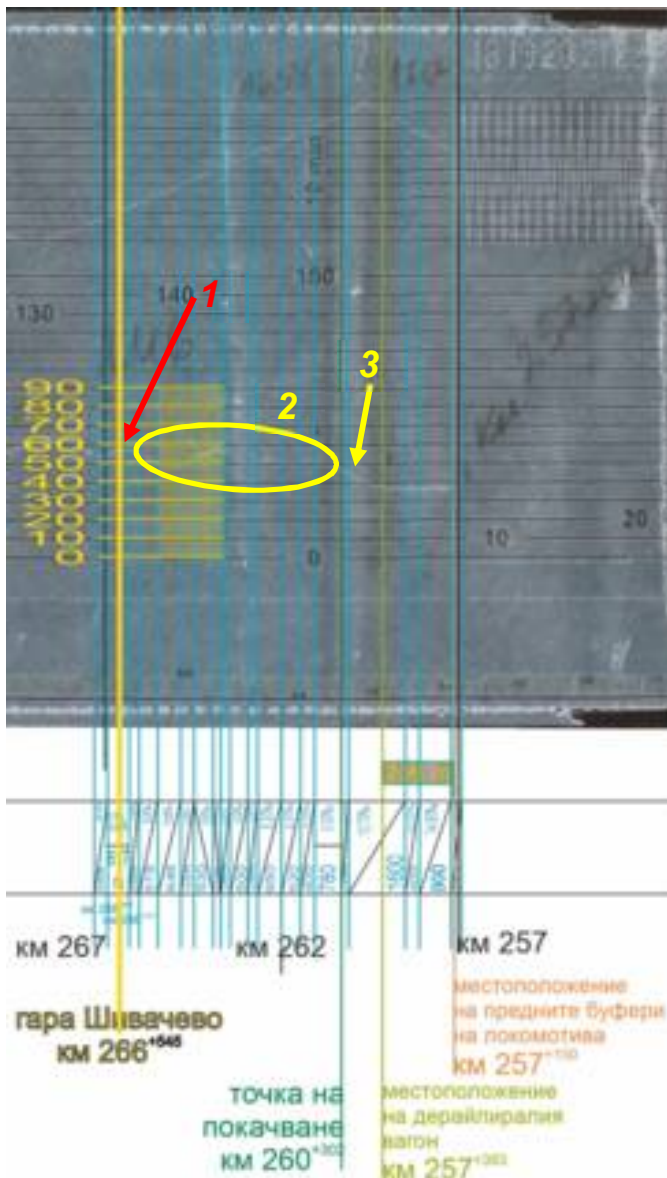
Fig. 4.5. Registration of movement of DFT 30610 from Shivatchevo station to km 257⁺¹⁵⁰.

At 16:57 p. m. DFT № 30610 passes without stopping Shivatchevo station at a speed of 57 km/h (Fig. 4.5, pos. 1).

After passing Shivatchevo station the speed of DFT № 30610 changes between 57 and 49 km/h (Fig. 4.5, pos. 2). The speed varies within such wide limits due to the diverse profile of the track along the section. In this mode, the train travels 5950 meters. This happens at 4:58 p.m. The speed is 50 km/h and from that moment, it starts to decrease gradually, passing 2000 meters, reaching 38 km/h (Fig. 4.5, pos. 3). The decrease in speed is due to the movement of the train in uphill 13 ‰. From km 257⁺⁰⁰⁰ the speed of the train is set at a constant value of 37 km/h until the moment of derailment.

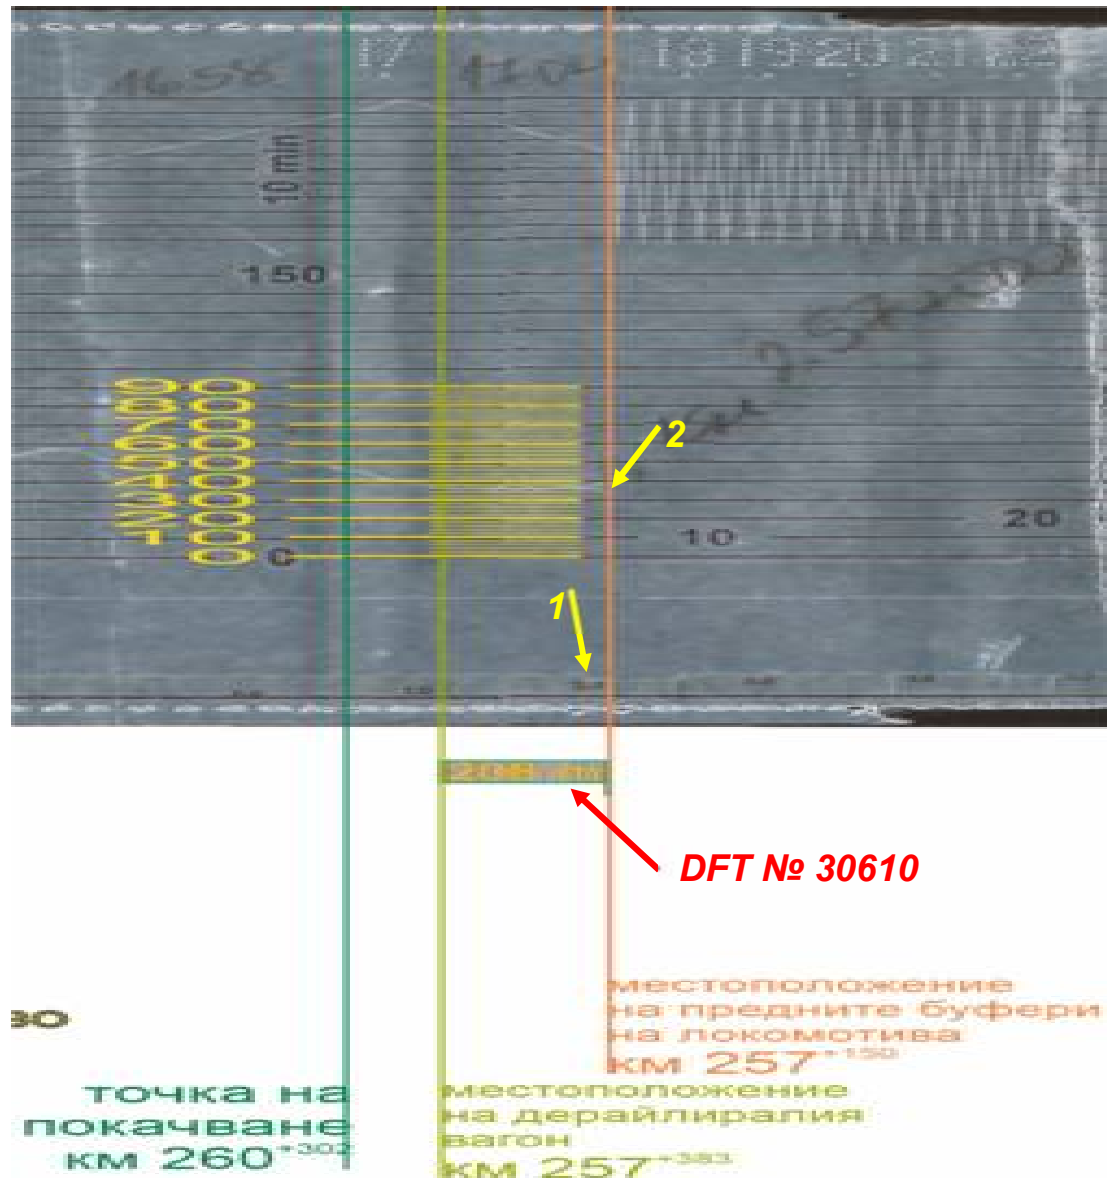
Fig. 4.6. Registration of movement of locomotive of DFT 30610 from Shivatchevo station to km 257⁺¹⁵⁰.

At 17:03, when the locomotive is located at km 257⁺⁴⁵⁰, the pressure in the main air duct begins to decrease (Fig. 4.6, pos. 1). The reduction of the pressure in the main air duct is due to the splitting of the train because of the derailment of wagon № 31525400845-3. After another 200 meters, the speed of the train decreases to 0 km/h, and the train stops (Fig. 4.6, pos. 2). The front buffers of the locomotive are located at km 257⁺¹⁵⁰, and the derailed wagon - at km 257⁺³⁸³.
