REPUBLIC OF BULGARIA
NATIONAL AIR, MARITIME AND RAILWAY ACCIDENTS
INVESTIGATION BOARD

FINAL REPORT

**Investigation of railway accident – fire in a coach of passenger train № 50215 while staying
in Pernik marshalling yard on 04.09.2021**

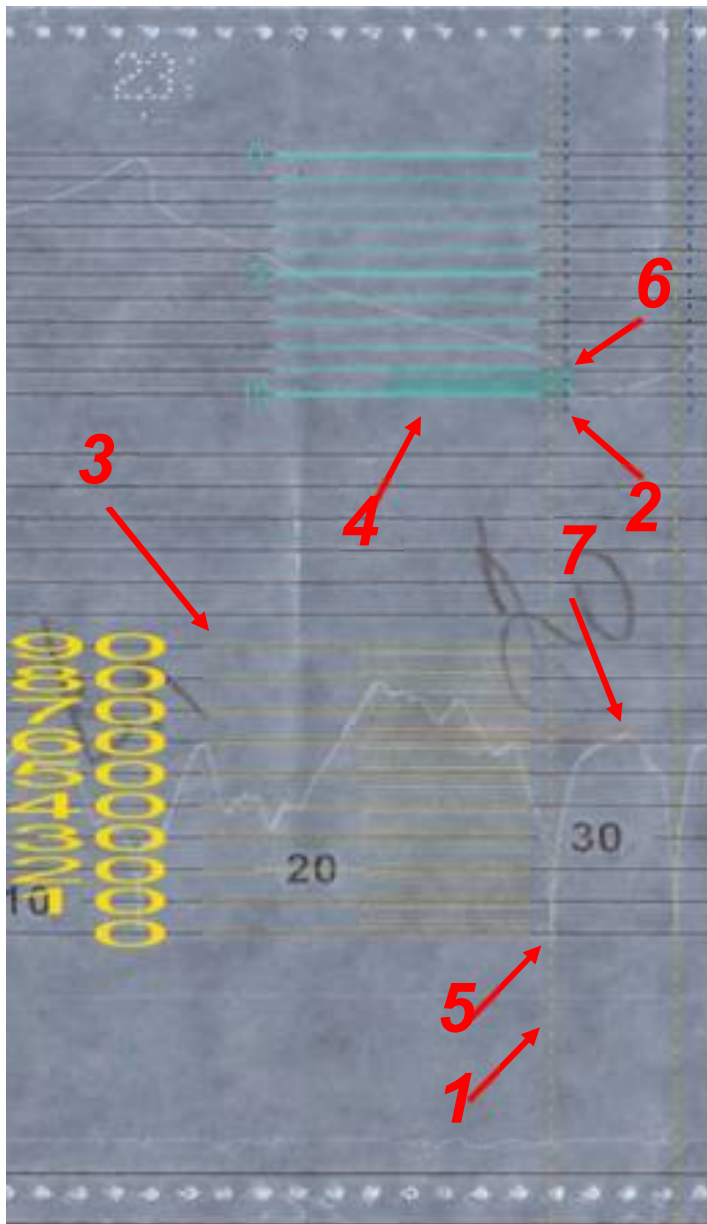
PT No 50215 arrives at Dragichevo station (Figure 4.1, pos. 5) at 23:09:00 p.m., and after a stay of 30 seconds departs at 23:09:30 p.m. (Fig. 4.1, pos. 6). Develops maximum speed 63 km/h (Fig. 4.1, pos. 7) when the allowed for Vladya - Pernik section is 90 km/h, then reduces the speed, holding twice with the automatic train brake, venting air from the main air-duct and at 23:11:20 p.m. settles at Daskalovo halt (Figure 4.2, position. 1). After a stay of 1 minute, departs at 23:12:20 p.m. (Figure 4.2, pos. 2). While travelling to Metal halt, it develops a maximum speed of 60 km/h (Fig. 4.2, pos. 3) and arrives at the halt at 23:14:00 p.m. (Fig. 4.3, pos. 1). It stays 30 seconds and departs at 23:14:30 p.m.

Fig. 4.1. Decoding of the train movement from the arrival at Dragichevo station to the stopping at Daskalovo halt.

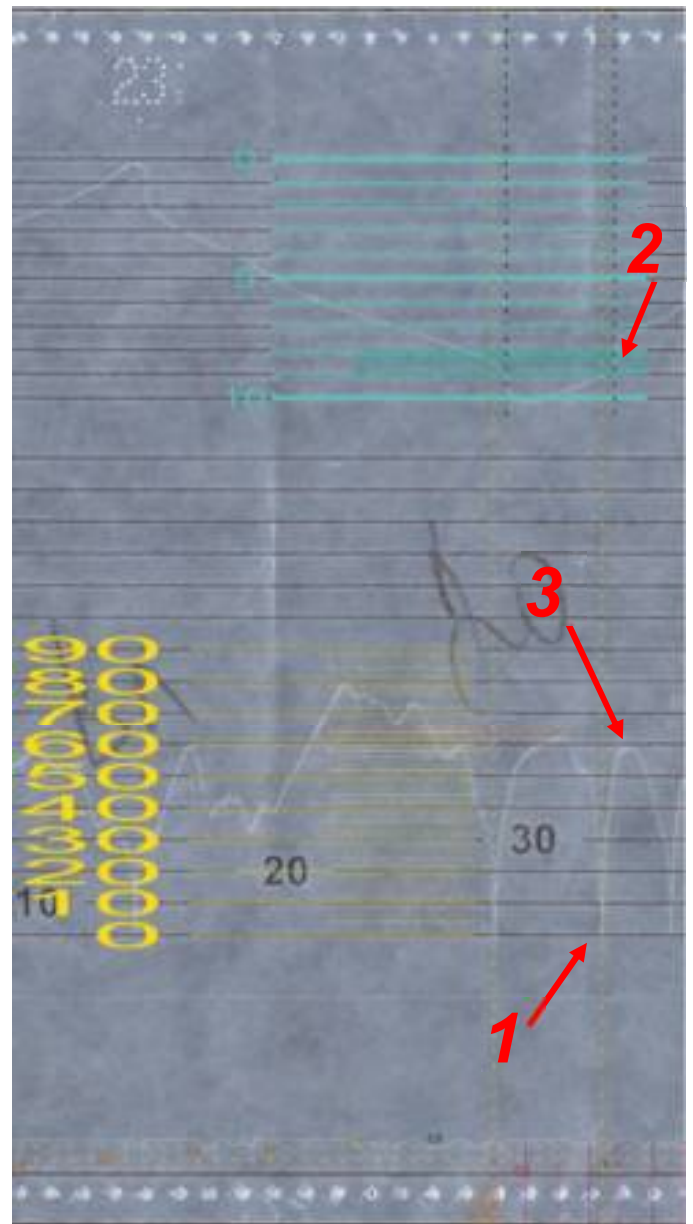
Fig. 4.2. Decoding of the train movement from the arrival at Daskalovo halt to the departure to Metal halt.

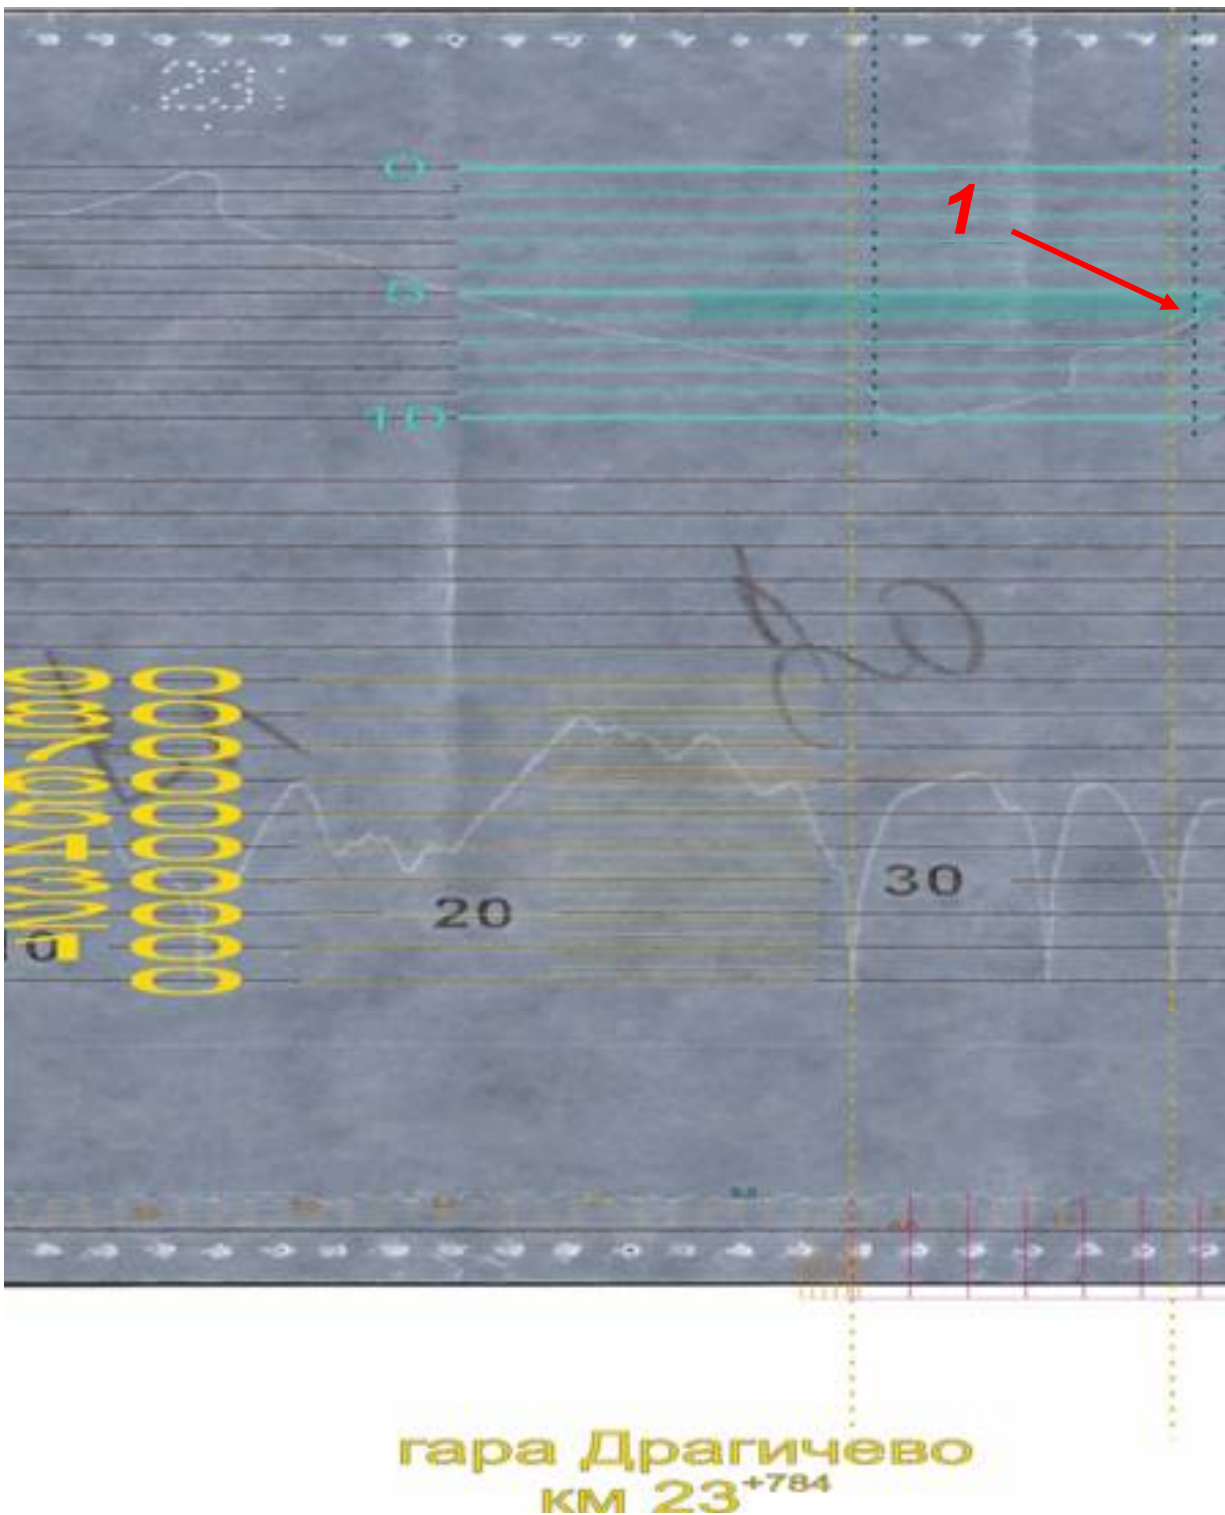
Fig. 4.3. Decoding of the train movement from the arrival at Metal halt to the departure for Pernik marshalling yard.

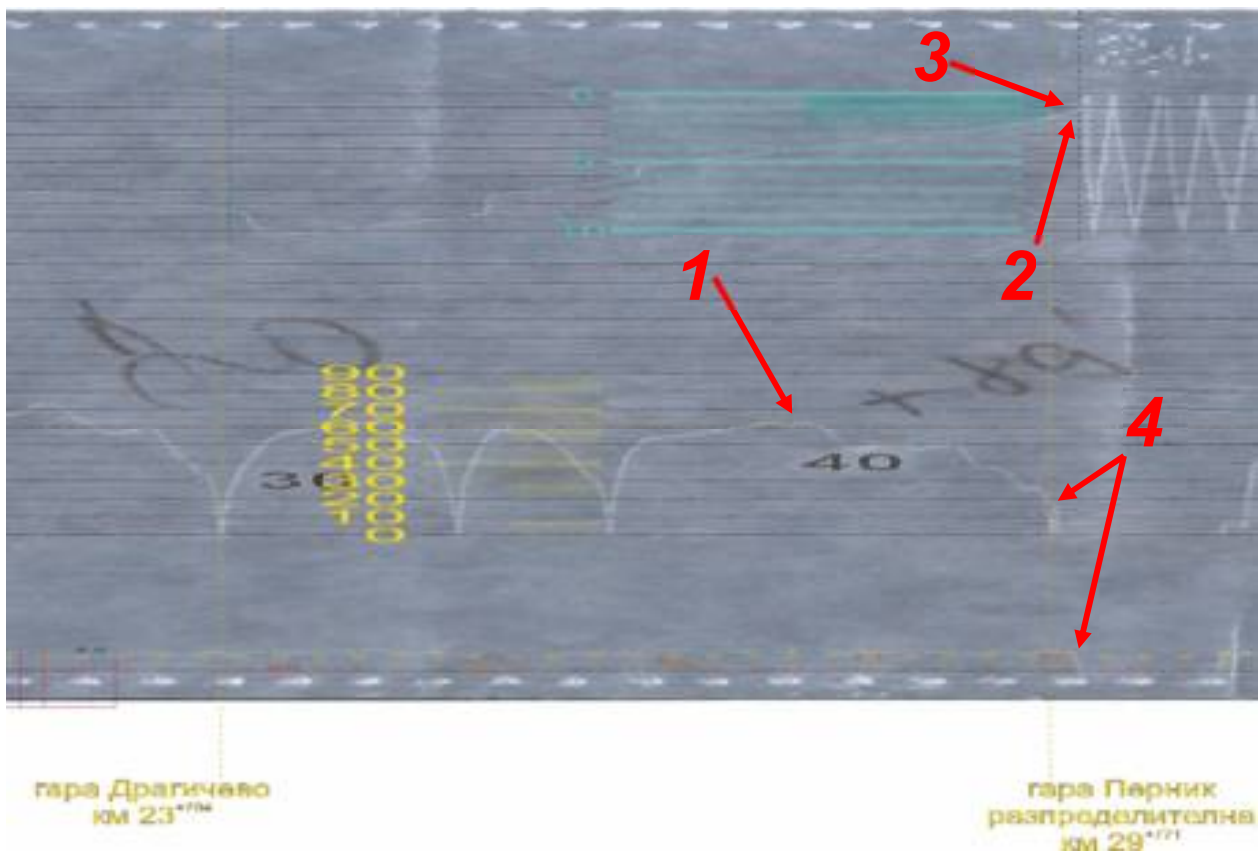
After departure from Metal halt, the train accelerates and again develops speed up to 63 km/h (Fig. 4.4, pos. 1), after which the speed starts to decrease gradually to 47 km/h due to the locomotive driver holding with the automatic train brake, reducing the pressure in the main air duct from 5 to 4 bar, then loosening the brake, the speed increases to 50 km/h, again the driver holds with the train brake, the speed decreases to 48 km/h, there is a new increase in speed to 50 km/h due to a new loosening of the brake, after which the speed begins to decrease again due to multiple retention with the automatic brake until finally the speed decreases to 0 km/h and the train settles at Pernik marshalling yard at 23:18:50 p.m. (Figure 4.4, pos. 2). The train stays for 30 seconds at the station (Figure 4.4, pos. 3).

Train № 50215 departs at 23:19:20 p.m., it develops speed to 15 km/h, passes 15-20 meters for around 10 seconds, and then stops sharply at 23:19:30 p.m. because of the activation of automatic train brake in a “fast stop” mode (fig. 4.4, pos. 4).

Fig. 4.4. Decoding of the train movement from the departure from Metal halt to the detection of the fire in coach № 51522563019-0 during its departure to Pernik marshalling yard.
