**R E P U B L I C O F B U L G A R I A**  
**NATIONAL AIR, MARITIME AND RAILWAY TRANSPORT**  
**ACCIDENTS INVESTIGATION BOARD (NAMRTAIB)**

**FINAL REPORT**

**investigation of serious railway accident – collision of fast train № 7623 in loaded truck at  
railway level-crossing between the stations Dimovo and Oreshets on 07.06.2022**

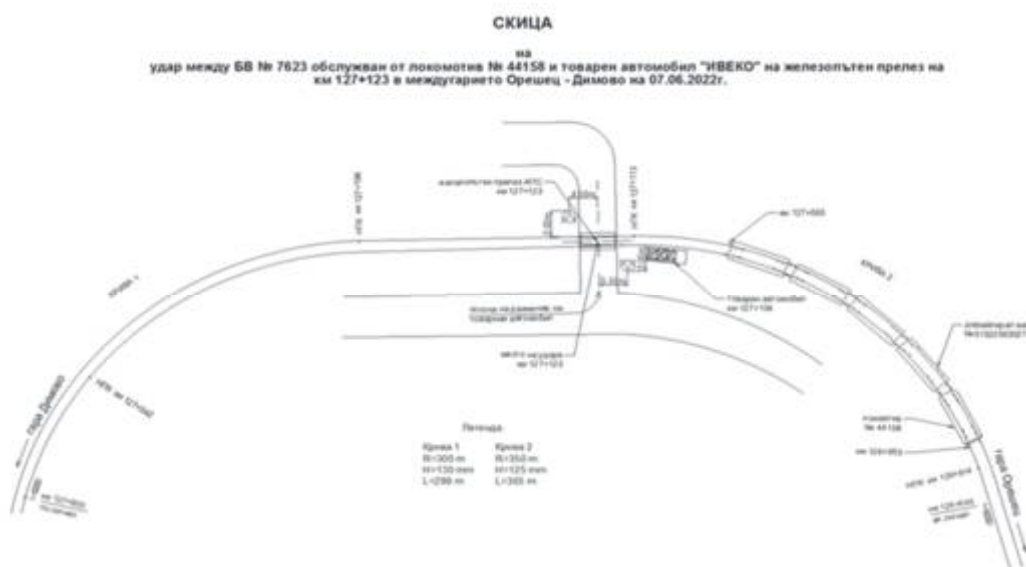
**Fig. 1.5. Scheme of the railway level crossing location – km 127+123.**

After the collision, the locomotive dragged 20 m and threw the freight vehicle to the right outside the railway track and the train continued its movement for another 170 meters (Fig. 1.5). Thus, the remains of the front buffers of the locomotive were found at km 126+953.

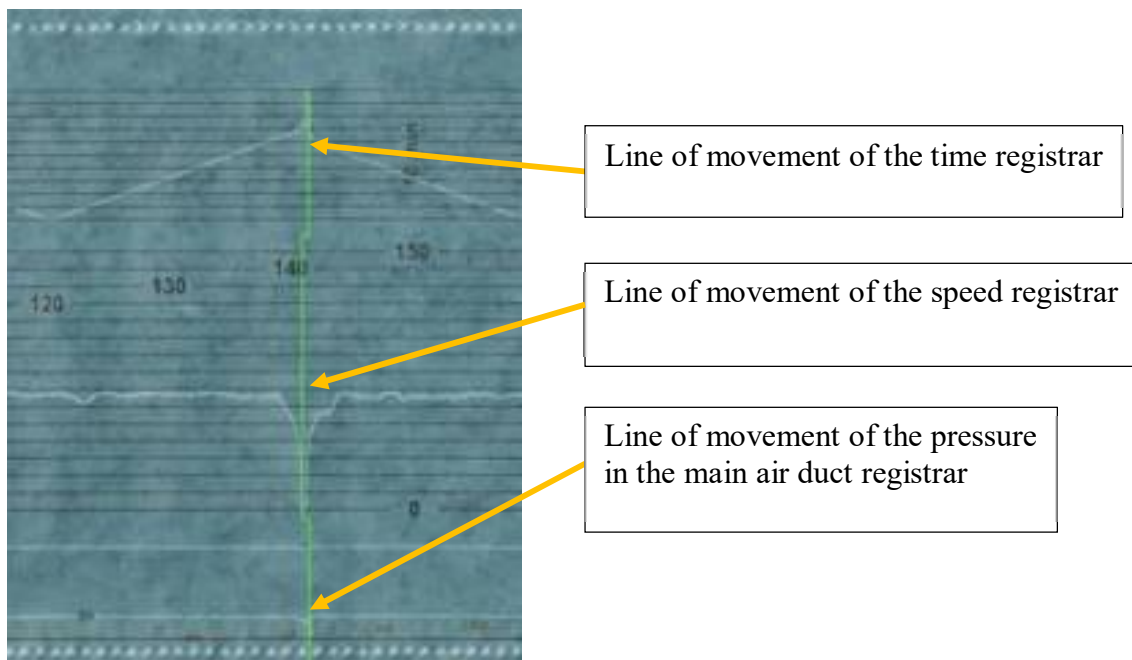
**Fig. 4.4.**

When examining the speedometer tape, it was found that the recorders recording the time and pressure in the main air duct were about 1 mm ahead of the recorder recording the speed of movement (Fig. 4.4). This was taken into account in the analysis of the train movement.

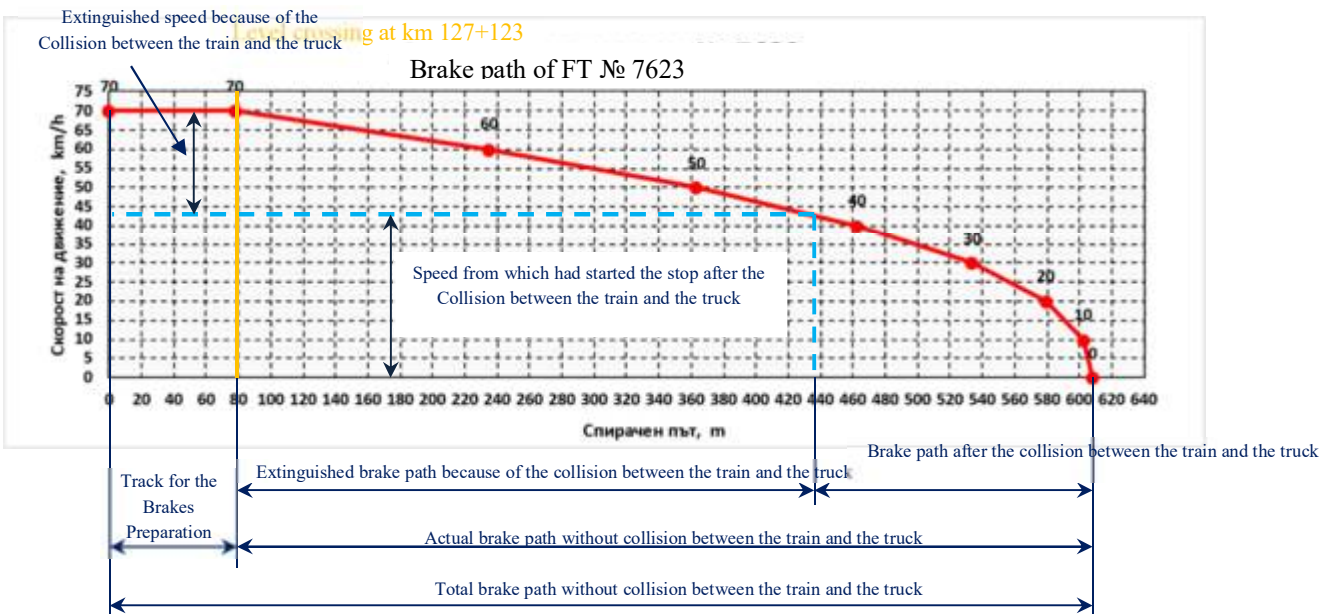
**Fig. 4.14.**

After a detailed and thorough analysis of the movement of the train in the last meters of its movement, it was found that the braking distance of the train should have continued as described in fig. 4.14 curve and that it stopped 608 meters after the moment of arrest with the automatic train brake, at km 126+587. In fact, the train's braking distance was shortened by the collision with the truck, which resulted in a significant dissipation of the train's kinetic energy, followed by a sharp deceleration, and it stopped at km 126+953 (where the front buffers of the locomotive were after the suspension), i.e. 366 meters shorter braking distance was realized.
